**CHARLES WILLIAMS STREAM, WETLAND, AND BUFFER SITE**  
**DMS Project No. 80**

**MONITORING YEAR 6 – VEGETATION ONLY (2018)**  
**Construction Completed February 2013**  
**Planting Completed February 2014**

**Randolph County, NC**  
**State Construction Project No. 07-07125-01A**

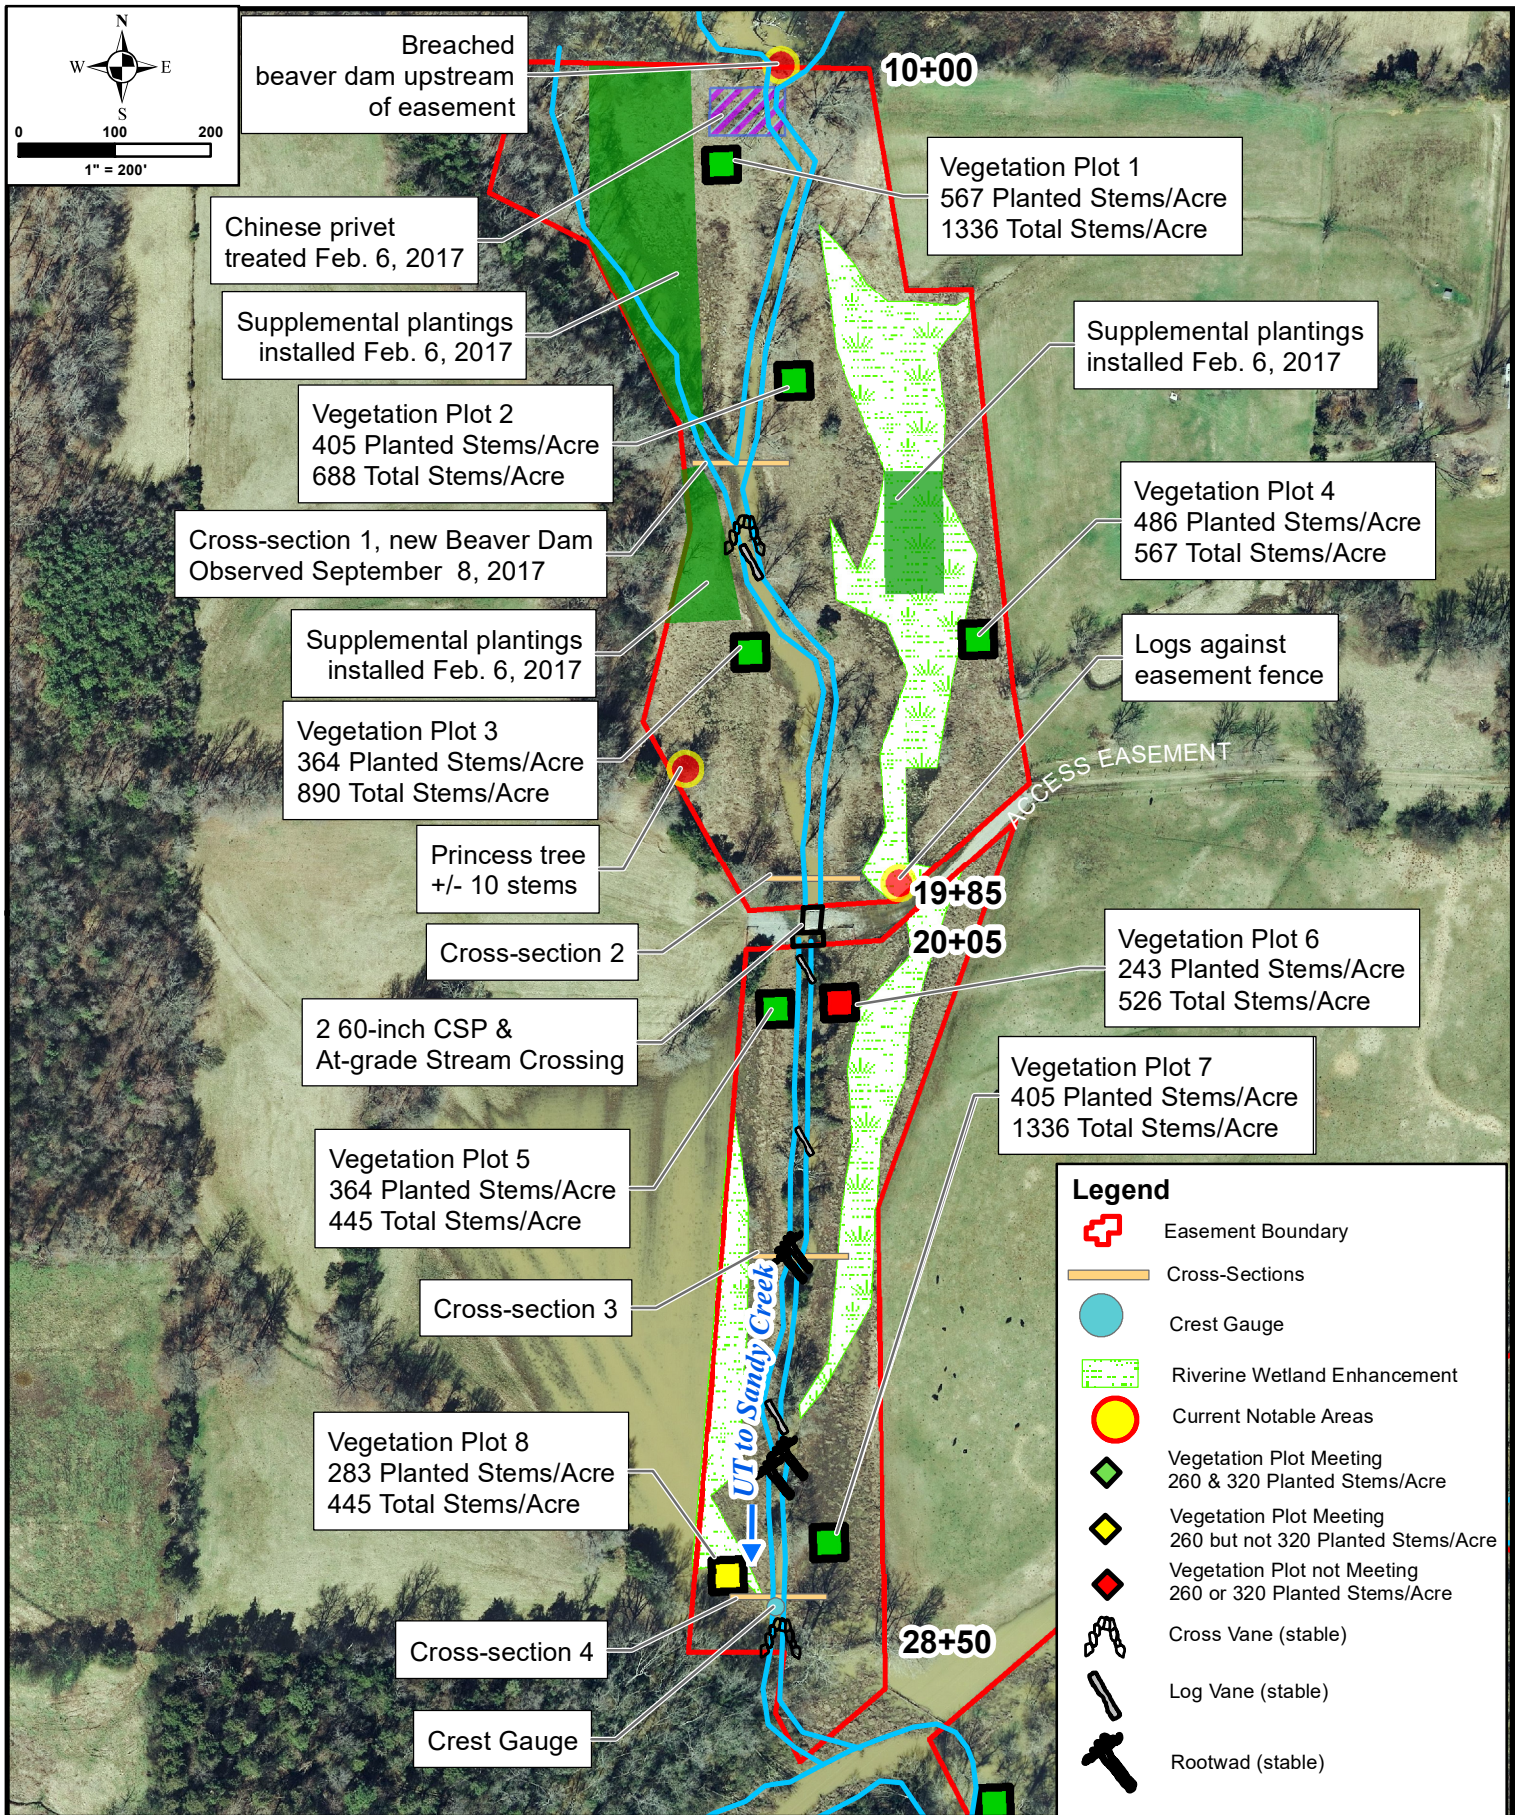
**FIGURE 3a**

Planted Acreage: 16 acres							
Vegetation Category	Definitions	Mapping Threshold	CCPV Depiction	Number of Polygons	Combined Acreage	% of Planted Acreage	
Bare Areas	Very limited cover of both woody and herbaceous material.	0.1 acres	n/a	0	n/a	n/a	
Low Stem Density Areas	Woody stem densities clearly below target levels based on MY 3, 4, or 5 stem count criteria.	0.1 acres	Not depicted - natural woody stems bring woody stems up to target levels for veg. plots where planted stem survival is low.	0	n/a	0%	
				<b>Total</b>	0	0	1%
Areas of Poor Growth Rates or Vigor	Areas with woody stems of a size class that are obviously small given the monitoring year.	0.25 acres	n/a	0	n/a	n/a	
				<b>Cumulative Total</b>	0	0	0%
Estimated Acreage: 18 acres							
Vegetation Category	Definitions	Mapping Threshold	CCPV Depiction	Number of Polygons	Combined Acreage	% of Planted Acreage	
Invasive Areas of Concern	Areas or points (if too small to render as polygons at map scale).	<1,000 SF	See CCPV	2	<.1 acres	<1 %

Easement Encroachment Areas	Areas or points (if too small to render as polygons at map scale).	1,000 SF	See CCPV	1	0.3 acres	1%

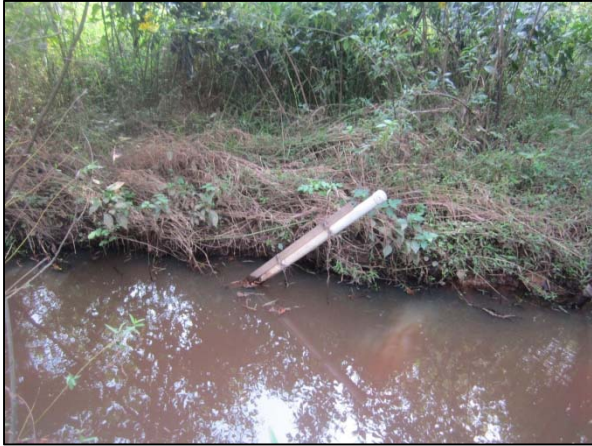
A crest gauge was installed near the downstream end of the Site along the UT to verify the on-site occurrences of bankfull events. In addition to the crest gage, observations of recently deposited overbank wrack and/or sediment serve to validate gauge observations, as necessary. Documentation of the highest stage during the monitoring interval is assessed during each site visit and the gauge is reset. However, this year the gauge was disturbed by debris and the data was not reliable.

Crest Gage Current Condition Sept. 2018

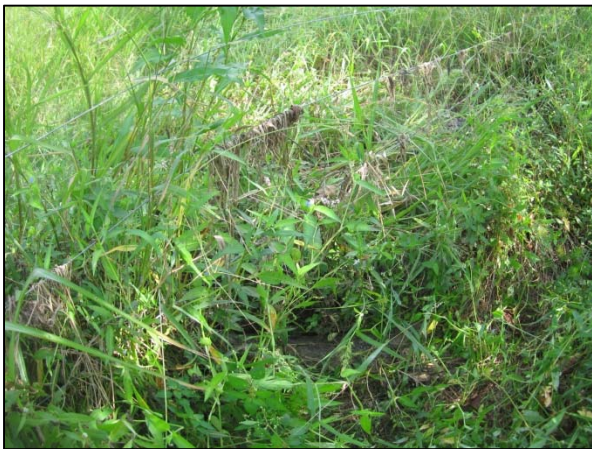
Evidence of overbank events was observed during the 2018 vegetation assessment in September and consisted of wrack material and sediment staining above the bankfull indicators along the channel, alluvial deposits outside the channel, debris along the fence associated with the stream crossing, and flattened vegetation far into the floodplain. The crest gauge had been adversely impacted by debris and was leaning downstream at nearly 45 degrees. As a result, any readings were not deemed valid. Hydrologic data associated with this year's monitoring assessment are provided in Appendix E and serves only as a comparison.

Wrack on fence wire indicating overbank flow

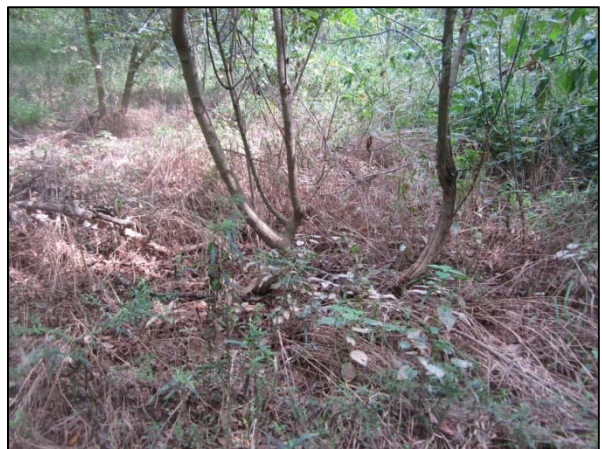
Water stained vegetation within floodplain

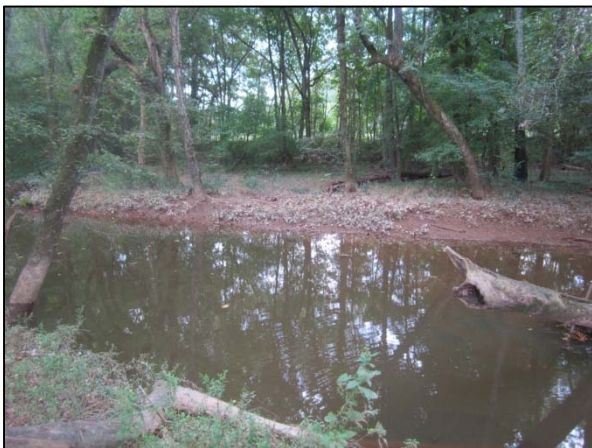
Sediment laden vegetation along Sandy Creek
