# **MONITORING YEAR 1 ANNUAL REPORT**

## **SASSARIXA SWAMP MITIGATION SITE**

Johnston County, NC  
Neuse River Basin  
HUC 03020201

DMS Project No. 100040  
DMS Contract No. 7425  
DMS RFP No. 16-007279  
USACE Action ID No. 2018-00432  
DWR Project No. 2018-0198

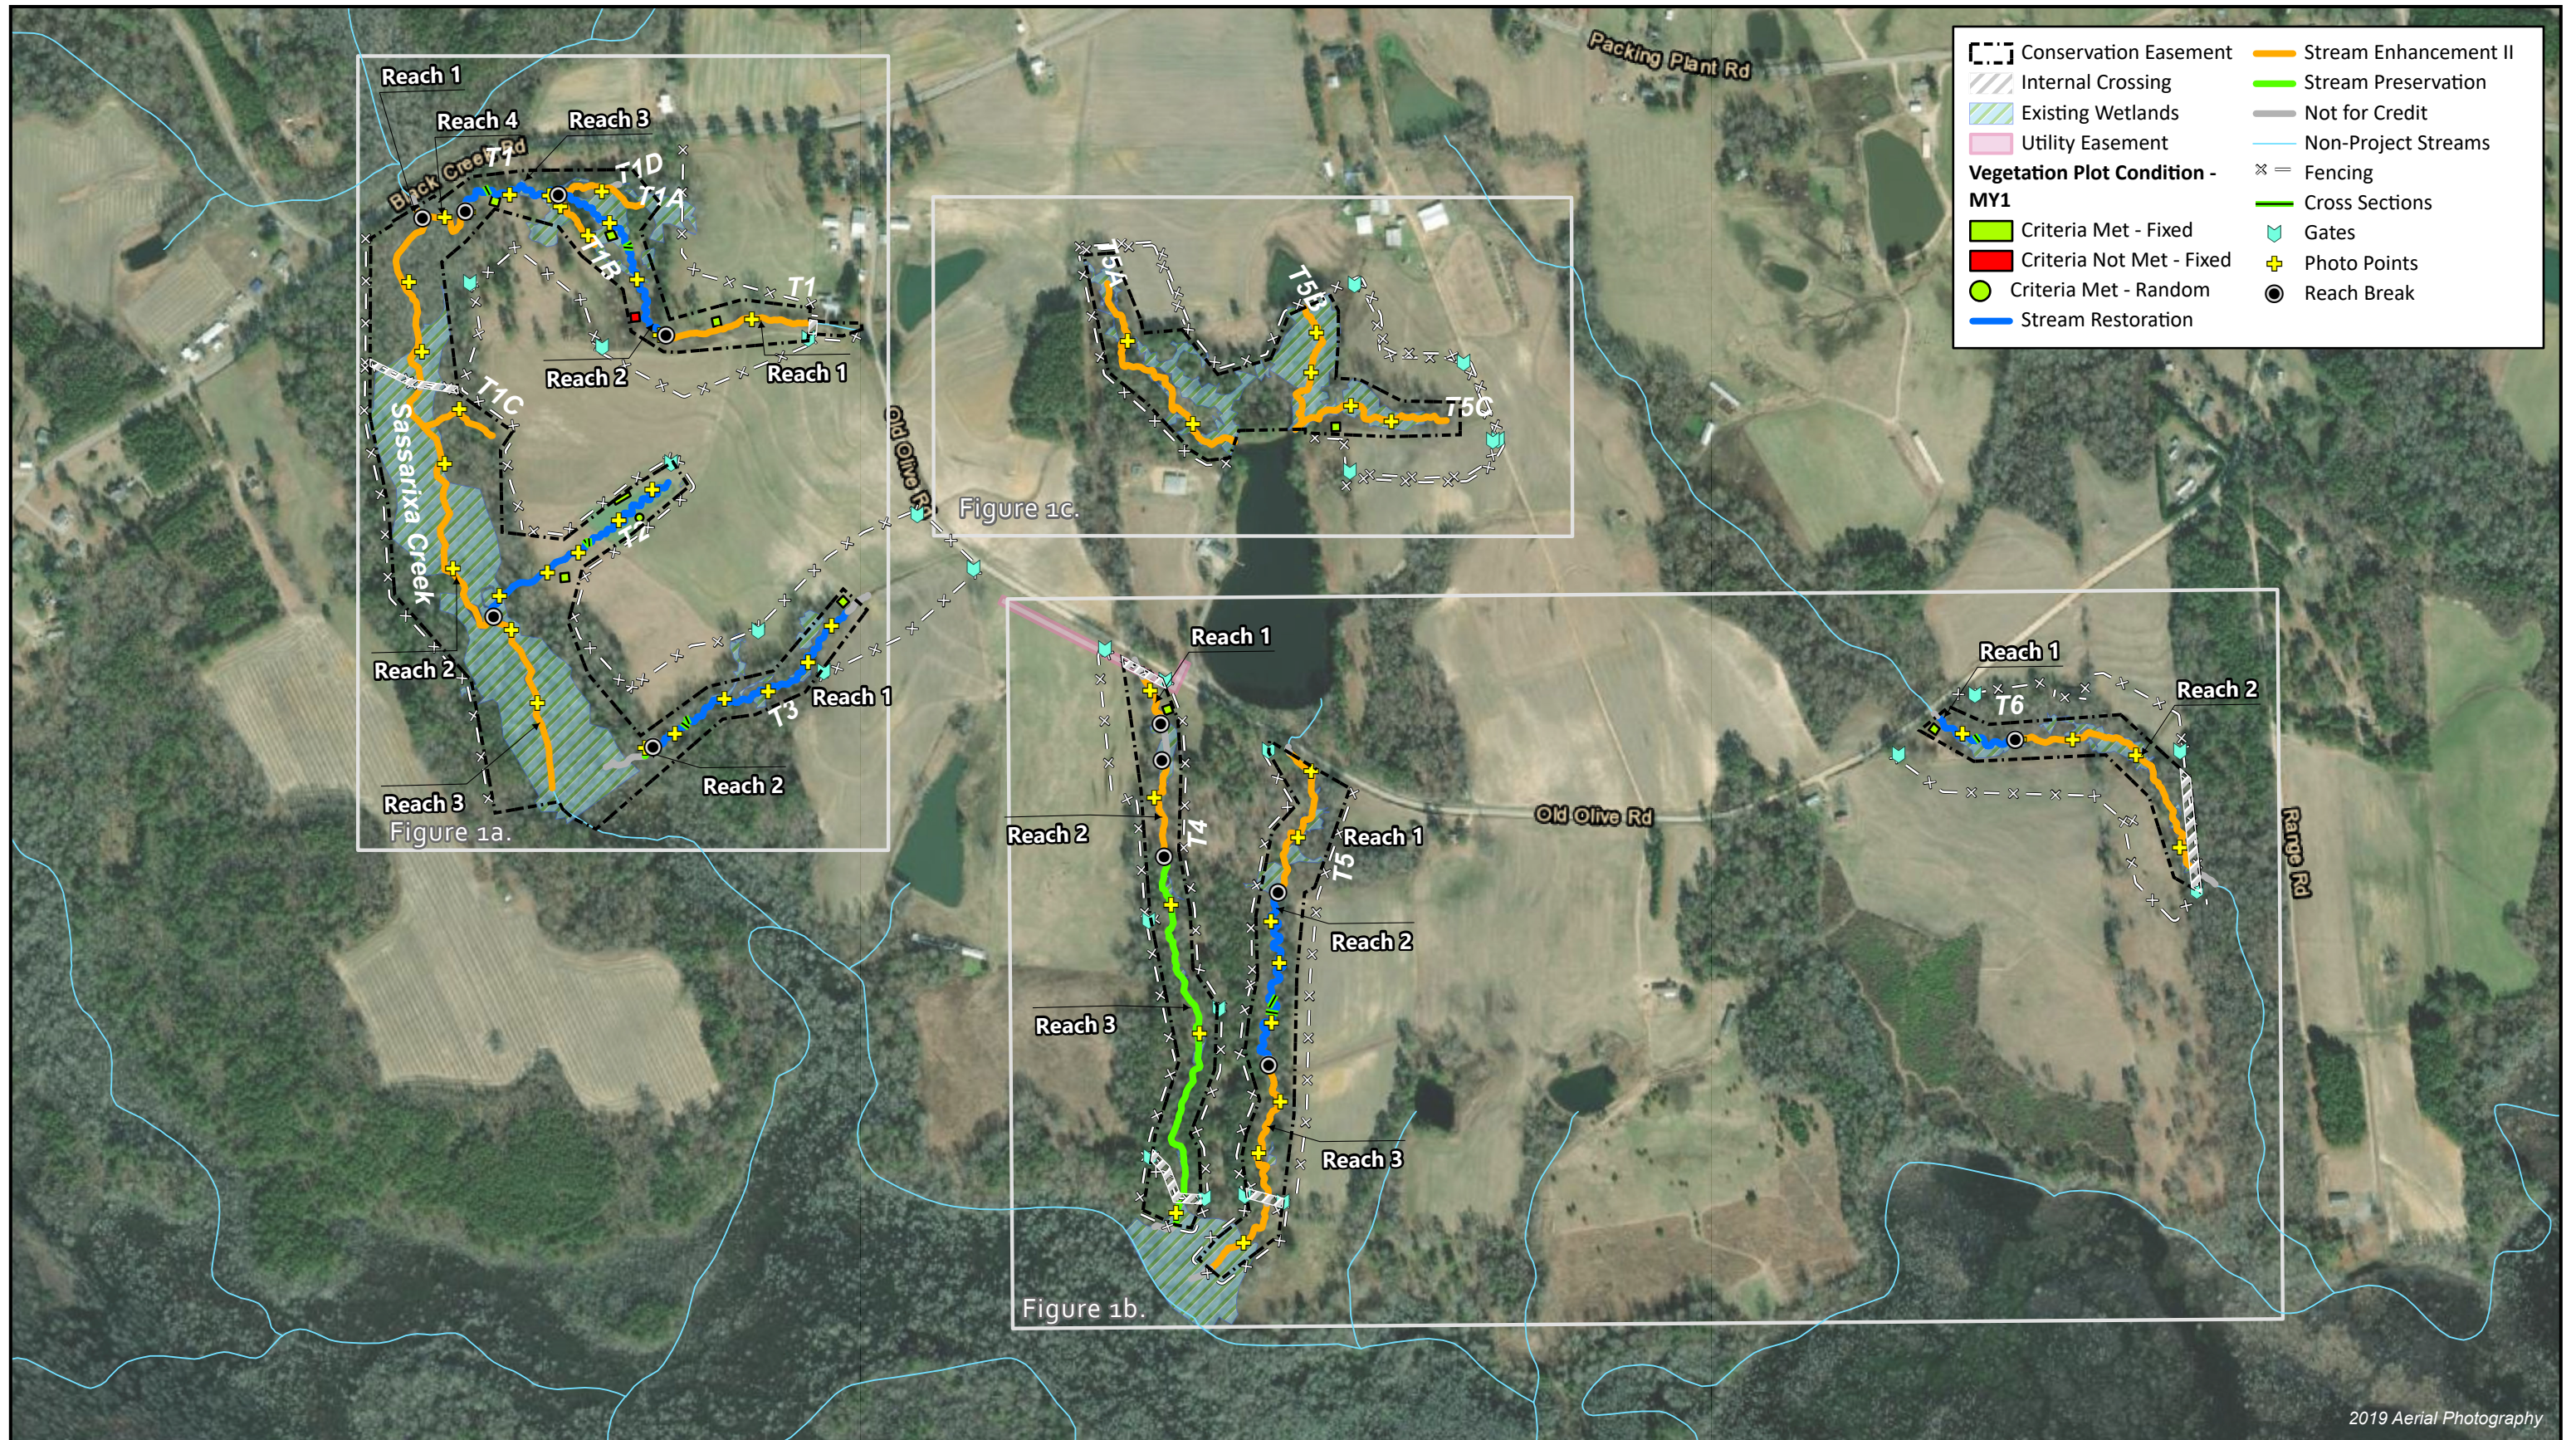
Figure 1a. Current Condition Plan View  
 Sassarixa Swamp Mitigation Site  
 DMS Project No. 100040  
 Monitoring Year 1 - 2021

Several cattle were observed within the Site throughout July 2021. Cattle had access to 11.39 acres of the Site between the Sassarixa Creek ford crossing to the top of T1 (Figure 1a). The cattle were entering the Site through the high tensile fence along the Sassarixa Creek ford crossing. The landowner has agreed to keep the outside gates closed unless supervising the cattle crossing Sassarixa Creek. No cattle have been seen in the easement since July 2021, indicating the easement encroachment has been resolved. No major damage occurred to the Site due to cattle encroachment, except for several dented easement signs.

The spring and summer of 2021 had below average rainfall. Due to dry conditions and lack of shade before woody vegetation has become established, *Murdanina* (Figure 1a-b) was observed in most tributaries. Wildlands was proactive with in-stream vegetation management and treated T1 Reach 1-3,
