MONITORING YEAR 3 ANNUAL REPORT Final

February 2024

SASSARIXA SWAMP MITIGATION SITE

Johnston County, NC
Neuse River Basin
HUC 03020201
DMS Project No. 100040
DMS Contract No. 7425
DMS RFP No. 16-007279
USACE Action ID No. 2018-00432
DWR Project No. 2018-0198

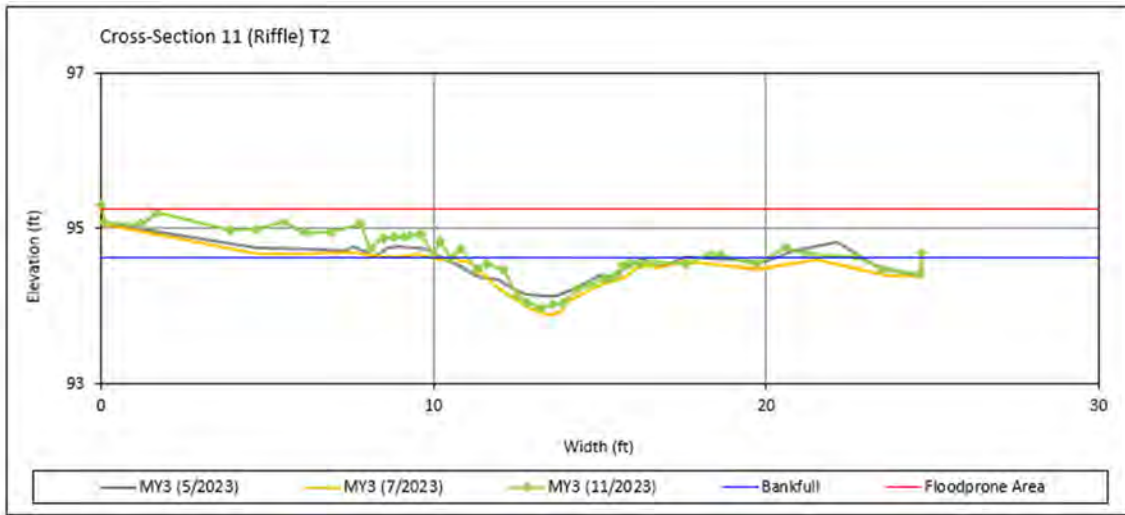
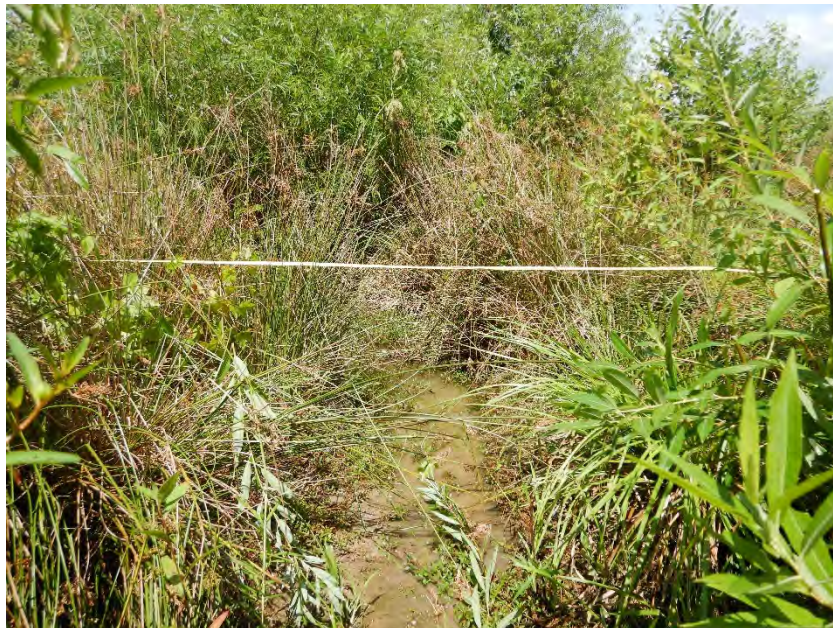
MY3 (5/31/2023)	MY3 (7/20/2023)	MY3 (11/14/2023)	MY4	MY5	MY7
Bankfull Elevation - Based on AB-Bankfull Area	94.62	94.52	94.57			
Bank Height Ratio - Based on AB-Bankfull Area	1.00	1.00	1.00			
Thalweg Elevation	94.13	93.88	93.98			
LTOB Elevation	94.62	94.52	94.57			
LTOB Max Depth	0.49	0.64	0.60			
LTOB Cross-Sectional Area	1.69	1.68	1.69

* An additional cross-section on the upper reach of T2 was requested by the NCIRT to monitor sedimentation and vegetation accumulating within the channel. The cross-section was installed in May 2023. The cross-section was surveyed to establish baseline conditions before vegetation and sedimentation were raked out to clear the stream. The cross-section was then surveyed after raking was completed, and then surveyed again 6 months later to observe any changes in channel stability.

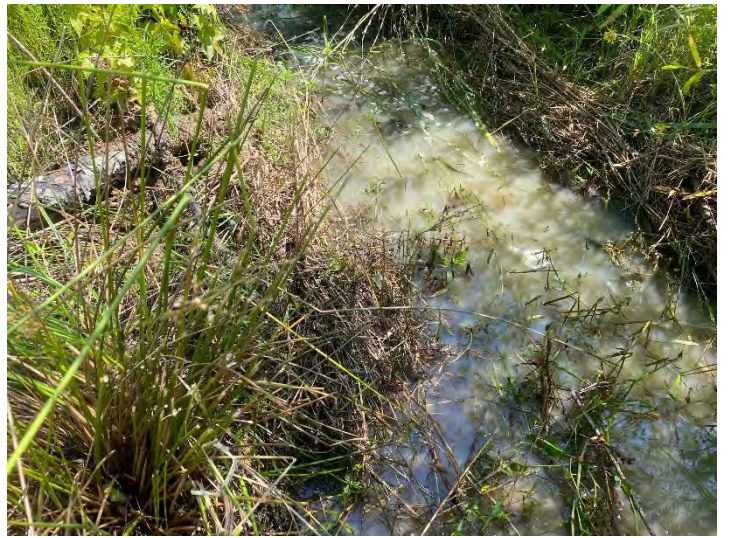
T2 (6/30/2023)

Due to concern over the upper third of T2 appearing to be turning into a linear wetland, the NCIRT requested that an additional cross-section be installed at the upstream end of T2. During and immediately following construction of the Site, sediment entered the top of T2 and began accumulating in the channel. This allowed in-stream vegetation to become established, which resulted in channel constriction and flow restriction. The additional cross-section (XS 11) was installed in May 2023 and a cross-section survey was taken to document geomorphology of the channel before being raked out. At the end of June 2023, approximately 545 linear feet of channel was raked out to remove in-stream vegetation and sediment (Figure 1a). An additional cross-section survey was completed immediately after the stream was raked out, and then again four months later. While the cross-sectional area experienced little change between the initial survey on May 31, 2023, and when it was resurveyed on July 20, 2023 after the raking, the max depth increased. The third survey on November 14, 2023, indicated minimal changes in cross-sectional area, bankfull elevations, thalweg elevation, and max depth. This indicates that the stream stable and moving sediment through the system. The upper third of T2 will continue to be monitored for further sediment accumulation or vegetation growth in the channel.
