**MONITORING YEAR 2  
ANNUAL REPORT**  
Final

**SASSARIXA SWAMP MITIGATION SITE**

Johnston County, NC  
Neuse River Basin  
HUC 03020201

DMS Project No. 100040  
DMS Contract No. 7425  
DMS RFP No. 16-007279  
USACE Action ID No. 2018-00432  
DWR Project No. 2018-0198

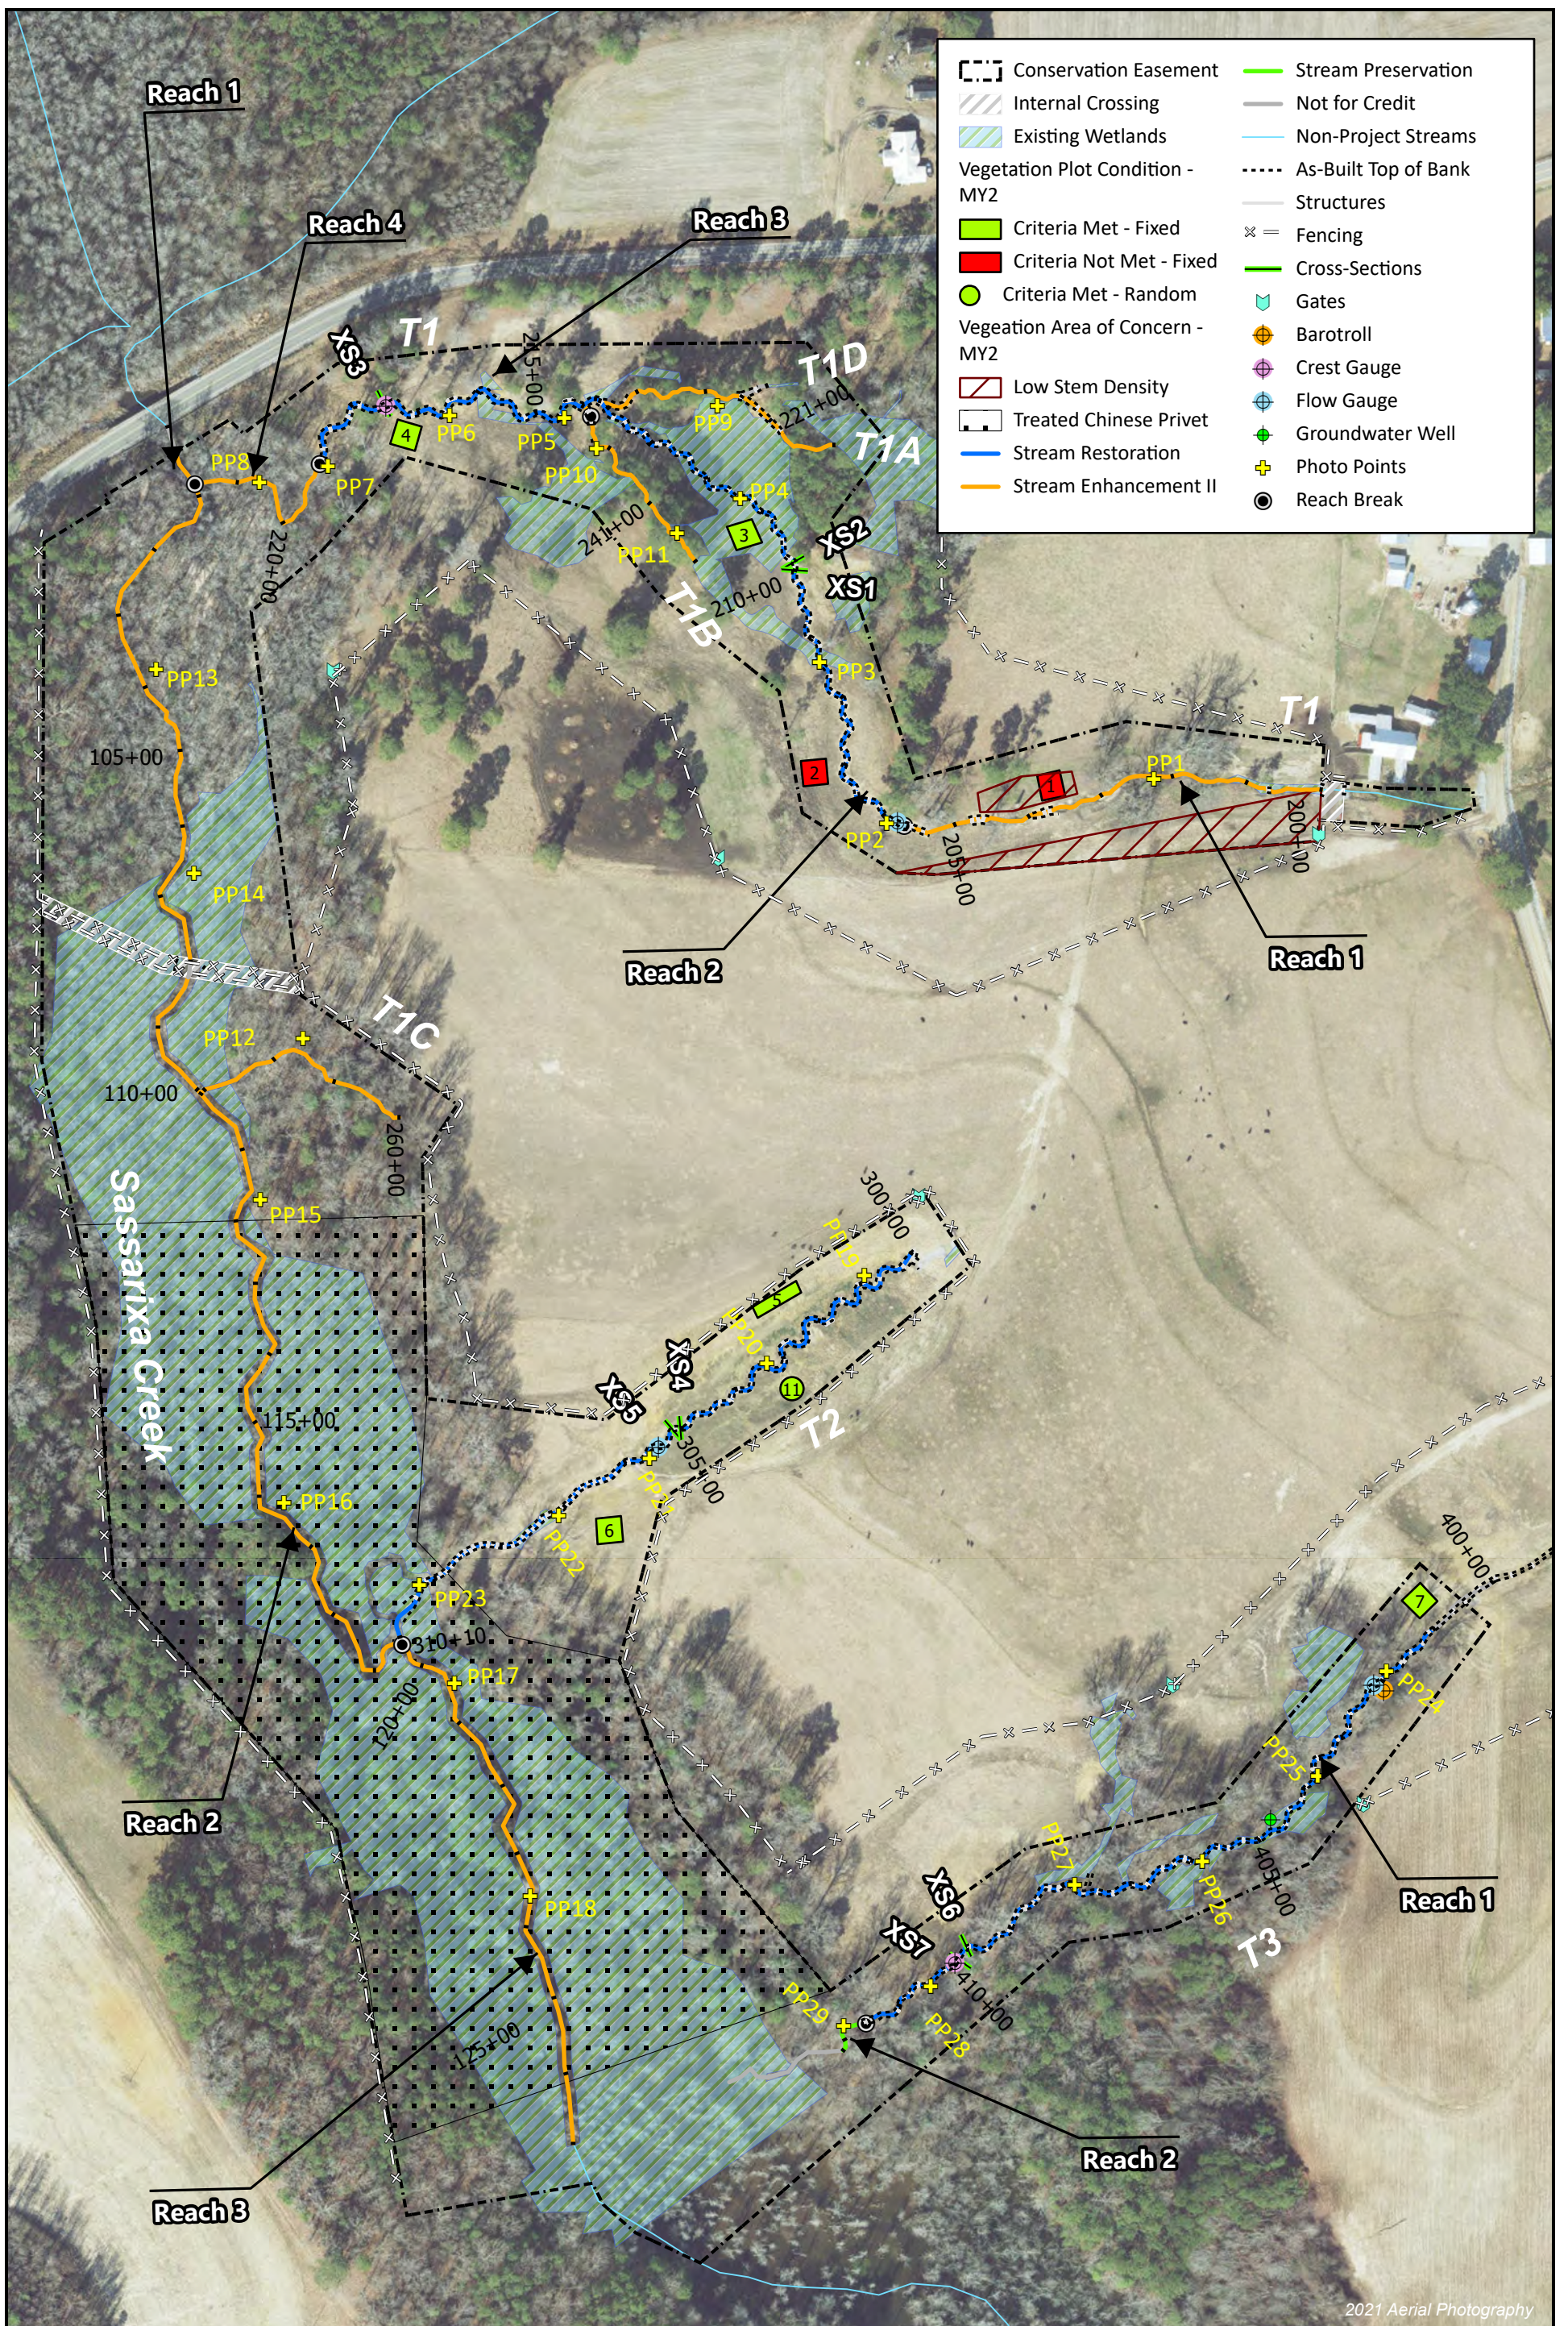
Figure 1a. Current Condition Plan View  
 Sassarixa Swamp Mitigation Site  
 DMS Project No. 100040  
 Monitoring Year 2 - 2022

A 0.55-acres of replanting will occur in the winter of 2022/2023 to supplement the tree mortality that was assessed along T1 (Figure 1a). This area and any new species not included in the approved Mitigation Plan (Wildlands, 2019) is currently under review by the IRT.

A follow up invasive treatment occurred in March 2022 along the 11.99 acres (Figure 1a) along the lower half of Sassarixa Creek to treat the Chinese privet (*Ligustrum sinense*) that resprouted from the originally treatment during construction. A combination of methods included foliar and cut stump applications. The Site will continue to be monitored for invasive species and follow up treatments will occur if necessary.

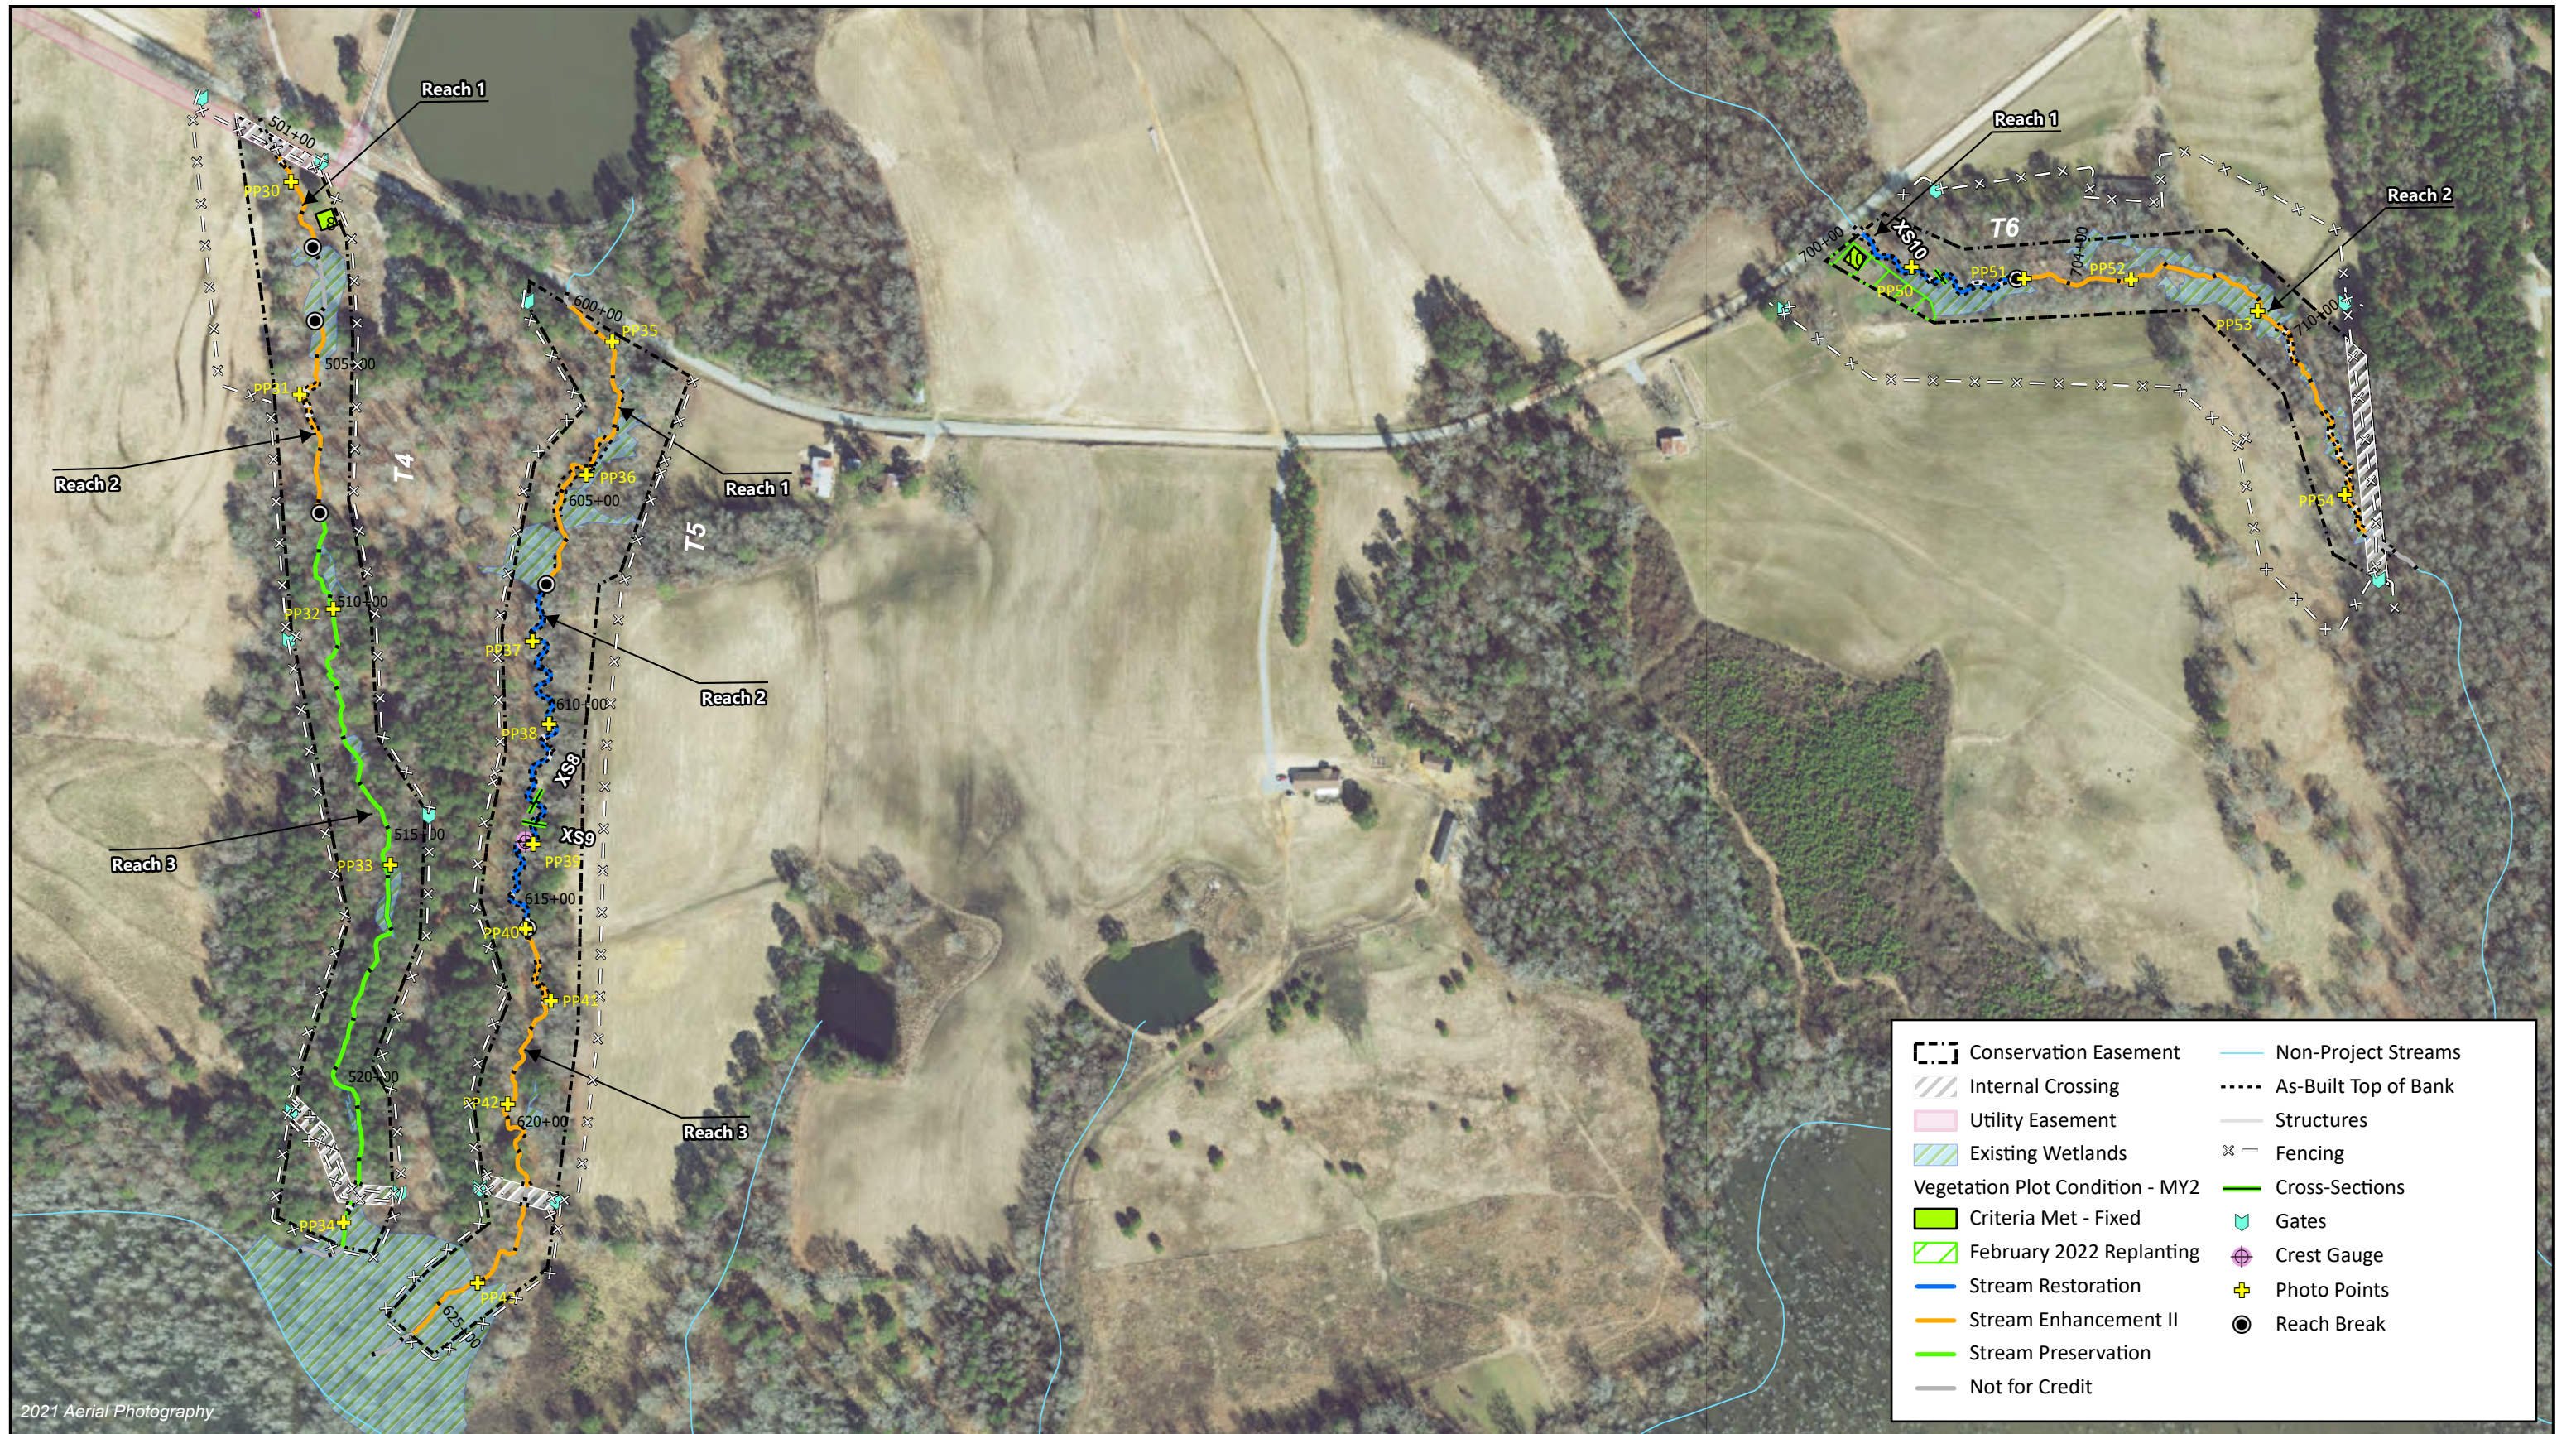
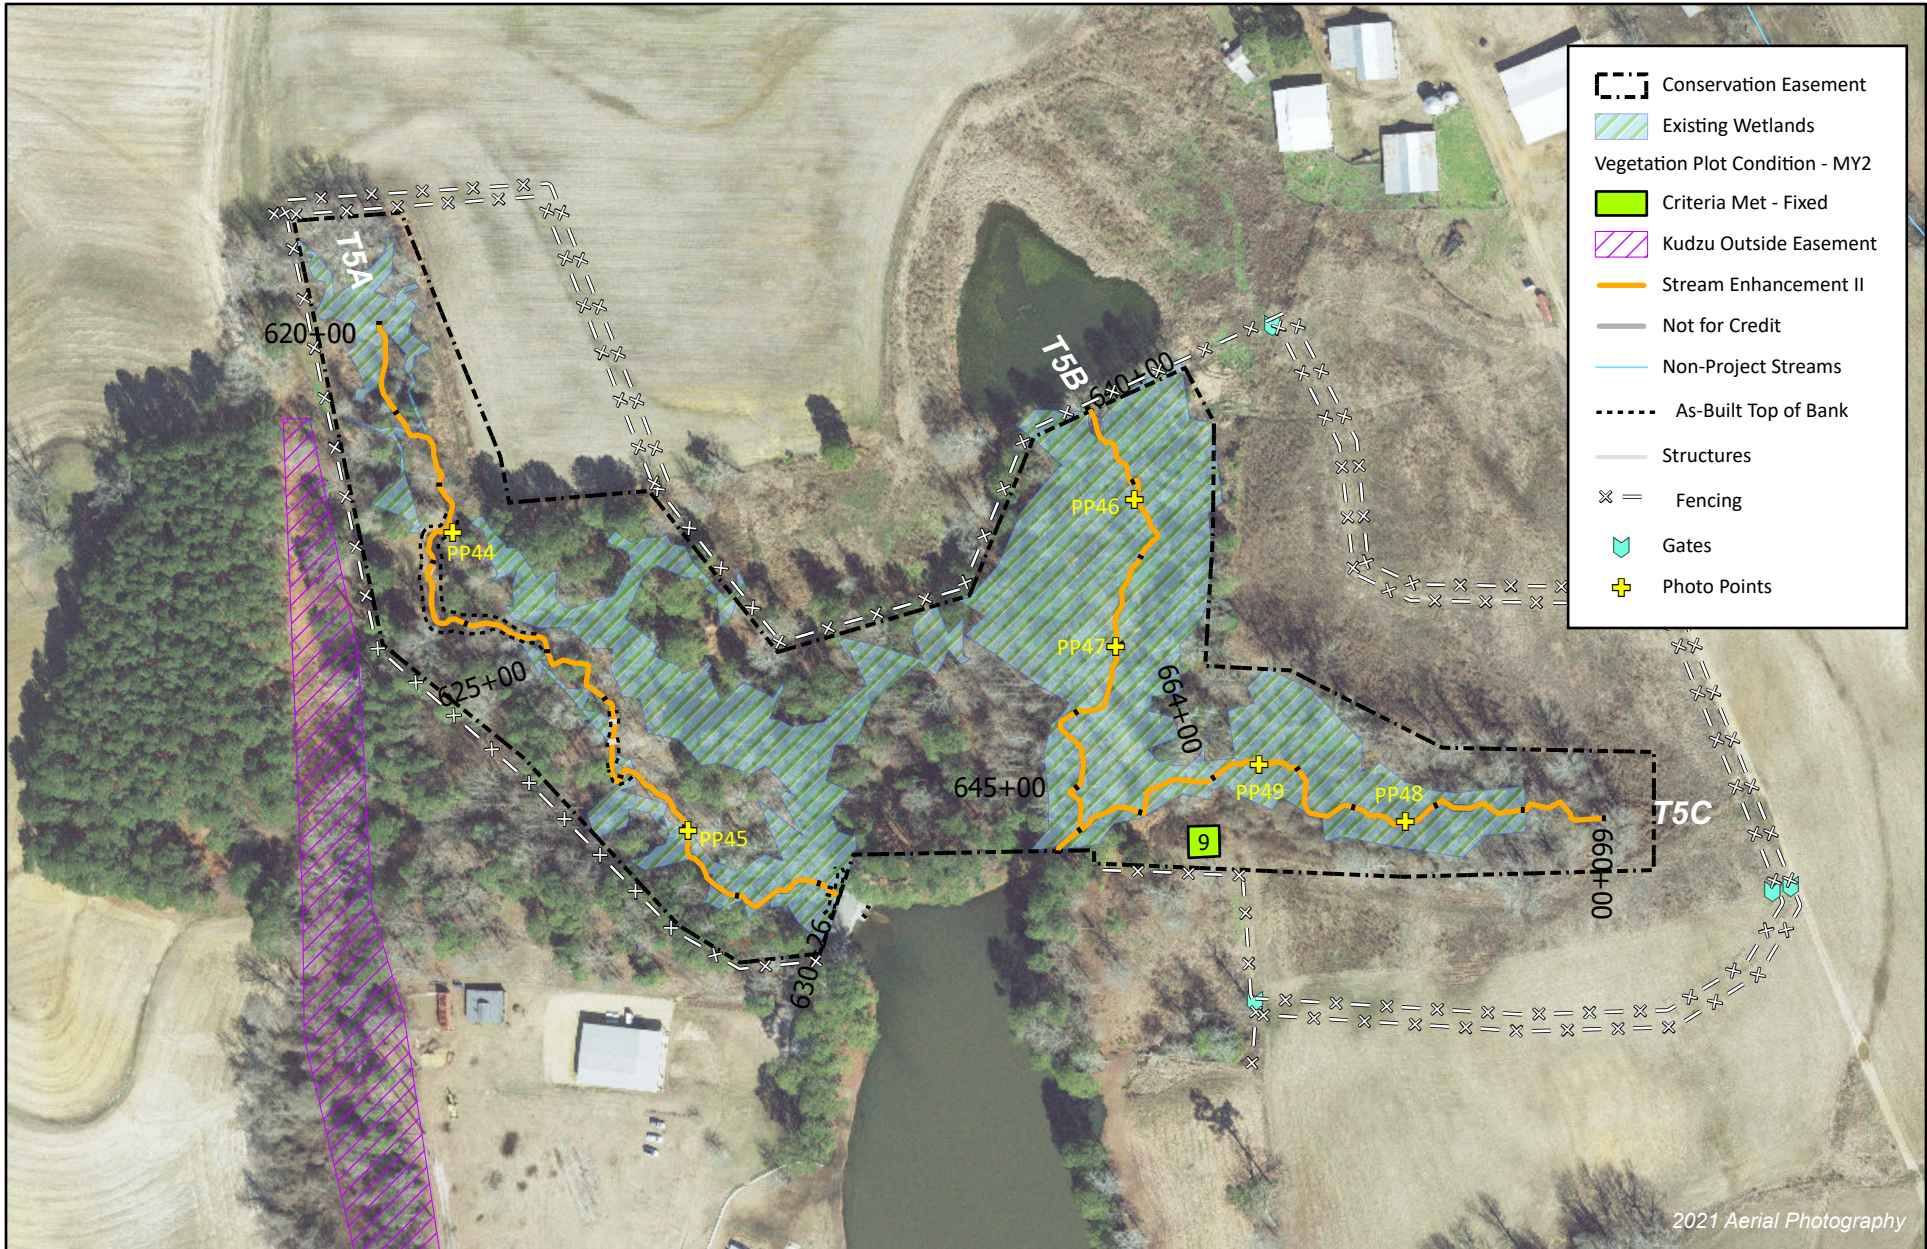
Figure 1c. Current Condition Plan View  
 Sassarixa Swamp Mitigation Site  
 DMS Project No. 100040  
 Monitoring Year 2 - 2022

Kudzu (*Pueraria montana*) has been established outside of the Site along the farm path leading up to T5a (Figure 1c). As a preventative measure to ensure Kudzu does not become established on Site, Wildlands received permission from the landowner to treat the Kudzu along the farm path in July 2022. Follow up treatments will be scheduled in the upcoming years.
