# MONITORING YEAR 4 ANNUAL REPORT Final

## SCALY BARK CREEK MITIGATION SITE

Stanly County, NC  
DENR Contract 002030  
NCEEP Project Number 94148

Data Collection Period: May 2014-July 2014  
Draft Submission Date: September 3, 2014  
Final Submission Date: September 29, 2014

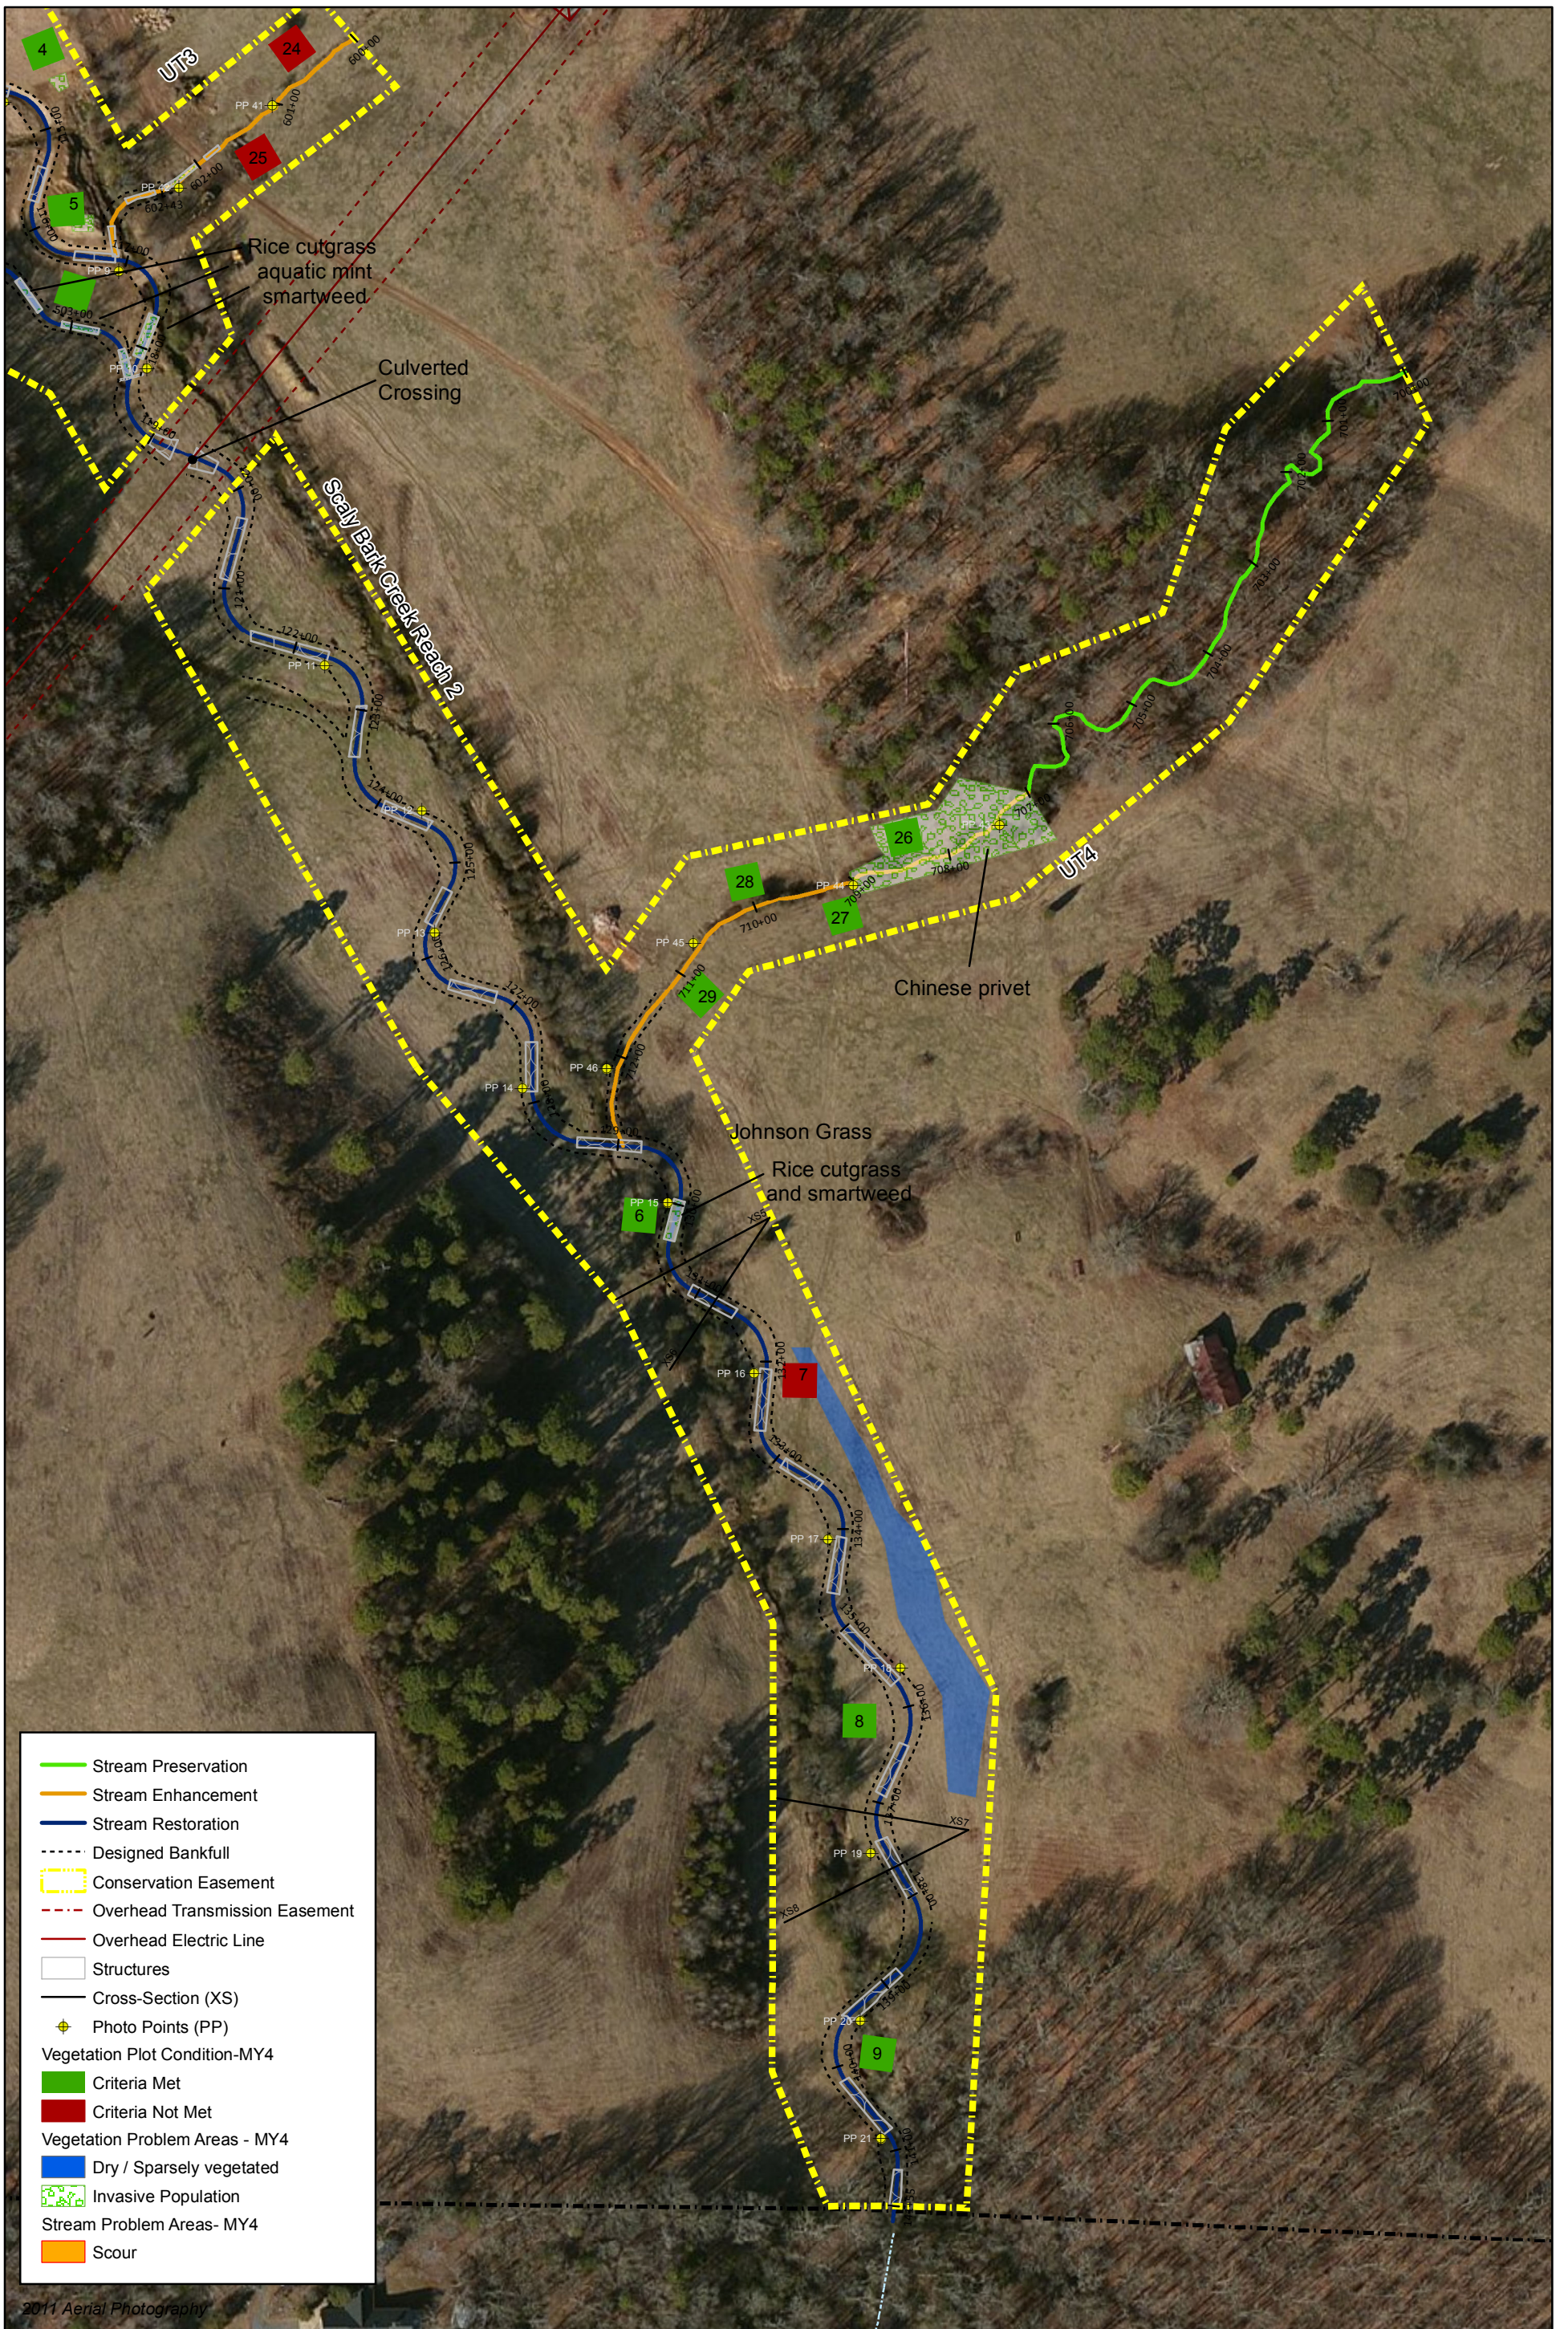
Figure 3.2 Integrated Current Condition Plan View (Sheet 2 of 3)  
 Scaly Bark Creek Mitigation Site  
 EEP Project Number 94148  
 Monitoring Year 4

There are distinct areas with characteristically low herbaceous growth and dry soil conditions along UT1 Reach 1 and Scaly Bark Reach 2. Along UT4 and UT1B, there are distinct areas with exceptionally dense herbaceous cover that has affected the survival rate of planted stems during MY2 and MY3. These sections will continue to be monitored closely to maximize survivability of planted stems. The non-native invasive aquatic weed muskgrass (*Chara* sp.) was found in pools in Scaly Bark reach 1. Both non-native and native plant species were observed within several riffles in Scaly Bark Reach 1 and Reach 2 and UT2: (rice cut grass (*Leersia oryzoides*), smartweed (*Polygonum hydropiperoides*), aquatic mint (*Mentha aquatic*), wartremoving herb (*Murdannia keisak*), and Asian dayflower (*Commelina communis*). Please refer to Appendix 2 and Figures 3.0-3.3 for the Current Condition Plan View, which outlines these areas of concern.
