MONITORING YEAR 5 ANNUAL REPORT

SCALY BARK CREEK MITIGATION SITE

Stanly County, NC
NCDEQ Contract 002030
NCDMS Project Number 94148

Data Collection Period: March 2015-July 2015
Draft Submission Date: September 21, 2015
Final Submission Date: November 20, 2015

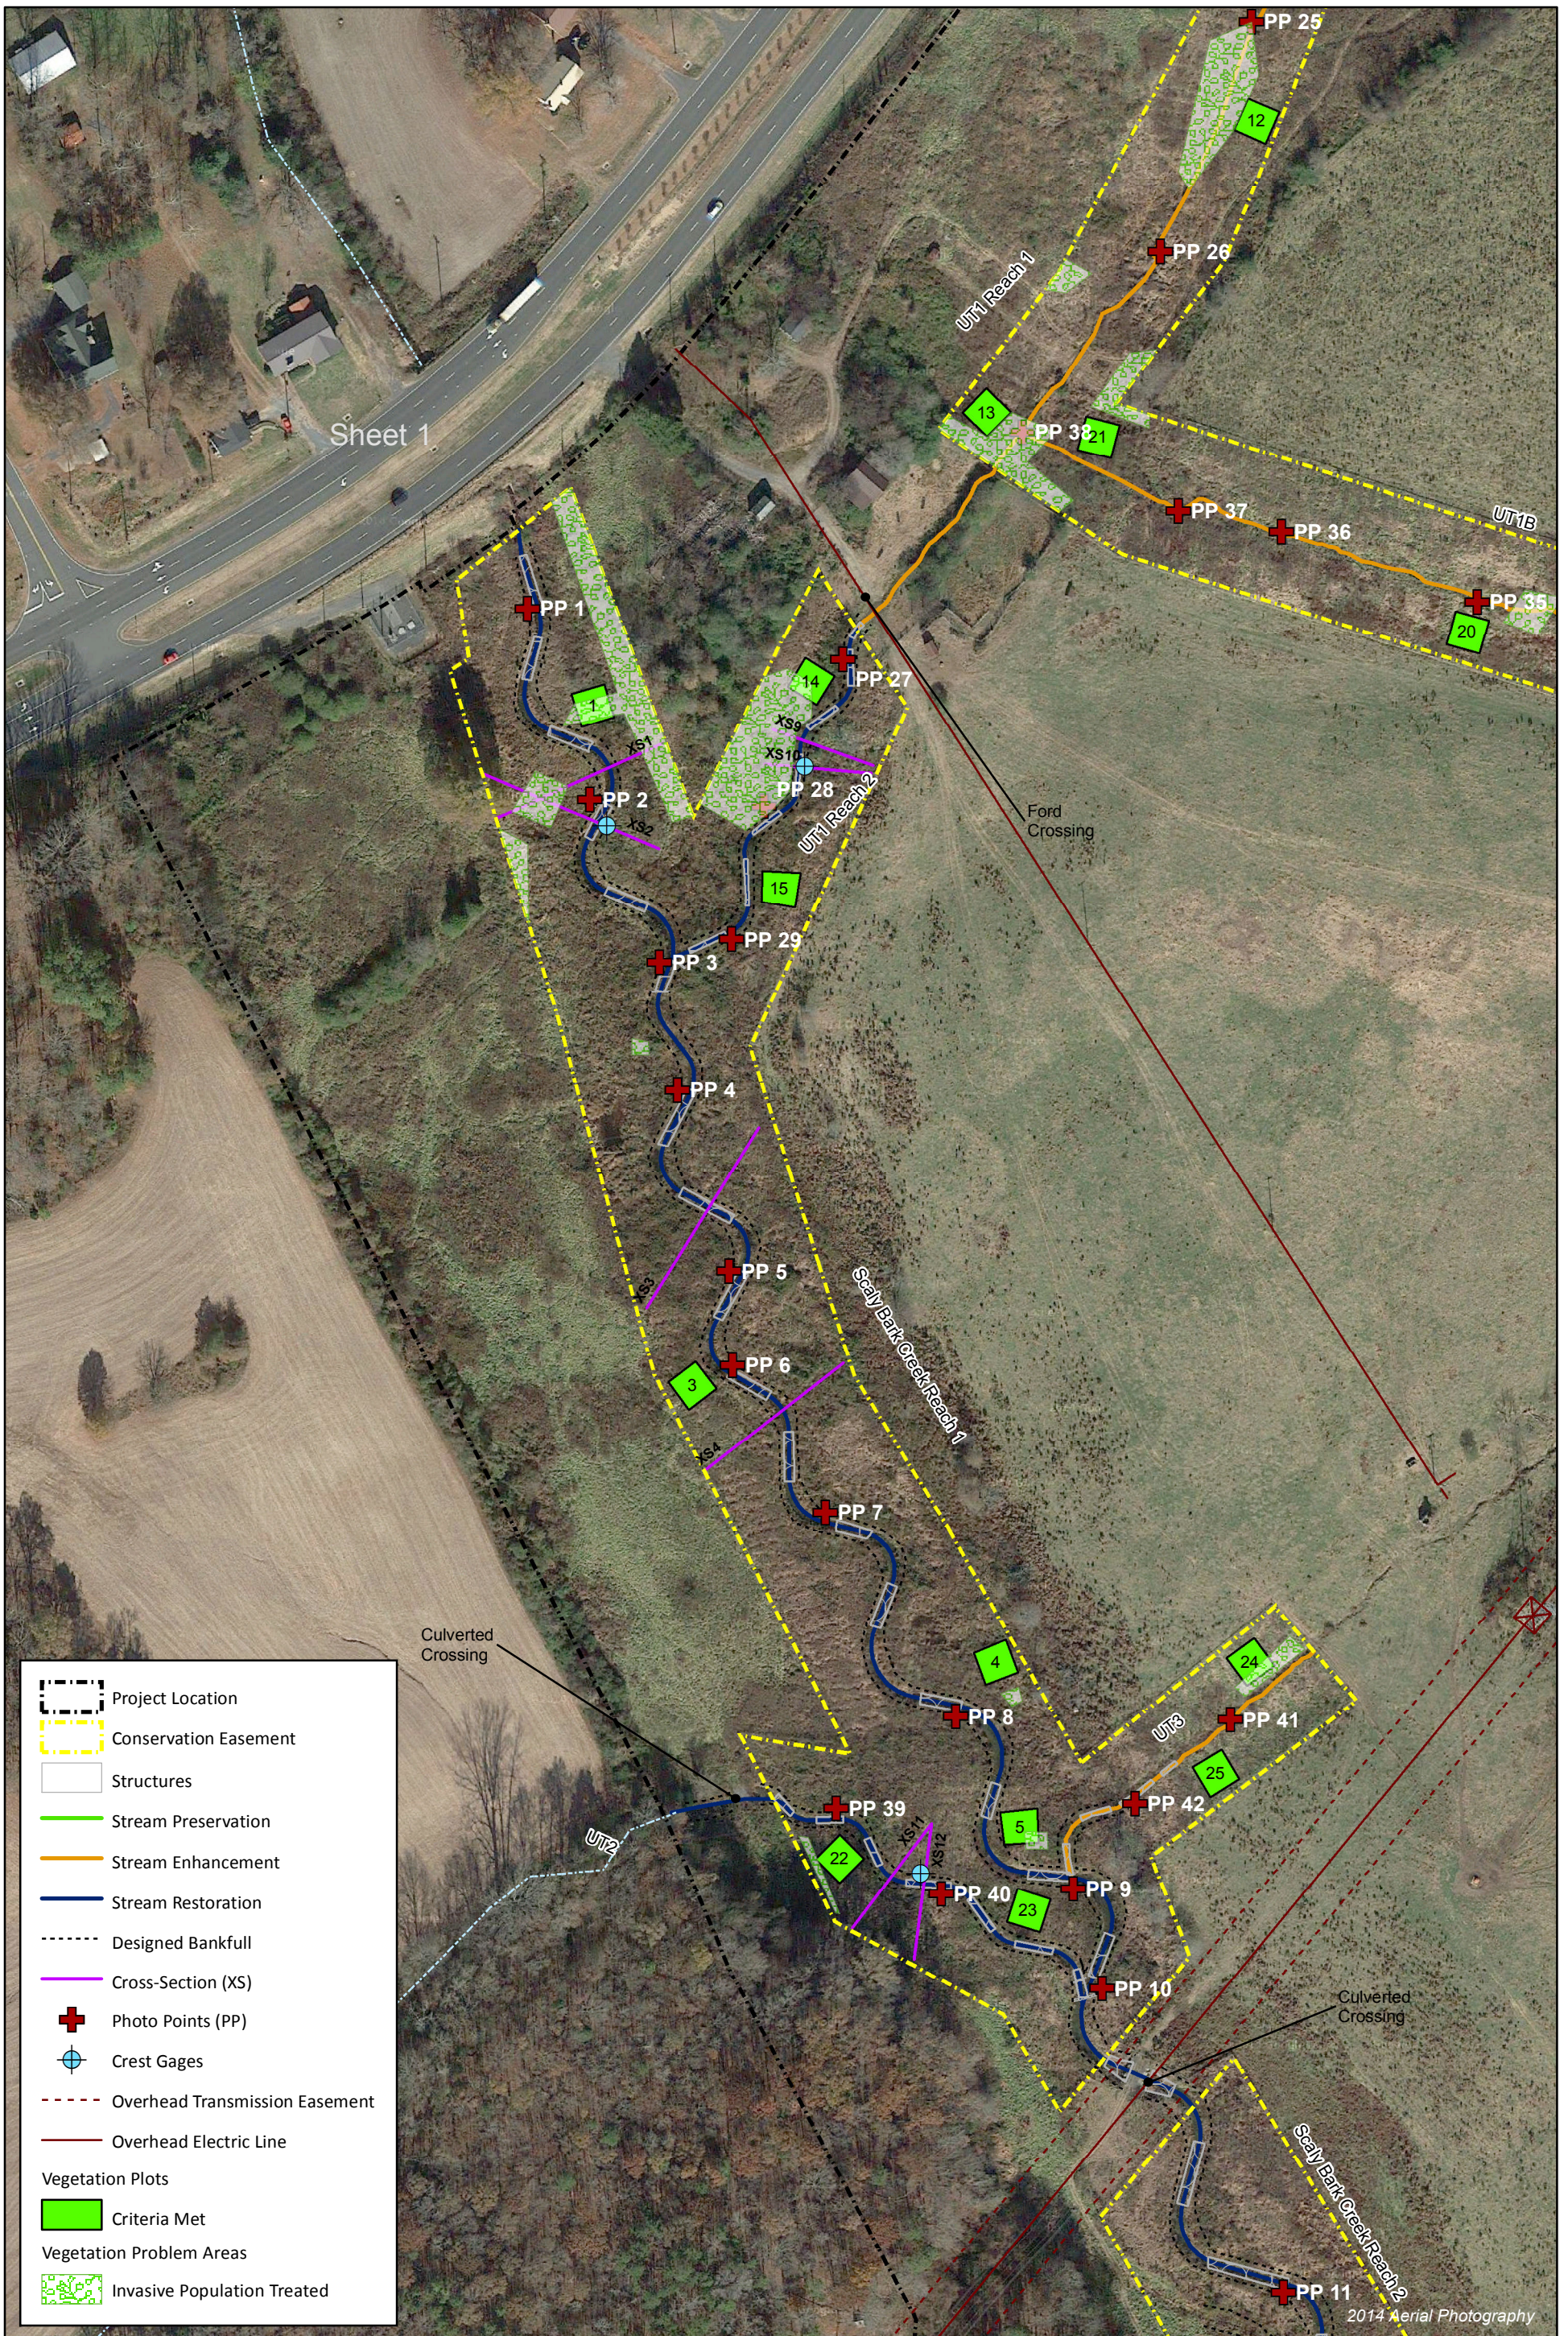
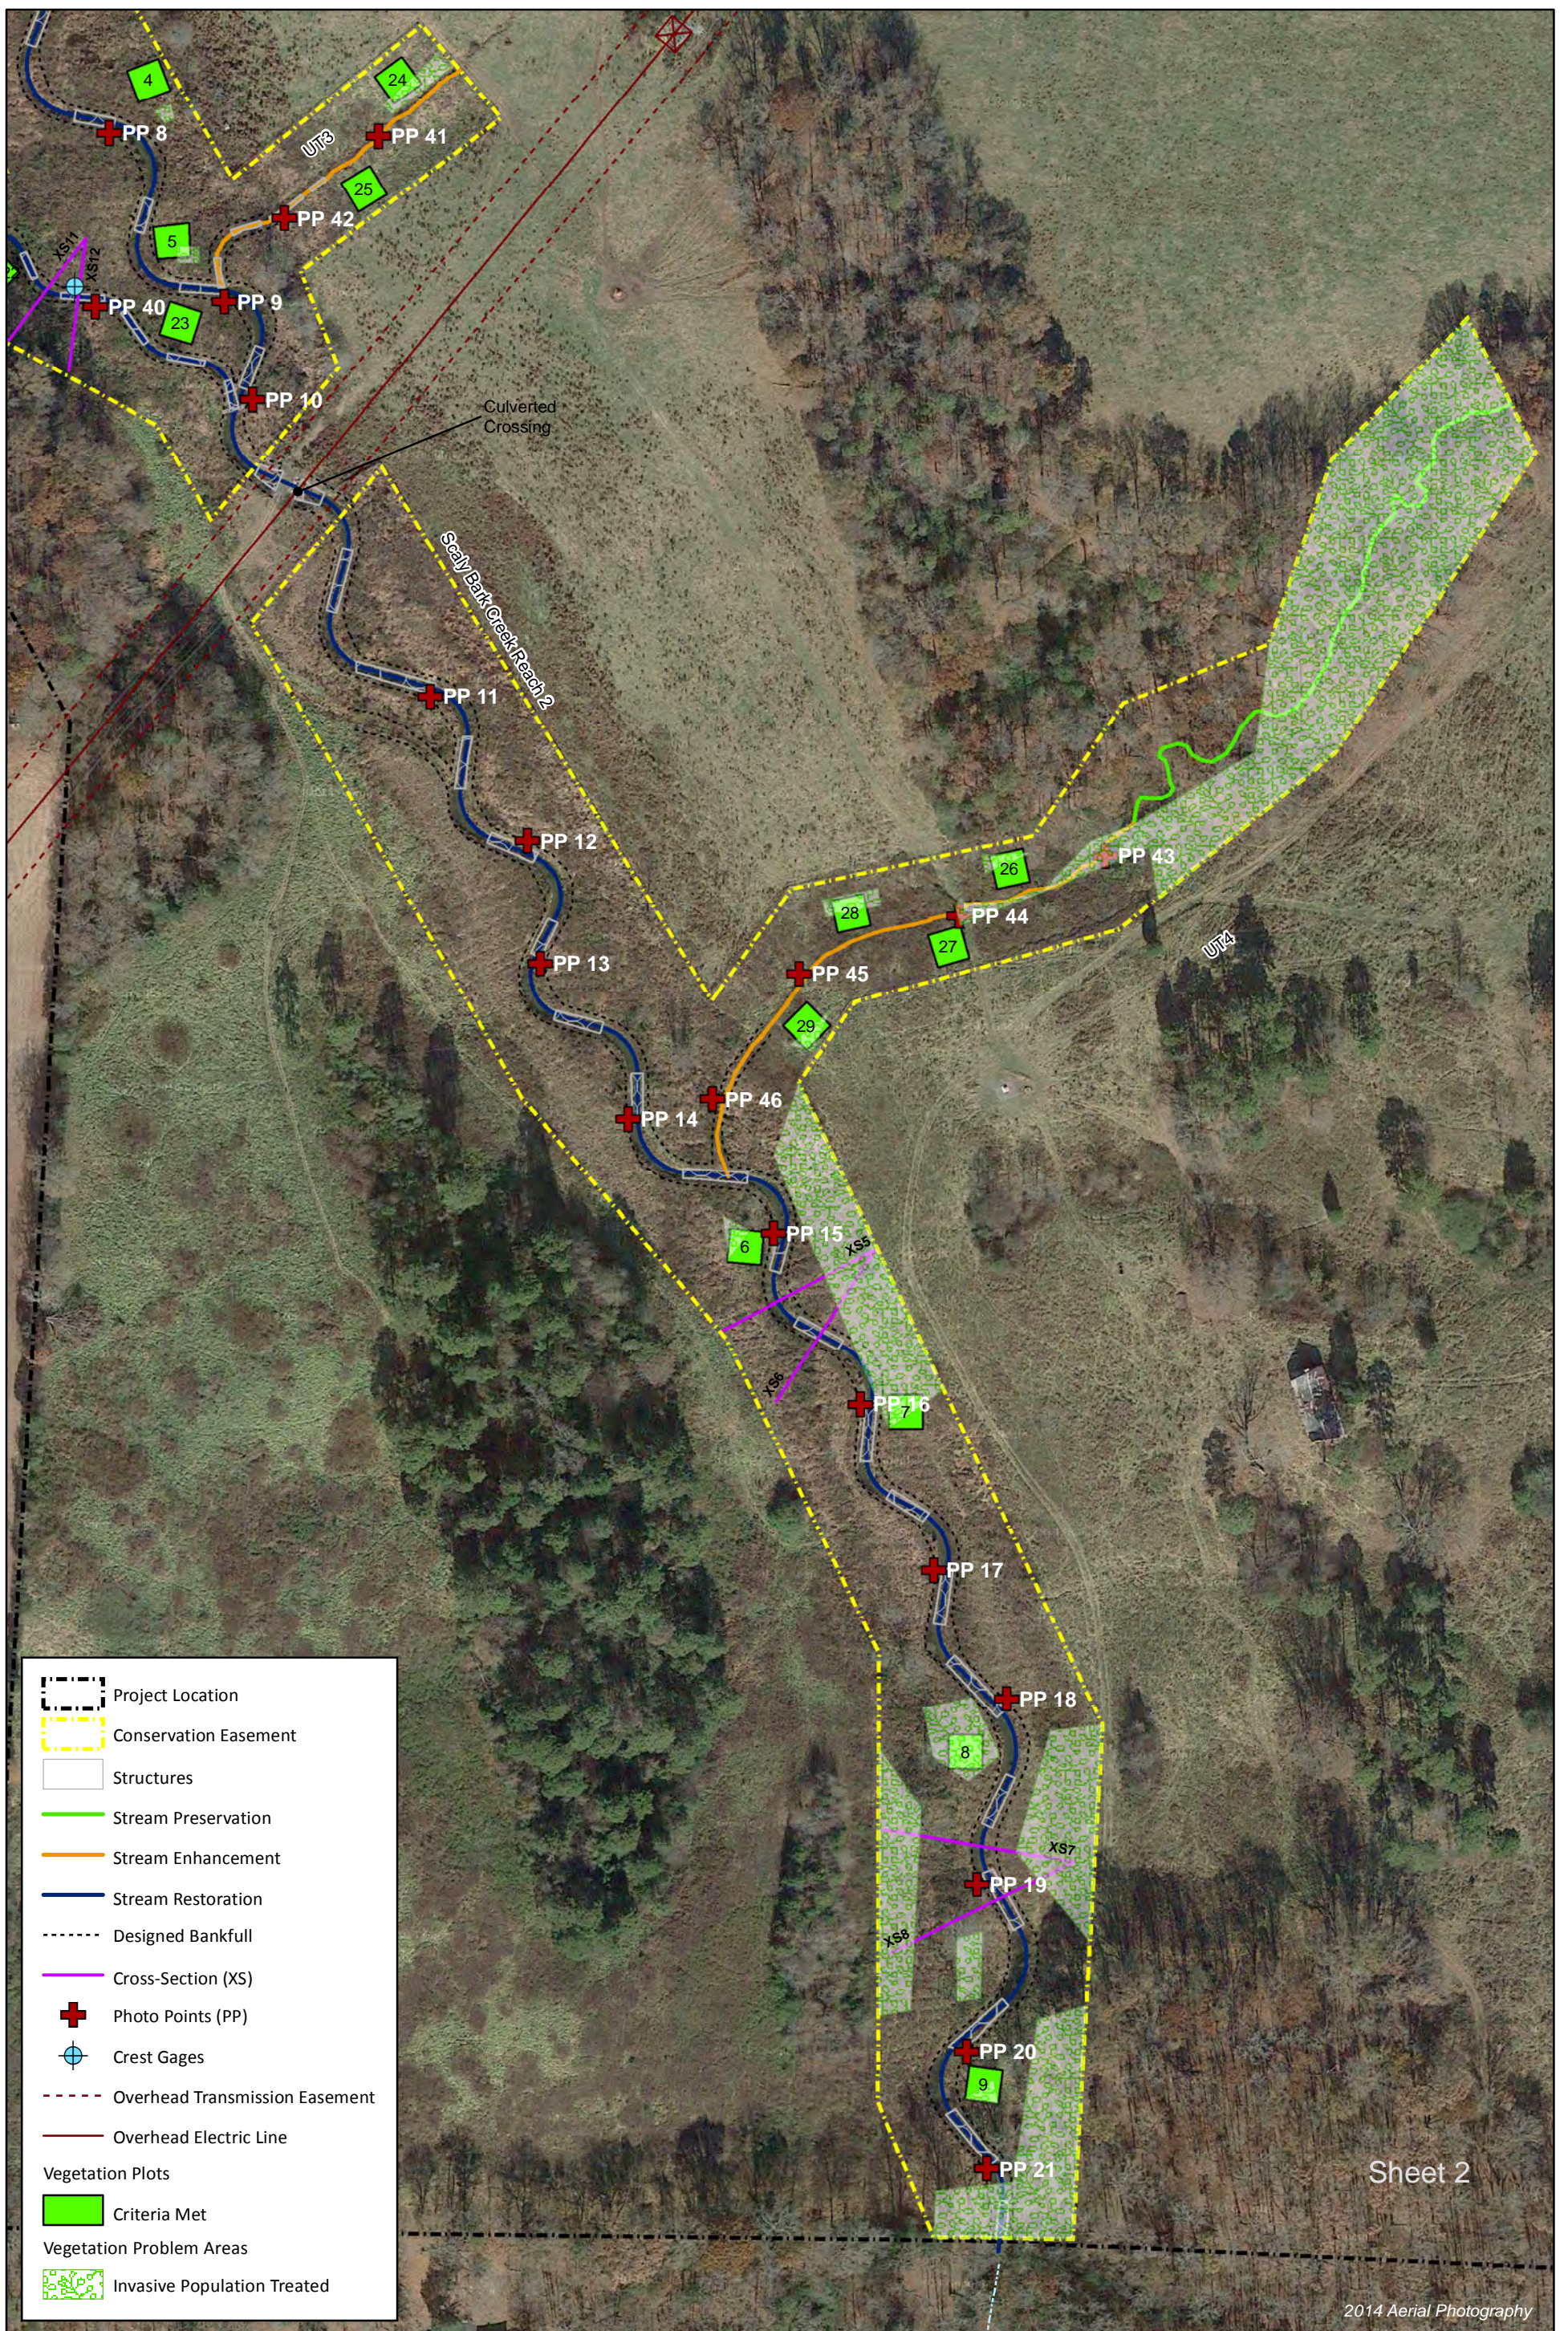
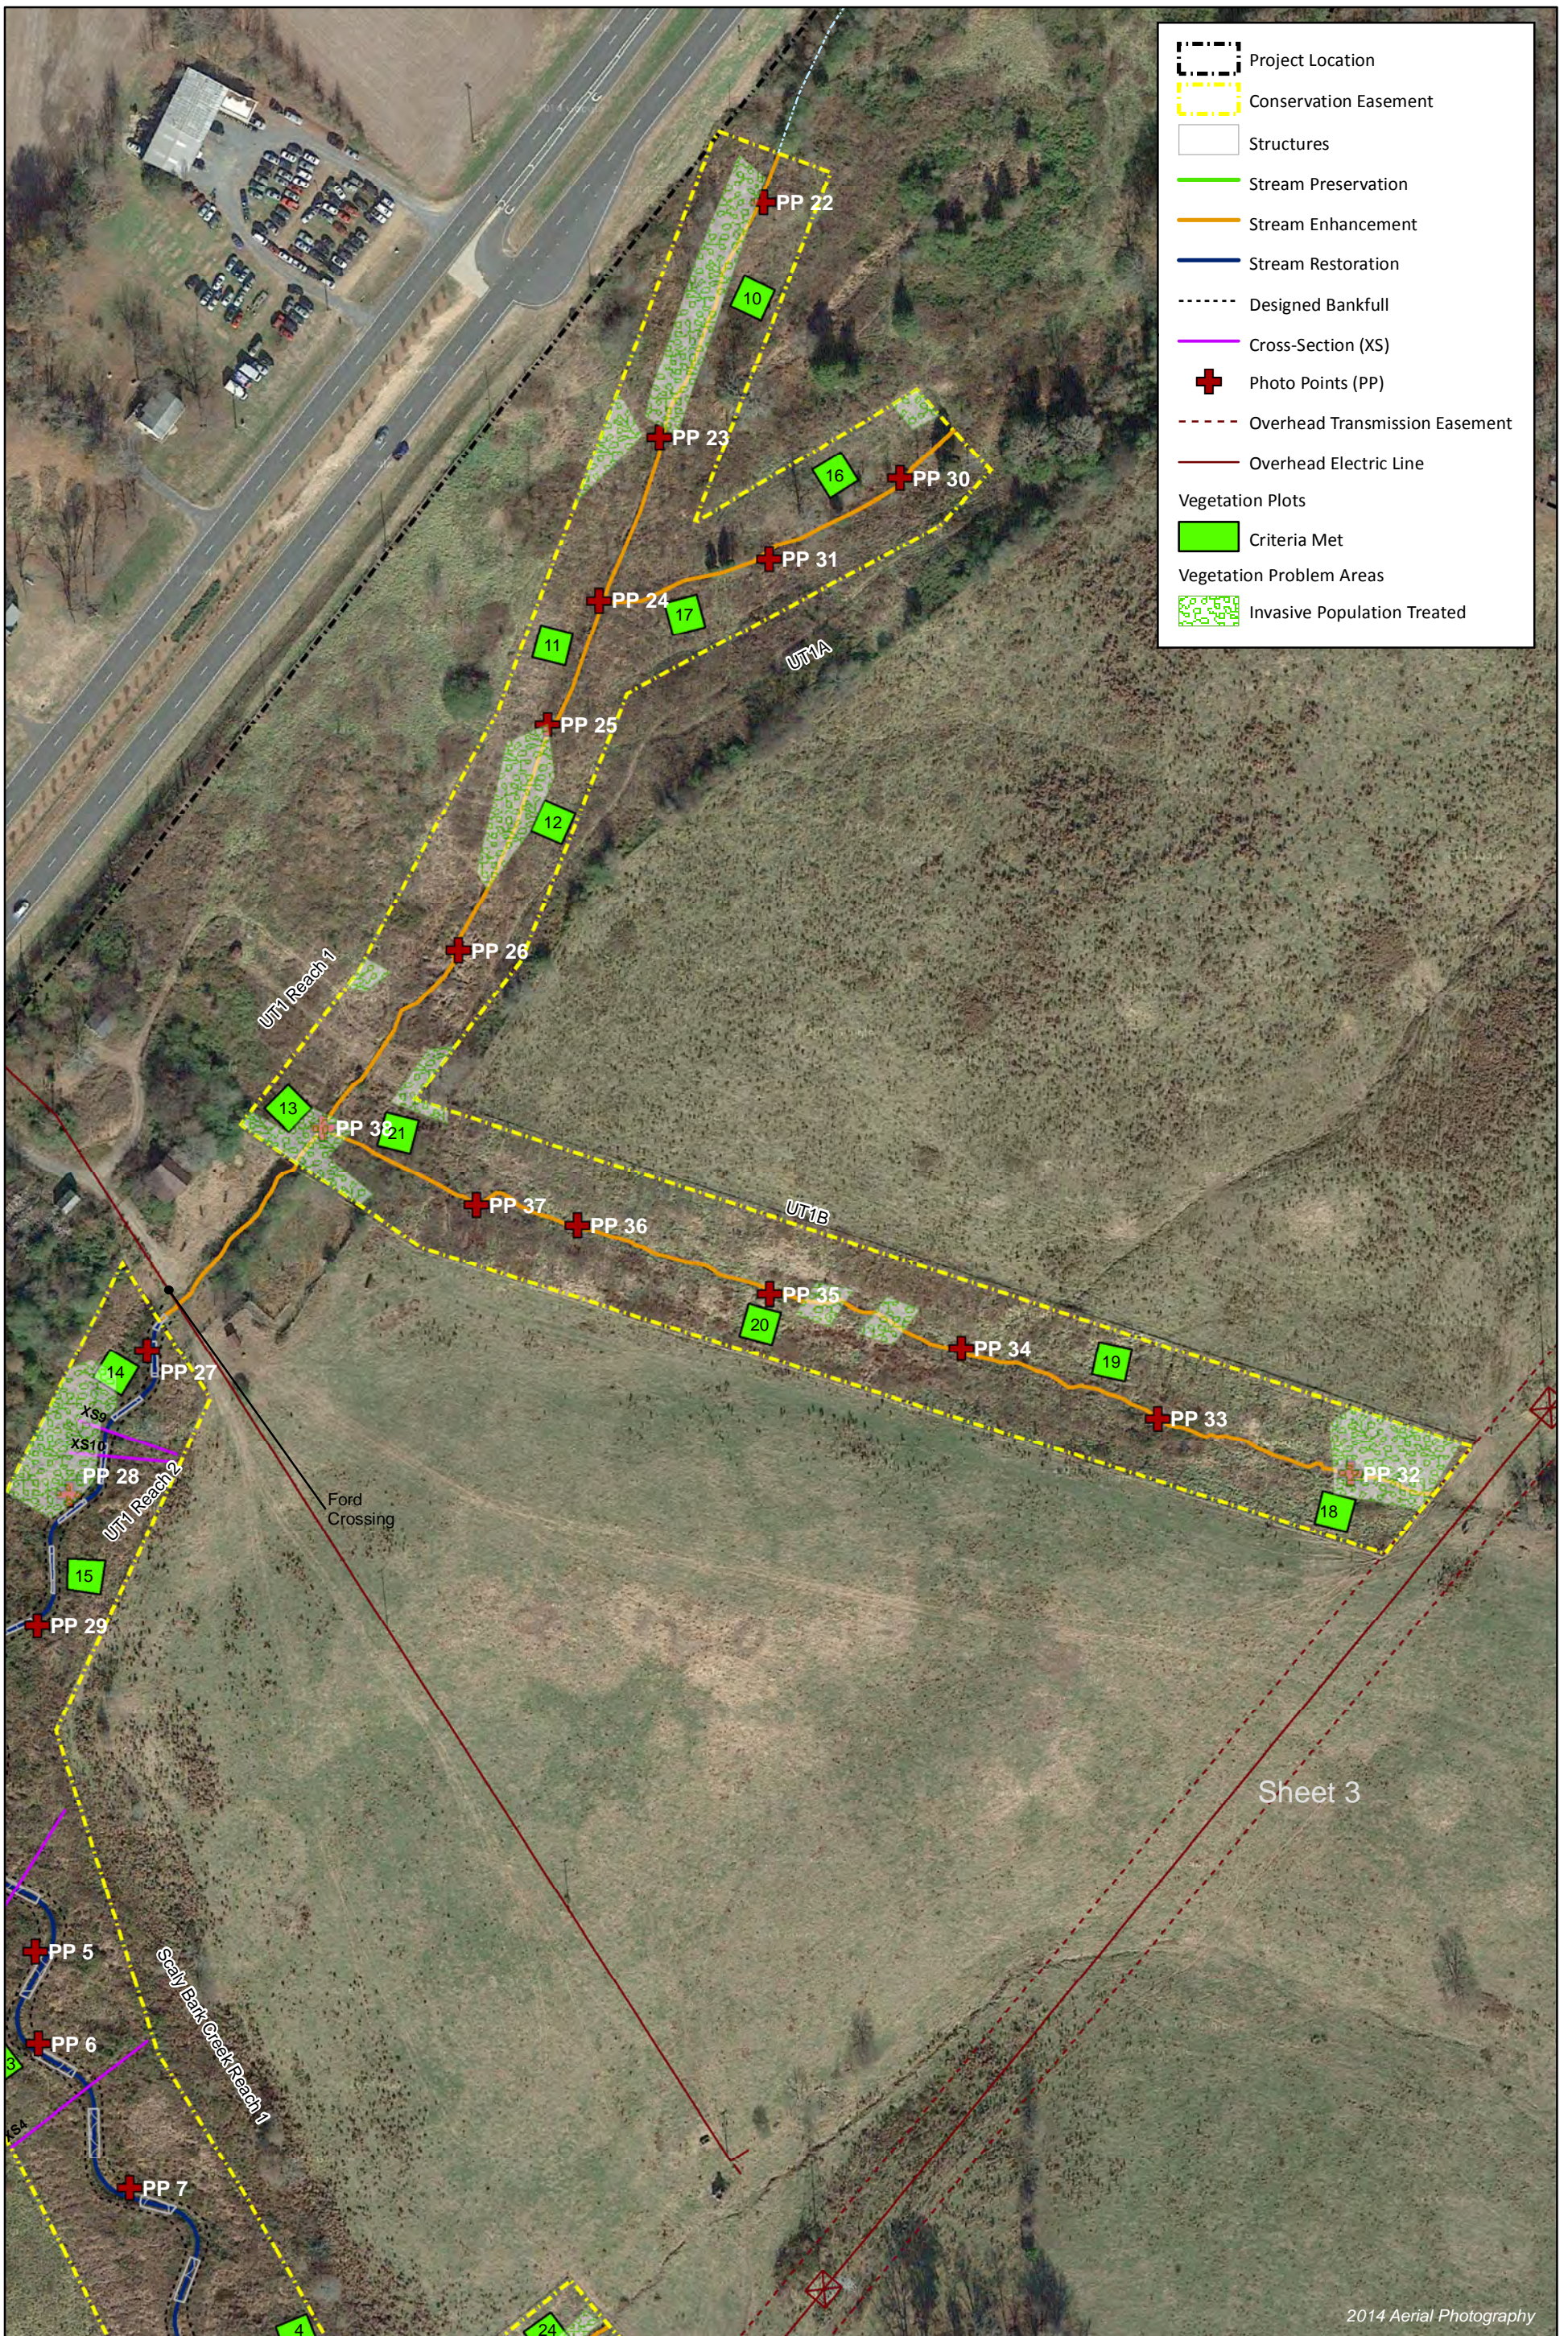
An invasive species management and control plan was initially initiated in MY3 and has continued annually during the monitoring period. The primary invasive species documented and controlled on the Site include tree of heaven (*Ailanthus altissima*), Chinese privet (*Ligustrum sinense*), and Japanese honeysuckle (*Lonicera japonica*). Invasive species management has included foliar herbicidal applications as well as cutting and applying herbicide directly to the cut stumps. Please refer to Appendix 2 and Figures 3.0-3.3 for the Current Condition Plan View (CCPV), which outlines the invasive species treatment areas.

While the Site has met the MY5 vegetation success criteria, there are a few areas in which the overall stem numbers and heights do not appear to be as vigorous. Visual assessments of the areas along UT1 Reach 1 and Scaly Bark Reach 2 that were previously classified as having characteristically low herbaceous growth and dry soil conditions indicated that these areas are sufficiently vegetated and are progressing towards the intended riparian vegetative community type.

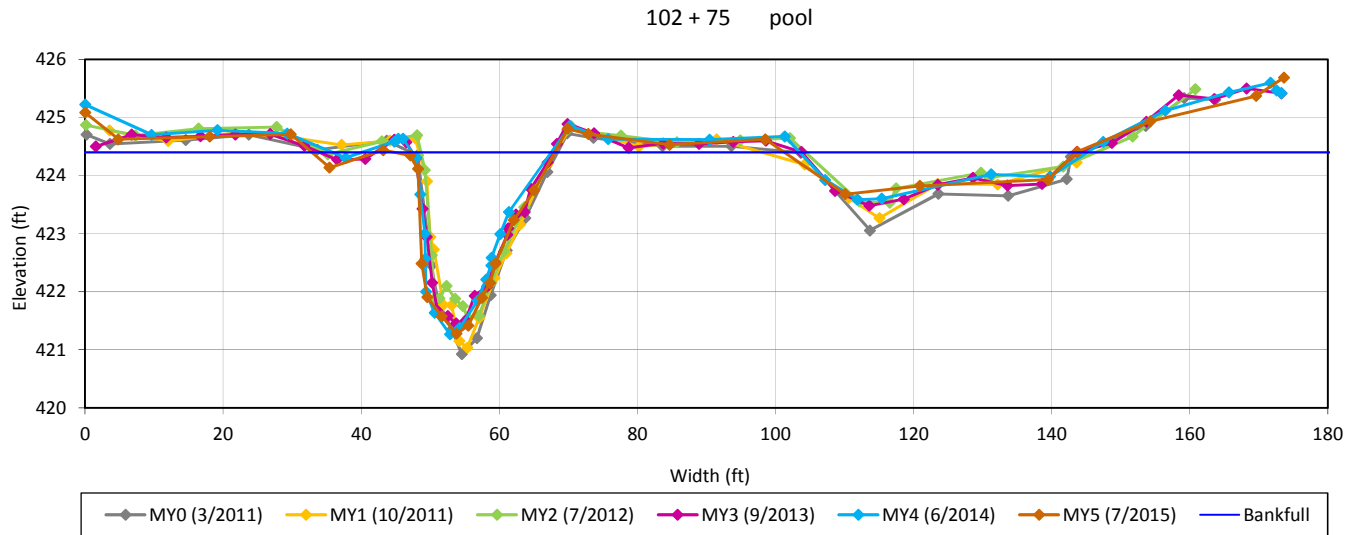
Cross Section 1-Scaly Bark Reach 1

37.3	x-section area (ft.sq.)
20.9	width (ft)
1.8	mean depth (ft)
3.1	max depth (ft)
22.7	wetted perimeter (ft)
1.6	hyd radi (ft)
11.7	width-depth ratio

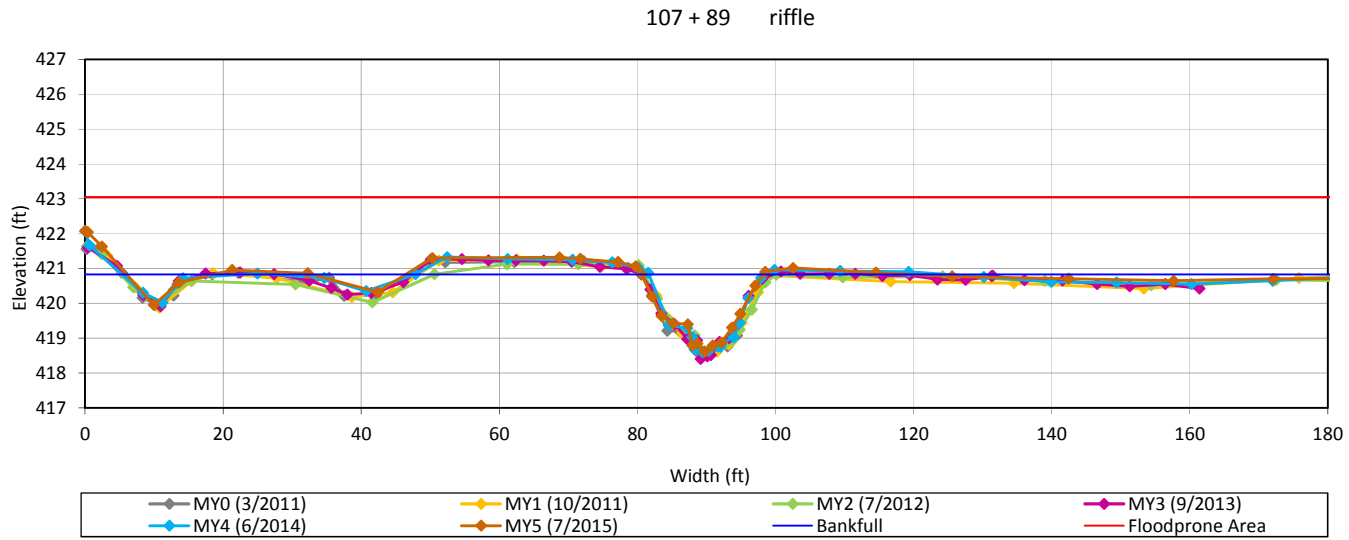
Cross Section 3-Scaly Bark Reach 1

22.8	x-section area (ft.sq.)
17.6	width (ft)
1.3	mean depth (ft)
2.2	max depth (ft)
18.5	wetted perimeter (ft)
1.2	hyd radi (ft)
13.7	width-depth ratio
1.0	bank-height ratio
2.2+	entrenchment ratio

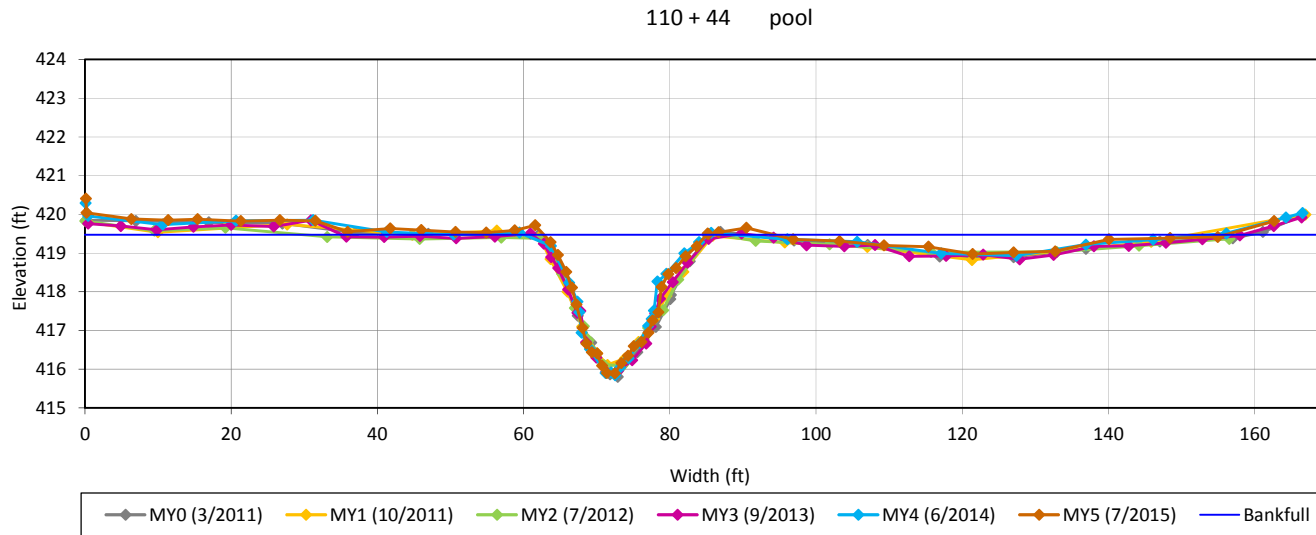
Cross Section 4-Scaly Bark Reach 1

40.5	x-section area (ft.sq.)
22.3	width (ft)
1.8	mean depth (ft)
3.6	max depth (ft)
23.9	wetted parimeter (ft)
1.7	hyd radi (ft)
12.3	width-depth ratio

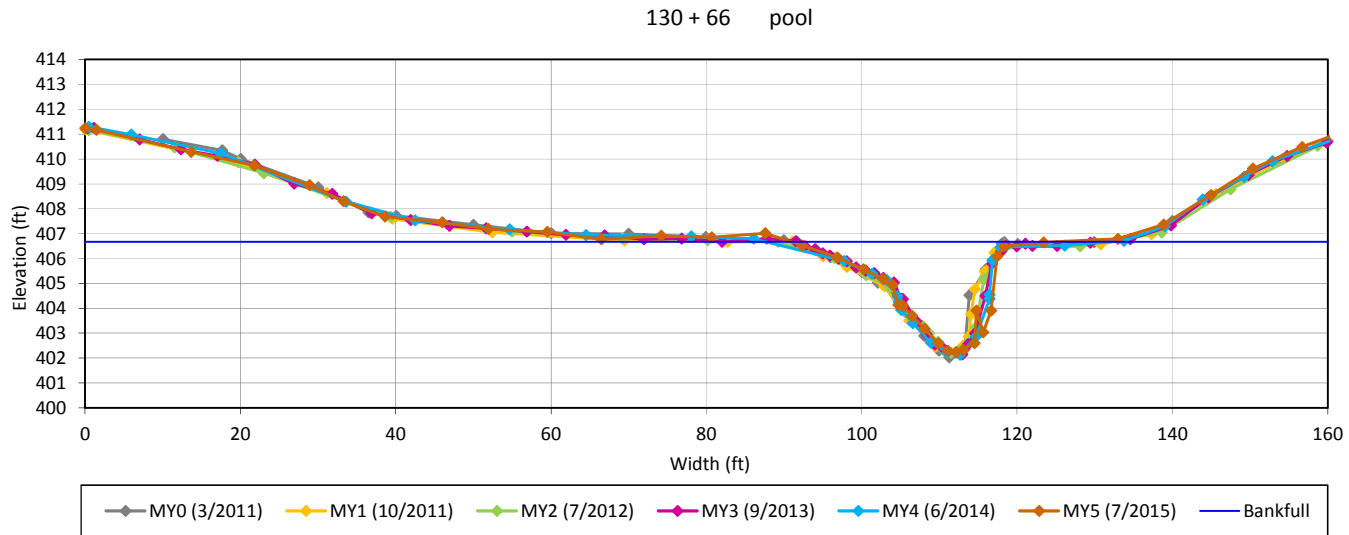
Cross Section 5-Scaly Bark Creek Reach 2

56.4	x-section area (ft.sq.)
26.5	width (ft)
2.1	mean depth (ft)
4.4	max depth (ft)
30.6	wetted parimeter (ft)
1.8	hyd radi (ft)
12.4	width-depth ratio

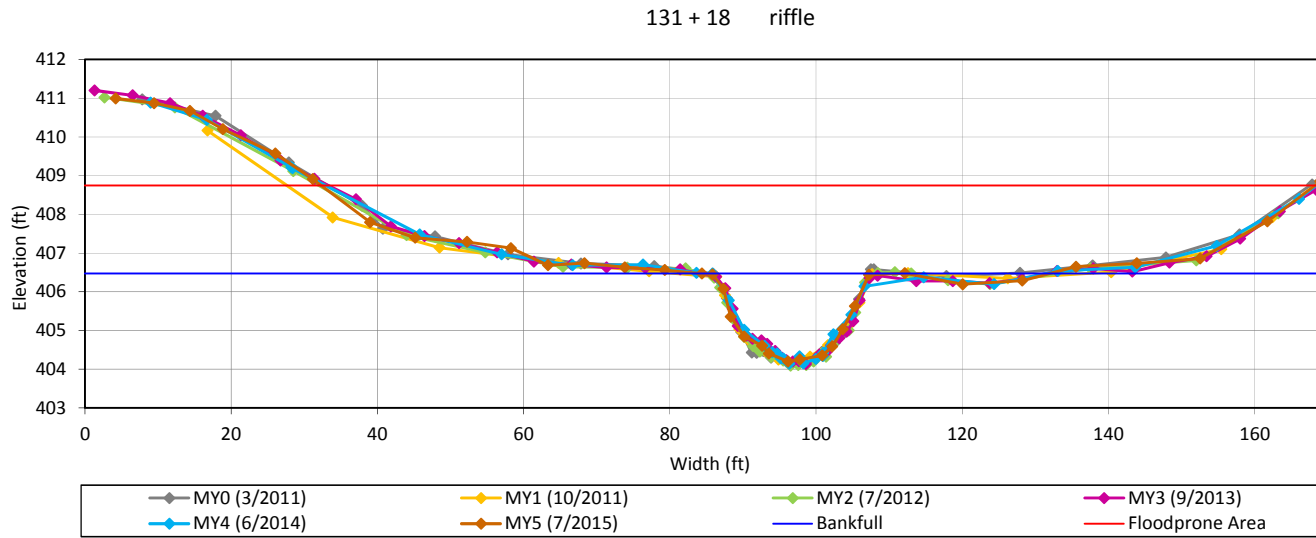
Cross Section 6-Scaly Bark Creek Reach 2

33.5	x-section area (ft.sq.)
22.7	width (ft)
1.5	mean depth (ft)
2.3	max depth (ft)
23.5	wetted perimeter (ft)
1.4	hyd radi (ft)
15.4	width-depth ratio
1.0	bank-height ratio
2.2+	entrenchment ratio

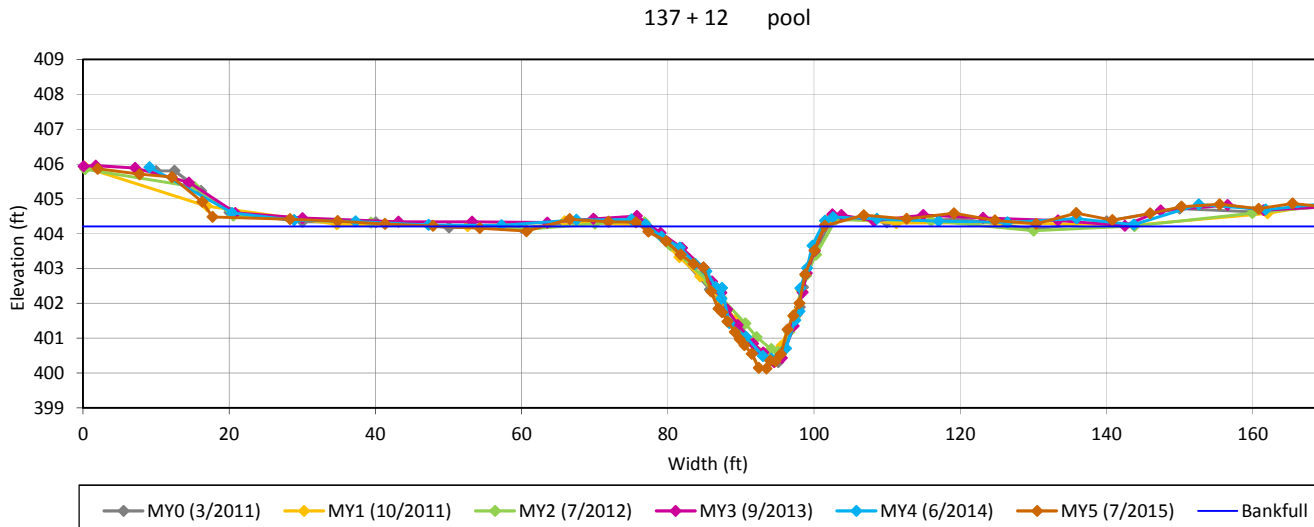
Cross Section 7-Scaly Bark Creek Reach 2

48.7	x-section area (ft.sq.)
25.0	width (ft)
1.9	mean depth (ft)
4.1	max depth (ft)
26.9	wetted parimeter (ft)
1.8	hyd radi (ft)
12.9	width-depth ratio

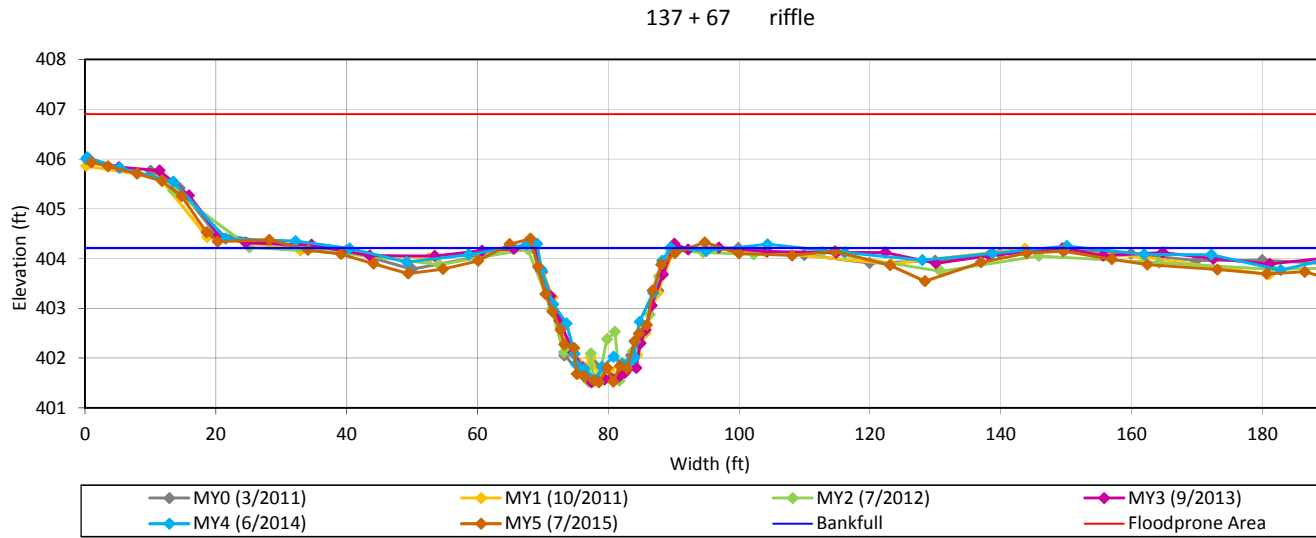
Cross Section 8-Scaly Bark Creek Reach 2

36.3	x-section area (ft.sq.)
21.7	width (ft)
1.7	mean depth (ft)
2.7	max depth (ft)
23.0	wetted perimeter (ft)
1.6	hyd radi (ft)
13.0	width-depth ratio
1.0	bank-height ratio
2.2+	entrenchment ratio

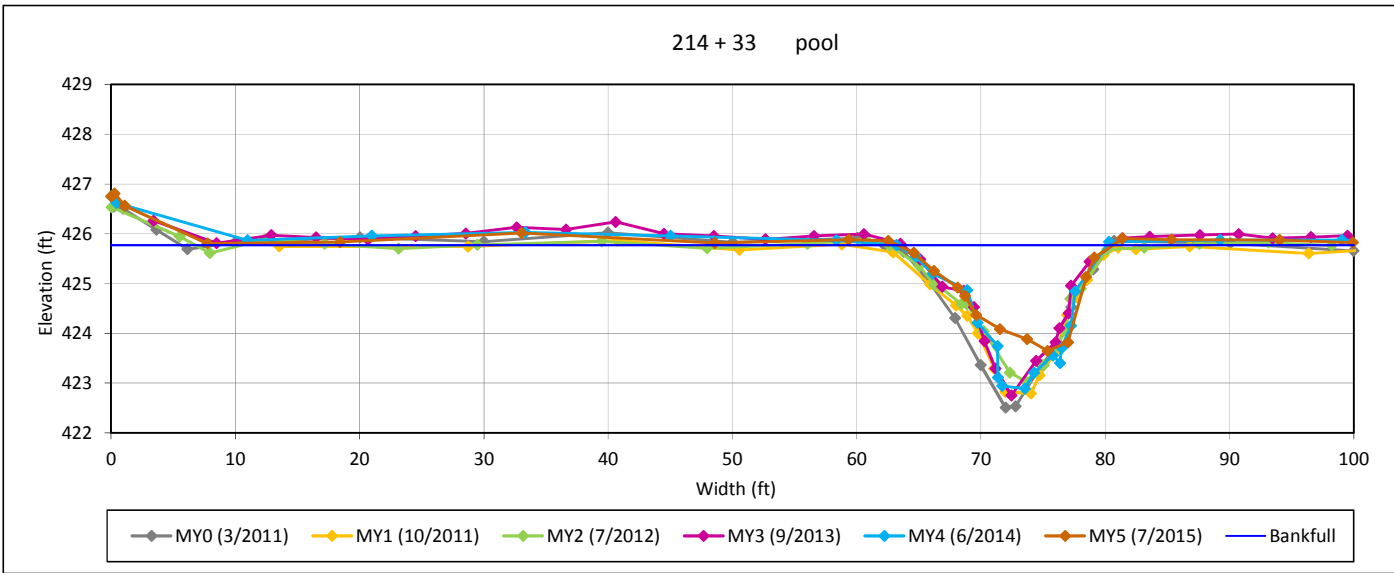
Cross Section 9-UT1 Reach 2

19.4	x-section area (ft.sq.)
17.3	width (ft)
1.1	mean depth (ft)
2.1	max depth (ft)
18.1	wetted parimeter (ft)
1.1	hyd radi (ft)
15.3	width-depth ratio

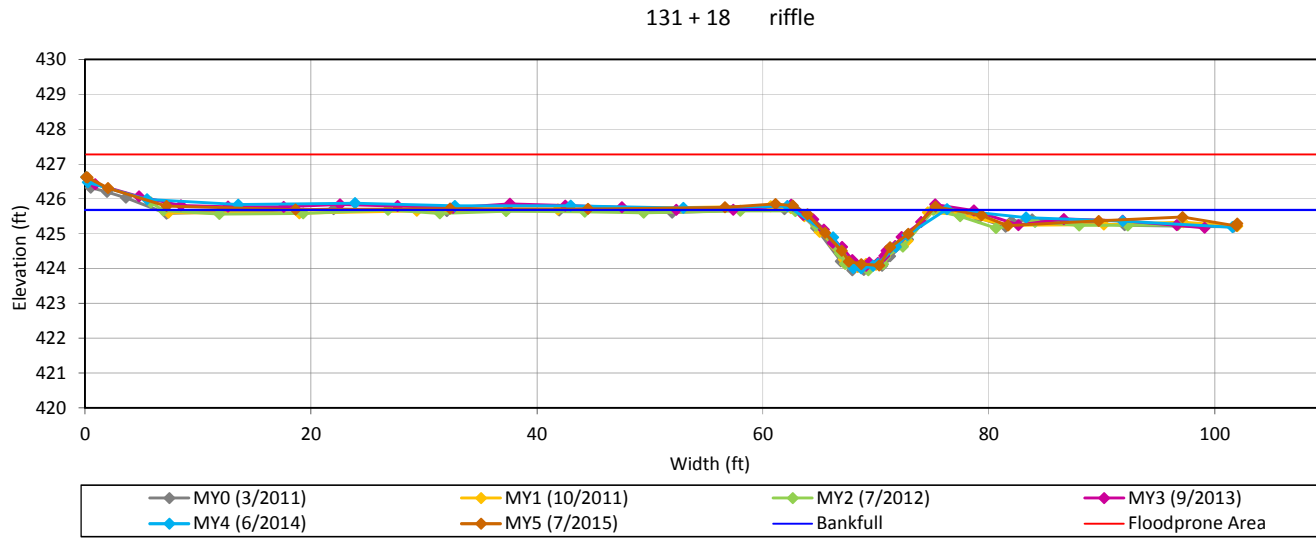
Cross Section 10-UT1 Reach 2

- 10.4 x-section area (ft.sq.)
- 11.7 width (ft)
- 0.9 mean depth (ft)
- 1.6 max depth (ft)
- 12.2 wetted perimeter (ft)
- 0.9 hyd radi (ft)
- 13.1 width-depth ratio
- 1.0 bank-height ratio
- 2.2+ entrenchment ratio
