FINAL-MY2 Monitoring Report

Seniard Creek Mitigation Site

NCDMS Project No. 100017

Subject: Draft MY2 Monitoring Report
Seniard Creek Site, Henderson County
French Broad River CU 06010105
DMS Project ID No. 100017 / DEQ Contract #7189

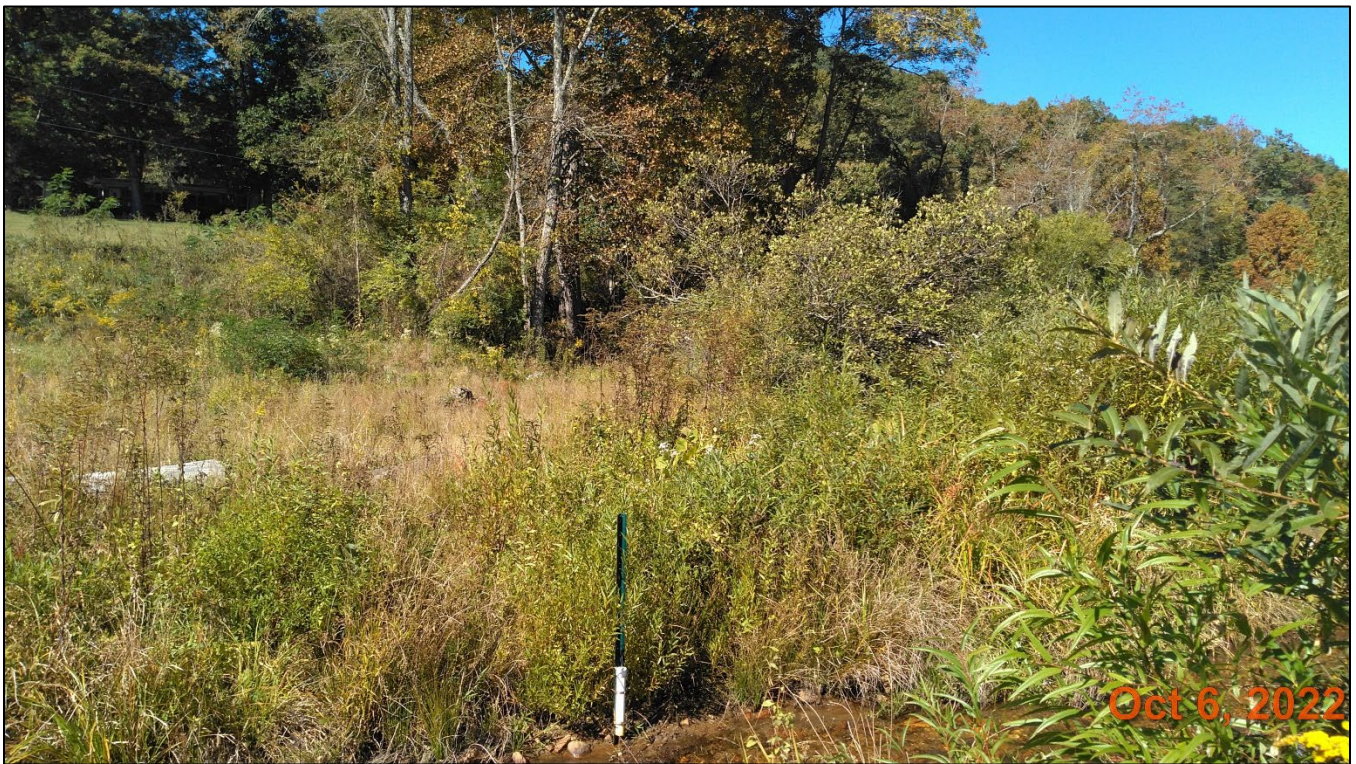
Photo Point 2.1 Seniard Creek Reach 1 Stage Recorder and Pre-existing Wetland.

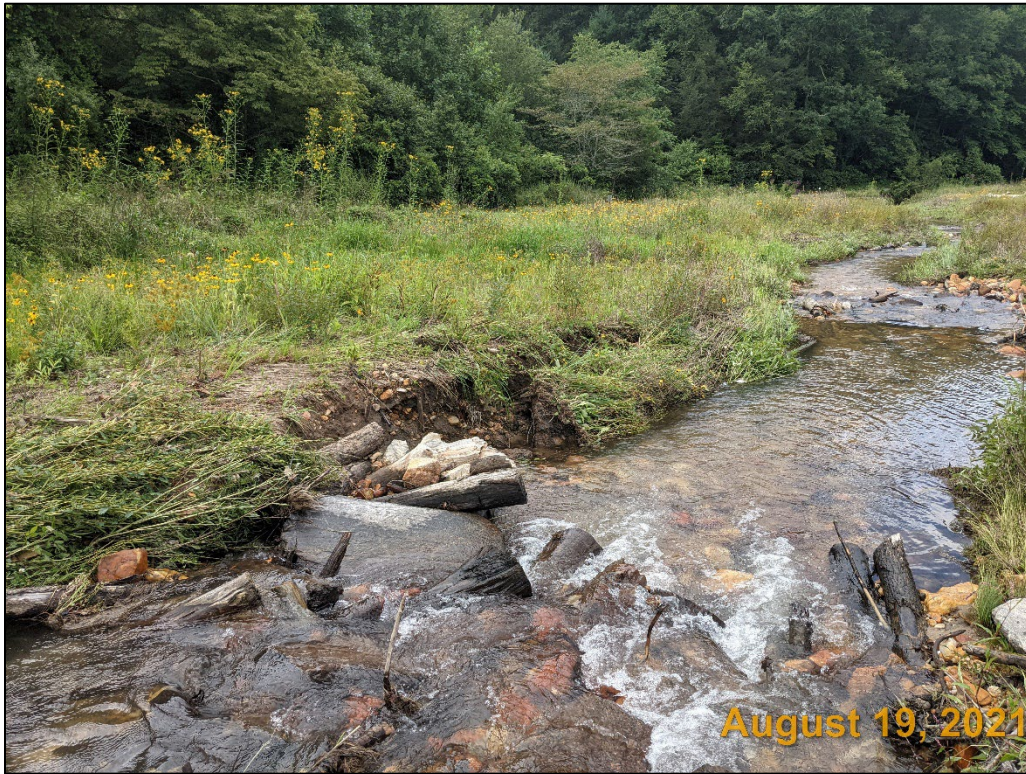
The two areas along Lee and Sitton Creek identified in MY1 as problem areas, Lee Branch at Station 300+25 and Sitton Creek at Station 211+25, have stabilized. Lee branch experienced a pulse of sediment related to a heavy storm event during MY1. Cross-section data indicate that Lee branch has maintained thalweg, bed, and bank through MY2. The area of bank scour and slump noted at Sitton Creek Station 211+25 during MY1 has stabilized into MY2. Additional livetakes were installed in this area during re-planting efforts in MY2. No further erosion has taken place in this area following the addition and growth of livestakes. No additional areas of concern were identified in MY2.

MY1 (2021) Sitton Creek Station 211+25 facing downstream.

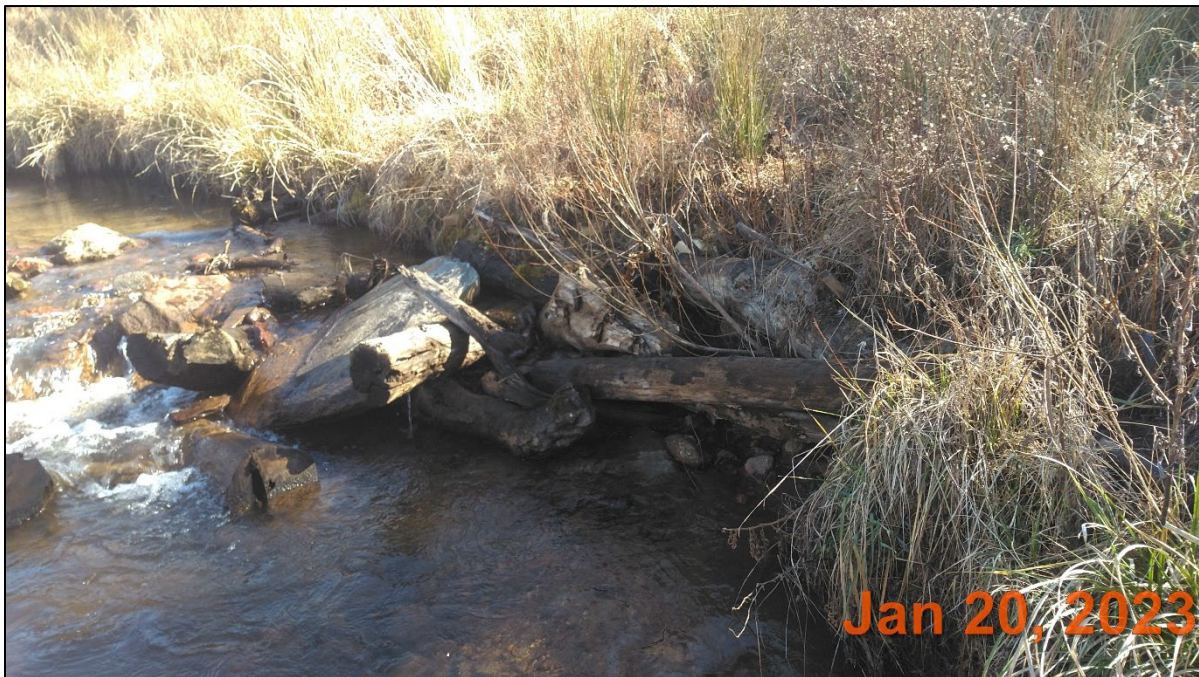
MY2 (2022) Sitton Creek Station 211+25 facing upstream.

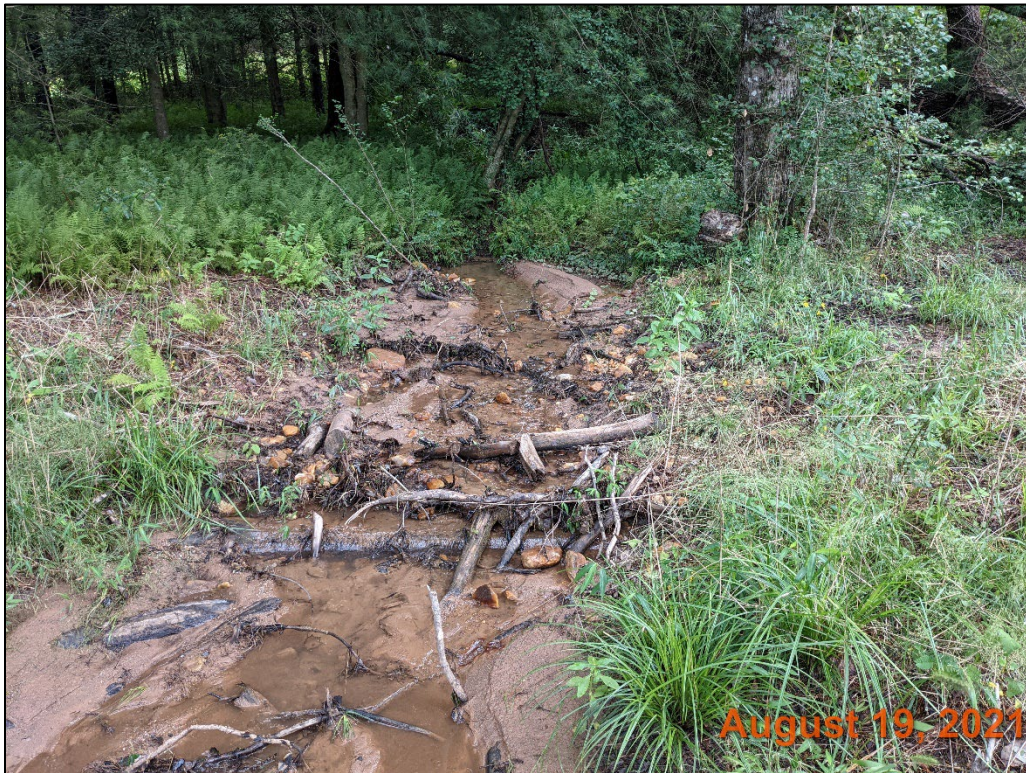
Initial concerns regarding the two problem areas were identified during MY1. Lee Branch has maintained thalweg, bed, and bank (referencing cross-section data) and has substantial riparian herbaceous regrowth. Sitton Creek, following the addition of livestakes, had appeared to begin to entrain sediment and organic debris in MY2. Additionally, livestake survival was high and herbaceous vegetation was re-establishing.

MY1 (2021) Lee Branch Station 300+25 facing upstream.

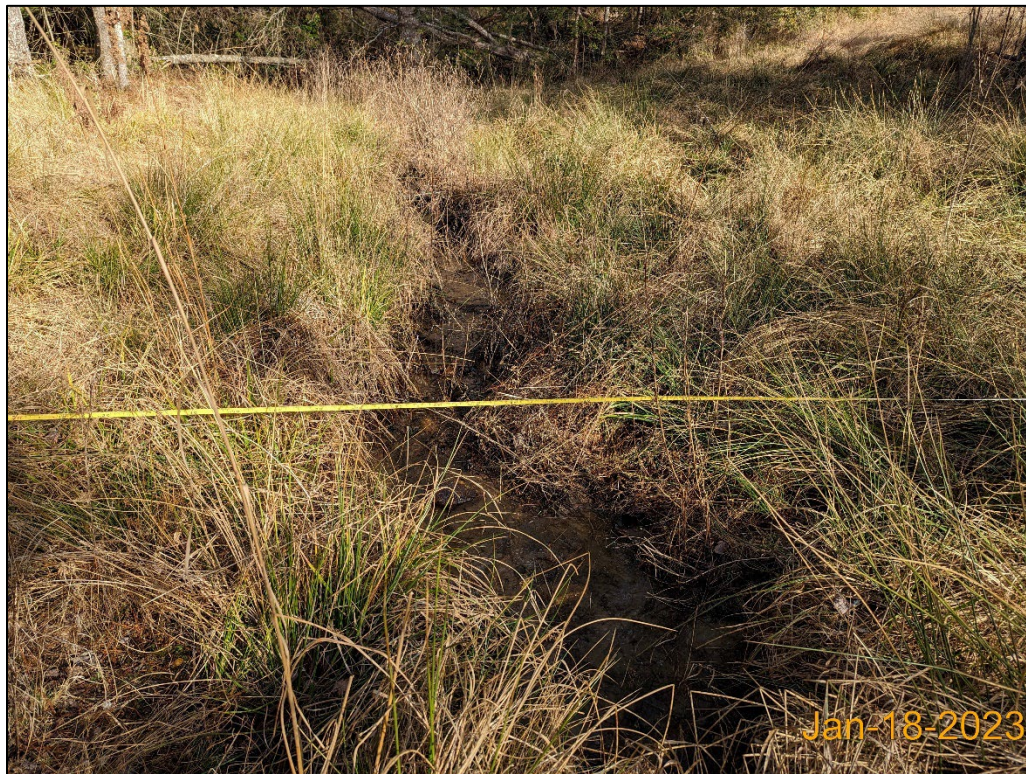
MY2 (2022) Lee Branch Station 300+25 facing upstream.
