**Shadrick Creek Restoration Project**  
**Annual Monitoring/Closeout Report**

Monitoring Year 5 of 5

Shadrick Creek Stream Restoration Project  
NCDMS Contract No. 7343  
NCDMS Project No. 92916  
DWR# 10-0465v2  
USACE Action ID: 2010-00764  
McDowell County, North Carolina  
Data Collected: April 2022 – November 2022  
Date Submitted: December 2022

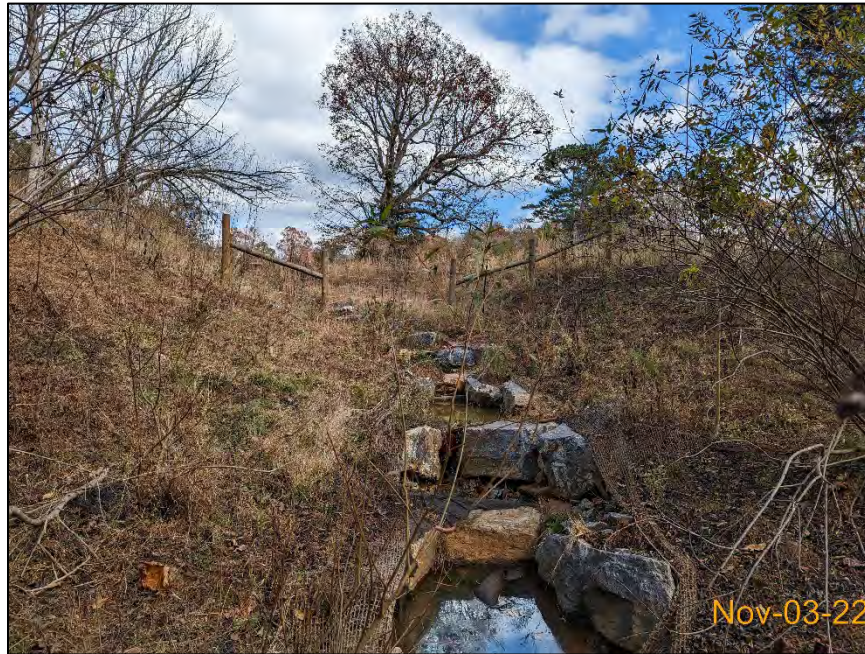
UT-10 – Permanent Photo Station 21 Supplemental  
Looking Upstream at head of project and 2021 Repair Area

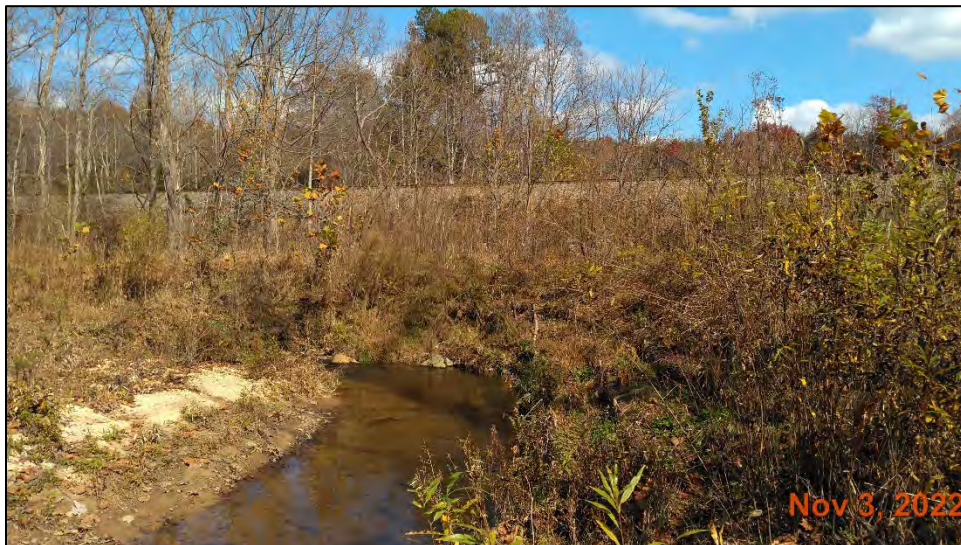
Shadrick Creek Reach 2 – Permanent Photo Station 23 Supplemental  
Looking Upstream towards 2021 Repair Area

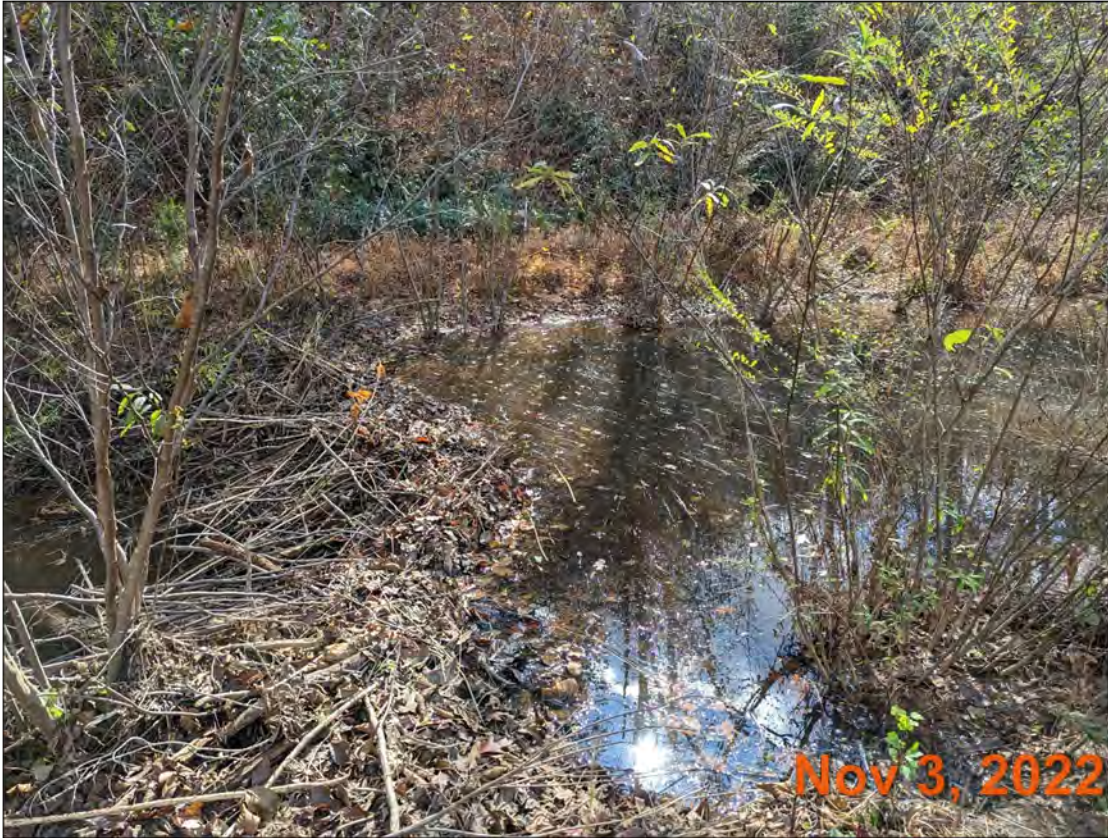
Three beaver dams were identified in October of 2022. The major dam was located at Station 34+74. A smaller dam was located Station 35+50. Two beaver dams were observed on UT9 Reach 2 (Stations 20+63 and 21+29). Backwater depth was significant enough to prevent the surveying of cross-

Shadrick Creek Reach 1 – Beaver dam Station 34+75

- 1.5.2 Stream Geomorphology: In the beaver discussion please include “APHIS is actively trapping the beaver and the dams will be removed once beaver have been trapped. This will occur in early December 2022.” **Added text**

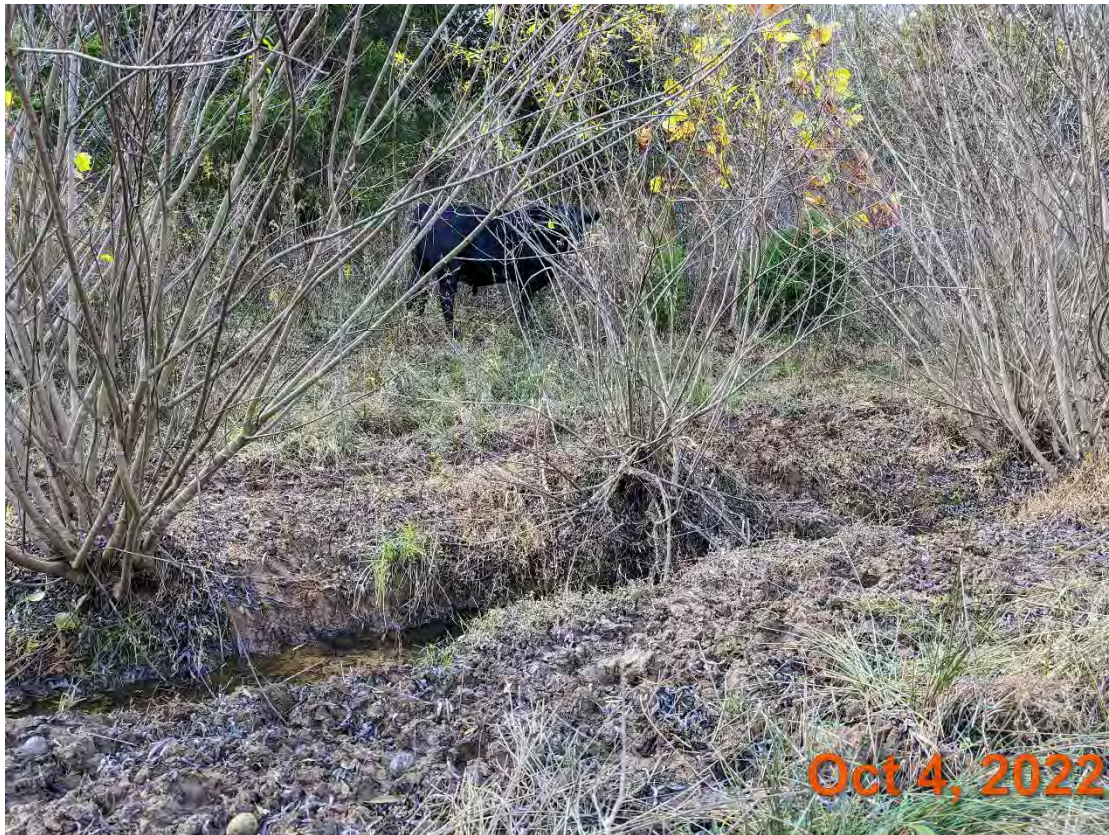
Cattle encroachment UT 10.
