Shadrick Creek Restoration Project

Annual Monitoring Report

Monitoring Year 1 of 5

NCDMS Contract No. 7343

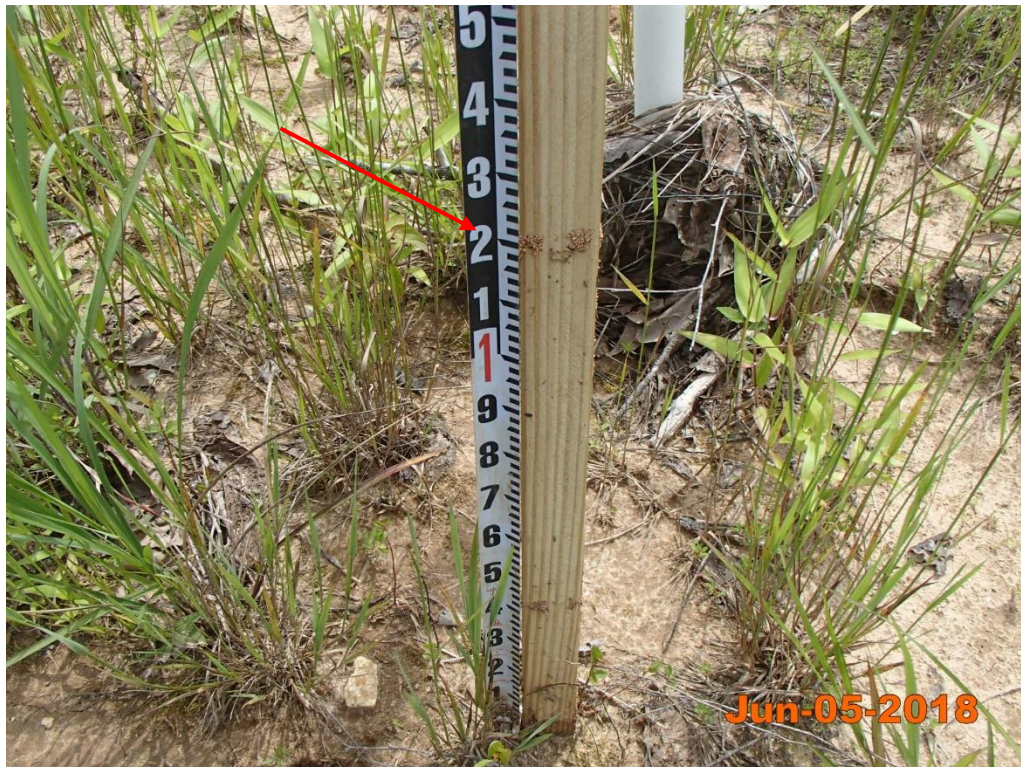
Photo #1 – Shadrick Creek Reach 1 Crest Gauge at 1.2 feet (Recorded bankfull 1.2 feet)

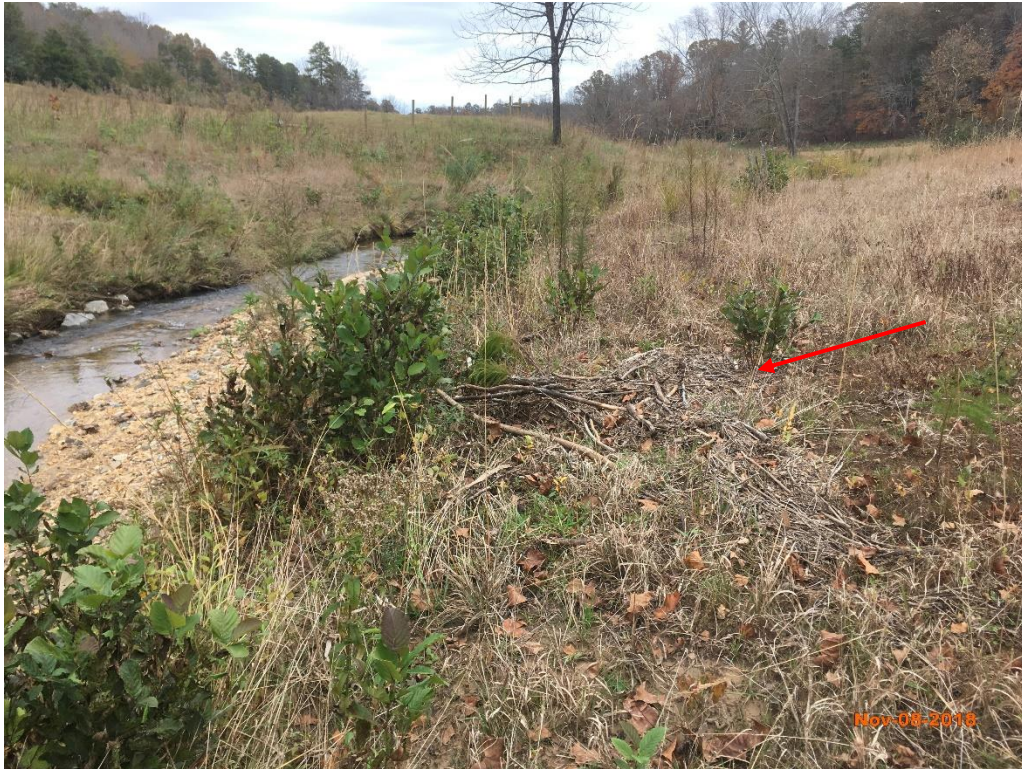
Photo #2 – Shadrick Creek Reach 1 STA 16+00 Wrack Lines

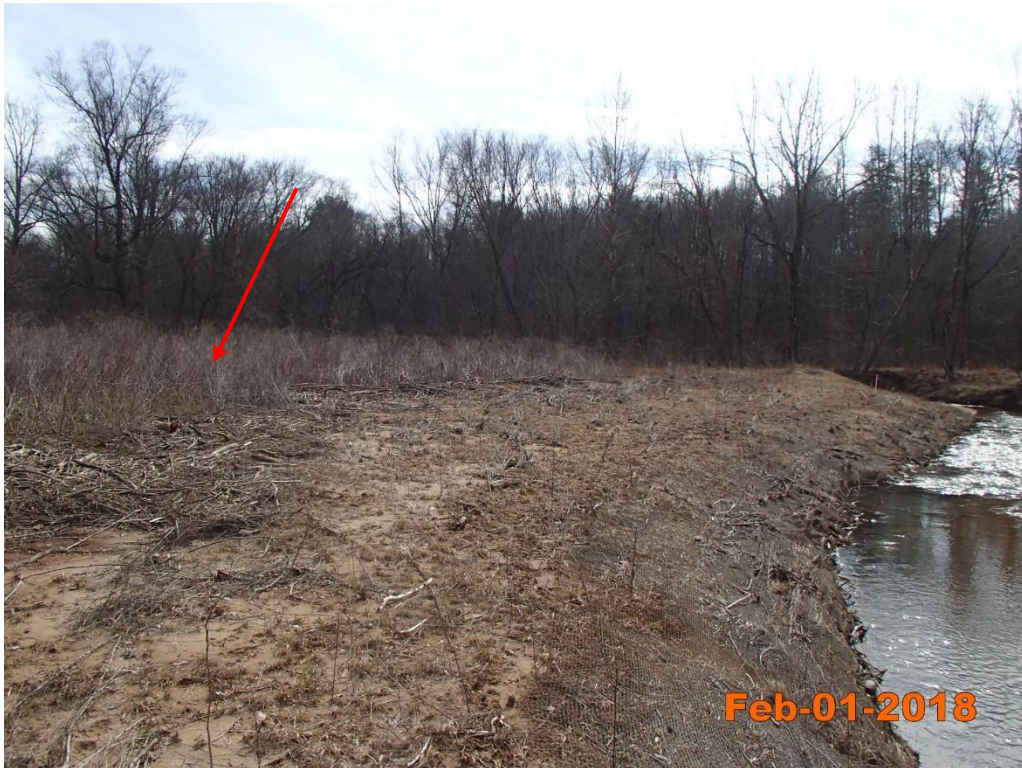
Photo #3 – Shadrick Creek Reach 3 STA 115+50 Wrack Lines

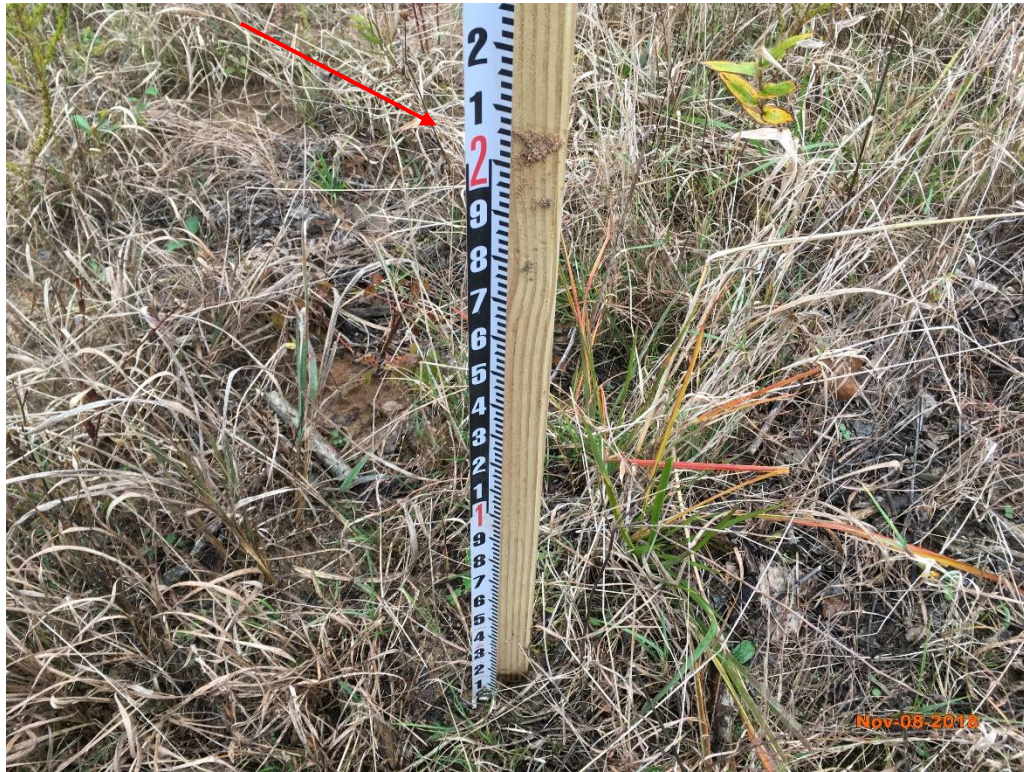
Photo #4 – Shadrick Creek Reach 3 Crest Gauge at 2.05 feet (Recorded bankfull 1.6 feet)
