Shadrick Creek Restoration Project

Annual Monitoring Report

Monitoring Year 2 of 5

Shadrick Creek Stream Restoration Project

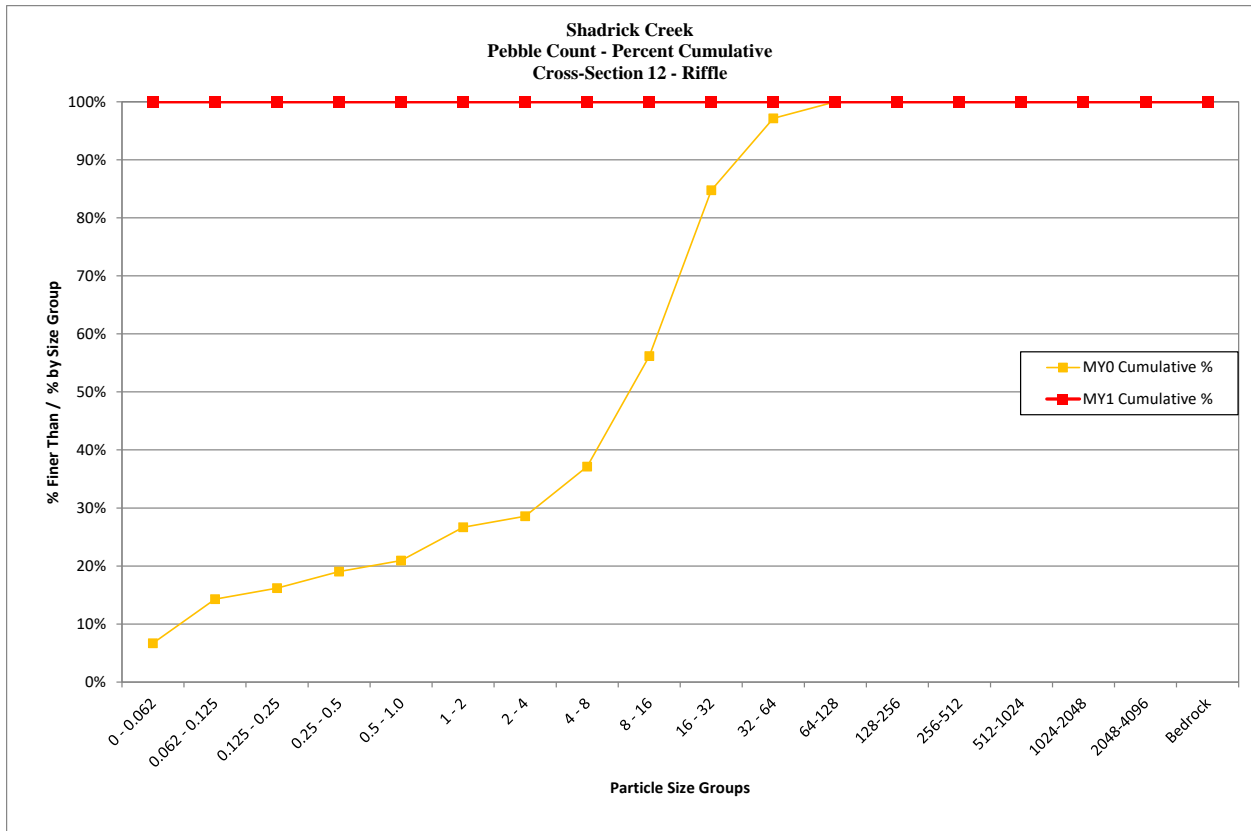
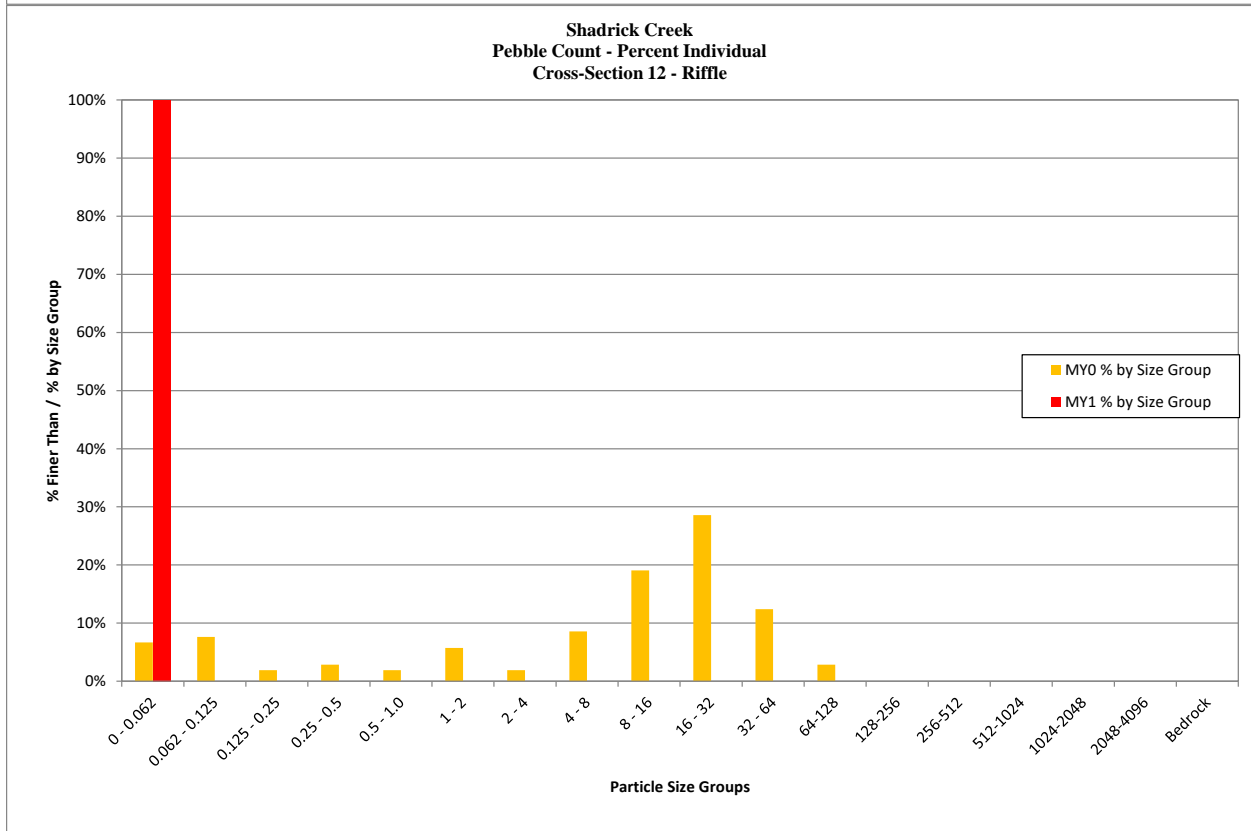
Shadrick Creek			
Cross Section 12 - Riffle			
Monitoring Year - 2019; MY2			
Bed Surface Material Particle Size Class (mm)	Number	% Individual	% Cumulative
0 - 0.062	0	N/A	N/A
0.062 - 0.125	0	N/A	N/A
0.125 - 0.25	0	N/A	N/A
0.25 - 0.5	0	N/A	N/A
0.5 - 1.0	0	N/A	N/A
1 - 2	0	N/A	N/A
2 - 4	0	N/A	N/A
4 - 8	0	N/A	N/A
8 - 16	0	N/A	N/A
16 - 32	0	N/A	N/A
32 - 64	0	N/A	N/A
64-128	0	N/A	N/A
128-256	0	N/A	N/A
256-512	0	N/A	N/A
512-1024	0	N/A	N/A
1024-2048	0	N/A	N/A
2048-4096	0	N/A	N/A
Bedrock	0	N/A	N/A
Total	0	N/A	N/A
		Summary Data	
		D50	N/A
		D84	N/A
		D95	N/A

*No data collected due to presence of beaver dam.

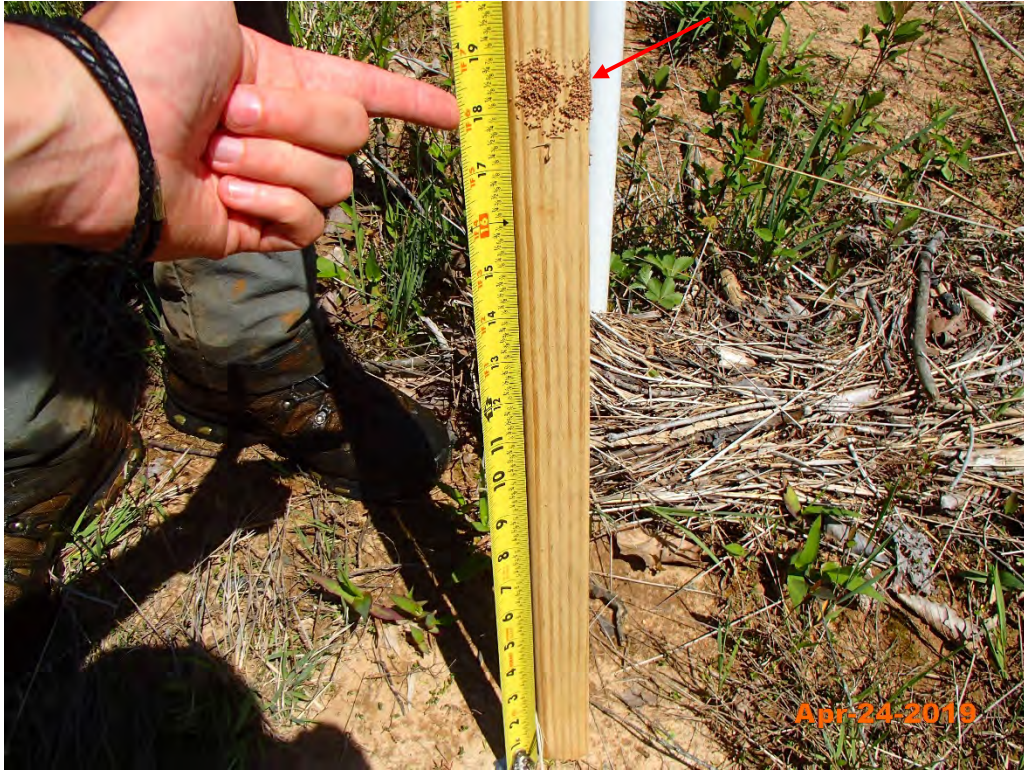
Photo #1 – Shadrick Creek Reach 1 Crest Gauge at 1.2 feet (Recorded bankfull 1.2 feet)

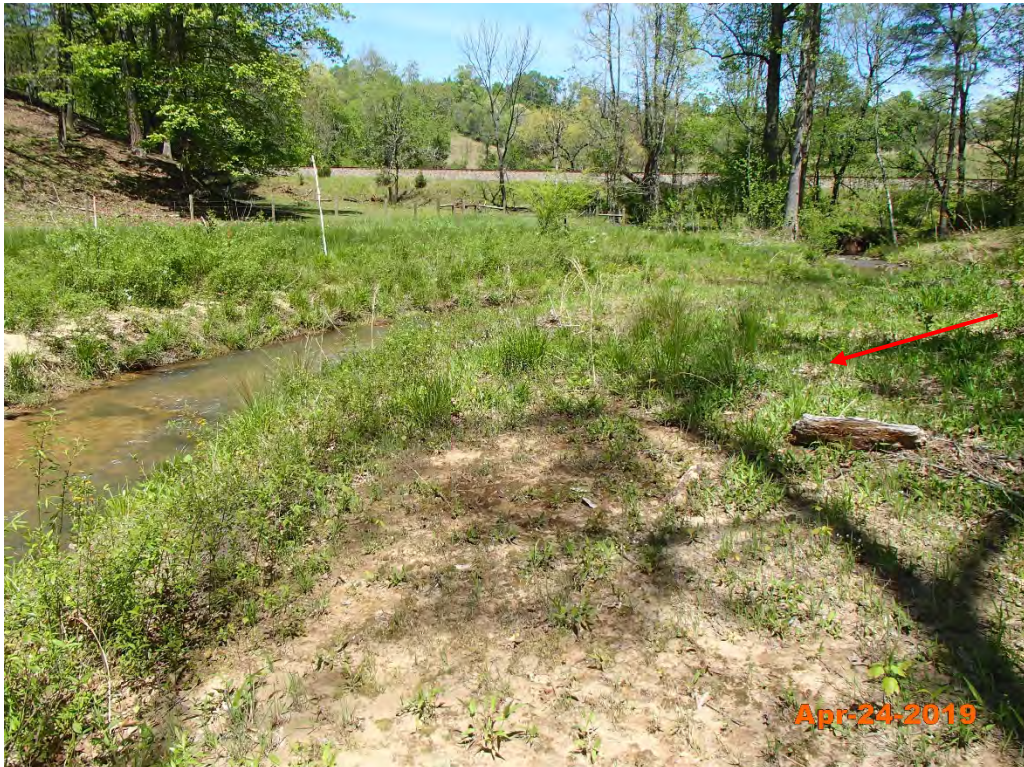
Photo #2 – Shadrick Creek Reach 1 STA 116+00 Wrack Lines

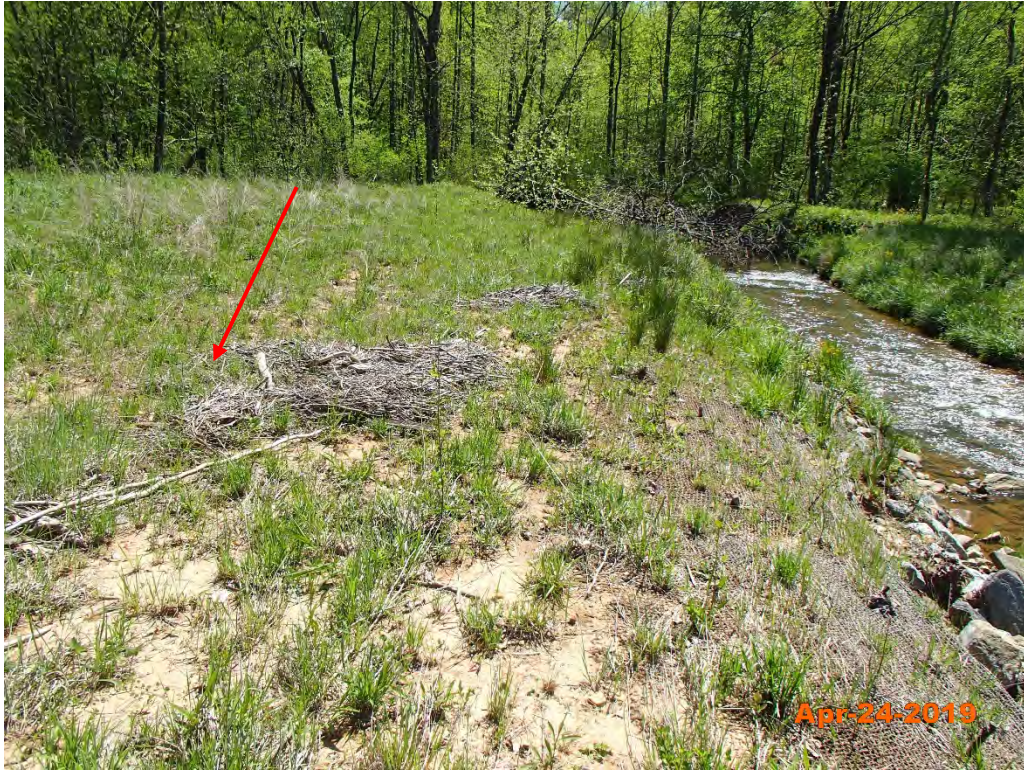
Photo #3 – Shadrick Creek Reach 3 STA 115+50 Wrack Lines

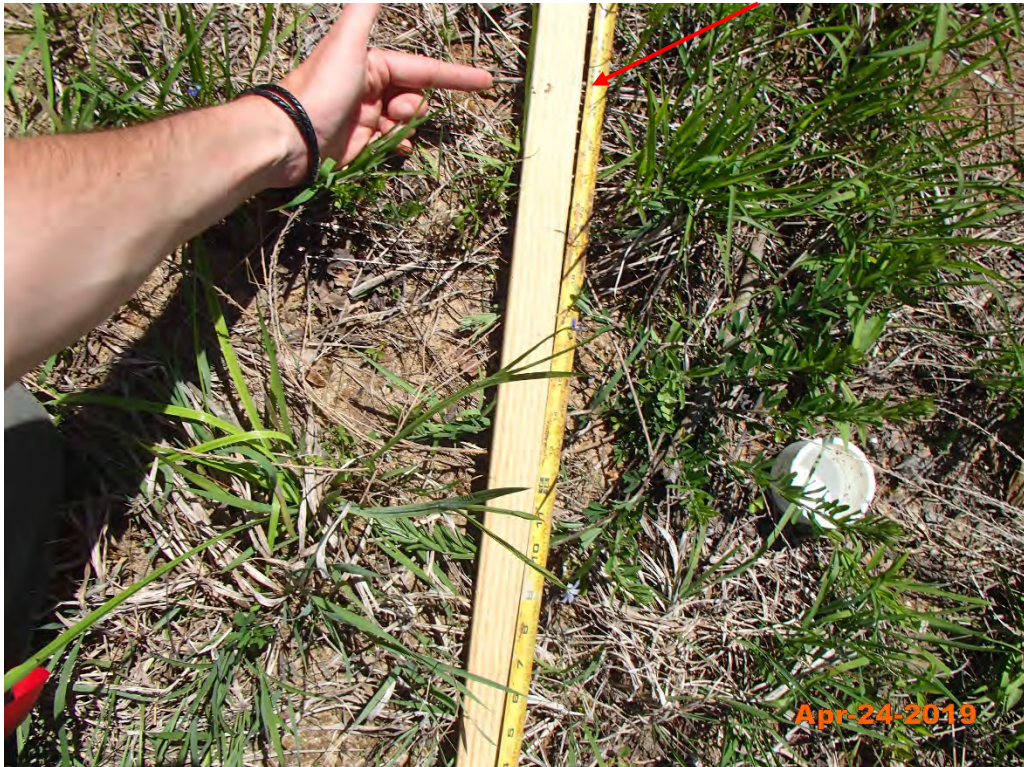
Photo #4 – Shadrick Creek Reach 3 Crest Gauge at 2.05 feet (Recorded bankfull 1.6 feet)
