Shadrick Creek Restoration Project

Annual Monitoring Report

Monitoring Year 3 of 5

McDowell County, North Carolina

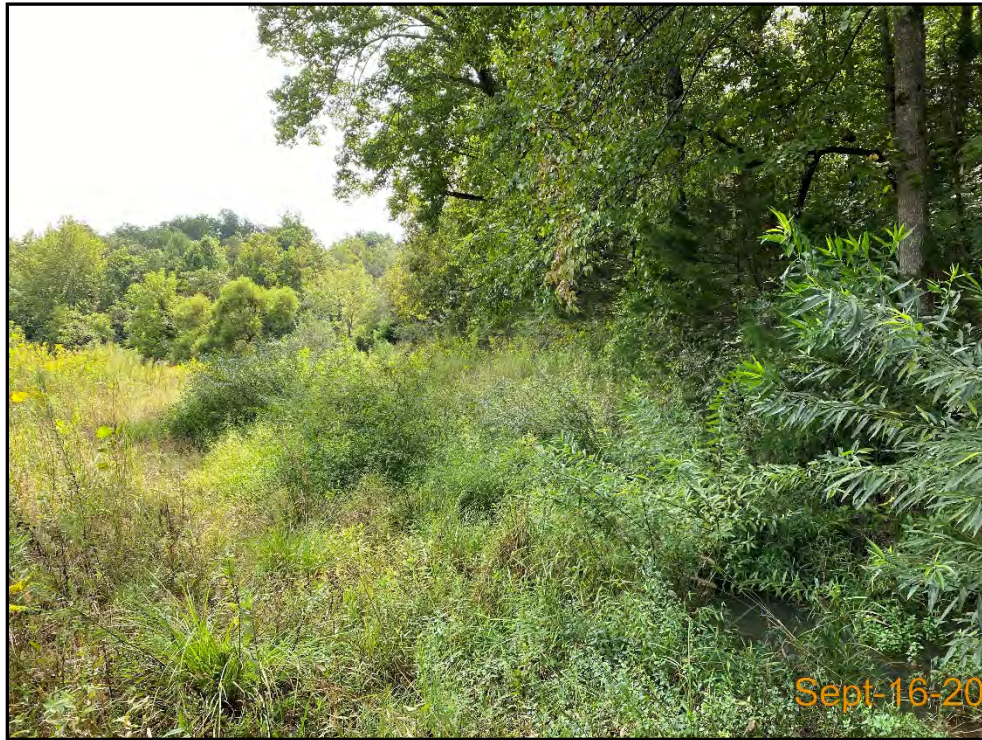
An approximately 10ft long headcut was documented as mass wasting at the farthest upstream extent of UT10 (Table 5, Figure 2 CPPV). This headcut is migrating towards the easement boundary. DMS has contracted with an engineer to develop a repair plan to be implemented in the Winter of 2021. This repair will be documented in the MY4 report and photos.

UT-10 – Permanent Photo Station 21
Looking Downstream

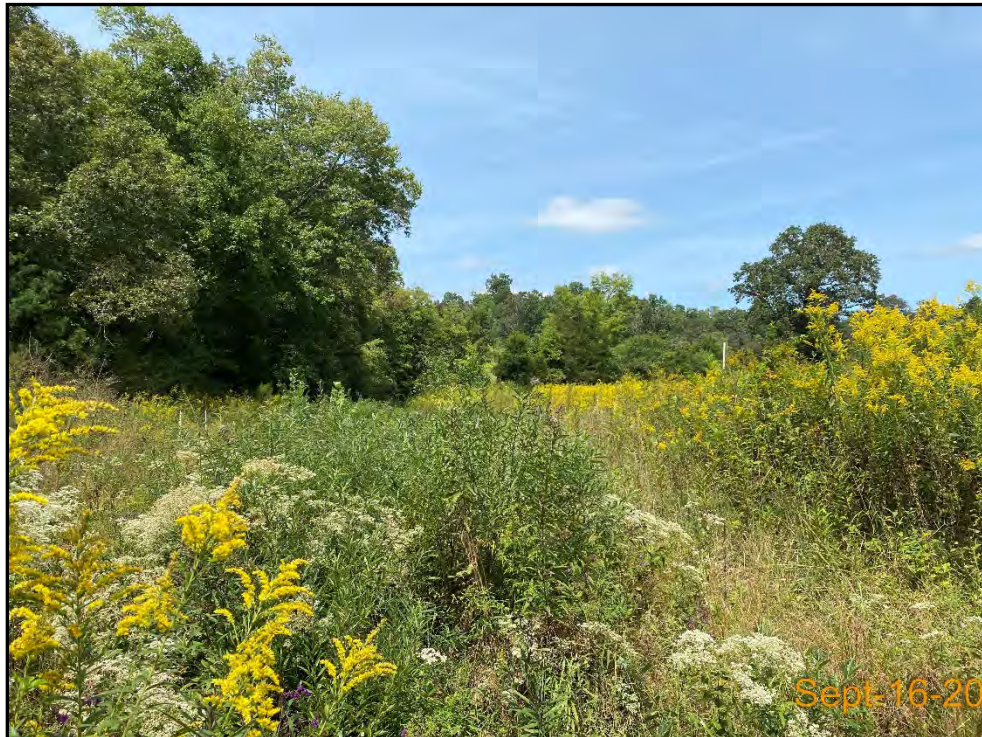
UT-10 – Permanent Photo Station 22
Looking Upstream
