MONITORING YEAR 1 ANNUAL REPORT

SHAKE RAG MITIGATION SITE

Madison County, NC
DEQ Contract No. 7190
DMS Project No. 100018
USACE Action ID No. SAW-2017-01570
DWR Certification No. 17-1157

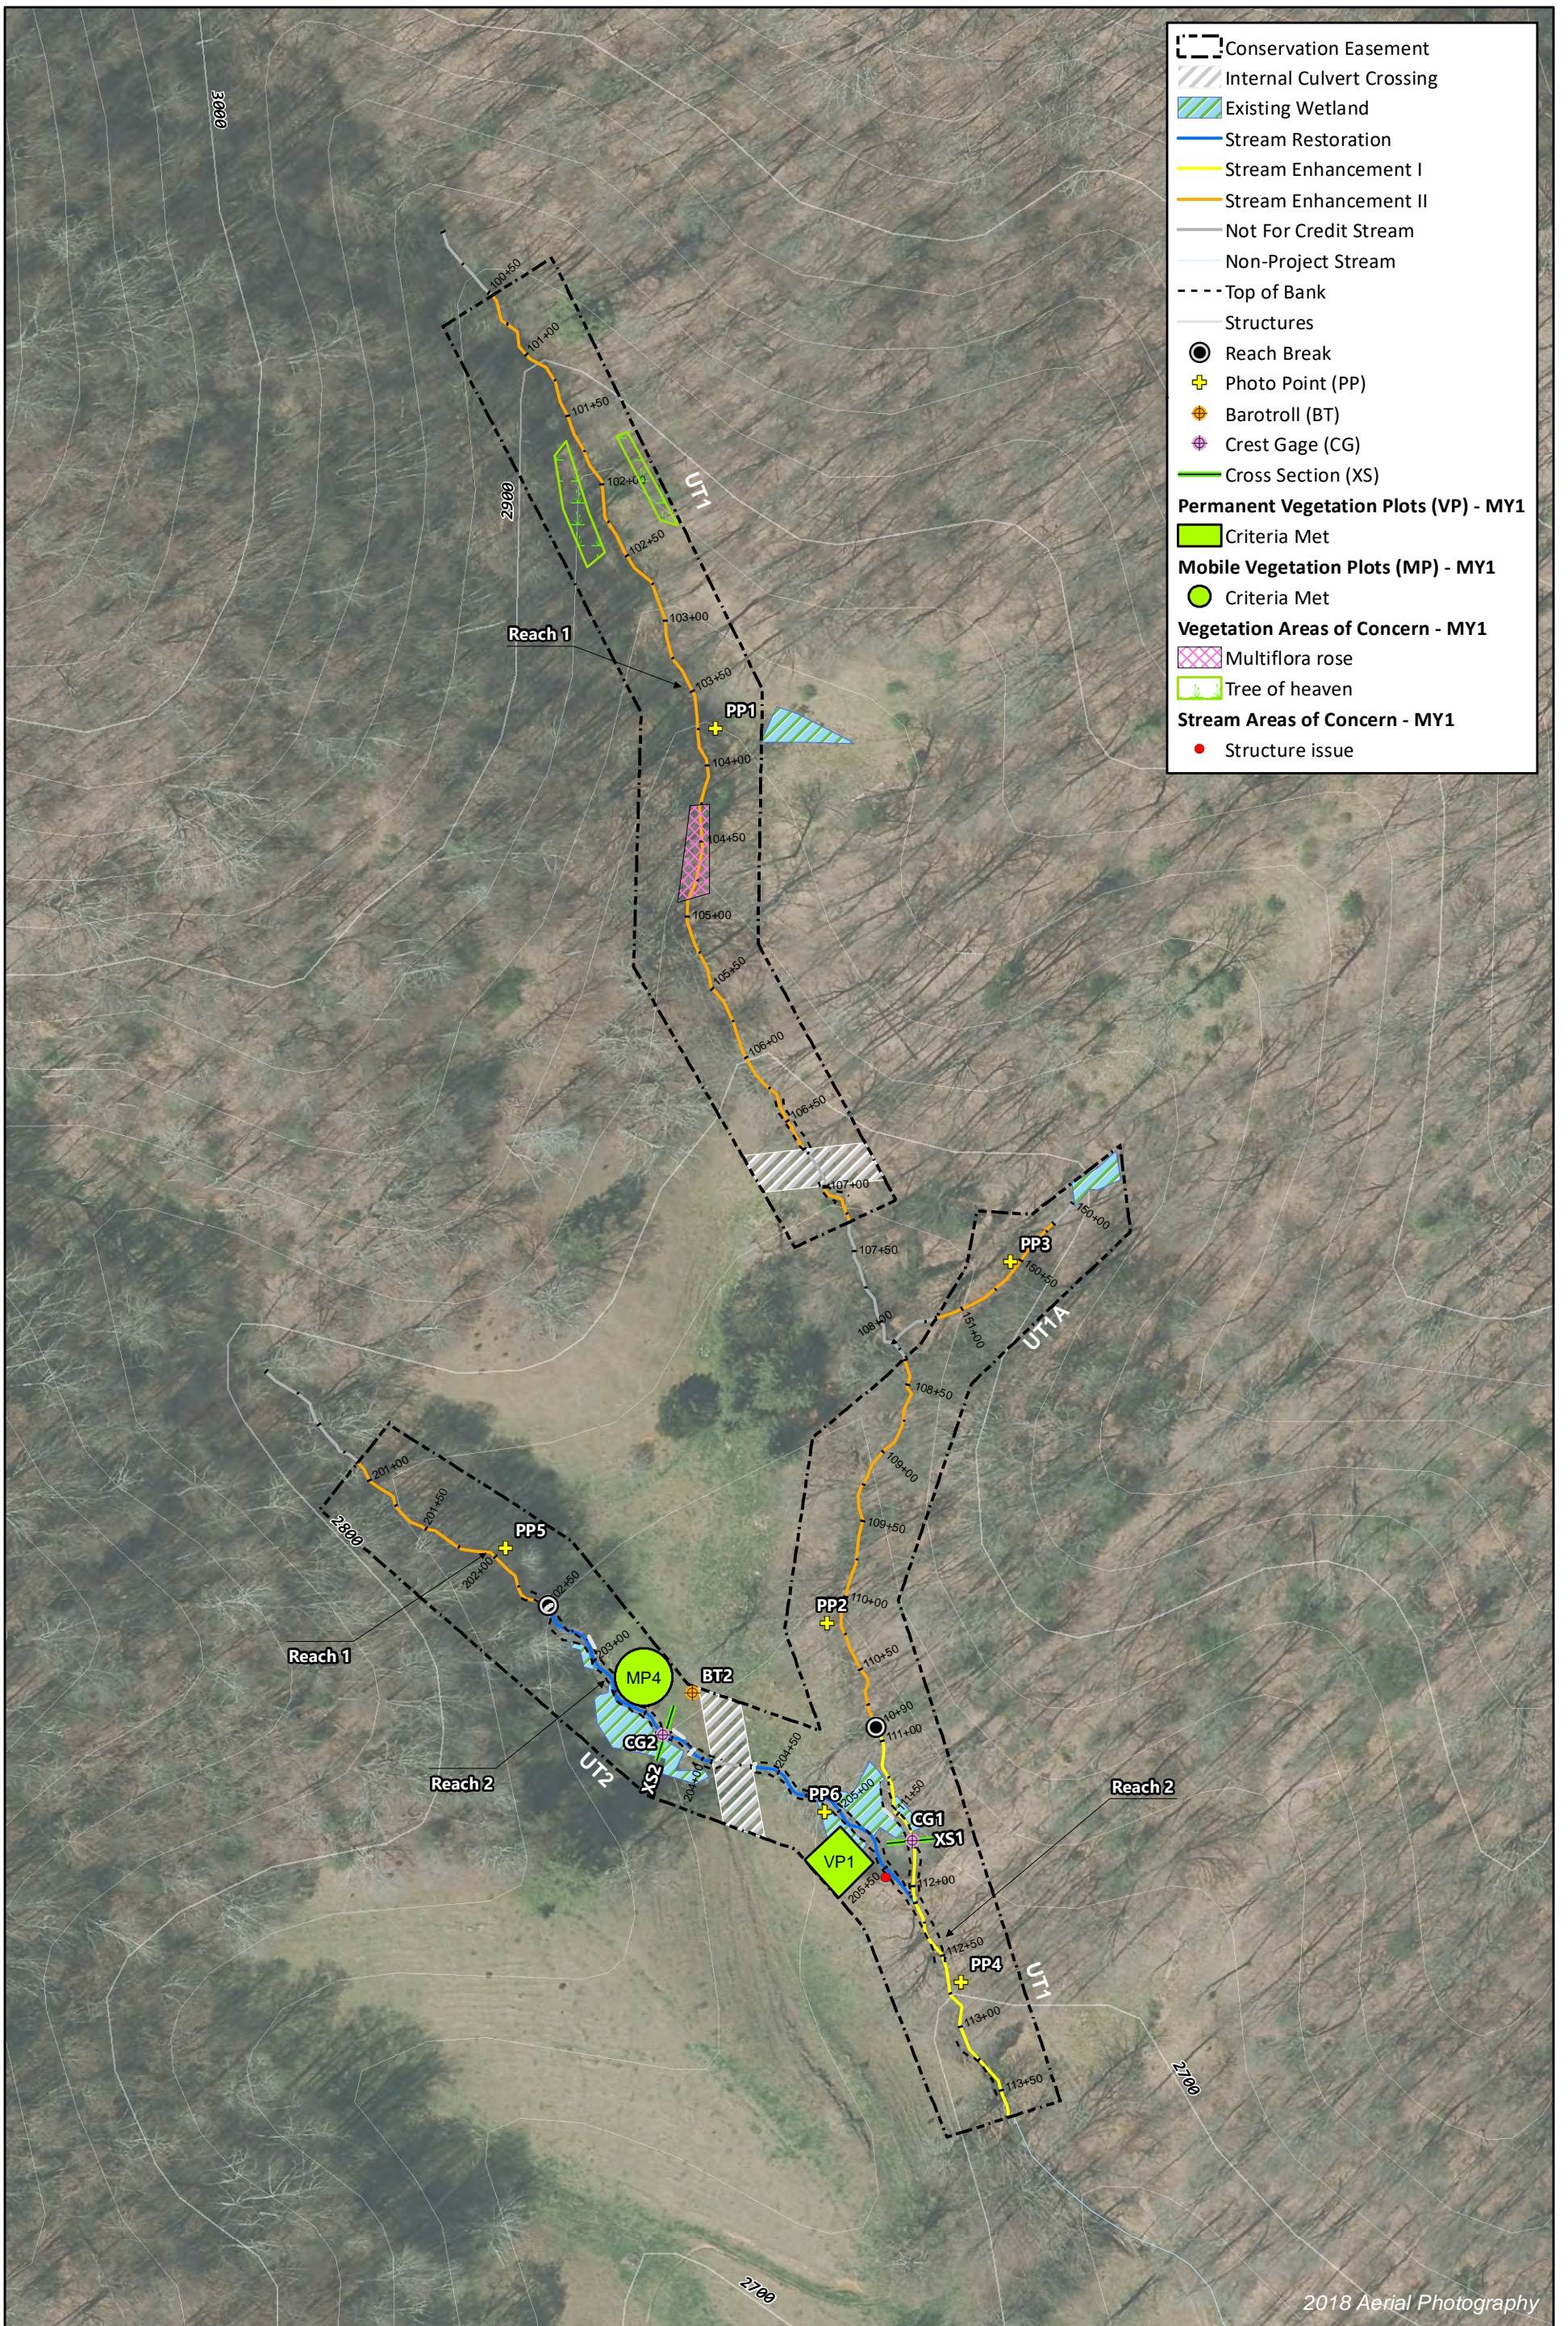
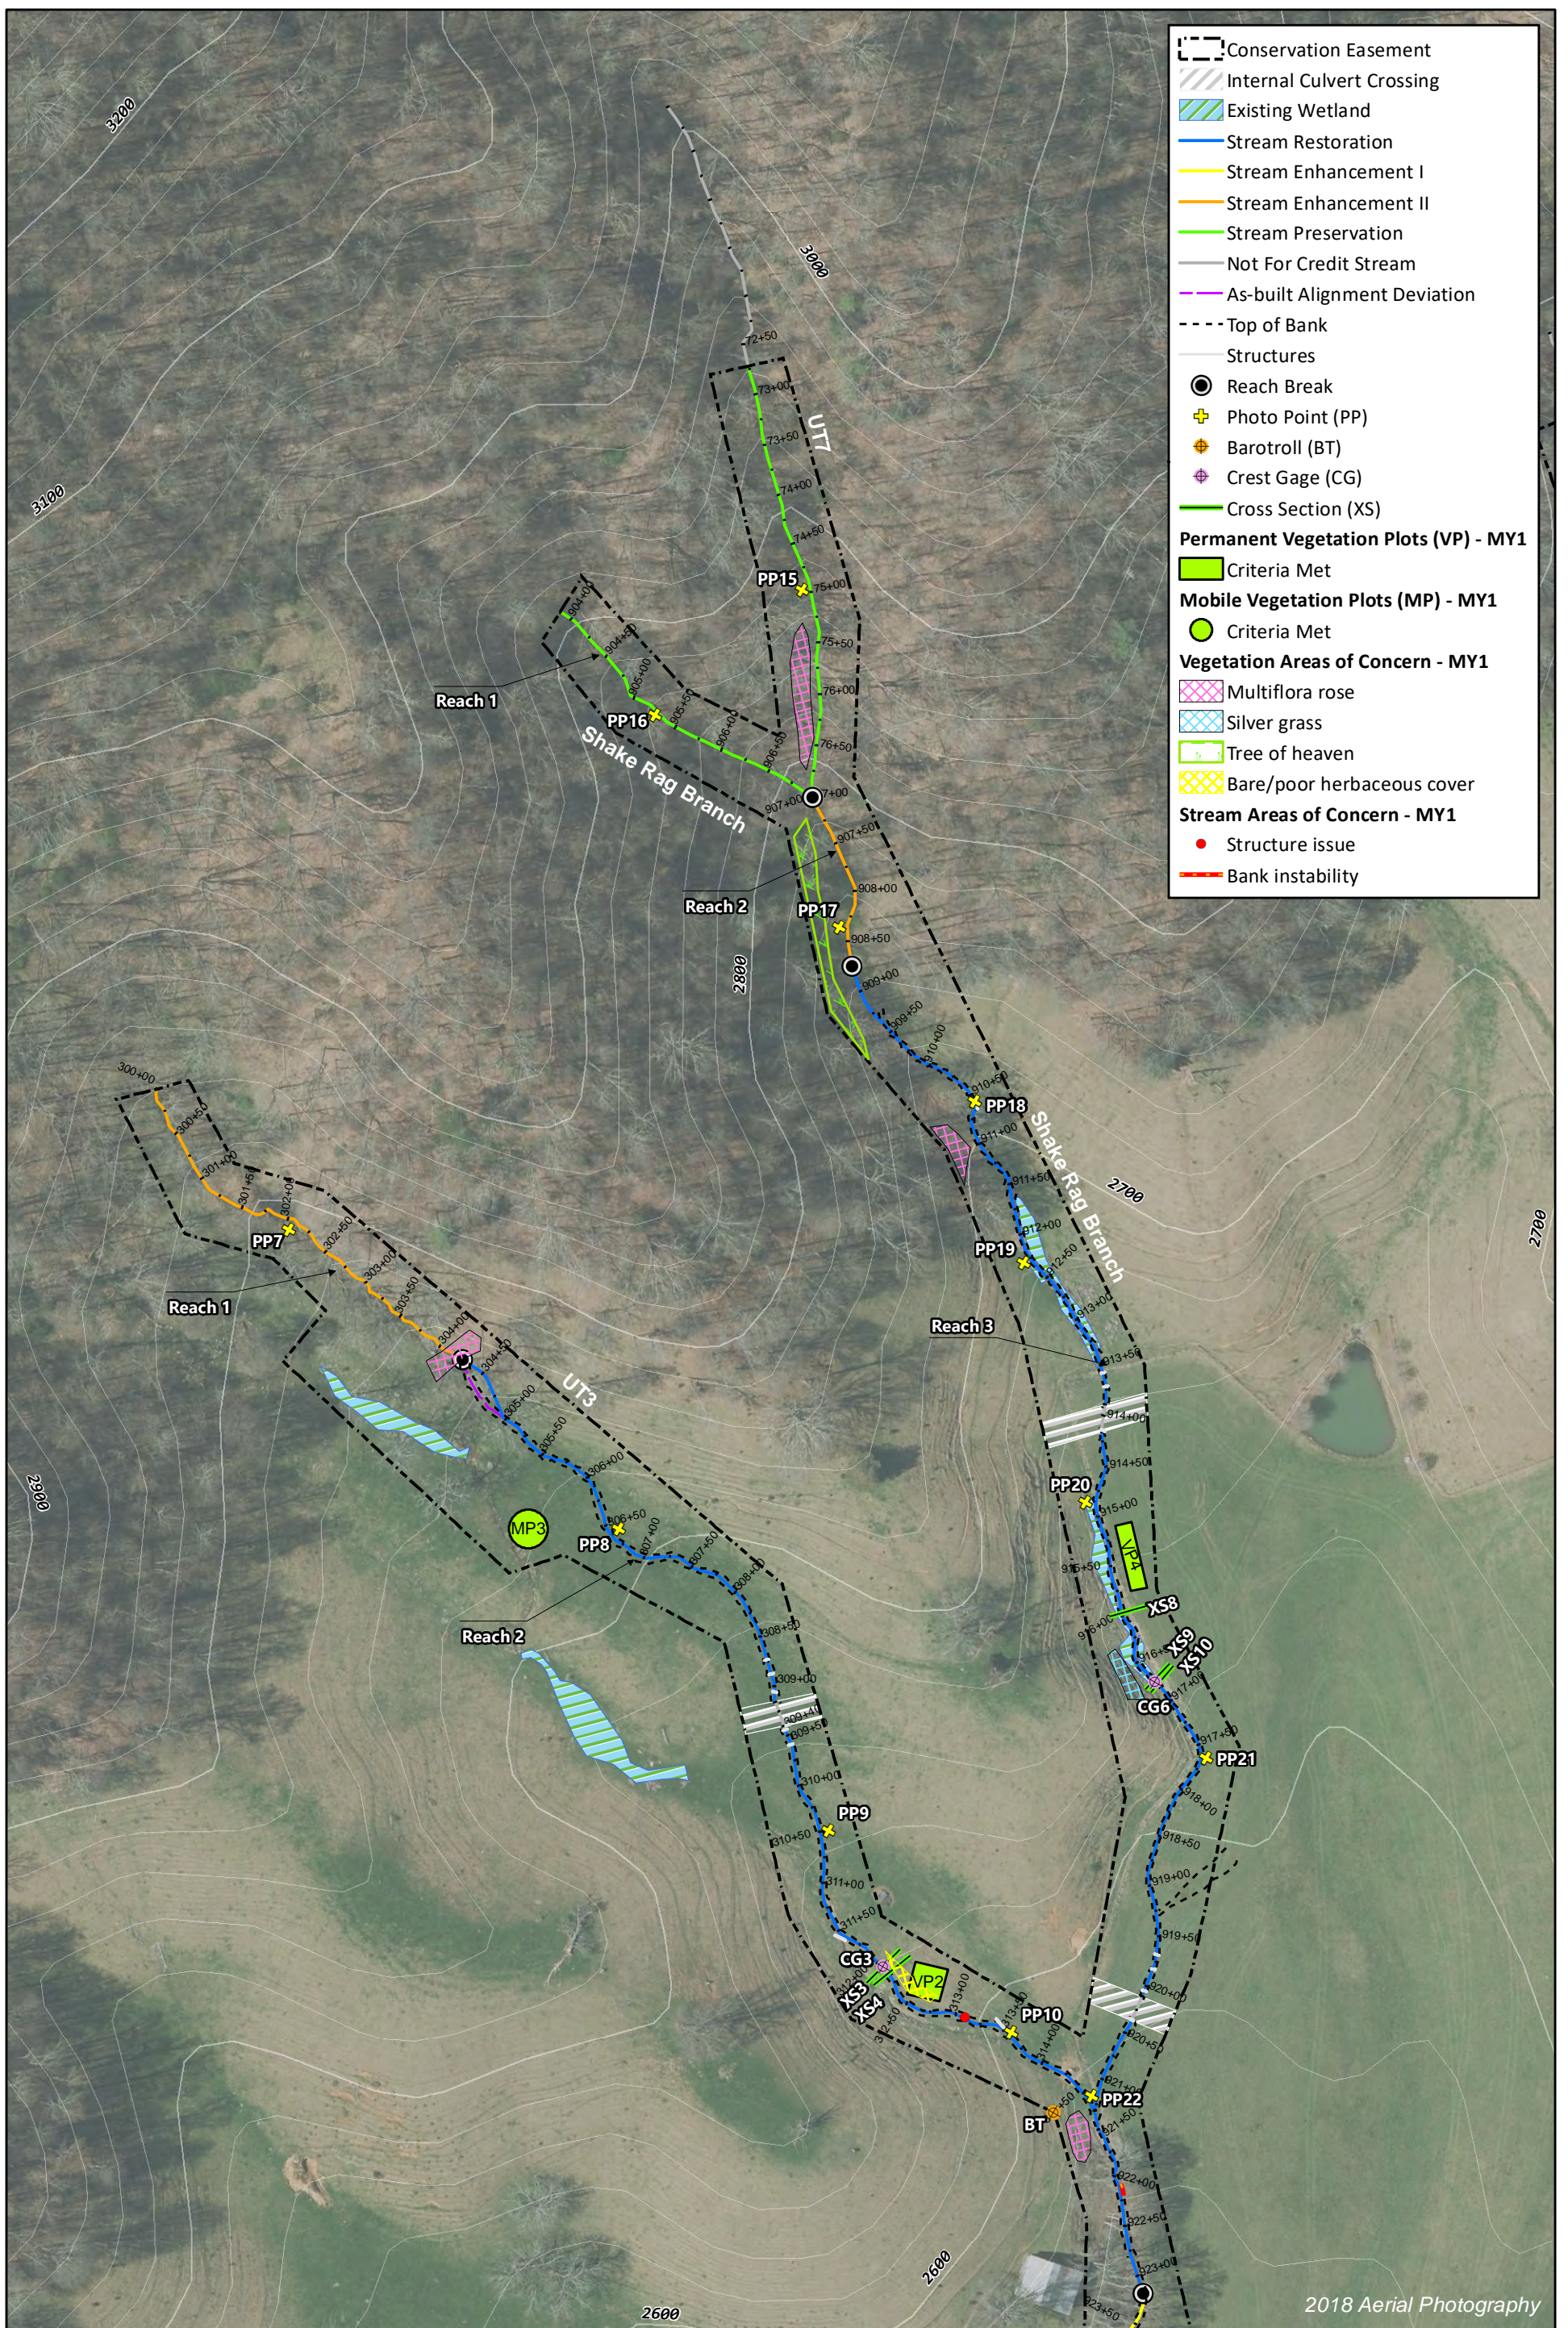
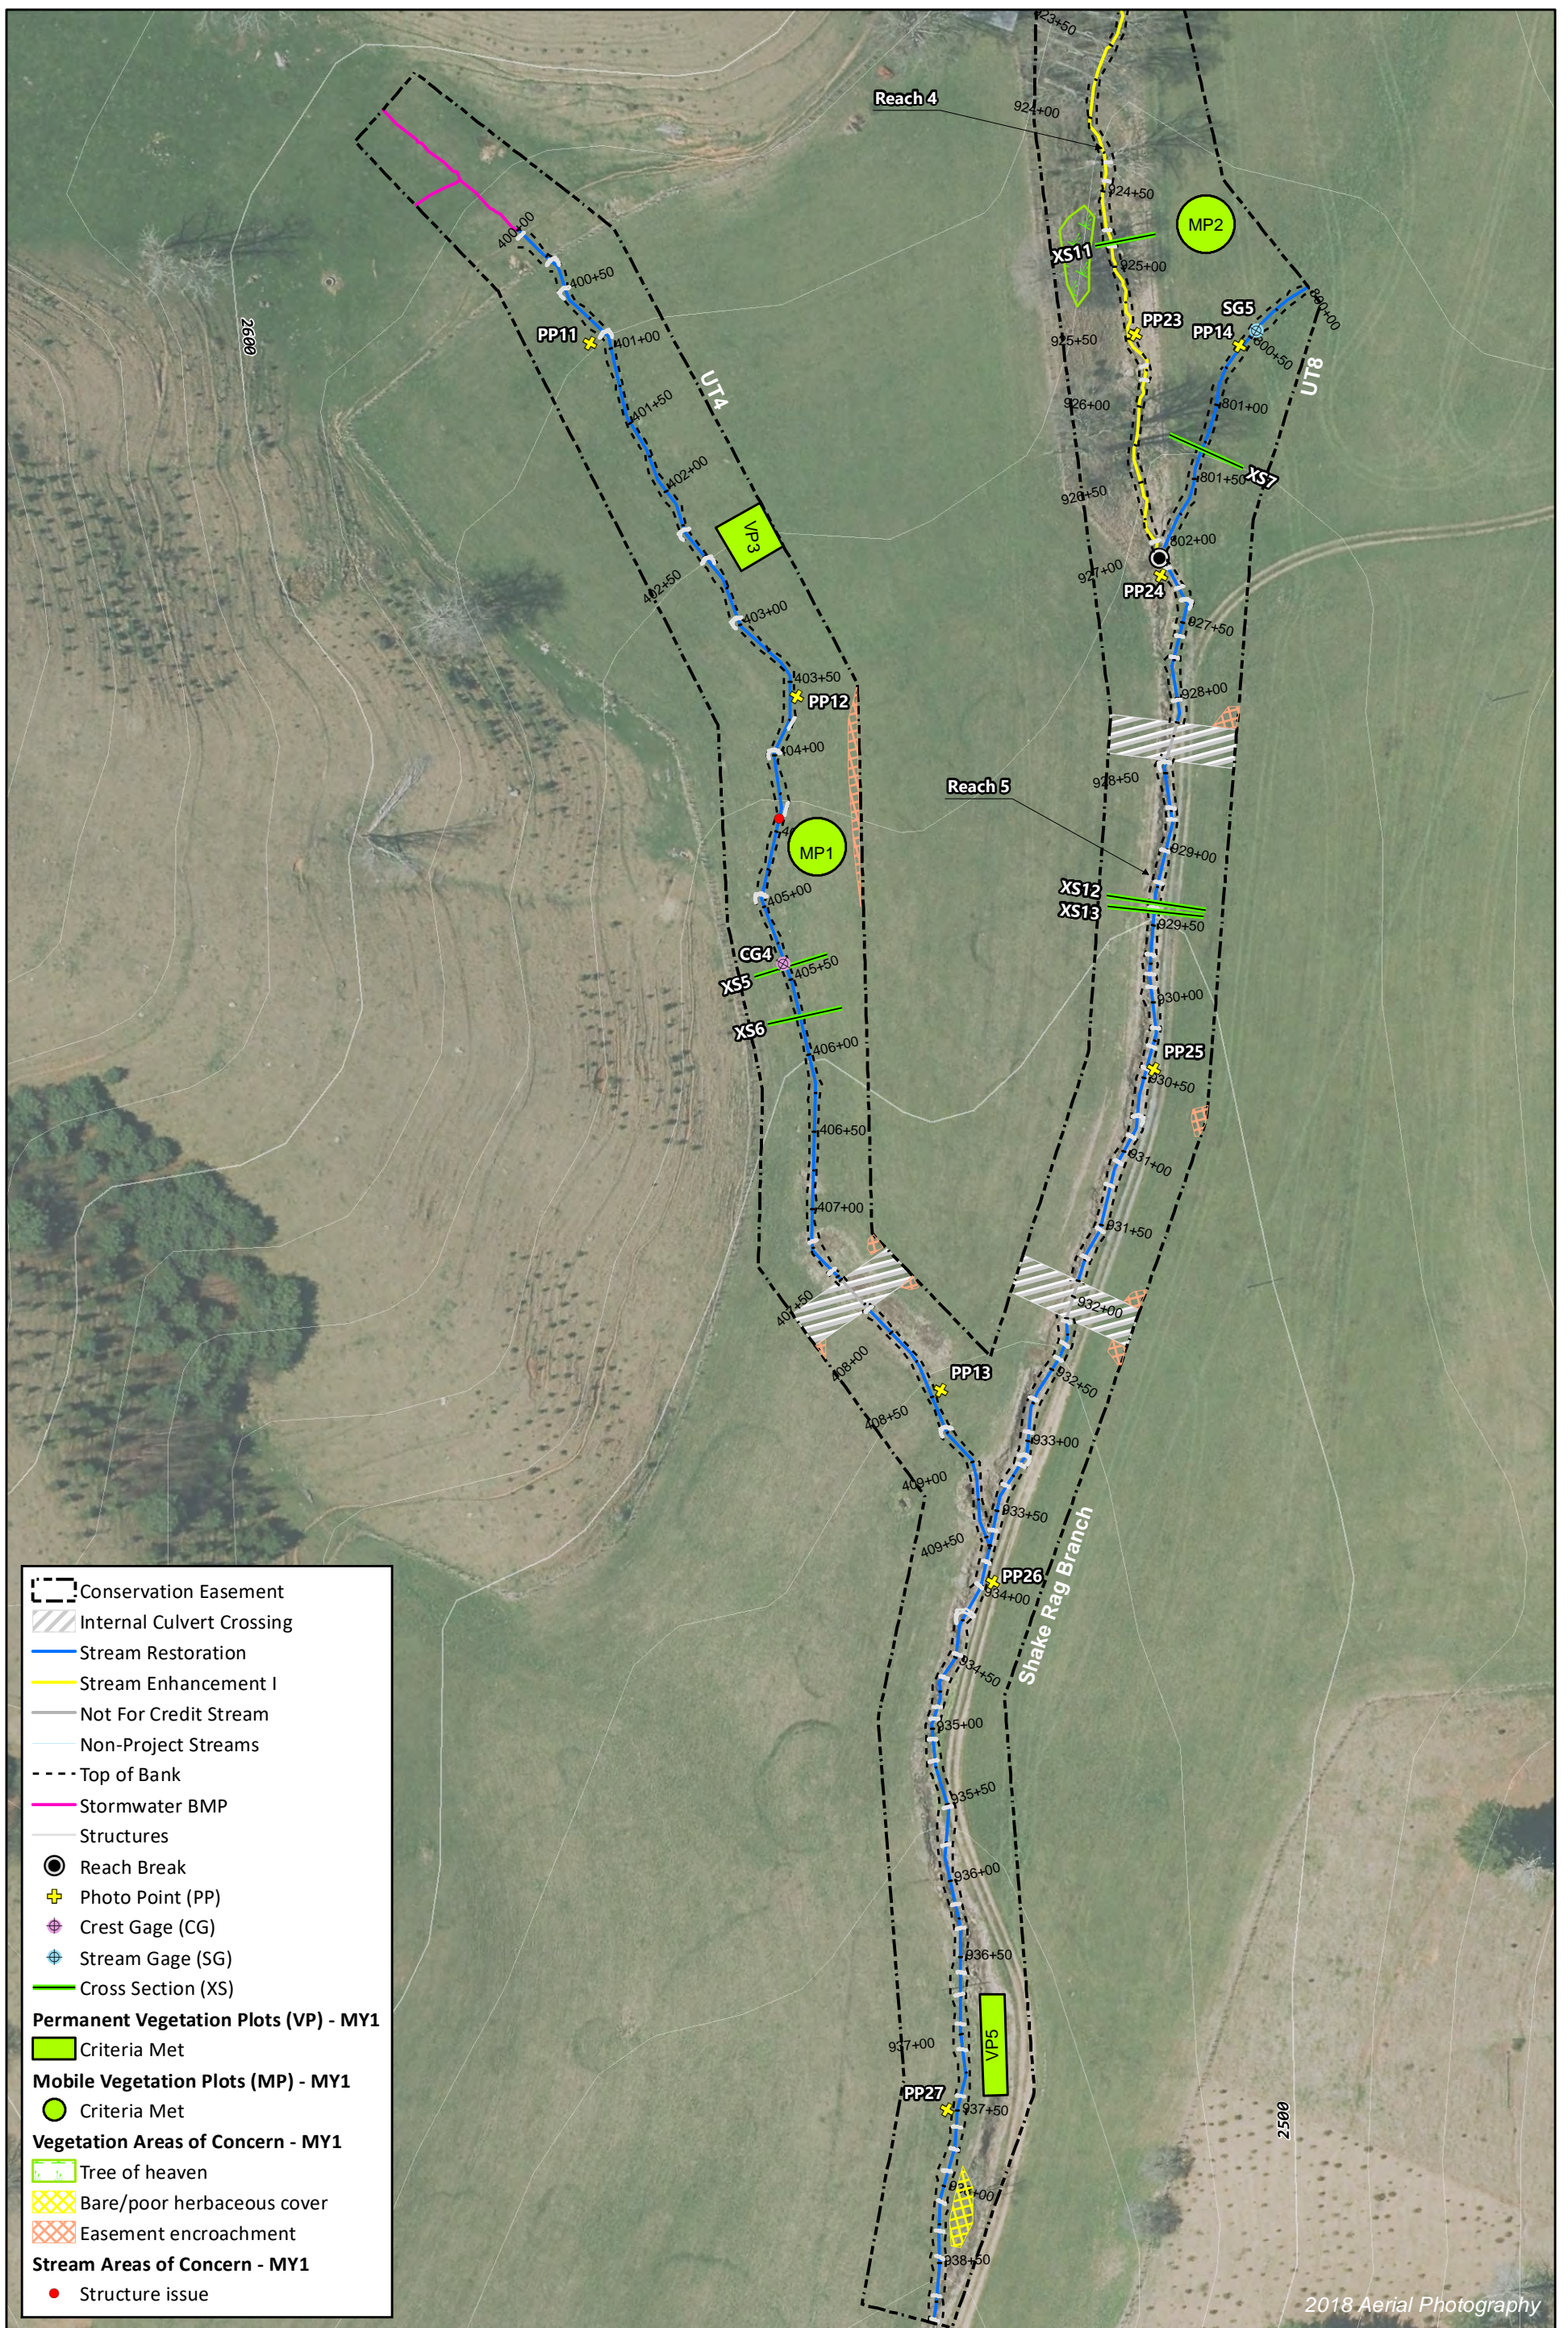
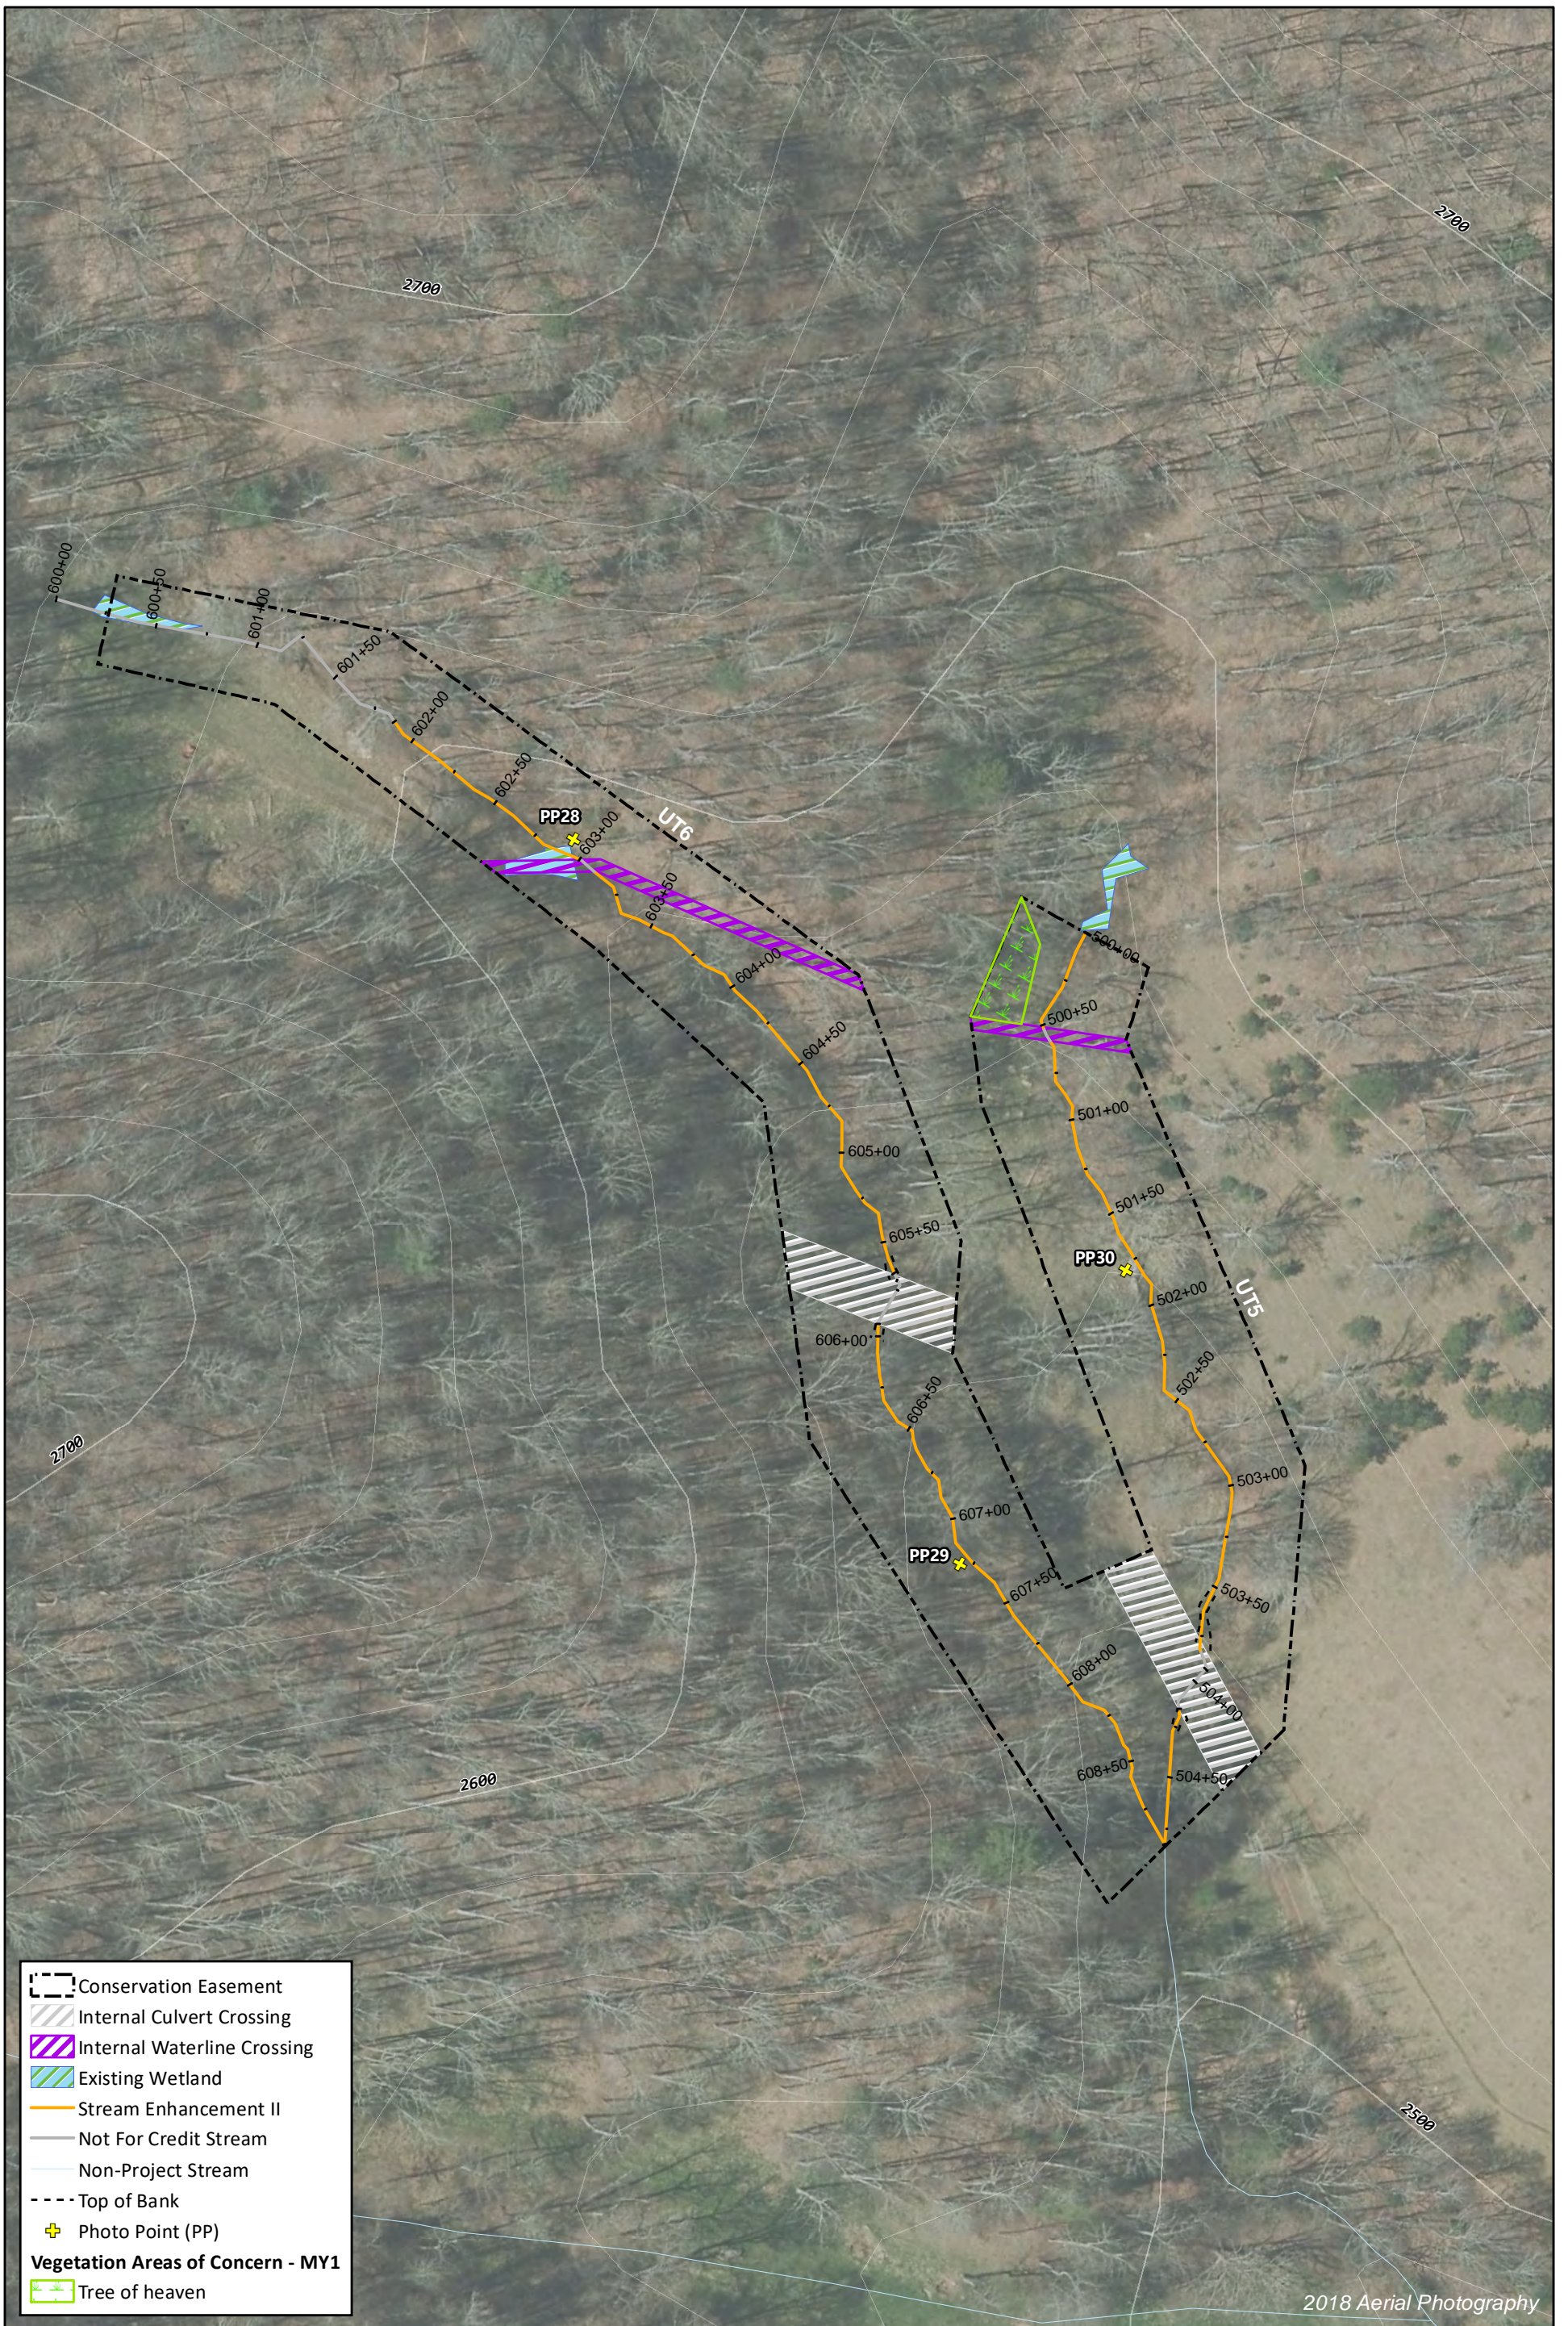
Figure 3.1 Monitoring Plan View Map
Shake Rag Mitigation Site
DMS Project No. 100018
Monitoring Year 1 - 2020

MY1 stream and visual assessments revealed stream areas of concern that include localized instances of structure issues and stream bed instability. In February 2020, several large storm events caused some grade control structures to experience piping around rock sills, bank scour, and riffle downcutting along Shake Rag Branch, UT2, UT3, and UT4. The first round of repairs was completed in Spring 2020 and addressed 3 major instances of rock step structure instability, 7 instances of bed scour, and 2 instances of bank scour. In November 2020, a few additional repairs were completed and included 2 instances of rock step structure piping and 5 instances of bed instability. Repair activities consisted of re-grading bank scour, adding riffle material, reinforcing some boulder structures, and plugging piping at boulder

steps to improve the grade control in the streams. A few minor stream areas of concern remain on the Site and are noted on the CCPV figures. Currently, these areas are not negatively impacting stream function or stability; however, they will continue to be monitored in future years for signs of instability. Please refer to Appendix 2 for stream stability tables and CCPV Figures 3.0 – 3.4.

Overall, the herbaceous cover is becoming well established throughout the site and wetland vegetation has filled in nicely in wet seeps preventing the potential for rills or gullies to form. Only a couple of small areas of poor herbaceous cover were noted on steeper slopes along UT3 and Shake Rag Branch. A few small areas of mowing overreach were observed inside the easement. They were primarily noted at the corners of a couple internal crossings on Shake Rag Branch Reach 5 and UT4. Wildlands has notified the landowners of the mowing error and will install additional posts if deemed necessary to prevent any additional encroachment.

These vegetation areas of concern are documented on Table 7 and shown on the Current Condition Plan View (CCPV) Figures 3.0 – 3.4 in Appendix 2.
