# MONITORING YEAR 3 ANNUAL REPORT

## SHAKE RAG MITIGATION SITE

Madison County, NC

DMS Project No. 100018

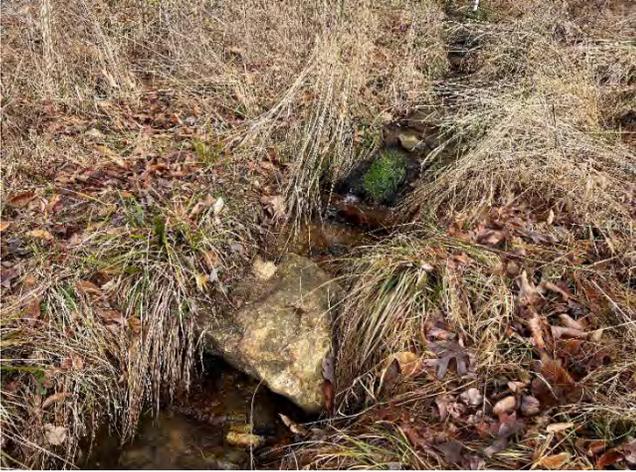
**UT1 Reach 2 STA 112+00: pre-repair downcutting behind dislodged structure, 3/8/2022**

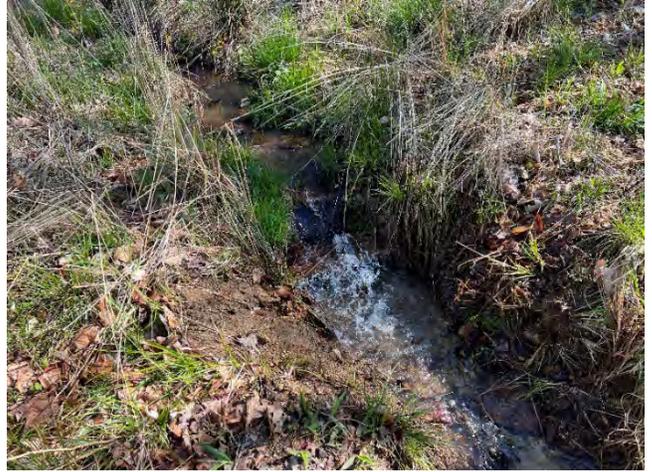
**UT1 Reach 2 STA 112+00: post-repair, 4/19/2022**

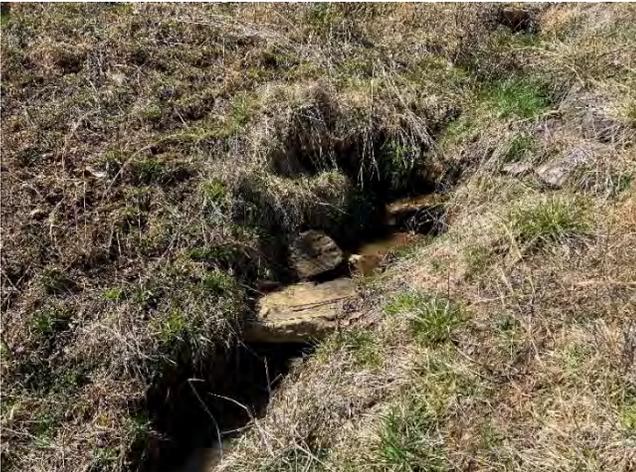
**UT3 Reach 2 STA 306+00: pre-repair, downcutting/structure piping, 3/8/2022**

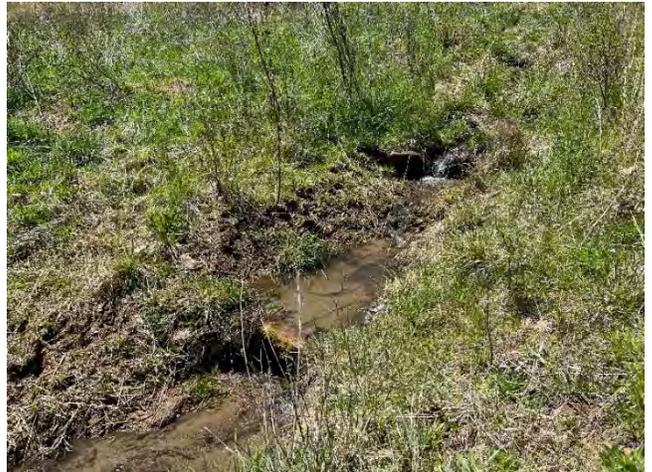
**UT3 Reach 2 STA 306+00: post-repair, 4/19/2022**

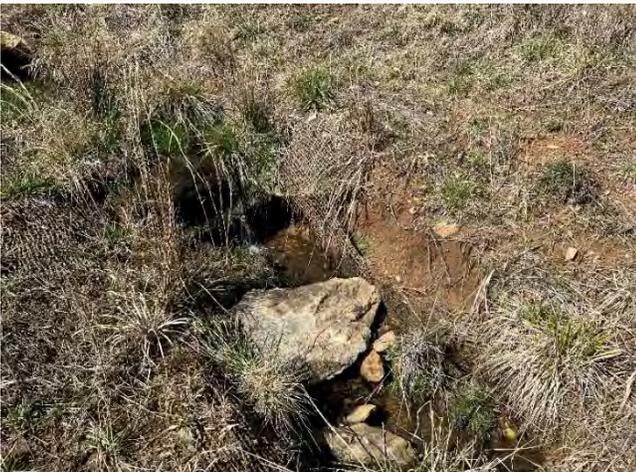
**UT3 Reach 2 STA 307+75: pre-repair, bank instability, 3/8/2022**

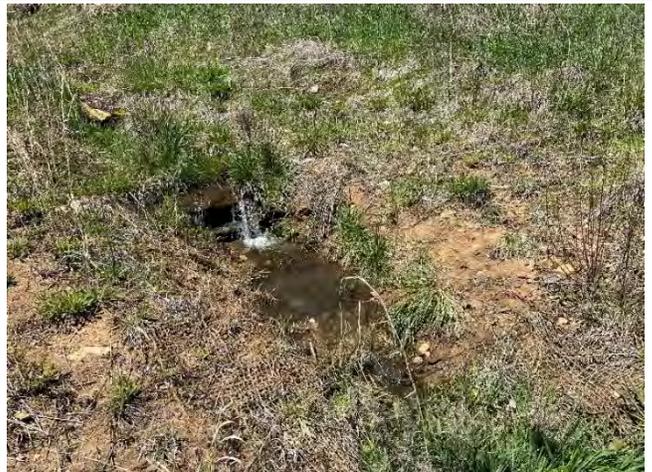
**UT3 Reach 2 STA 307+75: post-repair, 4/19/2022**

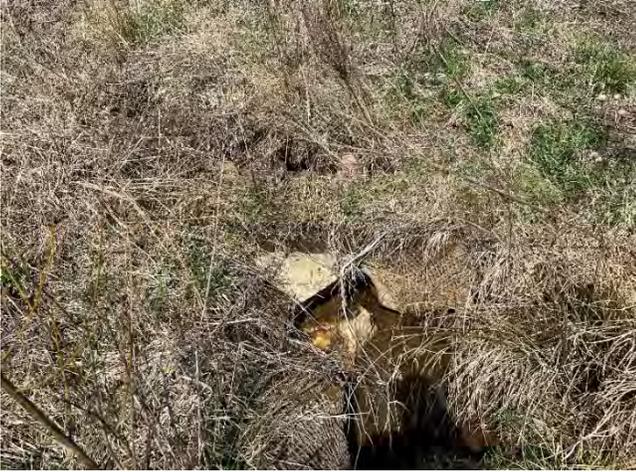
**UT3 Reach 2 STA 309+90: pre-repair, downcutting, riffle/structure piping at head, 3/8/2022**

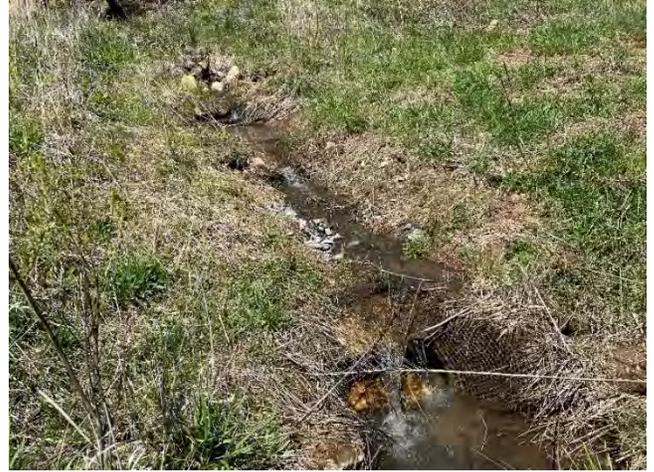
**UT3 Reach 2 STA 309+90: post-repair, 4/19/2022**

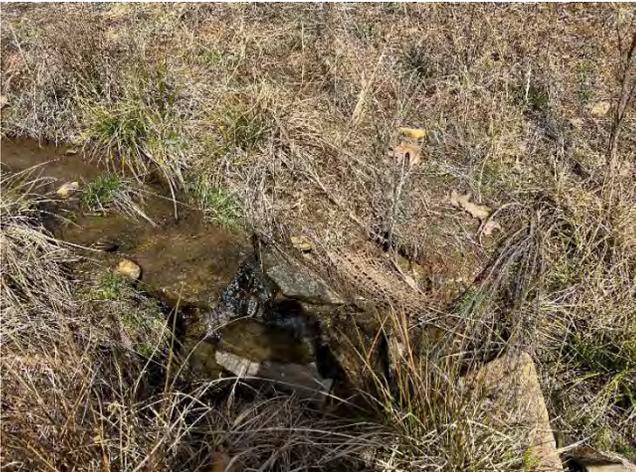
**UT3 Reach 2 STA 310+85: pre-repair, bank instability, 3/8/2022**

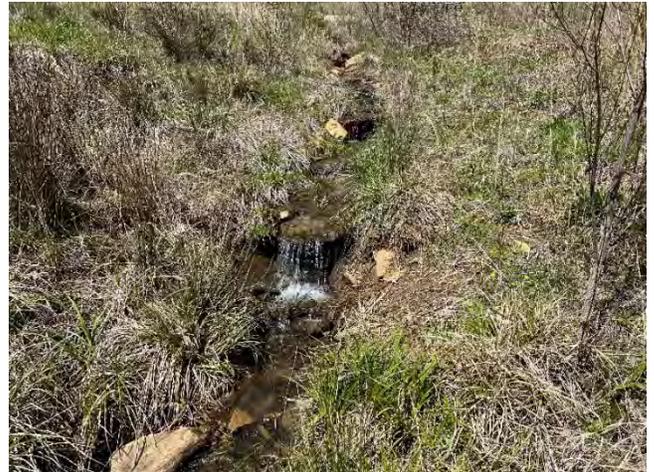
**UT3 Reach 2 STA 310+85: post-repair, 4/19/2022**

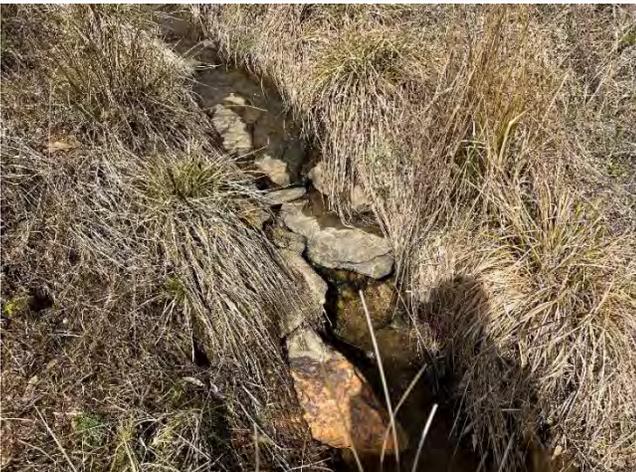
**UT3 Reach 2 STA 311+25: pre-repair, downcutting and shifting riffle material, 3/8/2022**

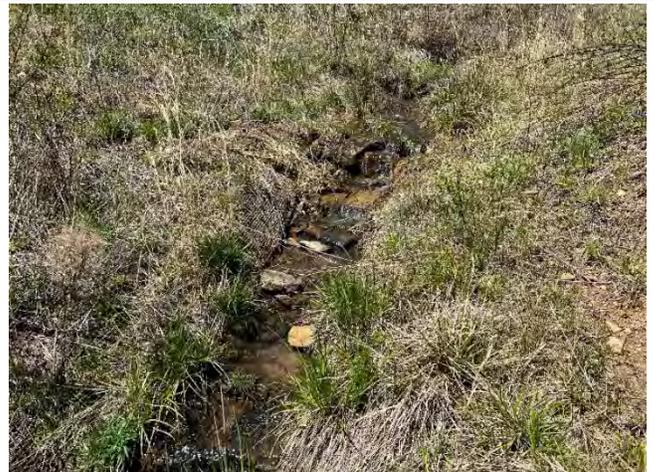
**UT3 Reach 2 STA 311+25: post-repair, 4/19/2022**

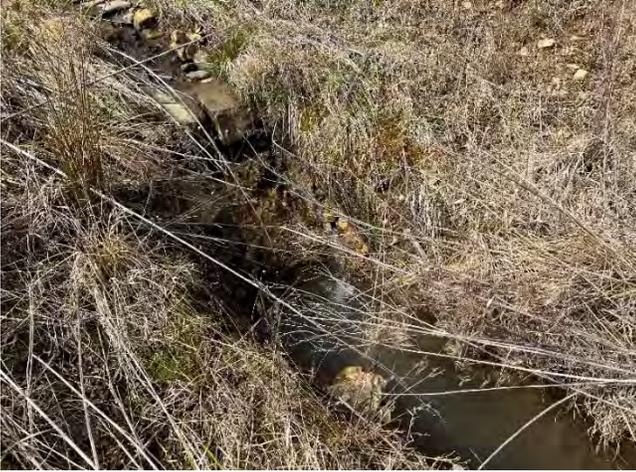
**UT3 Reach 2 STA 311+75: pre-repair, downcutting and shifting riffle material, 3/8/2022**

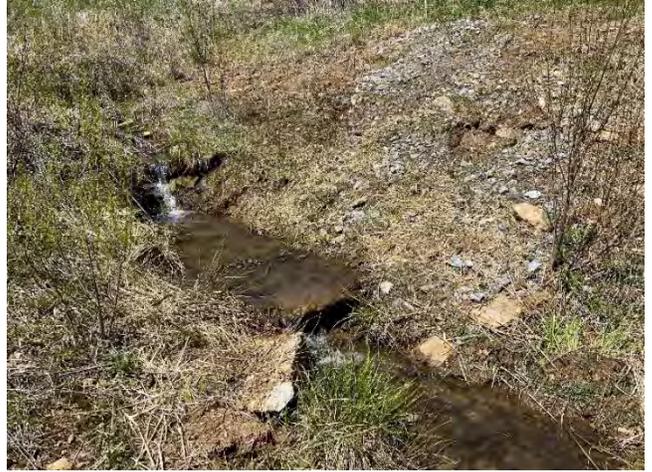
**UT3 Reach 2 STA 311+75: post-repair, 4/19/2022**

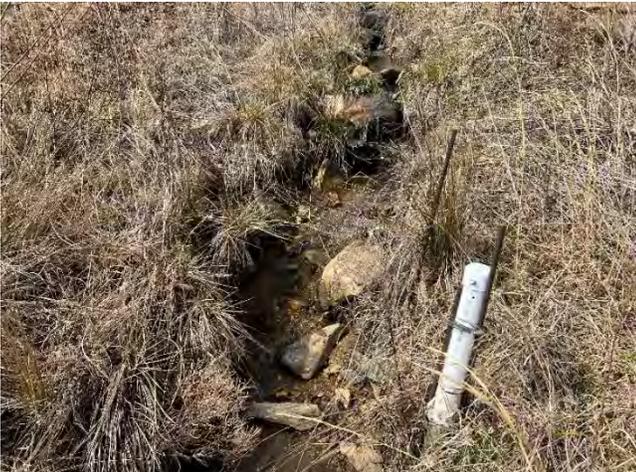
**UT3 Reach 2 STA 312+00: pre-repair, bed instability, 3/8/2022**

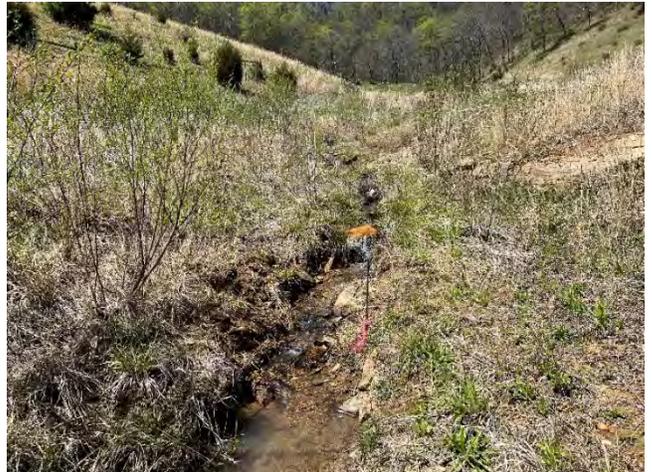
**UT3 Reach 2 STA 312+00: post-repair, 4/19/2022**

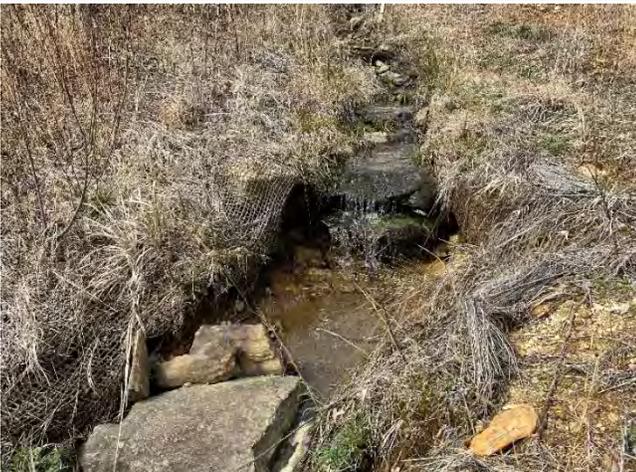
**UT3 Reach 2 STA 312+30: pre-repair, downcutting riffle material shift, 3/8/2022**

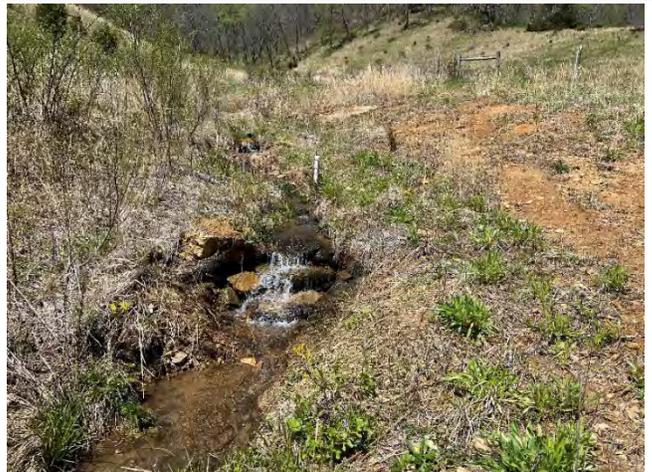
**UT3 Reach 2 STA 312+30: post-repair, 4/19/2022**

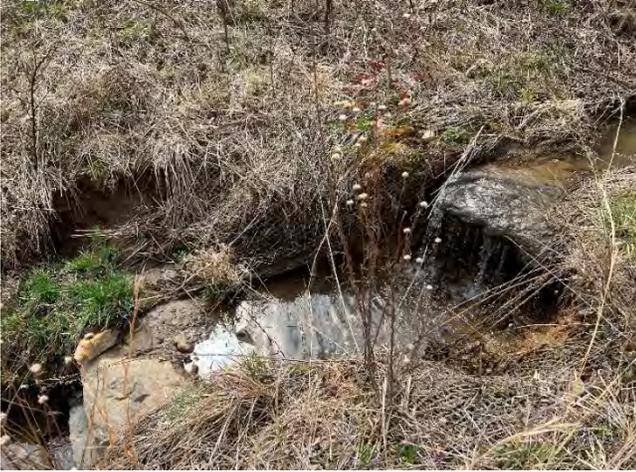
**UT3 Reach 2 STA 312+70: pre-repair, downcutting structure piping, 3/8/2022**

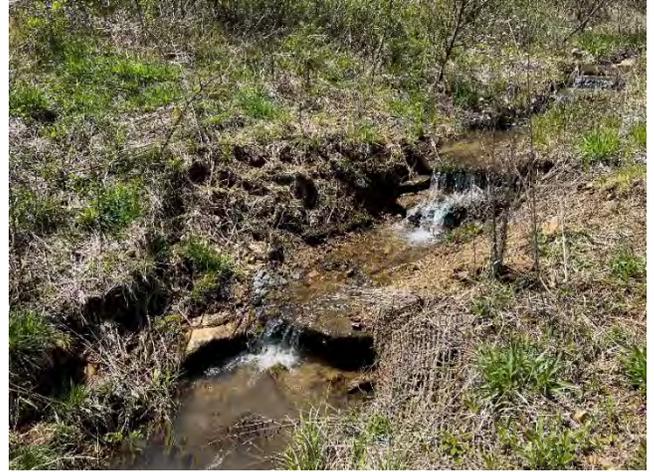
**UT3 Reach 2 STA 312+70: post-repair, 4/19/2022**

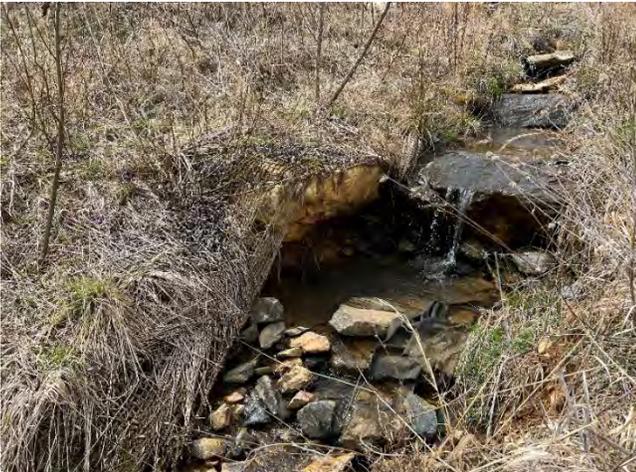
**UT3 Reach 2 STA 313+25: pre-repair, bed instability, 3/8/2022**

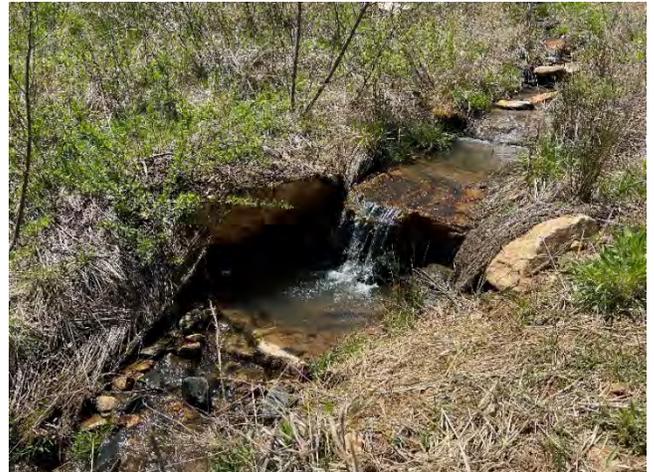
**UT3 Reach 2 STA 313+25: post-repair, 4/19/2022**

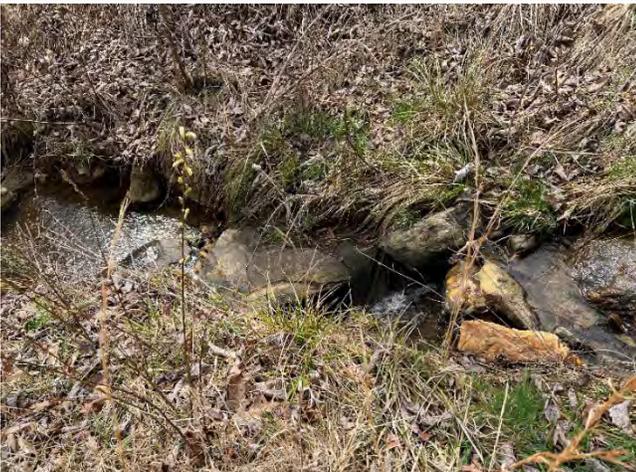
**Shake Rag Branch Reach 3 STA 921+50: pre-repair, bed instability, 3/8/2022**

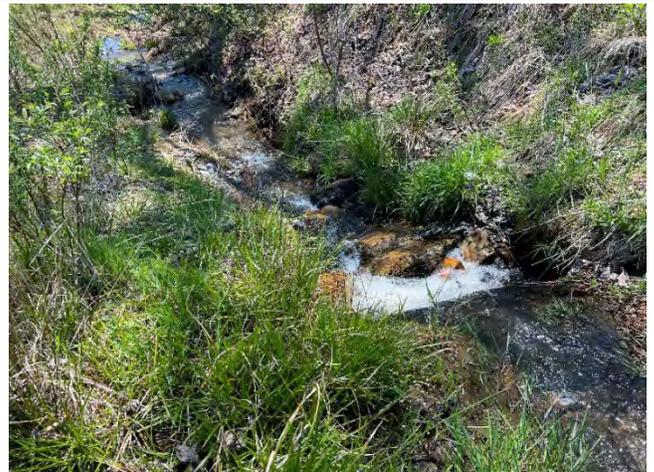
**Shake Rag Branch Reach 3 STA 921+50: post-repair, 4/19/2022**

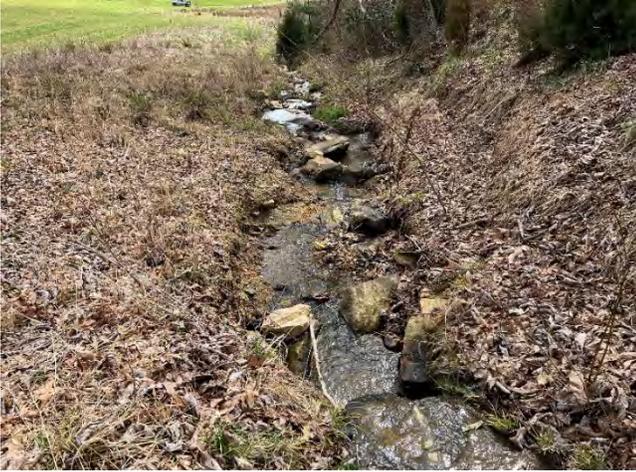
**Shake Rag Branch Reach 3 STA 921+75: pre-repair, bank instability, 3/8/2022**

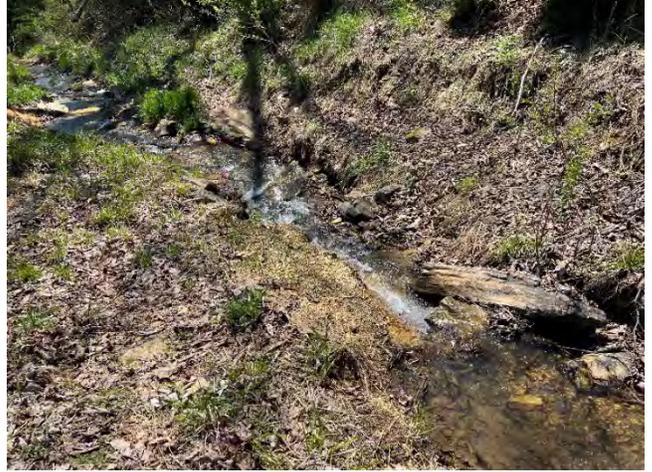
**Shake Rag Branch Reach 3 STA 921+75: post-repair, 4/19/2022**

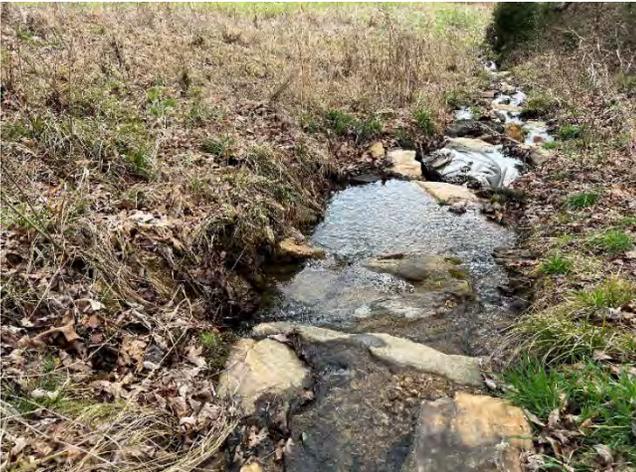
**Shake Rag Branch Reach 3 STA 922+15: pre-repair, bank instability, 3/8/2022**

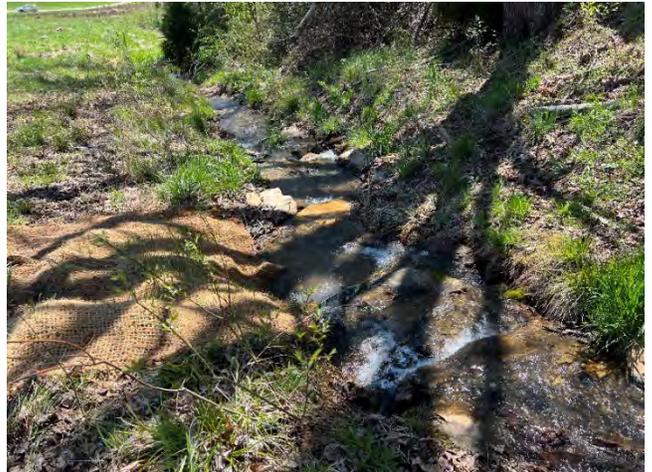
**Shake Rag Branch Reach 3 STA 922+15: post-repair, 4/19/2022**

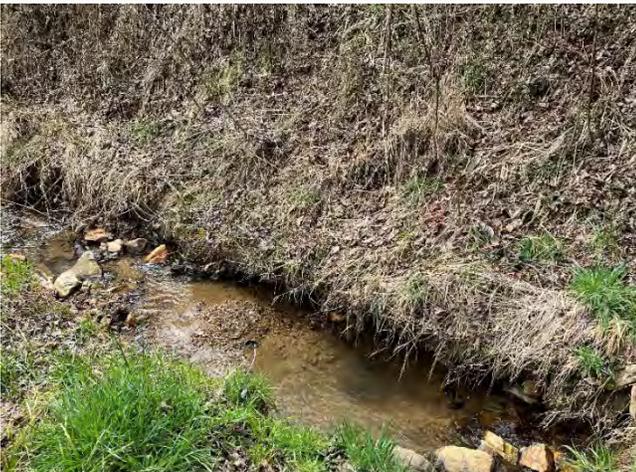
**Shake Rag Branch Reach 4 STA 924+00: pre-repair, bank instability, 3/8/2022**

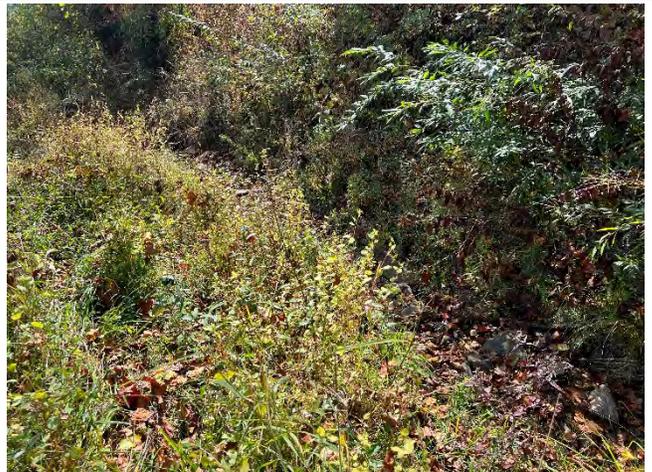
**Shake Rag Branch Reach 4 STA 924+00: post-repair, 10/11/2022**

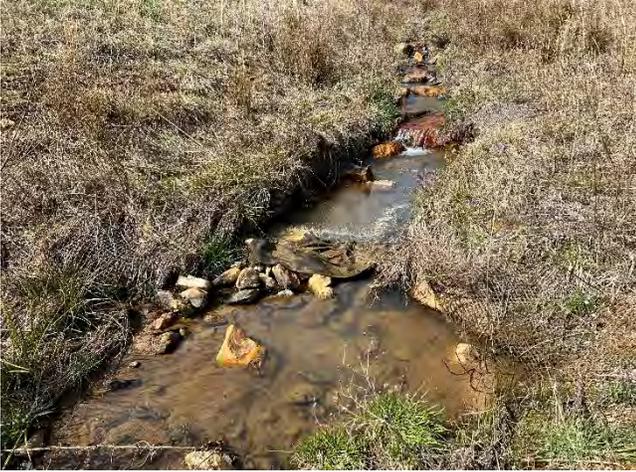
**Shake Rag Branch Reach 5 STA 937+75: pre-repair, structure dislodged, 3/8/2022**

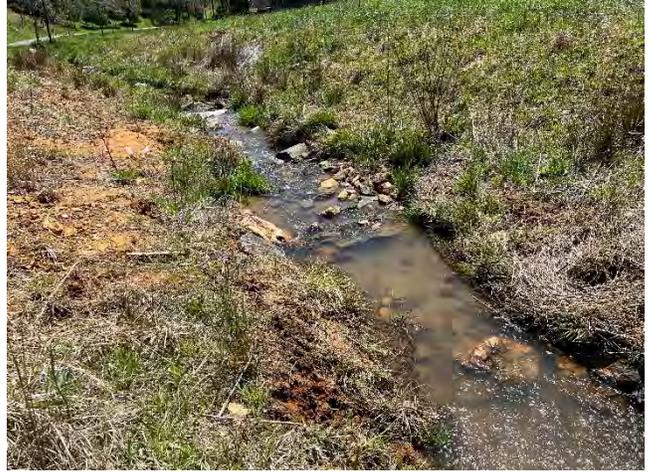
**Shake Rag Branch Reach 5 STA 937+75: post-repair, 4/19/2022**

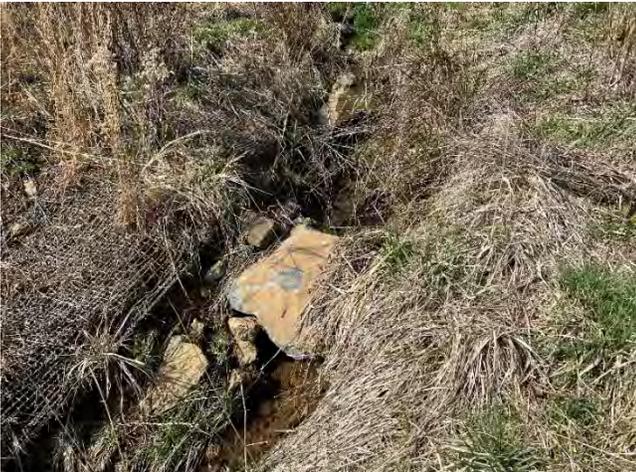
**UT4 STA 404+25: pre-repair, piping under structure, 3/8/2022**

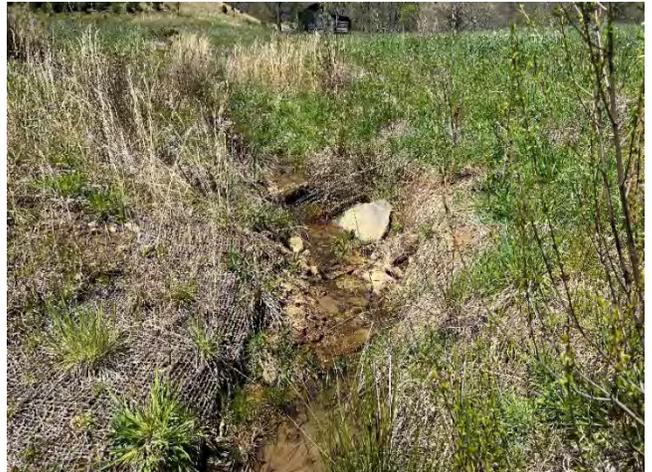
**UT4 STA 404+25: post-repair, 4/19/2022**

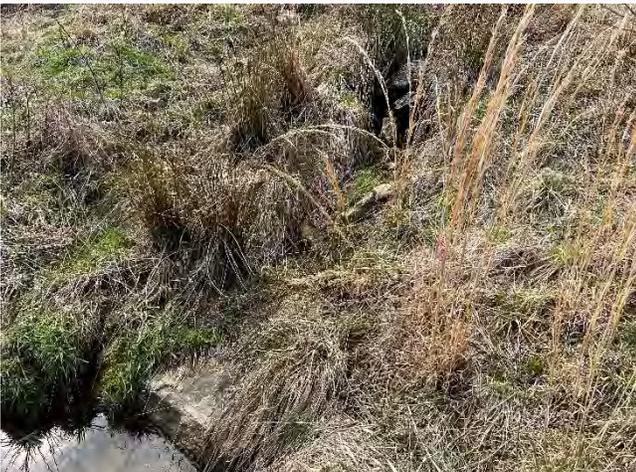
**UT4 STA 400+25: pre-repair, piping under structure, 3/8/2022**

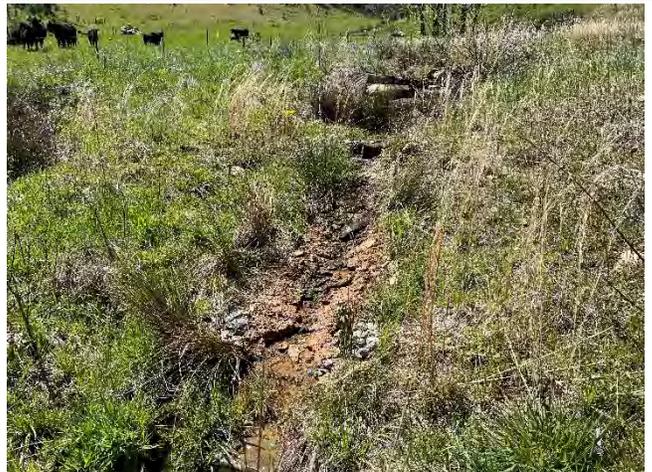
**UT4 STA 400+25: post-repair, 4/19/2022**
