MONITORING YEAR 4 ANNUAL REPORT

SHAKE RAG MITIGATION SITE

Madison County, NC
DEQ Contract No. 7190
DMS Project No. 100018
USACE Action ID No. SAW-2017-01570
DWR Certification No. 17-1157
RFP# 16-006991 (September 16, 2016)

Data Collection Period: January – October 2023
Draft Submission Date: November 30, 2023
Final Submission Date: January 4, 2024

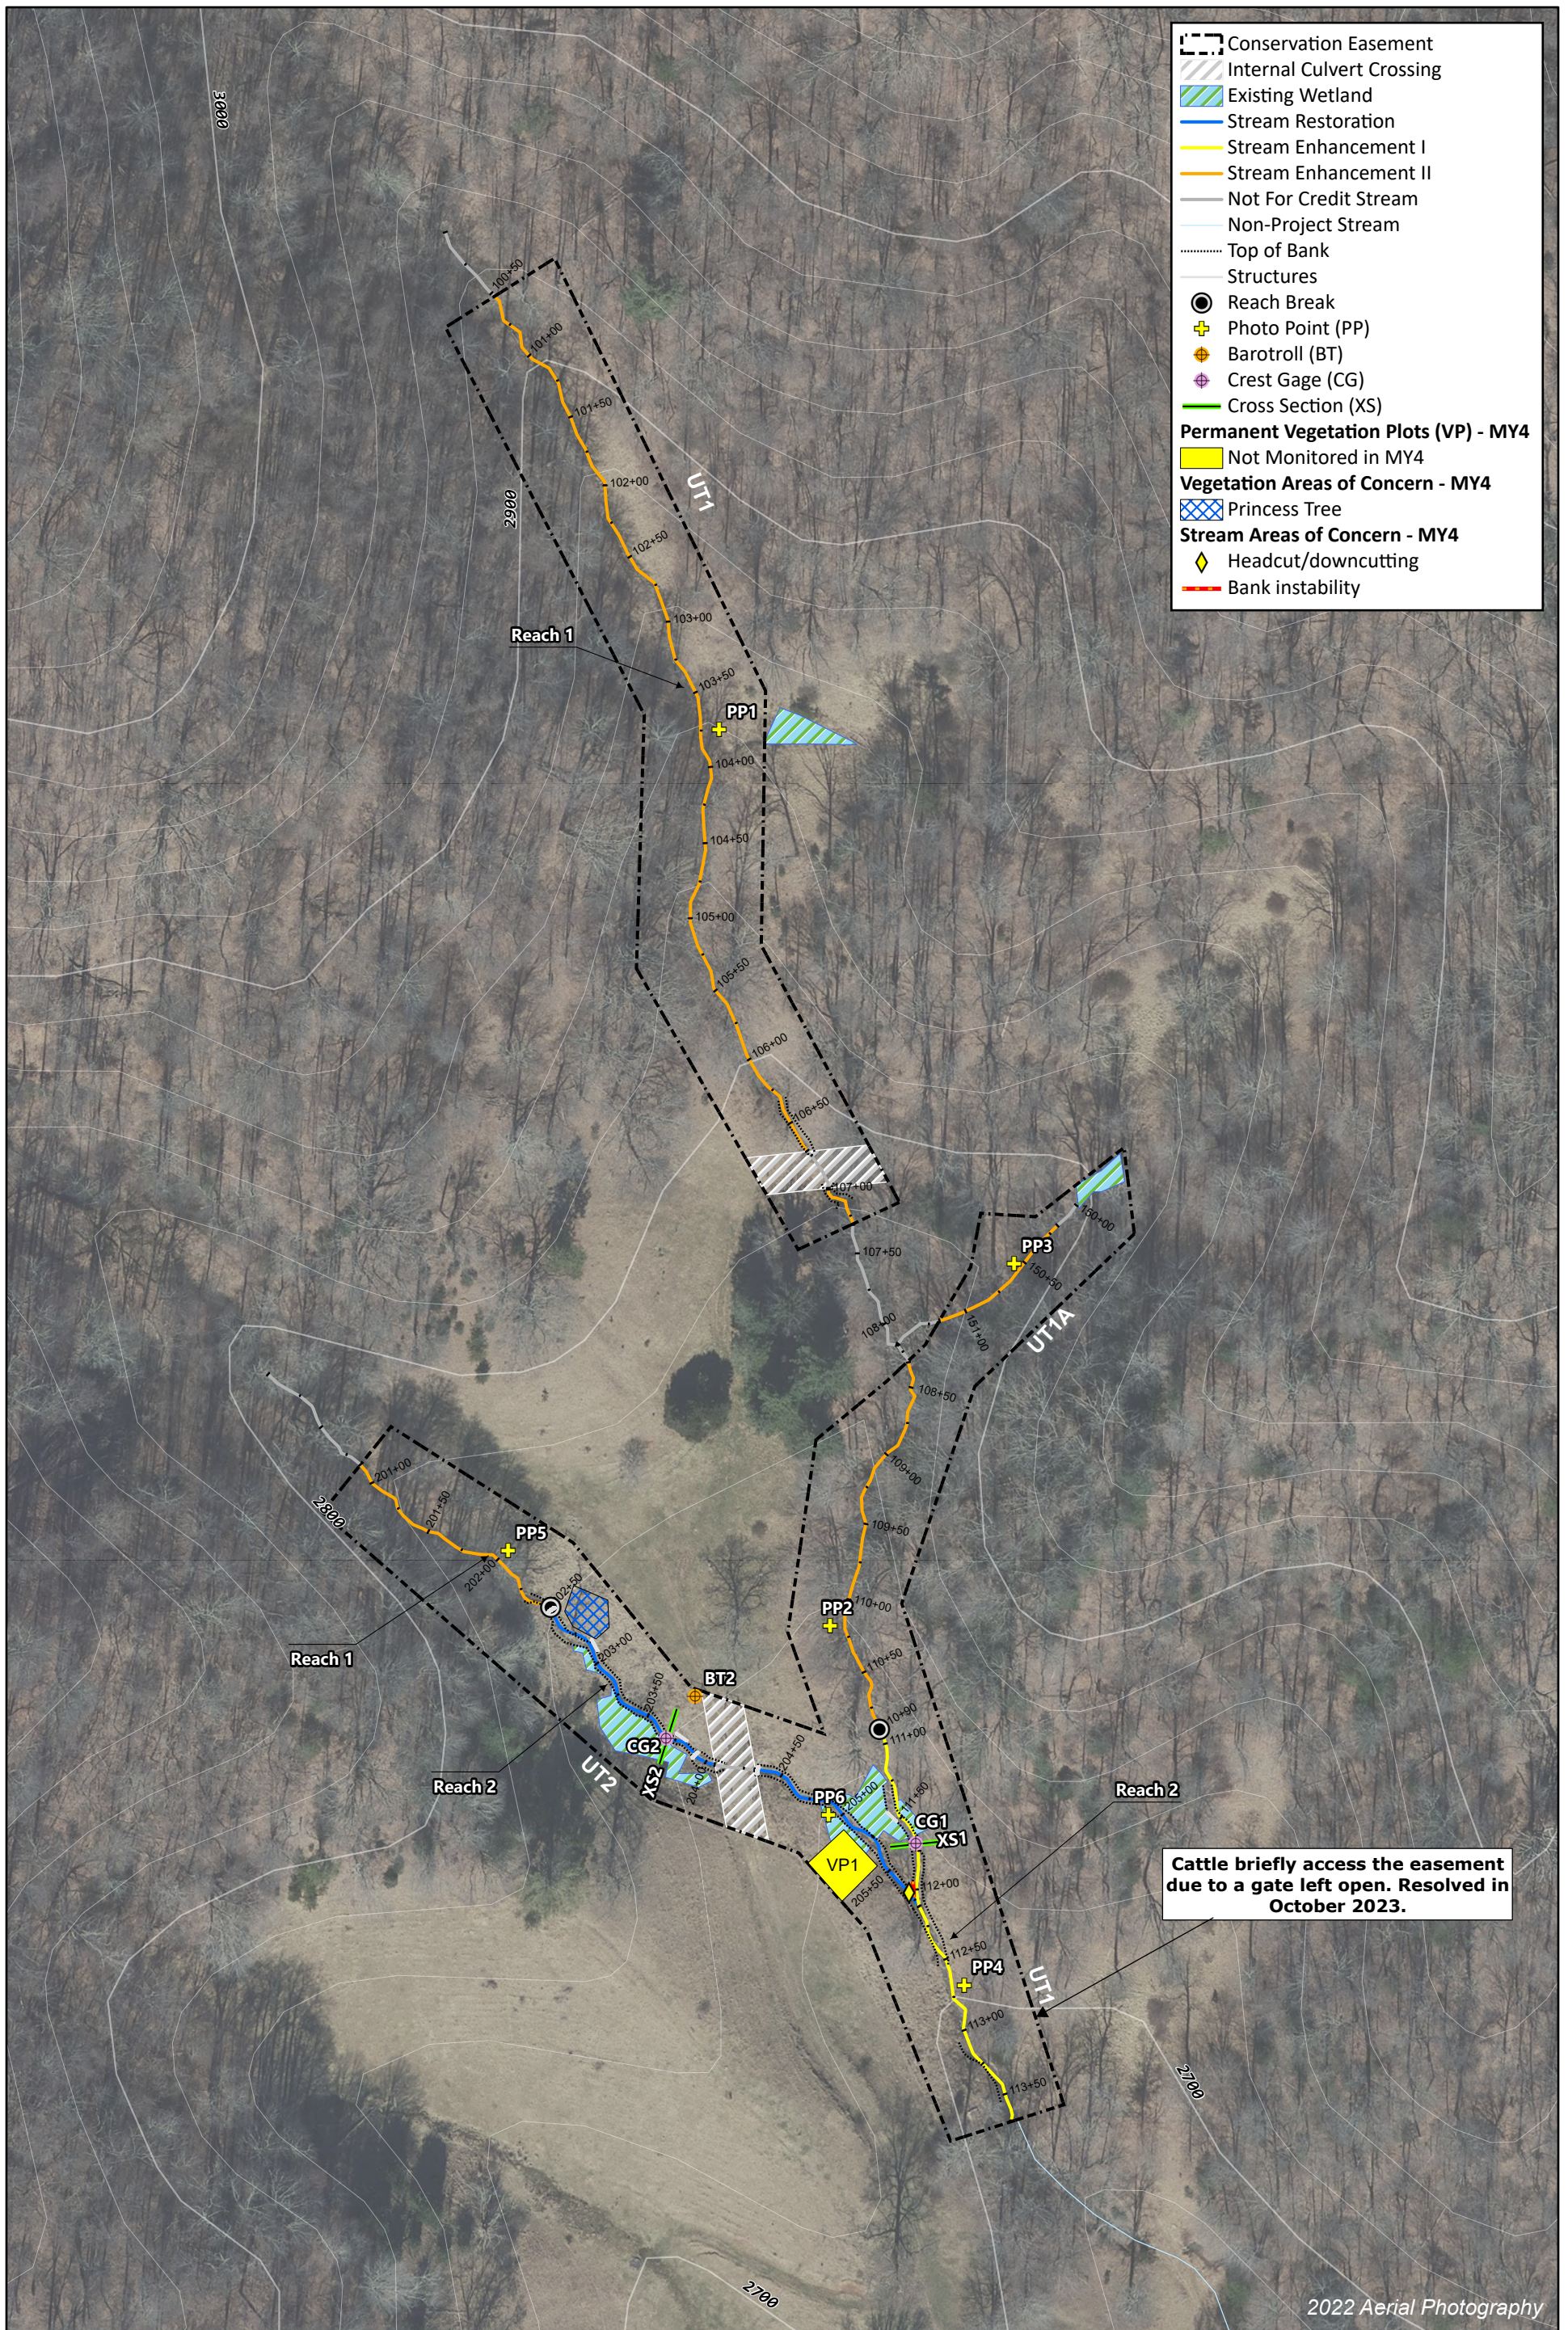
Figure 3.1 Monitoring Plan View Map
Shake Rag Mitigation Site
DMS Project No. 100018
Monitoring Year 4 - 2023

Cattle briefly access the easement due to a gate left open. Resolved in October 2023.

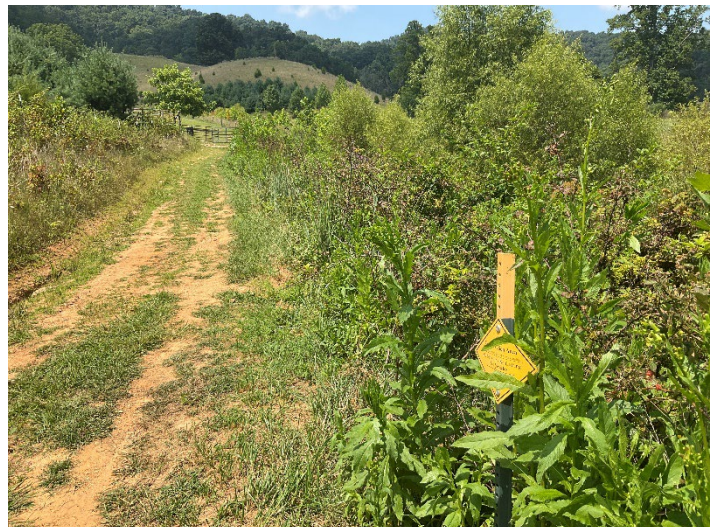
Encroachment resolved – UT4, view up-valley (10/02/2023)

Easement along farm road – UT4, view up-valley (08/24/2023)

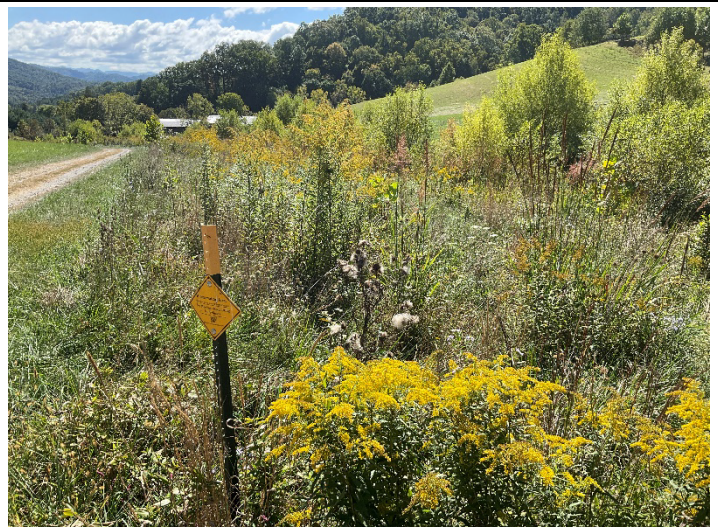
Pipe removed from easement – UT4, view up-valley (10/02/2023)

Easement along farm road – SRB R5, view down-valley (10/02/2023)

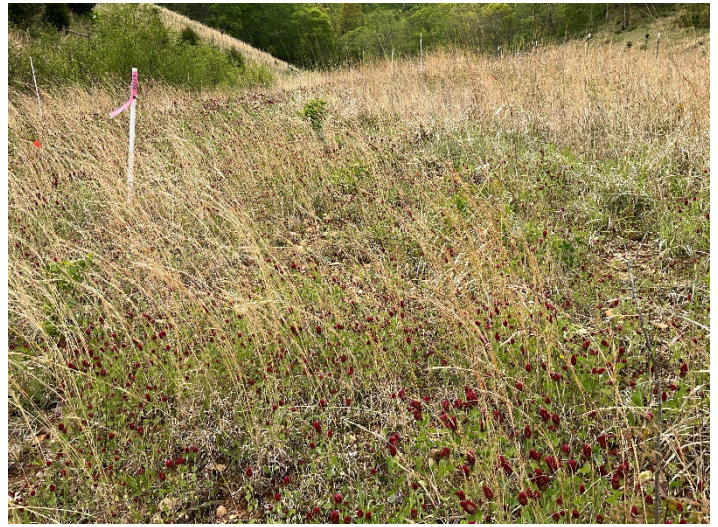
Poor herbaceous cover – UT3 Reach 2 near VP2 (12/03/2021)

Herbaceous cover improving – UT3 Reach 2 near VP2 (4/28/2023)

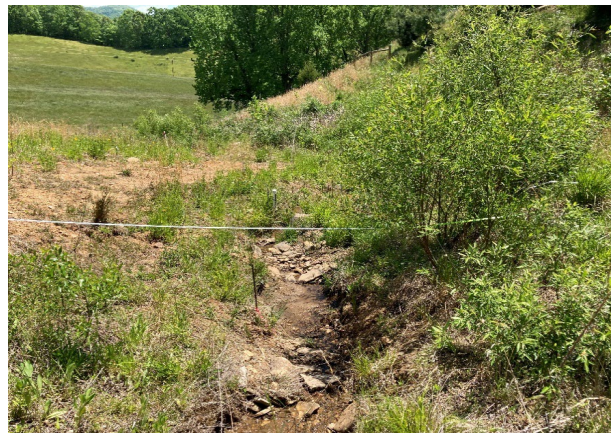
View Downstream

Note: Survey captures MY3 repairs with current low top of bank
