# MY2 (2022) MONITORING REPORT

## SHAW'S RUN MITIGATION SITE

Columbus County, North Carolina

DMS Project No. 100055

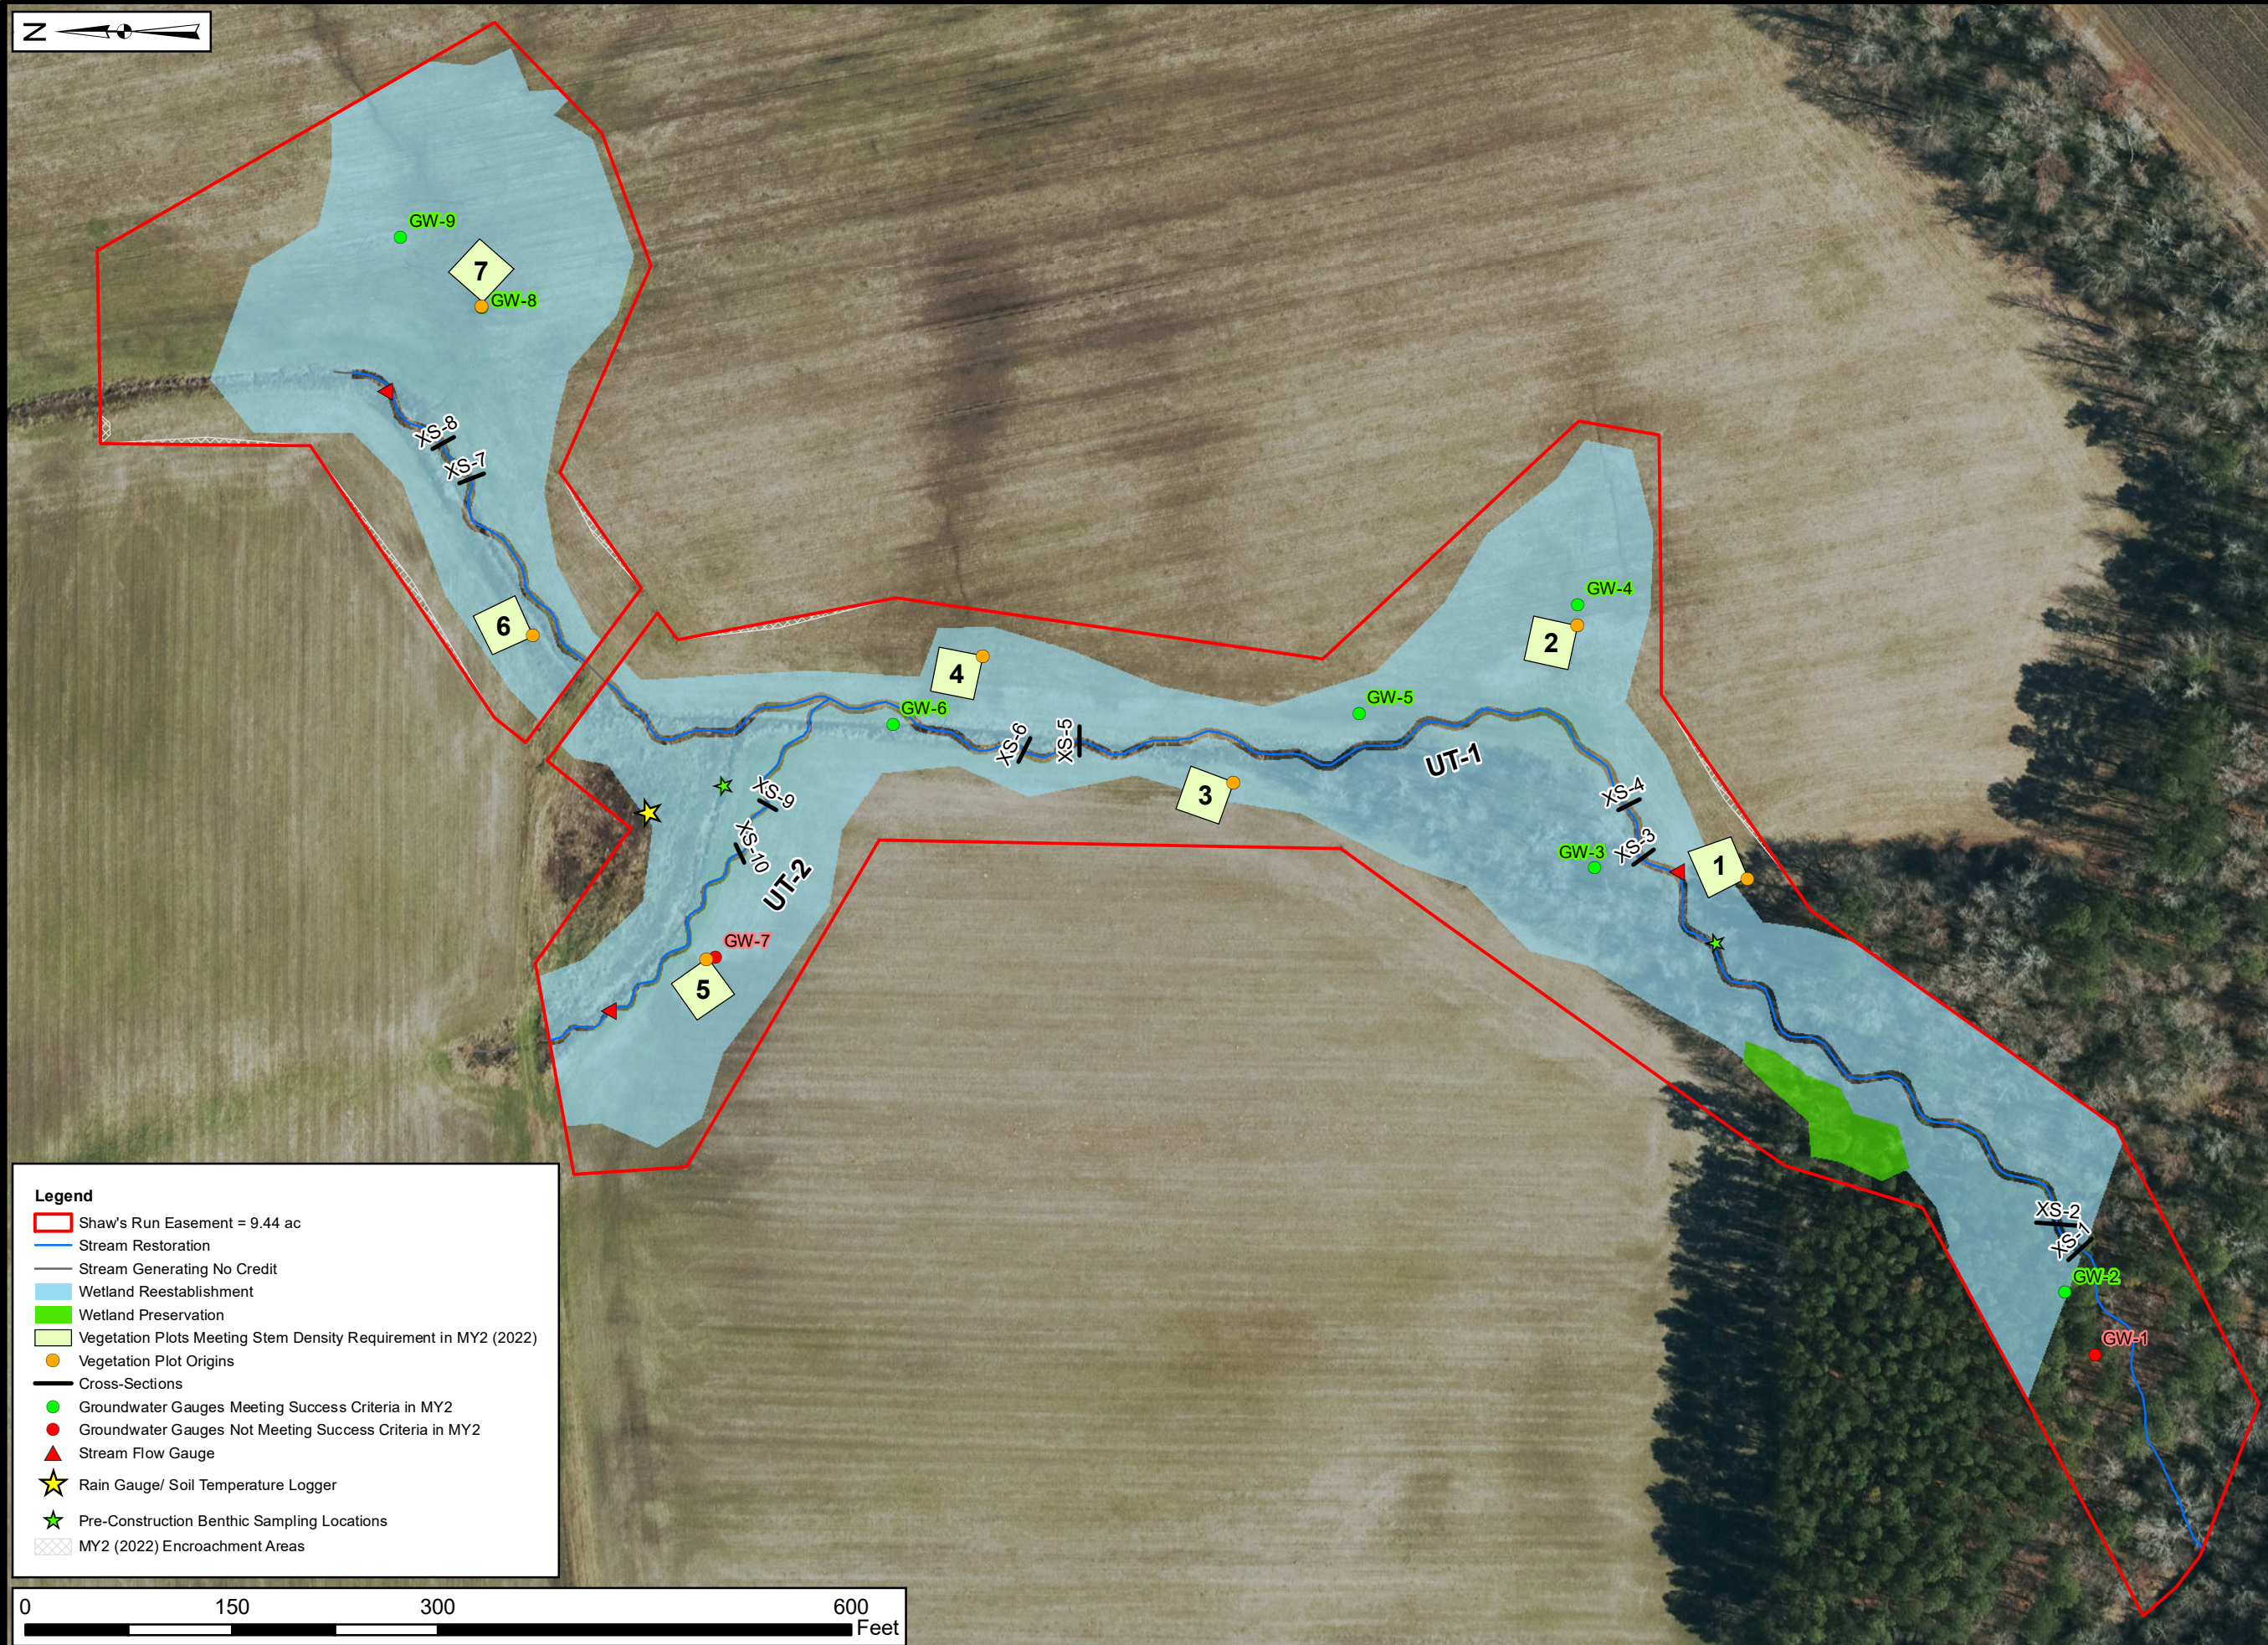
Figure 1. Current Conditions Plan View

Response: A narrative regarding the small farming encroachments around the Site (0.057 acres total) was added to the Monitoring Summary portion of the report which includes corrective actions. The encroachment areas were also added to the CCPV and Table 5.

- Six areas of encroachment were observed in 2022 post-crop harvest (Appendix A, Figure 1. Current Conditions Plan View). The total area equaled 0.057 acres (2,483 sq. ft.).

Step Number	Action Item	Completed / Planned Date
#1	Meet with Landowner to review areas of encroachment	Completed 02/03/2023
#2	Add additional easement posts (4-inch treated) along encroachment lines as needed +/- every 50-100 feet, and add additional signage	March 2023
#3	Meet with tenant farmer ahead of 2023 field preparation for crops	March/April 2023
#4	Site check for encroachment from 2023 ag. planting, and review planted vegetation along areas of 2022 encroachment to determine if larger caliber trees need to be planted. A current review of the encroachment areas indicates no planting is necessary.	April/May 2023
#5	Ahead of harvest, confirm boundary marking is adequately visible, and remind tenant farmer of the easement.	September 2023

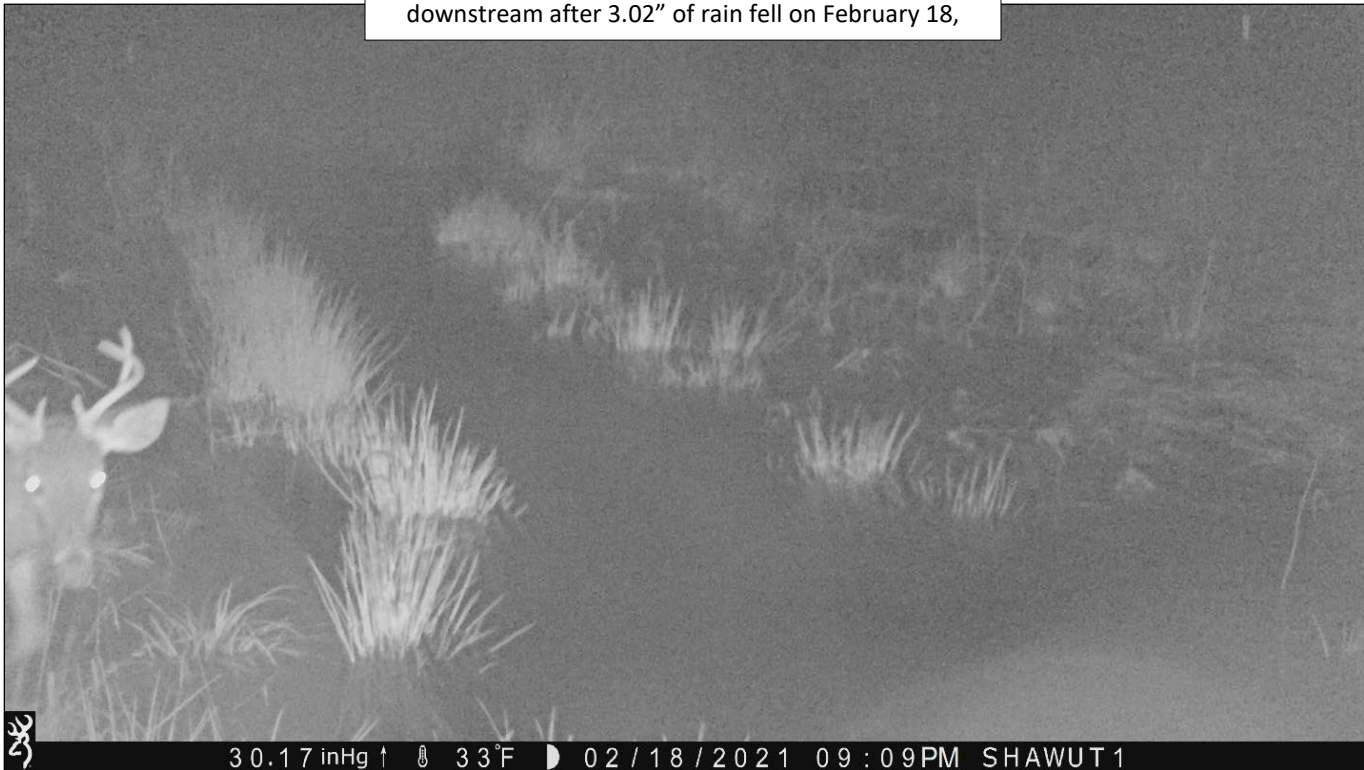
Photo 1: Bankfull event documented on UT 1 downstream after 3.02" of rain fell on February 18,

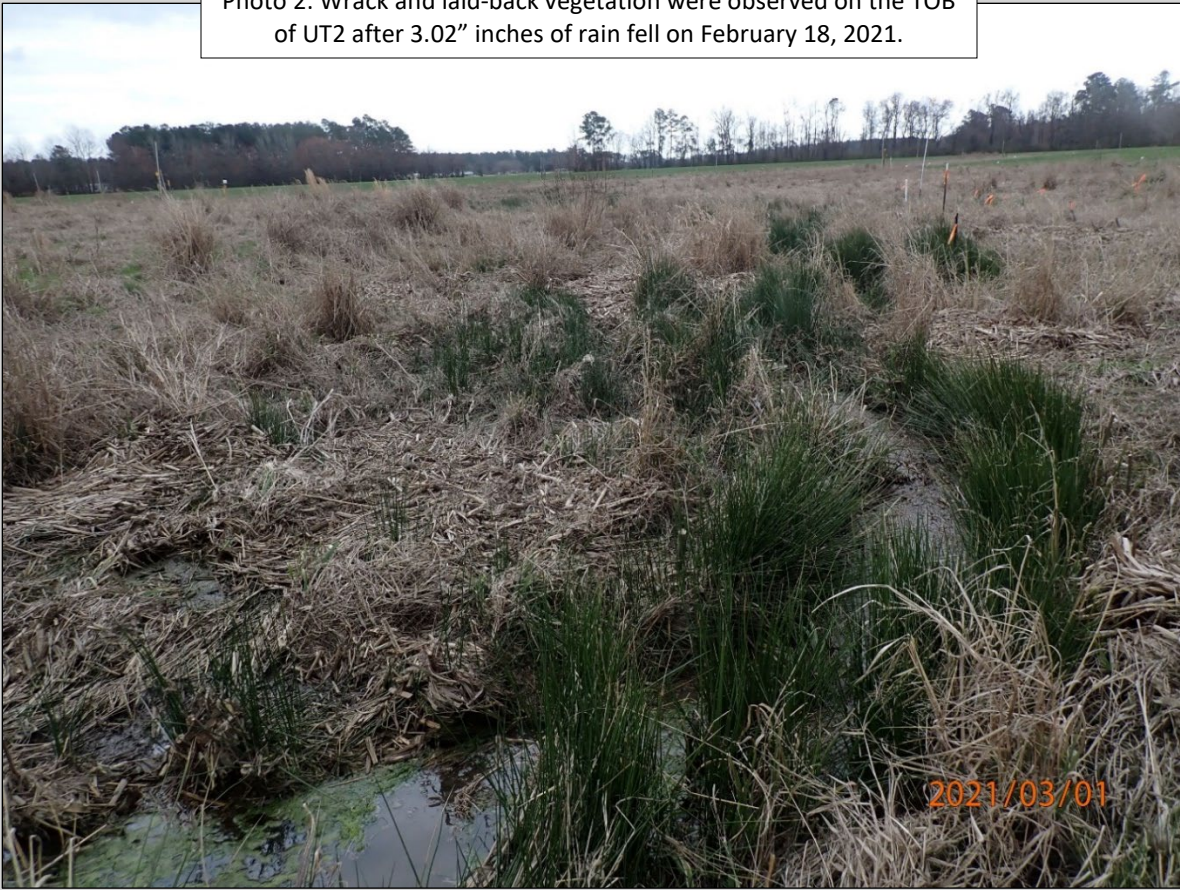
Photo 2: Wrack and laid-back vegetation were observed on the TOB of UT2 after 3.02" inches of rain fell on February 18, 2021.

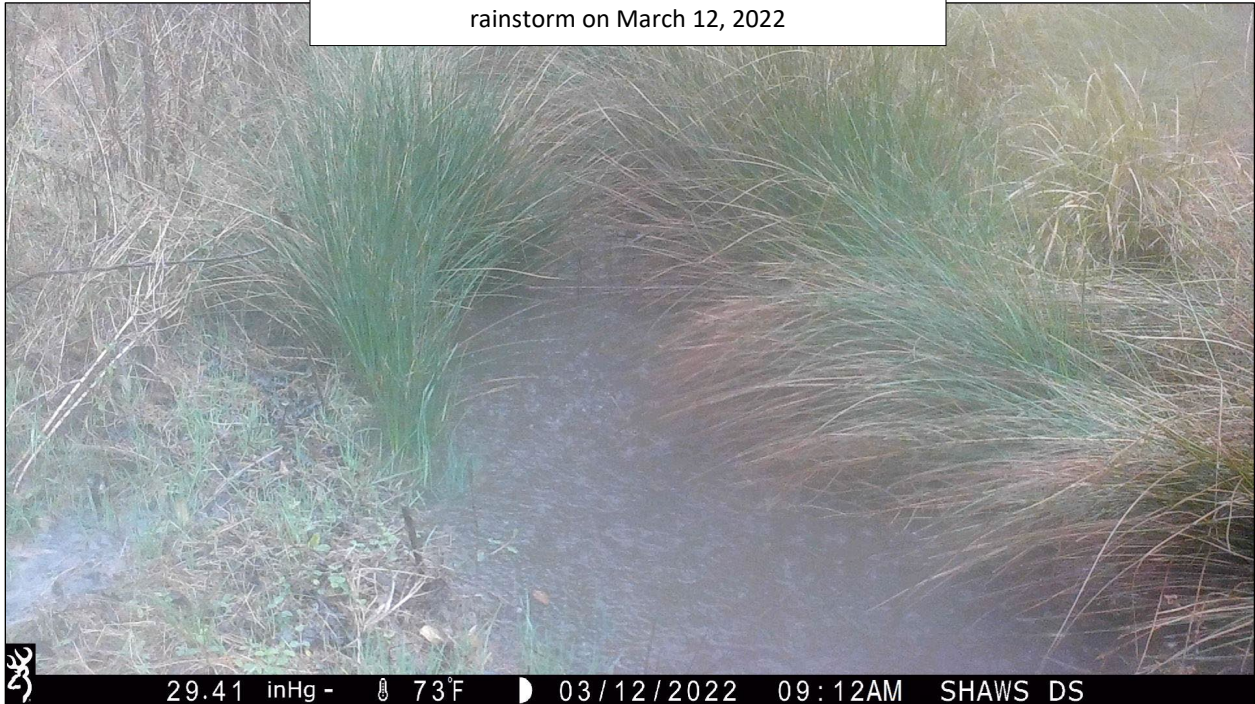
Photo 3: UT 1 swelling to bankfull during a 1.20" rainstorm on March 12, 2022

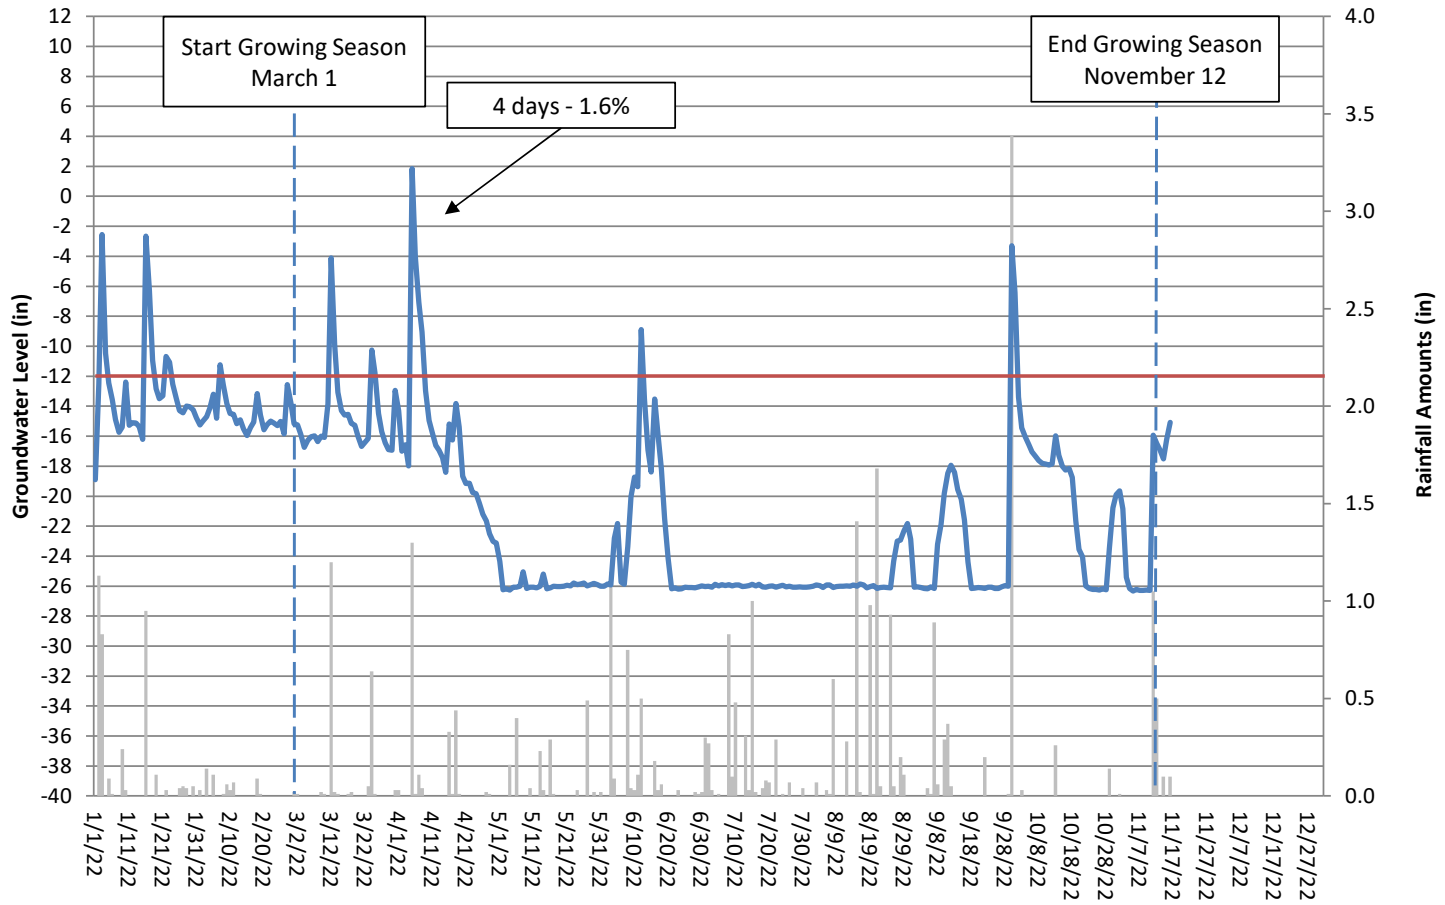
# Shaws Run Groundwater Gauge 1 Year 2 (2022 Data)

\* Gauge 1 is not located in a credit-generating area.

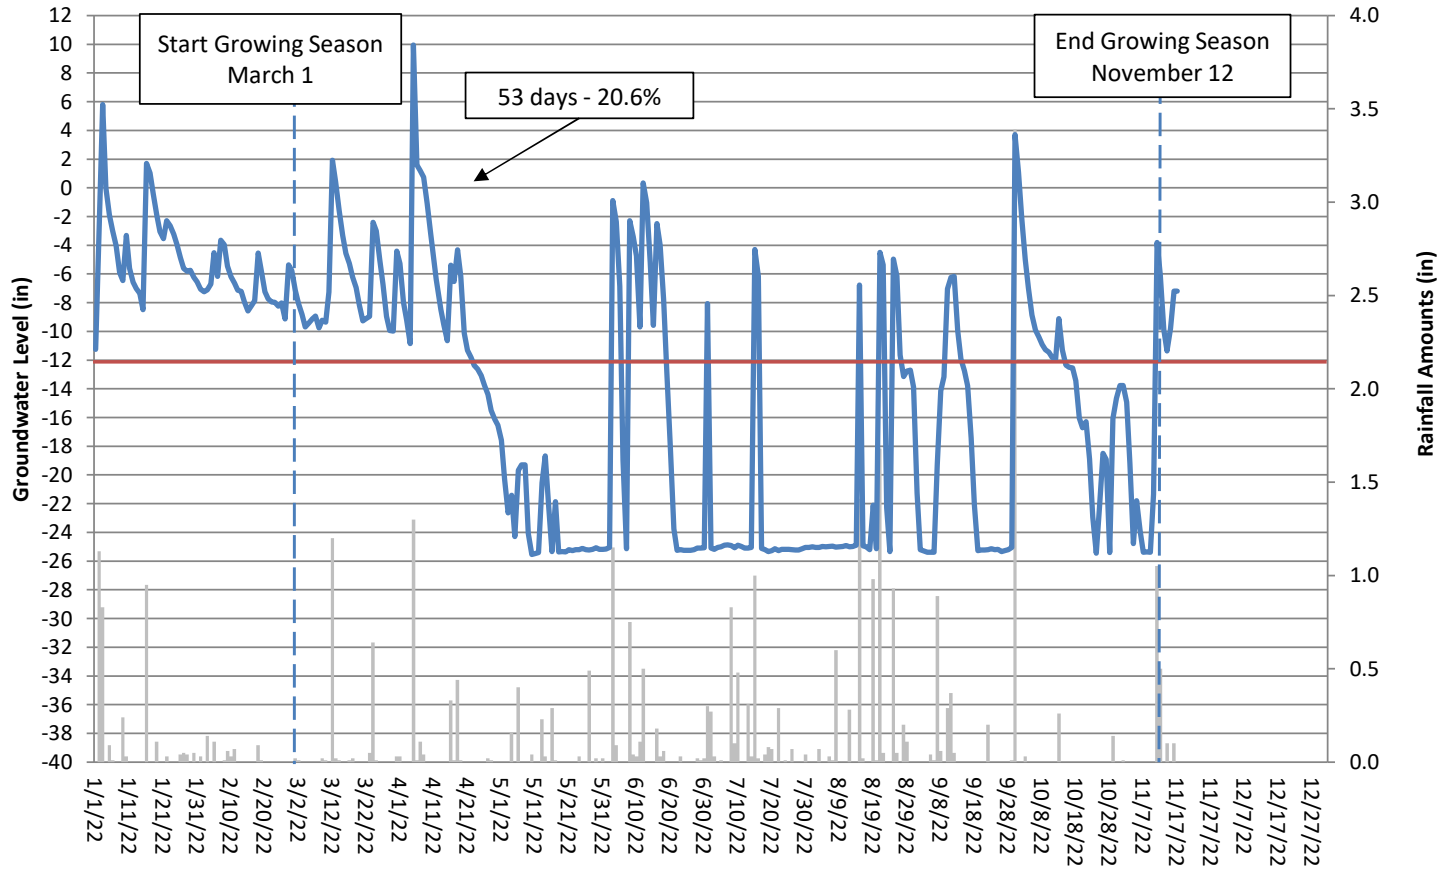
## Shaws Run Groundwater Gauge 2 Year 2 (2022 Data)

^ Gauge 2 likely would have met success criteria, however, logger failure occurred at the start of the growing season.

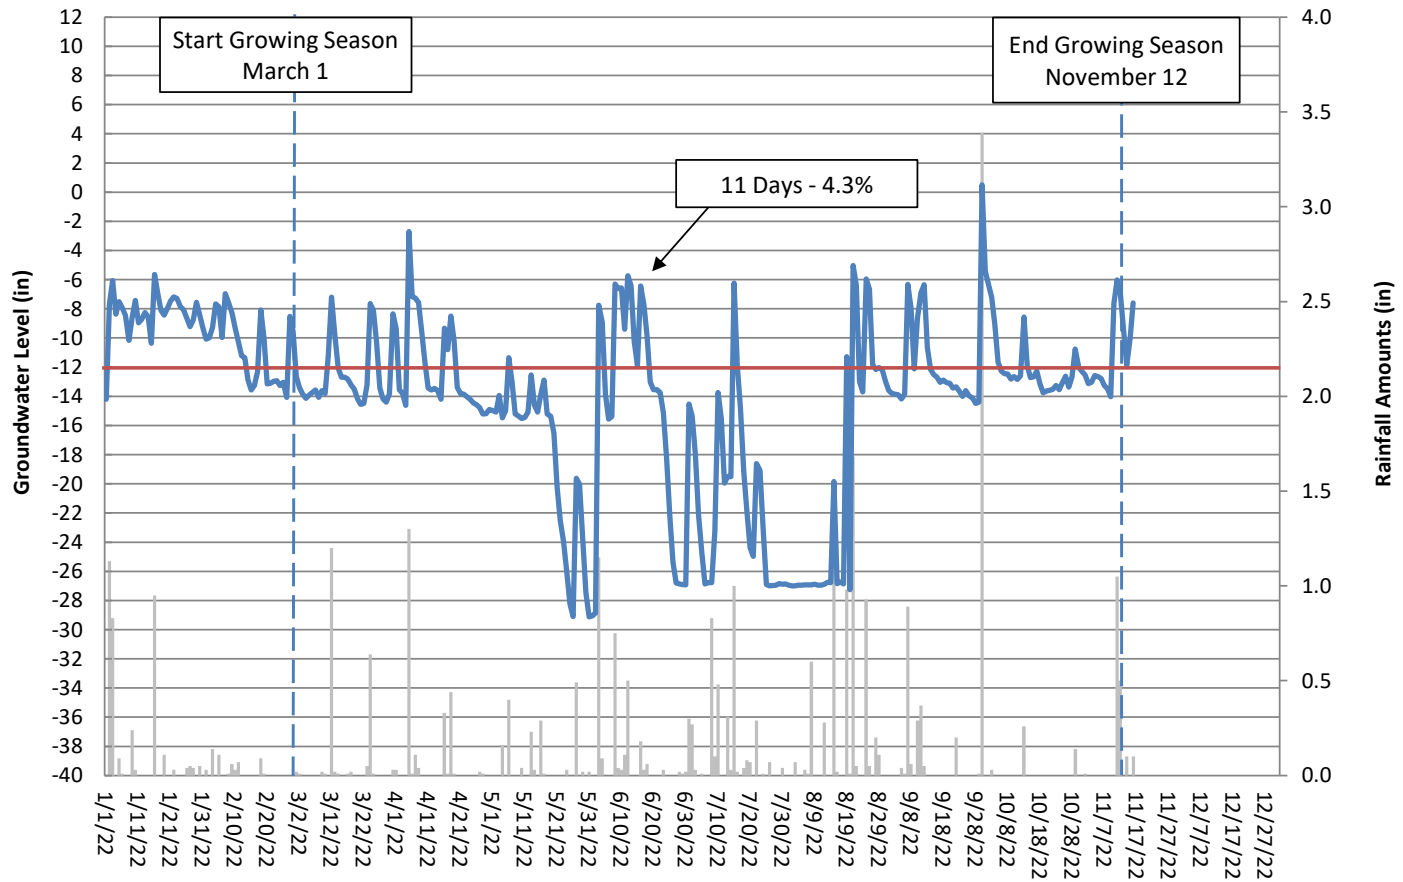
# Shaws Run Groundwater Gauge 7 Year 2 (2022 Data)

- All groundwater gauges met success criteria for the year 2 (2022) monitoring period except Gauges 1 and 7 (Appendix D). Gauge 1 was installed outside the credit-generating area to confirm the drainage influence from the Greene Swamp Canal. It had a similar hydroperiod during year 1 (2021). The gauge would likely have met success criteria under normal rainfall conditions, especially early in the growing season (Figure D1, Appendix D). Gauge 7 read within 12 inches of the surface for just 11 consecutive days (4.3%); however, readings hovered between 12 and 15 inches from the surface for the first 80 days of the growing season. Groundwater gauge data is in Appendix D.

All groundwater gauges met success criteria for the year 2 (2022) monitoring period except Gauges 1 and 7 (Appendix D). Gauge 1 was installed outside of the credit generating area in order to confirm the drainage influence from the Greene Swamp. It had a similar hydroperiod during year 1 (2021). Gauge 7 read within 12 inches of the surface for just 11 consecutive days (4.3%), however, readings hovered between 12 and 15 inches from the surface for the first 80 days of the growing season. The gauge likely would have met success criteria under normal rainfall conditions, especially early in the growing season (Figure D1, Appendix D). Groundwater gauge data is in Appendix D.

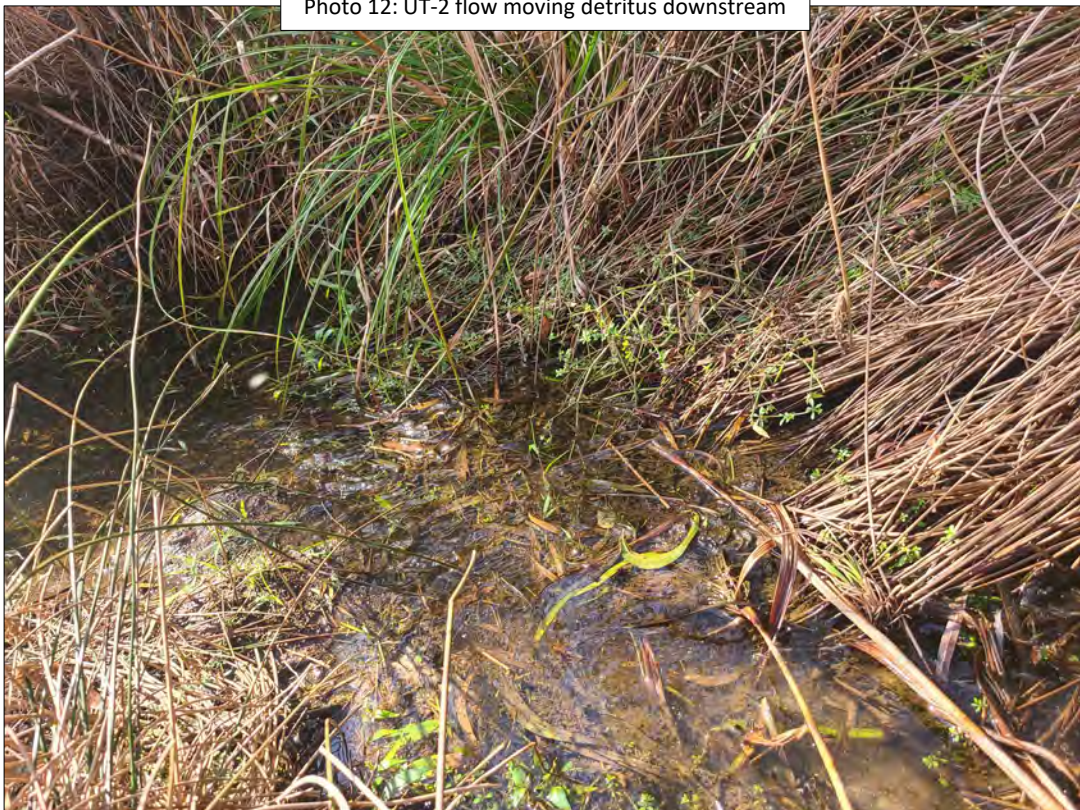
Photo 12: UT-2 flow moving detritus downstream

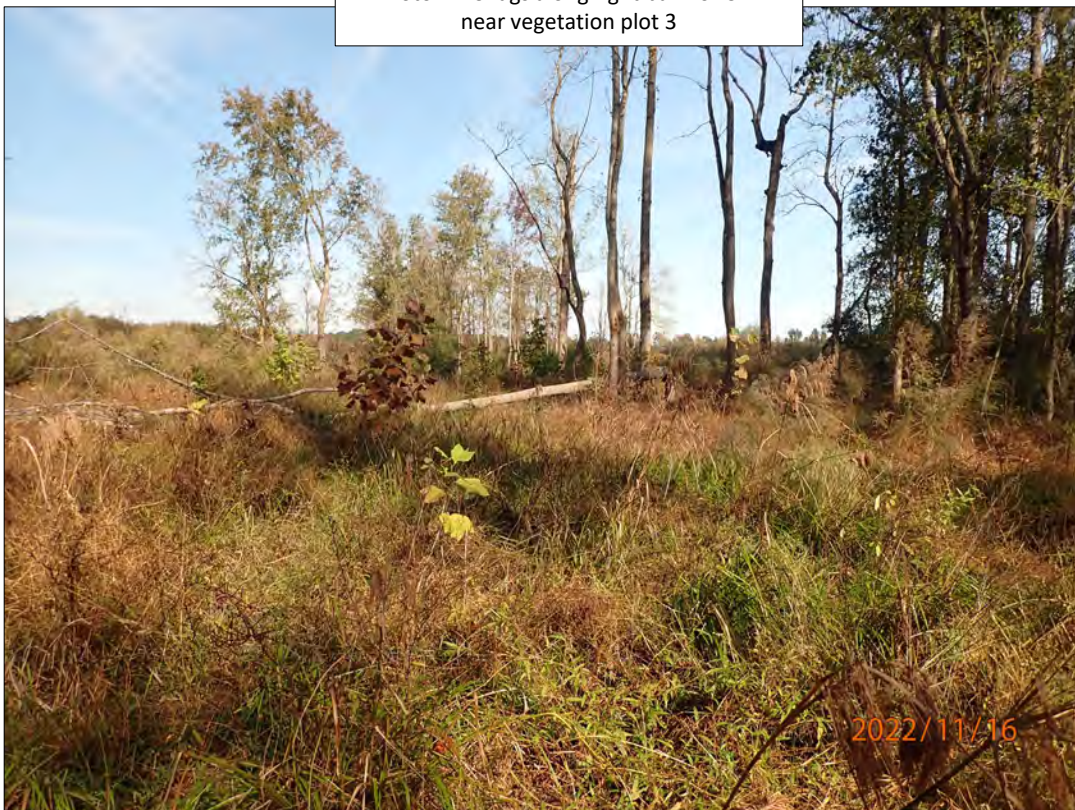
Photo 14: Snags along right bank of UT1  
near vegetation plot 3

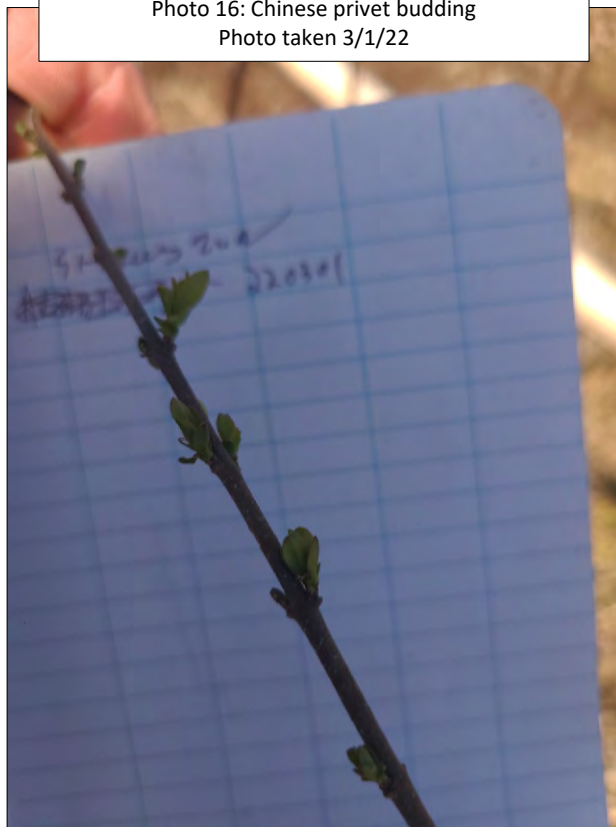
Photo 16: Chinese privet budding  
Photo taken 3/1/22

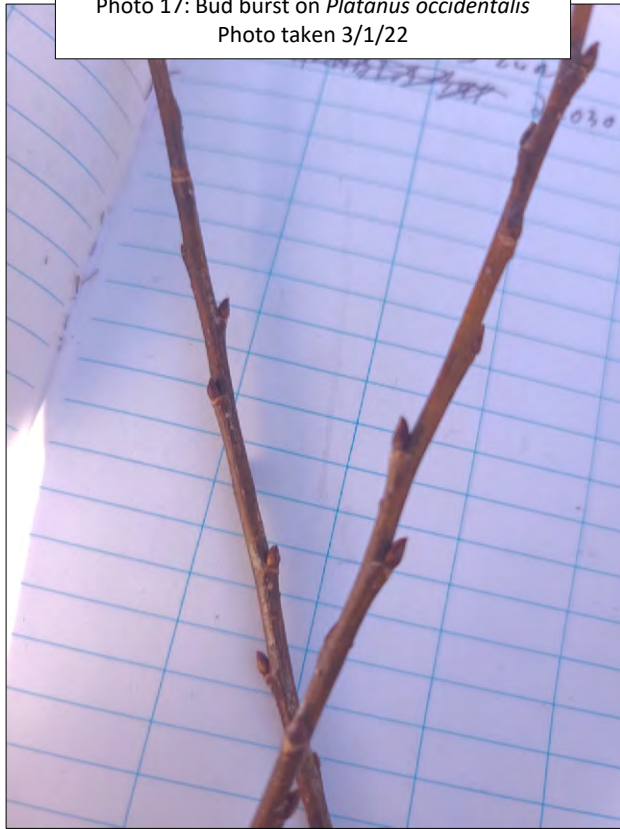
\*Based on observed/documented bud burst on the Site on March 1, 2022, and soil temperature of 53.9oF.

Photo 17: Bud burst on *Platanus occidentalis*  
Photo taken 3/1/22
