FINAL
MY3 (2023) MONITORING REPORT

SHAW'S RUN MITIGATION SITE
Columbus County, North Carolina
Lumber River Basin
Cataloging Unit 03040203

DMS Project No. 100055
Full Delivery Contract No. 7515
DMS RFP No. 16-007337
USACE Action ID No. SAW-2018-01169
DWR Project No. 2018-0866

Data Collection: January – November 2023
Submission: January 2024

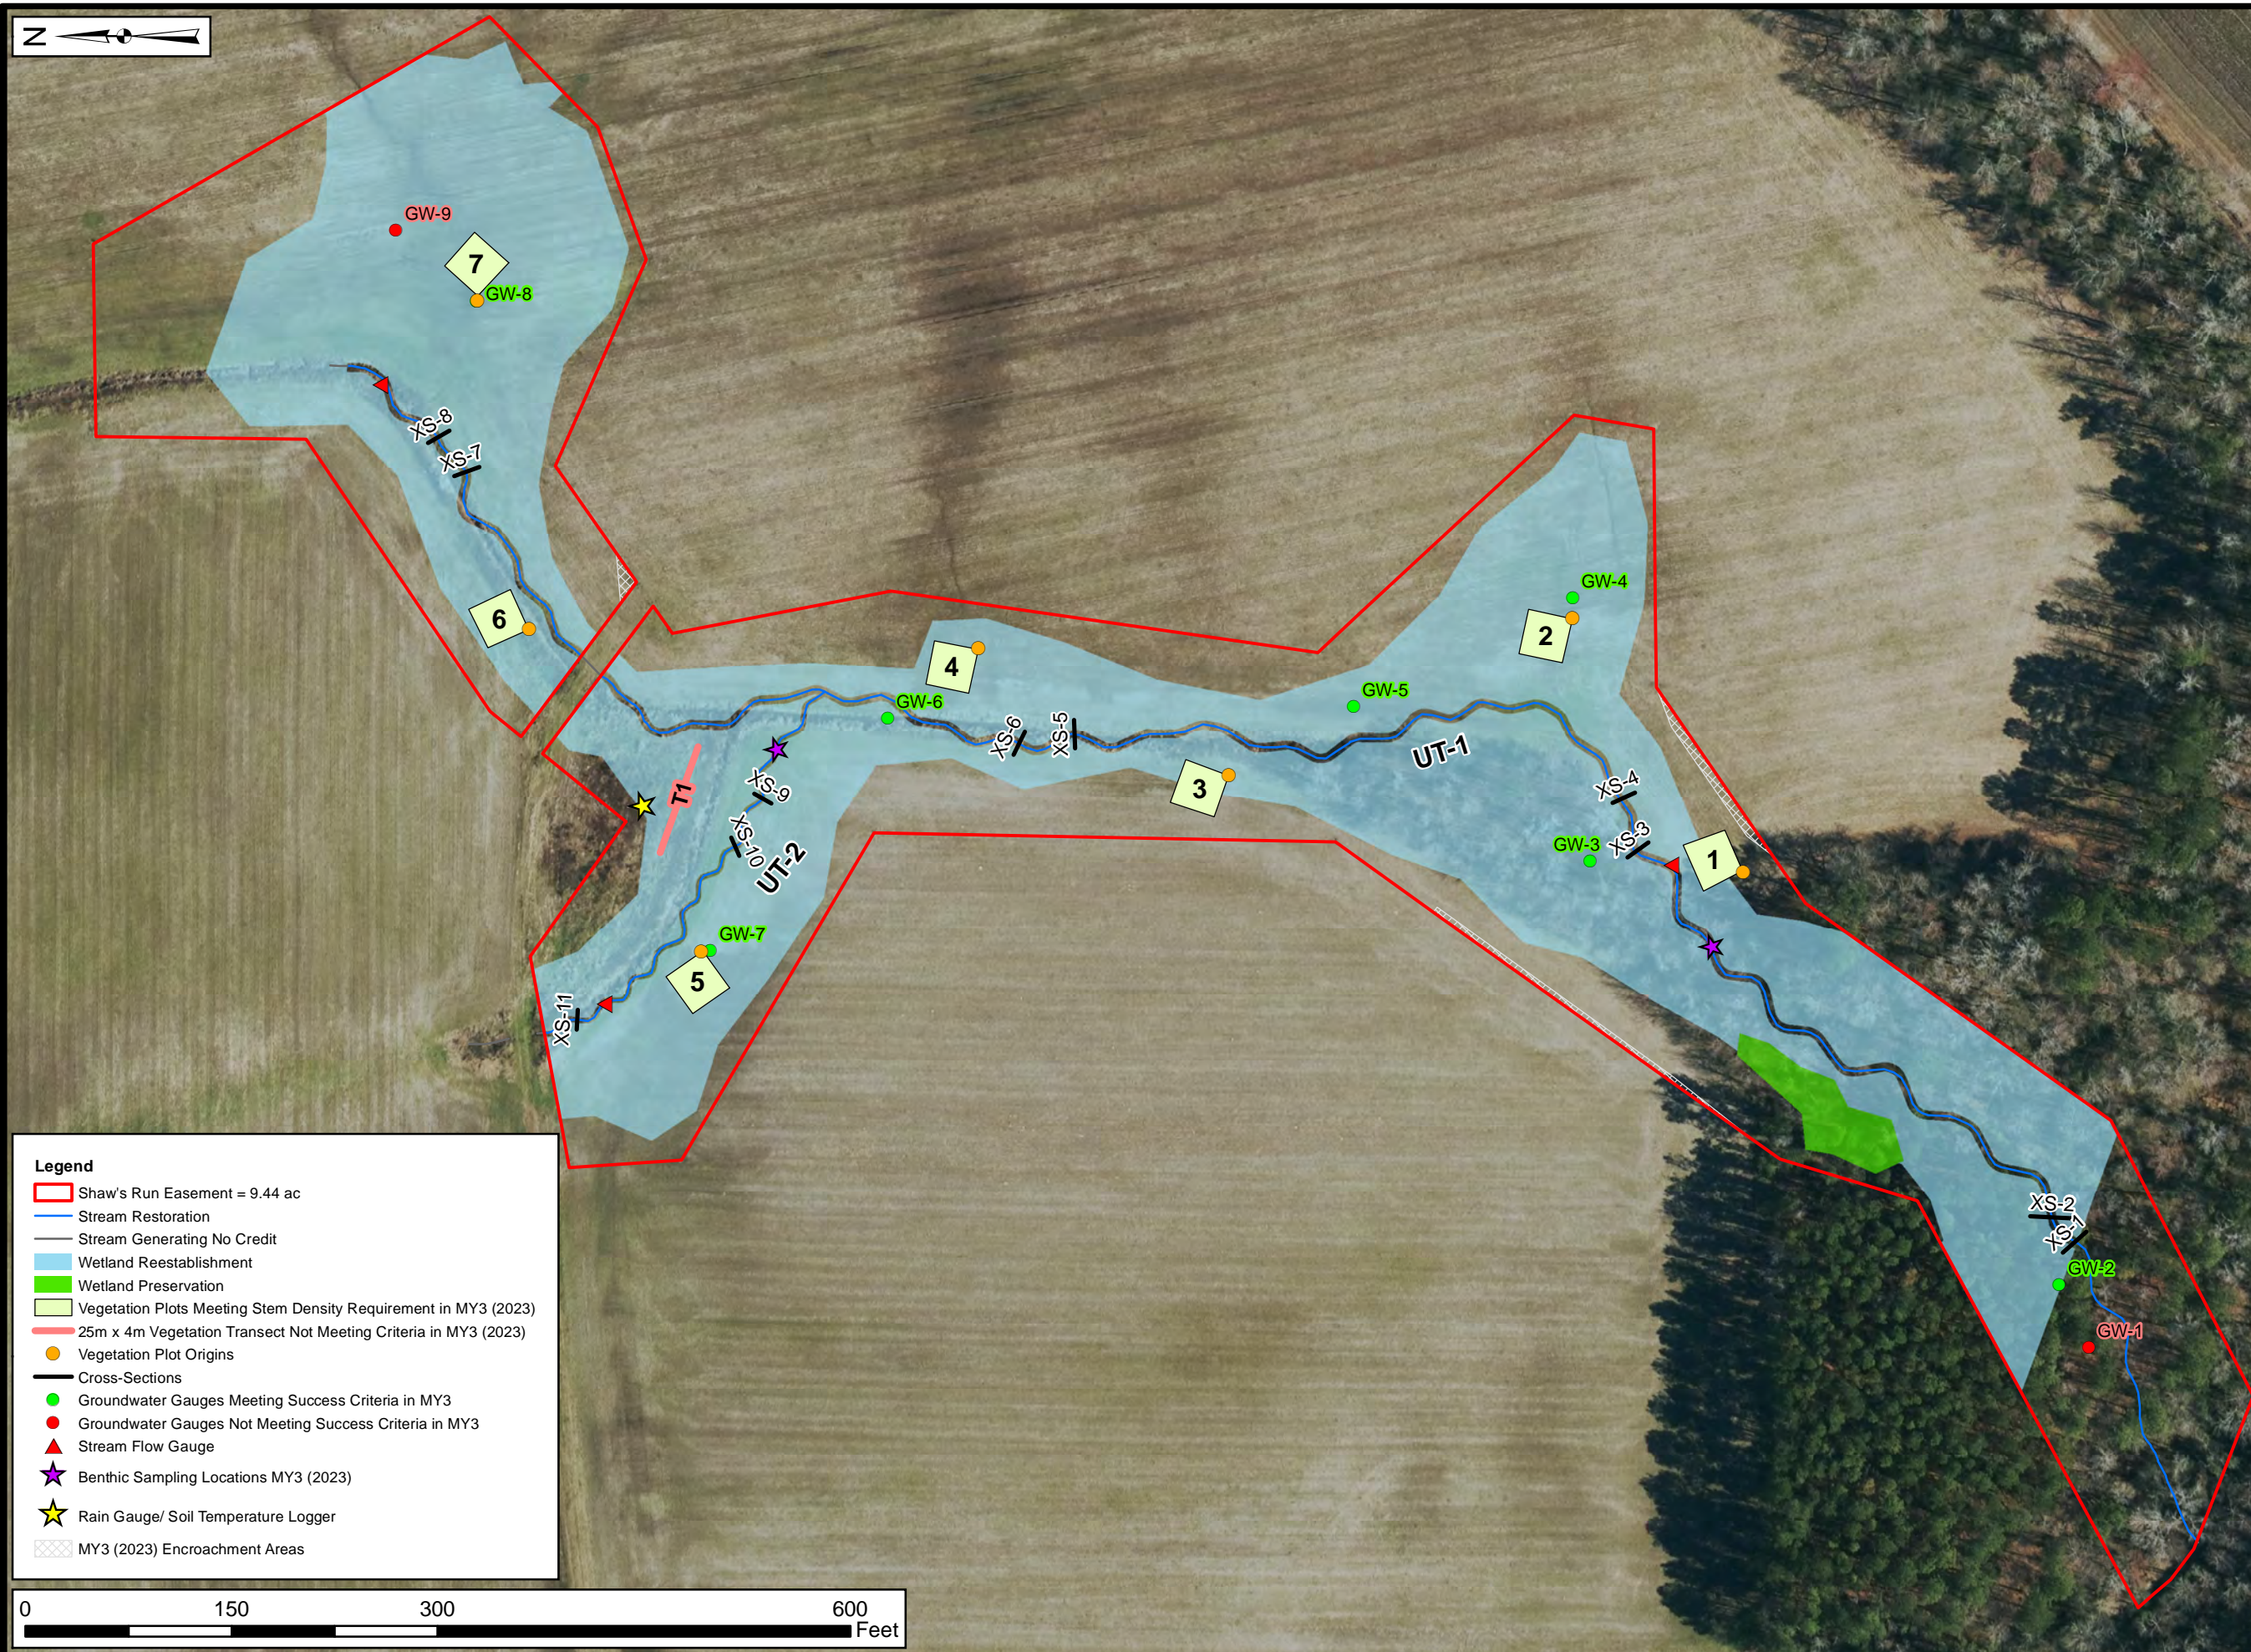
**Current
Conditions
Plan View**

- Three small areas of encroachment totaling 0.06 acres were observed from farm scalloping. These areas have been replanted with 3-gallon containerized species from the approved Site Mitigation Plan. RS also installed additional wooden posts and PVC pipe with signage and horse tape along the easement boundary to improve visibility. On-site conversations with the farmer also took place to ensure encroachment ceases.
- Additional signs were added to ensure signs are in place every 200-feet along the easement.
- For tree mounted signs, steel screws were replaced with aluminum nails.
- No evidence of nuisance animal activity (i.e., heavy deer browsing, beaver, etc.) observed.

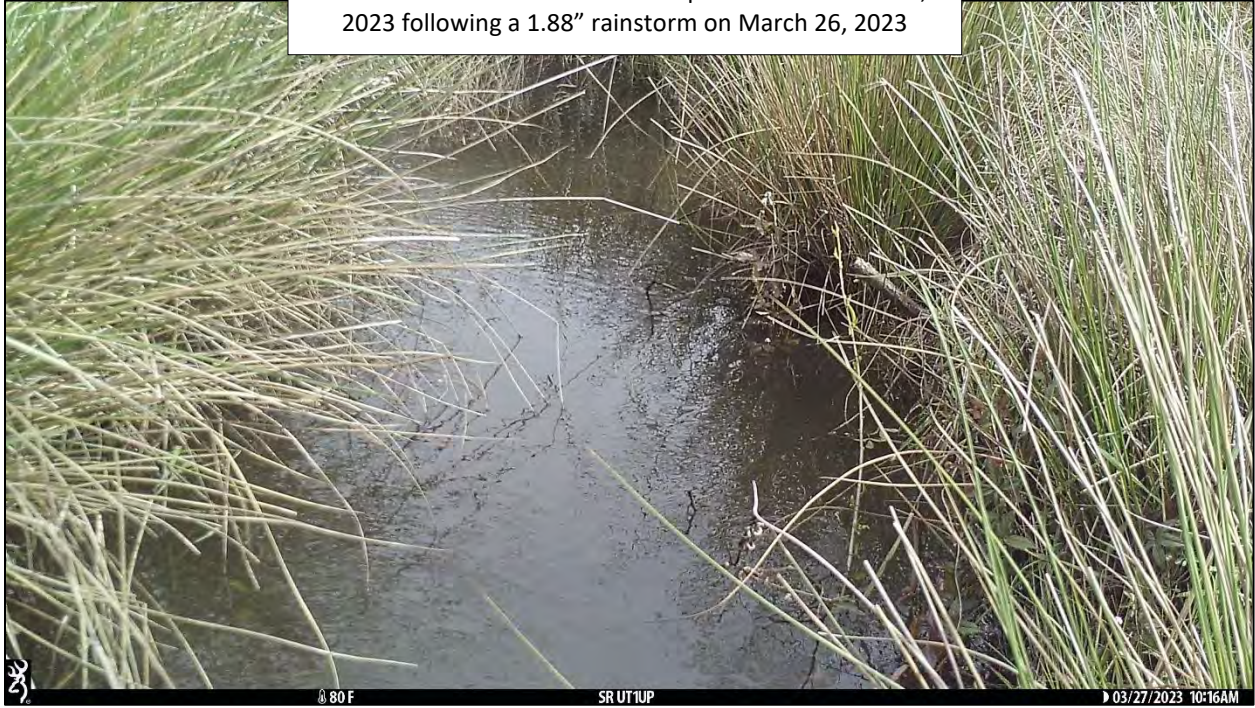
Photo 4: Bankfull event on UT-1 upstream on March 27, 2023 following a 1.88" rainstorm on March 26, 2023

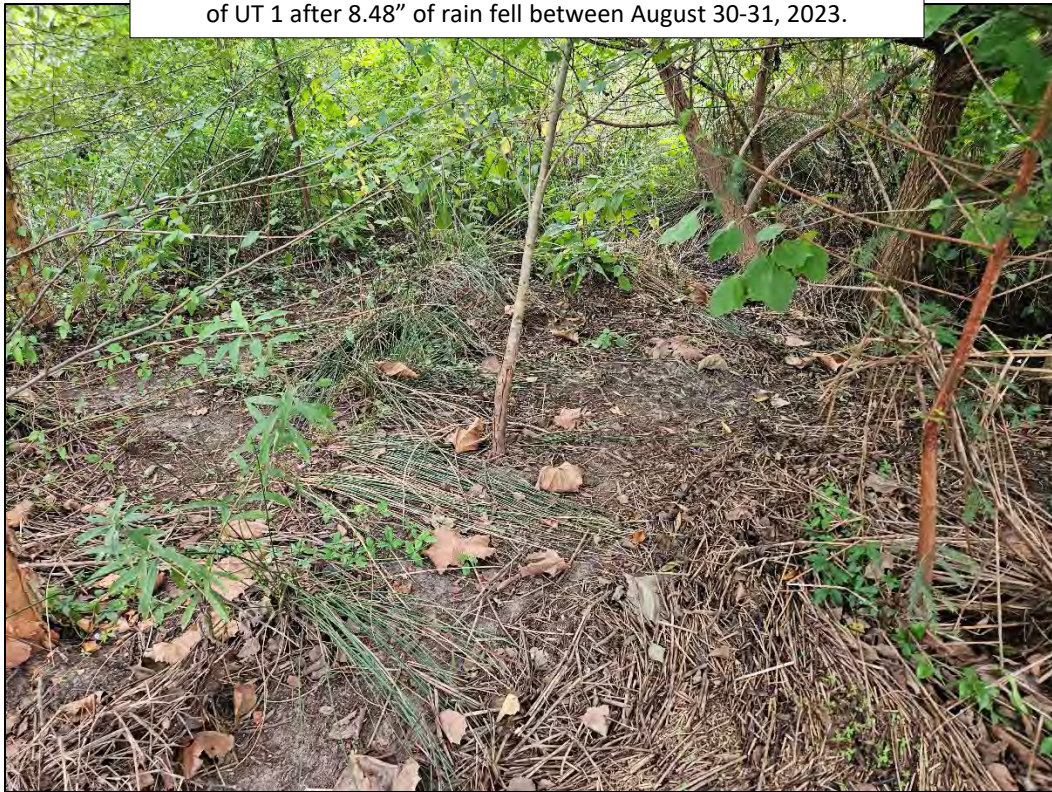
Photo 5: Wrack and laid-back vegetation were observed on the TOB of UT 1 after 8.48" of rain fell between August 30-31, 2023.

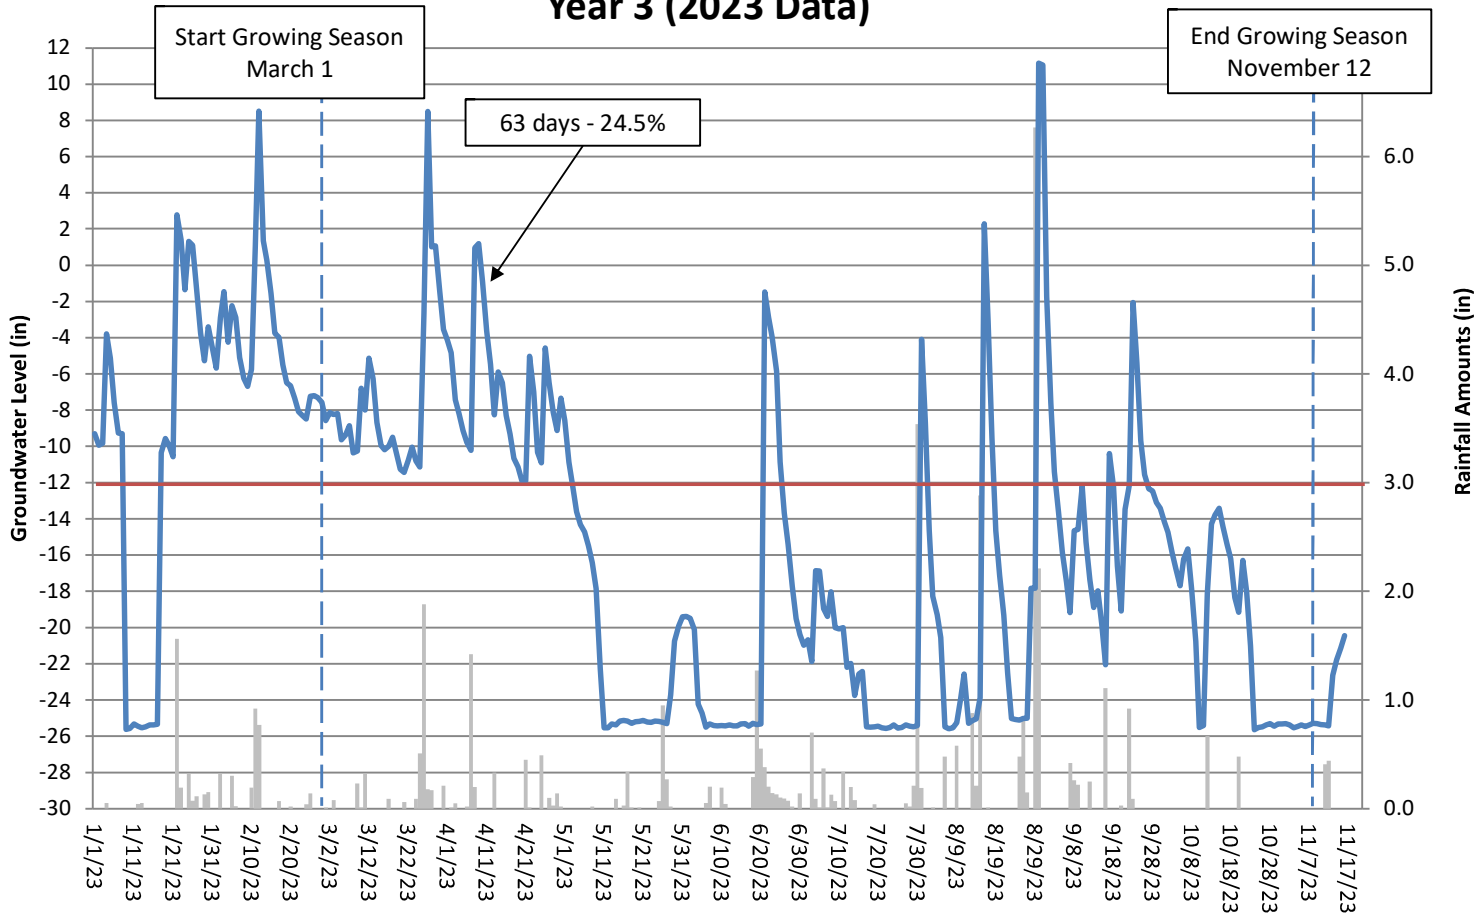
Shaws Run Groundwater Gauge 2 Year 3 (2023 Data)

^ Gauge 2 likely would have met success criteria, however, logger failure occurred at the start of the growing season.

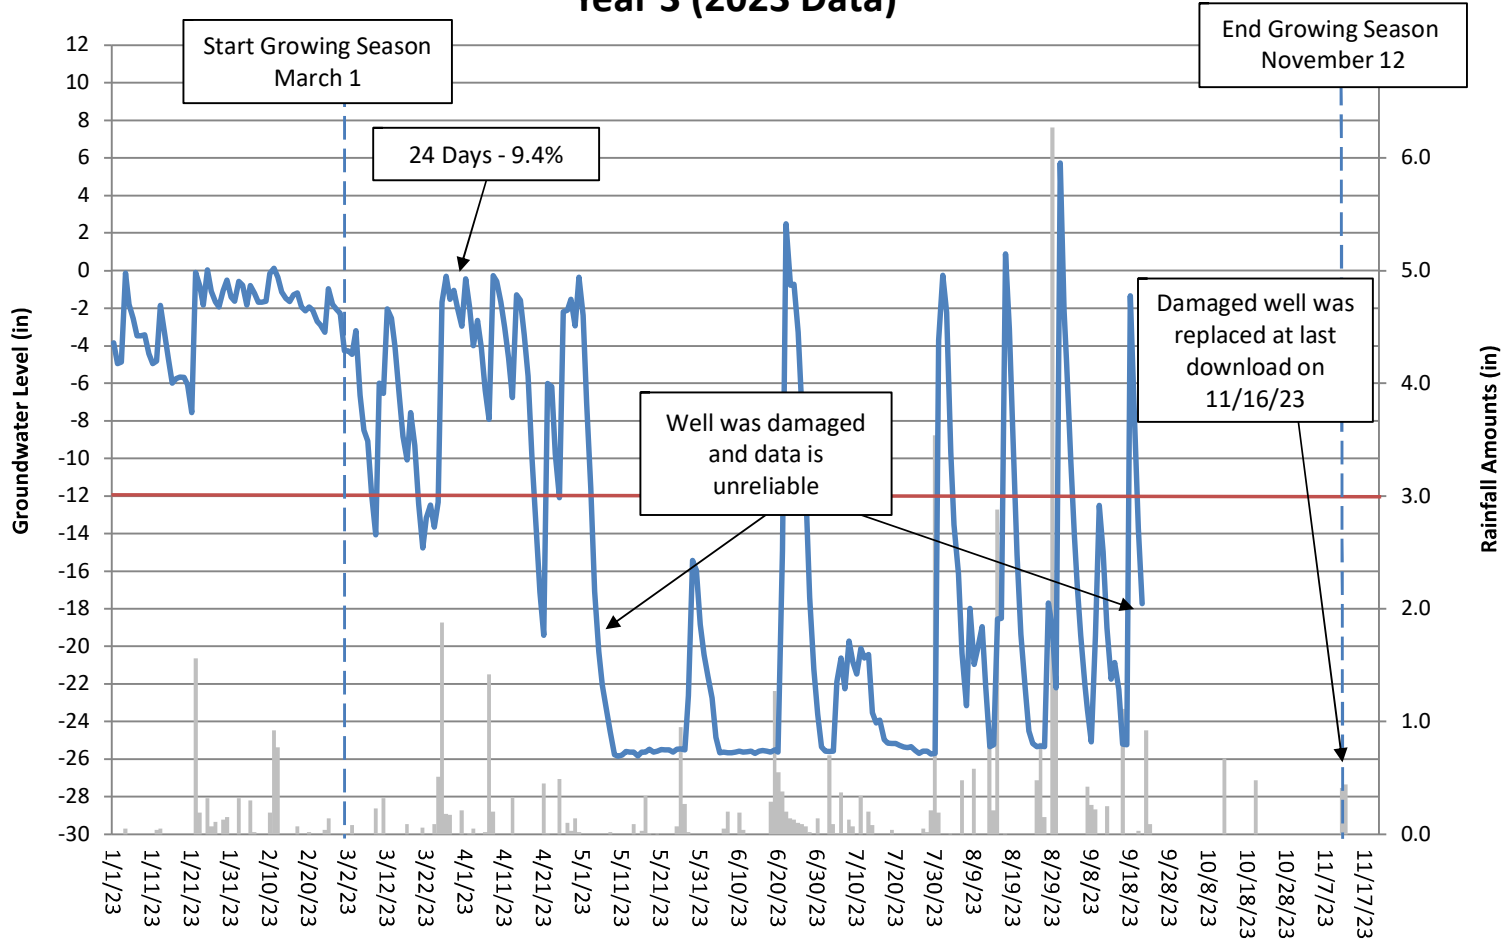
Shaws Run Groundwater Gauge 9 Year 3 (2023 Data)

All groundwater gauges met success criteria for the Year 3 (2023) monitoring period except Gauges 1 and 9 (Appendix D). Gauge 1 was installed outside of the credit generating area to confirm the drainage influence from the Greene Swamp. It had a similar hydroperiod during Years 1 and 2 (2021 and 2022). Gauge 9 read within 12 inches of the surface for 24 consecutive days (9.4%) during the growing season before it dropped below for just 3 days. The gauge read within the top 12 inches for 11 of the 15 days immediately following the drop. Additionally, Gauge 9 was damaged late in the year and was replaced at the end of the monitoring period. Groundwater gauge data is in Appendix D.

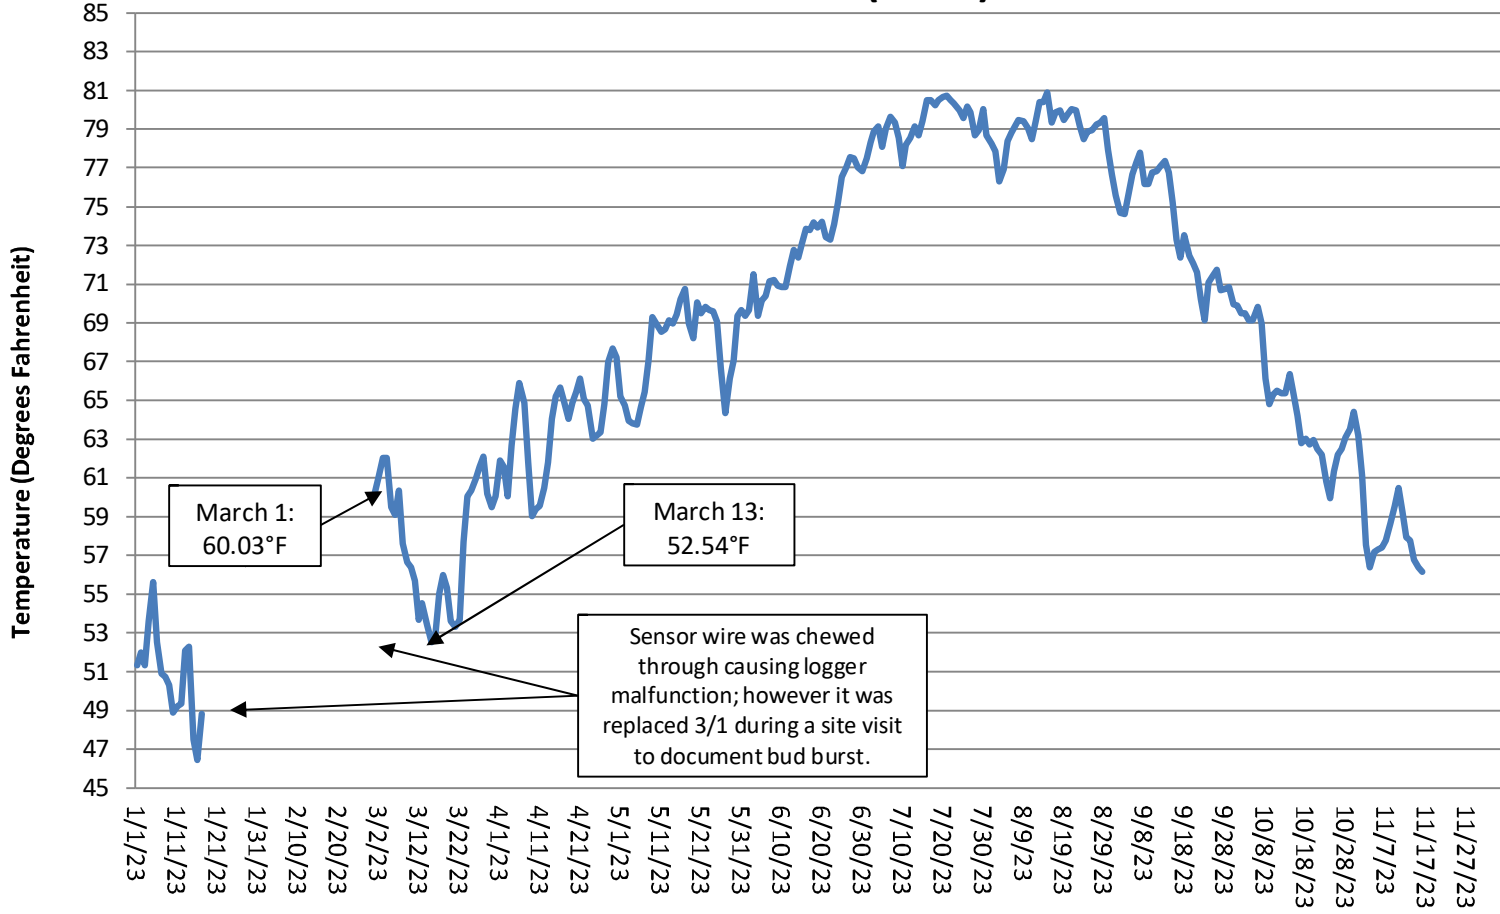
Shaw's Run Soil Temperature Data Year 3 (2023)

Sensor wire was chewed through causing logger malfunction; however it was replaced 3/1 during a site visit to document bud burst.

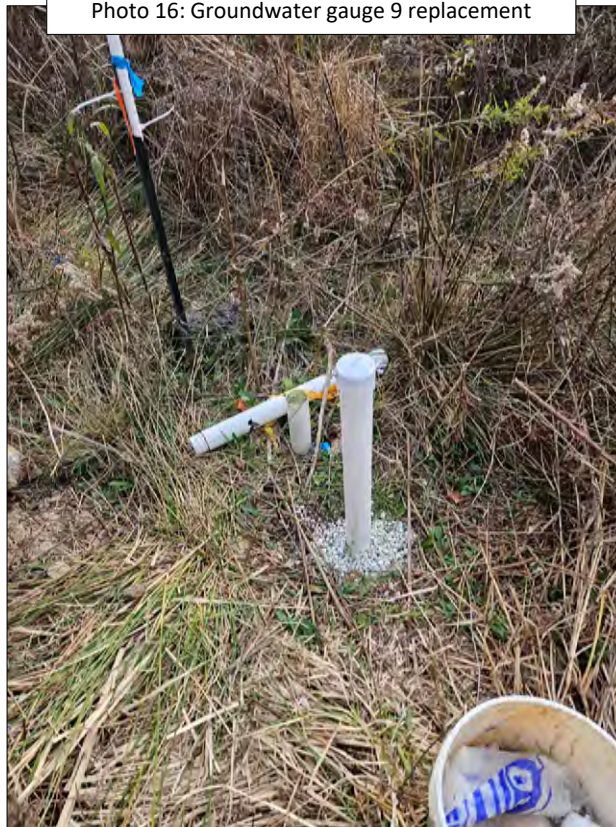
Photo 16: Groundwater gauge 9 replacement

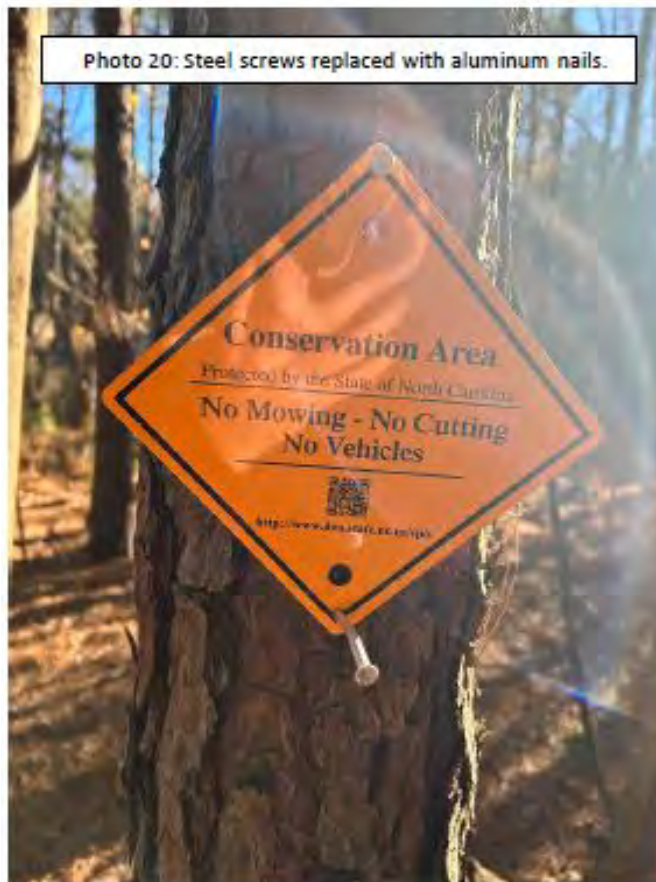
Photo 20: Steel screws replaced with aluminum nails.

Invasive Species Work	Maintenance work
<p>5/18/2023: Chinese Privet, Autumn Olive, Nodding Thistle, Multiflora Rose</p> <p>10/12/23: Chinese Privet, Mimosa, Chinese Tallow, Chinaberry</p>	<p>9/30/2023: Easement Encroachment Area (added horse tape)</p> <p>12/11/2023: Easement Encroachment Area (3-gallon container planting)</p> <p>12/14/2023: Easement Encroachment Area (added additional signage, added wooden posts, added PVC pipe, added horse tape); Replaced steel screws with aluminum nails</p>

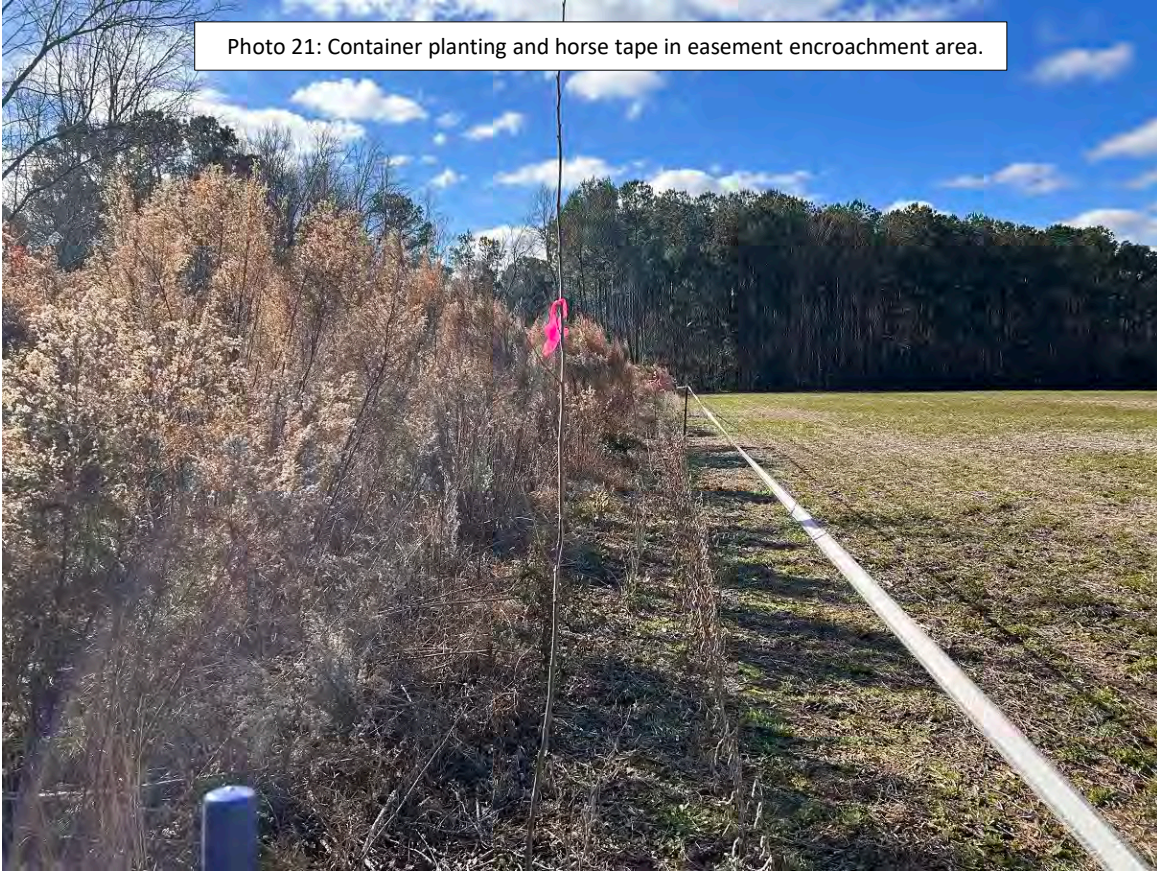
Photo 21: Container planting and horse tape in easement encroachment area.

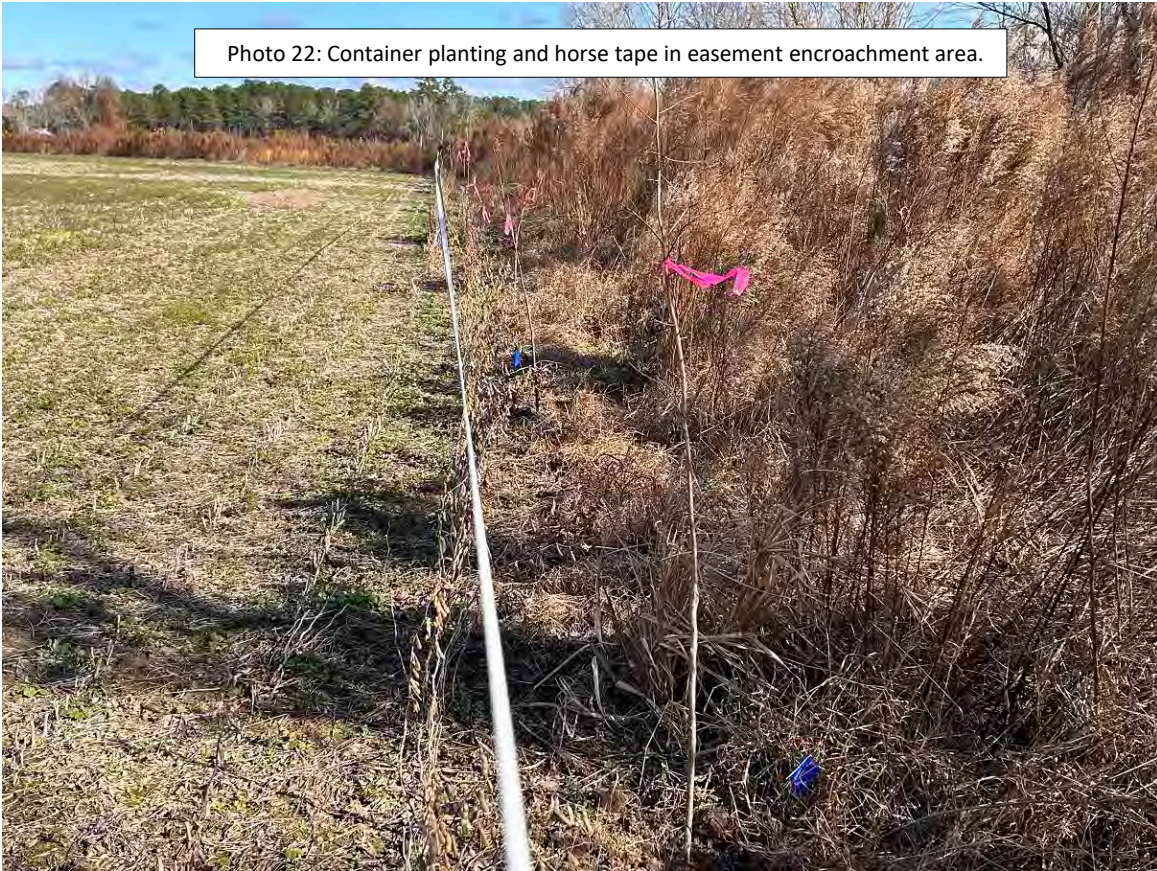
Photo 22: Container planting and horse tape in easement encroachment area.

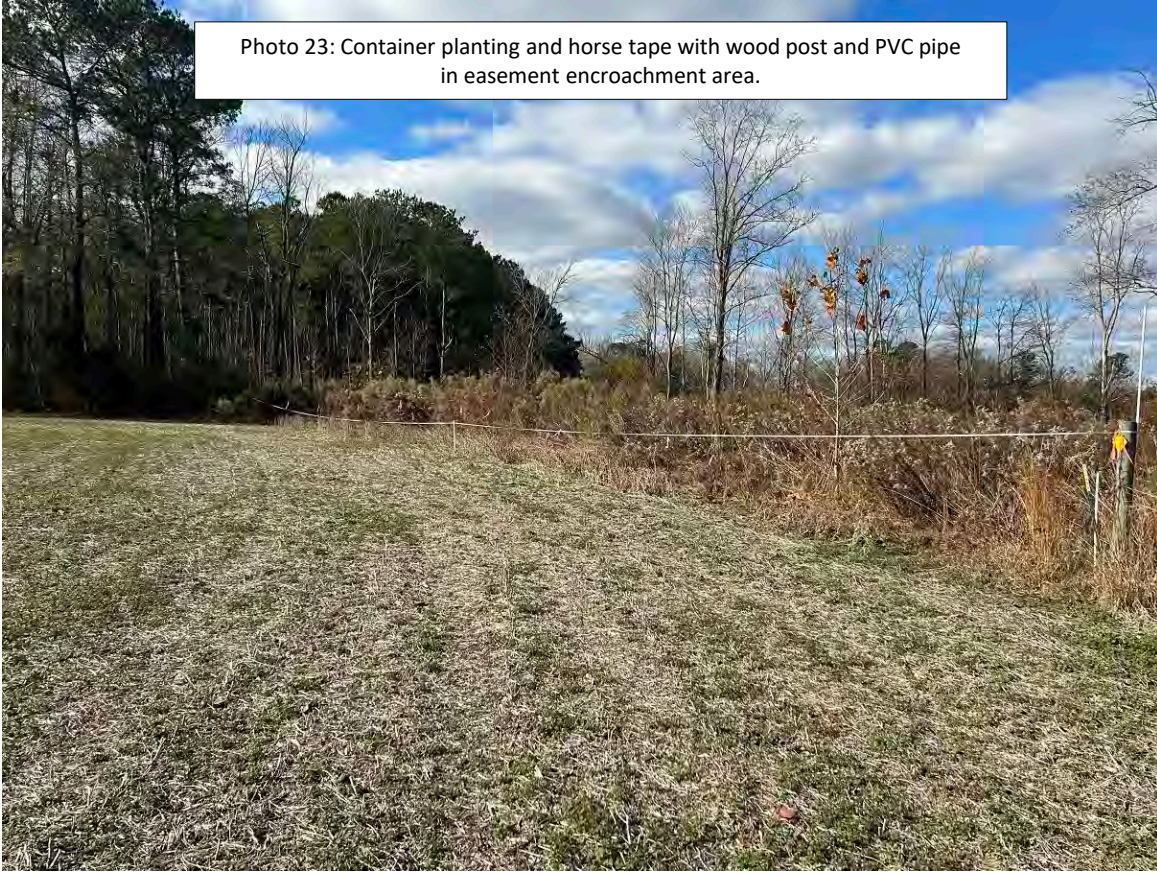
Photo 23: Container planting and horse tape with wood post and PVC pipe in easement encroachment area.

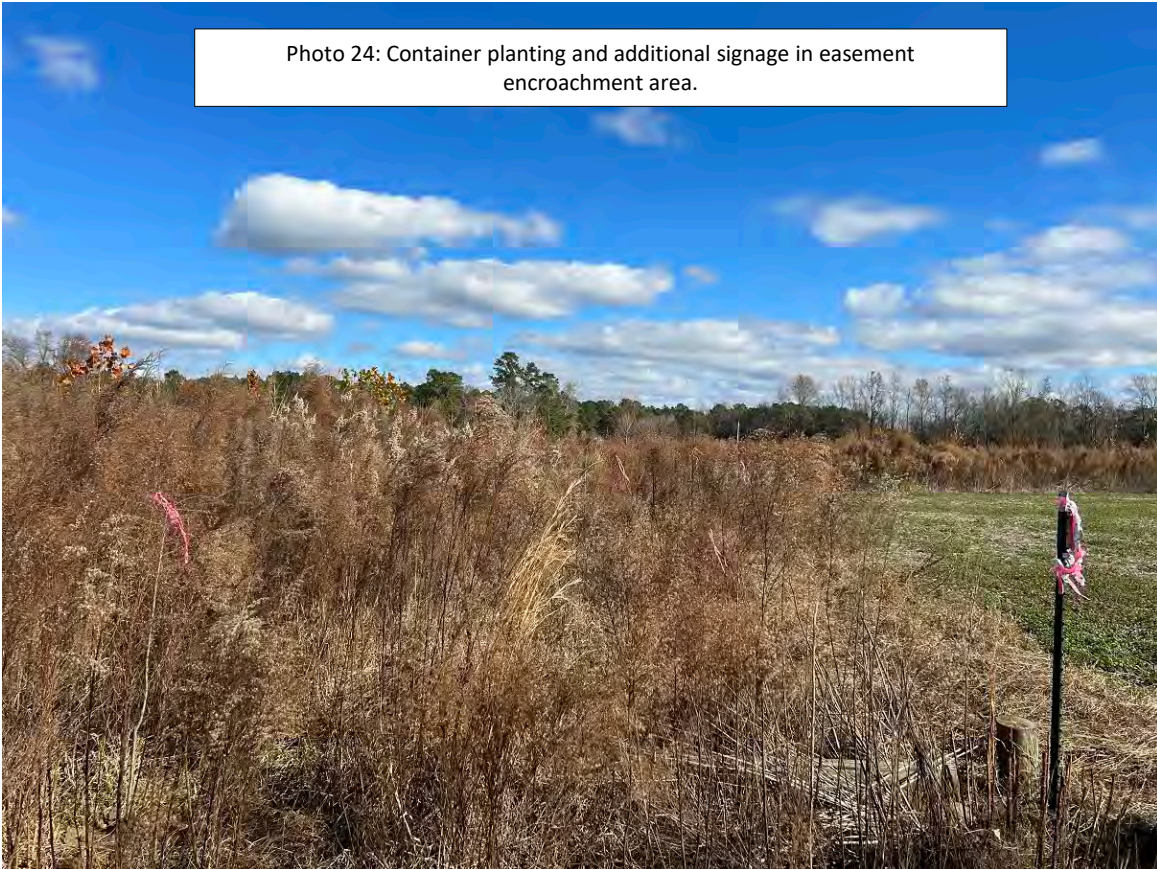
Photo 24: Container planting and additional signage in easement encroachment area.

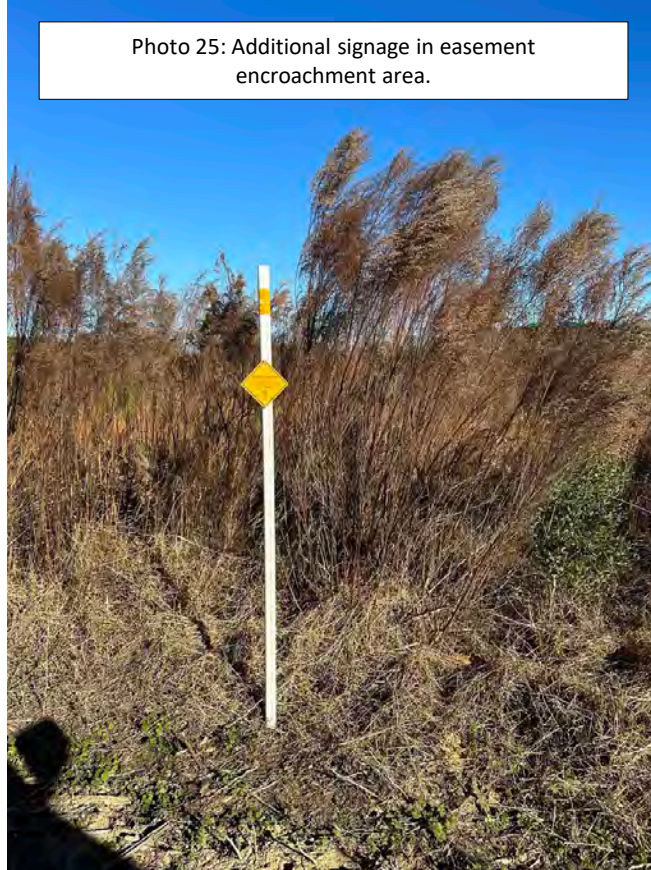
Photo 25: Additional signage in easement encroachment area.
