# **Year 1 Monitoring Report**

## **Shepherds Tree Stream & Wetland Restoration**

**February 2006**  
**S&EC Project No. 9440.D1**  
**EEP Project No. 00078**

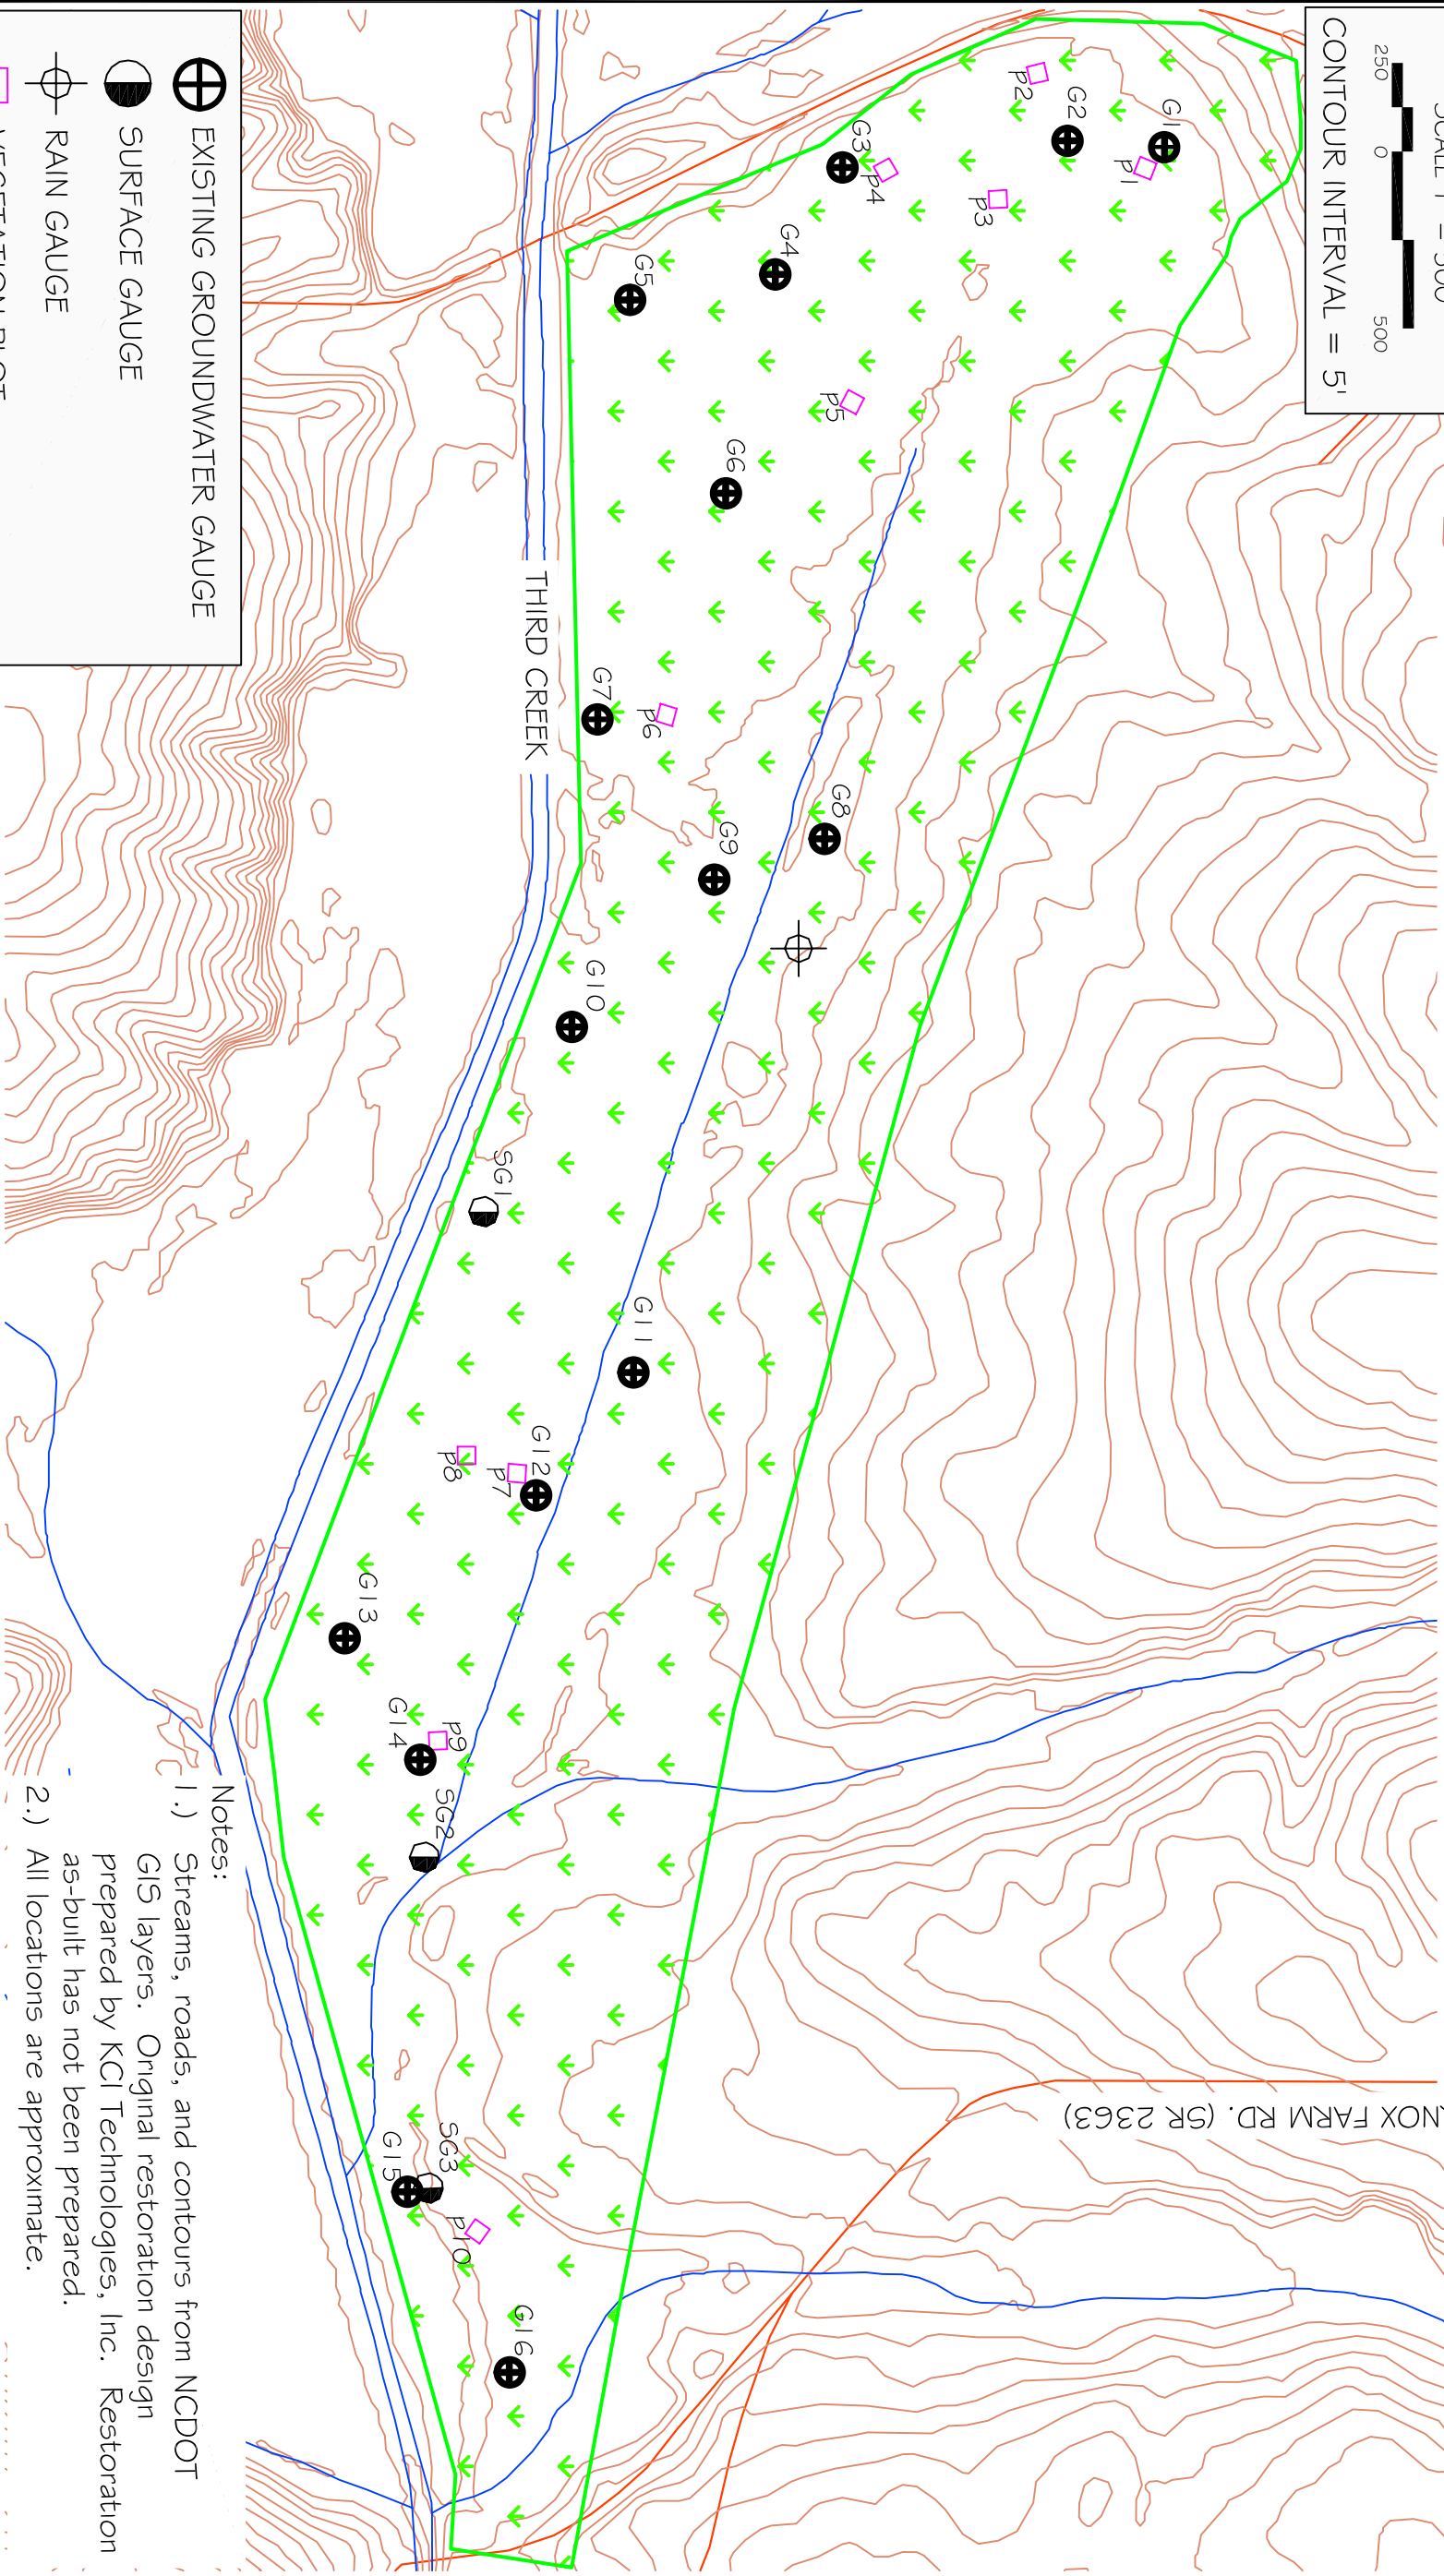
### MONITORING PLAN VIEW

Nineteen (19) electronic monitoring gauges were previously installed onsite. Sixteen (16) are groundwater gauges and three (3) are surface gauges. The gauges have been configured to record water levels. A rain gauge is also present onsite, however no usable data was collected from it, as it has not been properly maintained. It is recommended that this rain gauge be replaced.

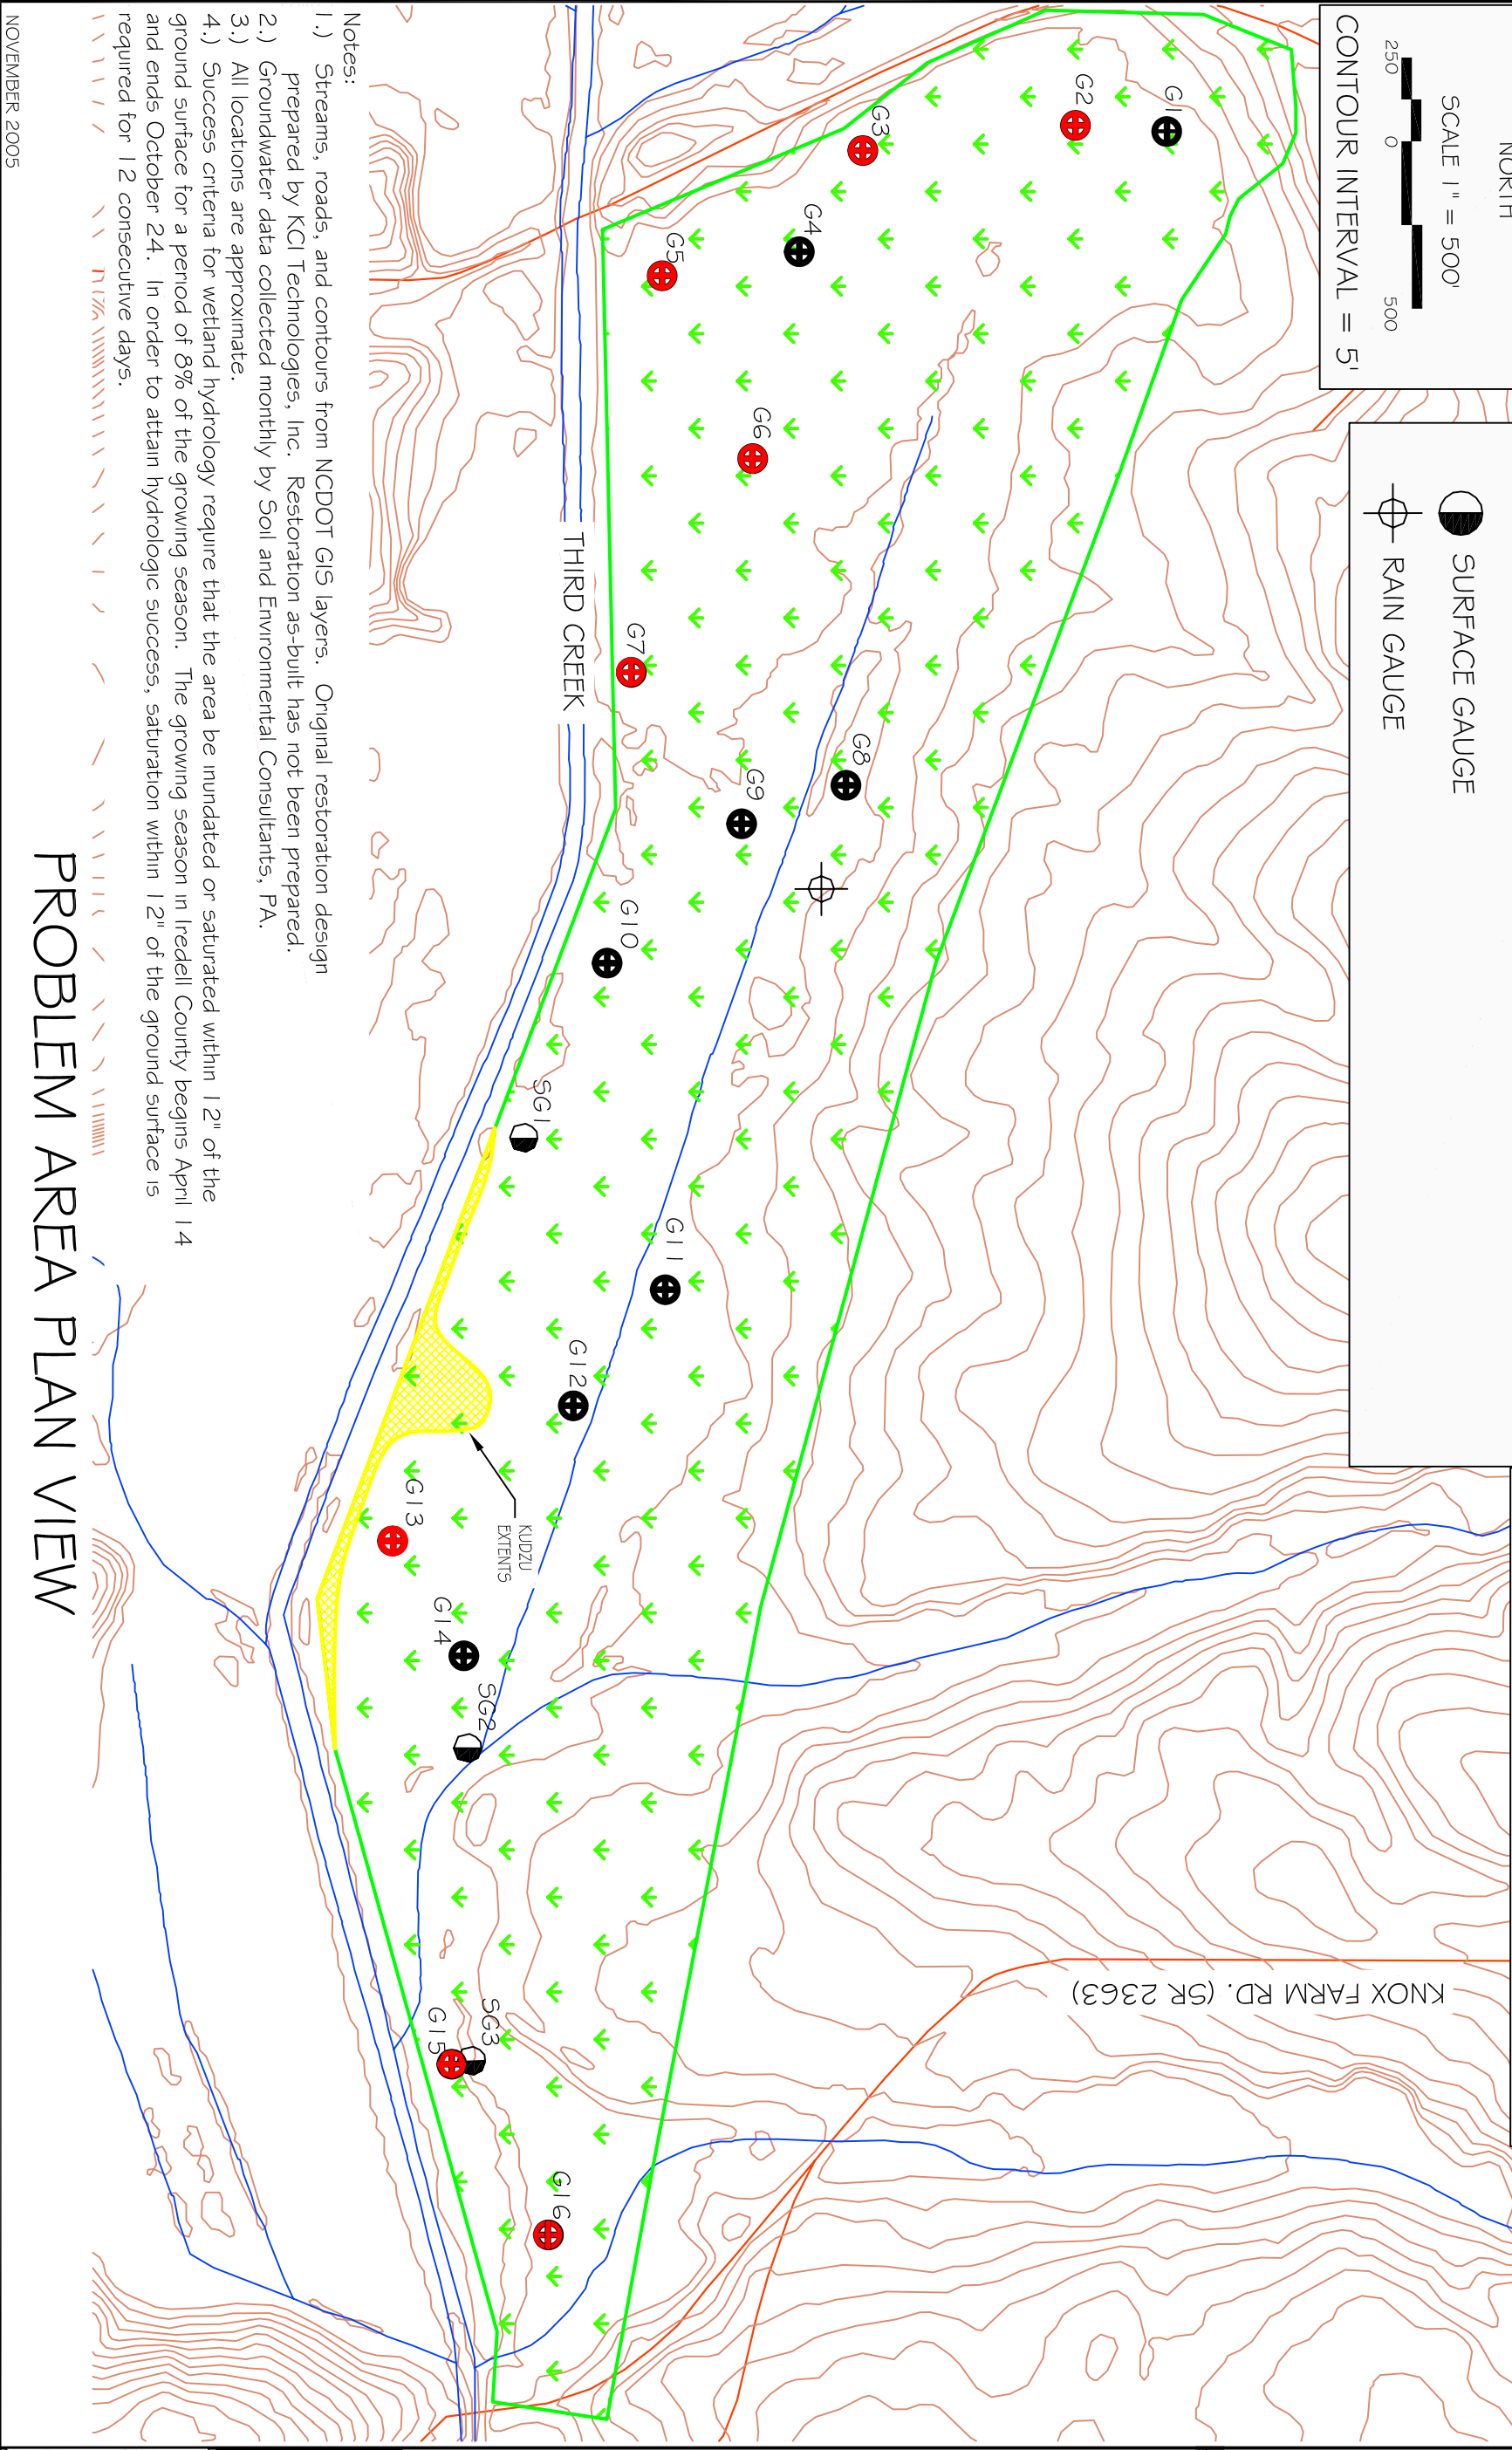
## PROBLEM AREA PLAN VIEW

Vegetative problem areas are shown on Sheet 2 (Problem Area Plan View).

As shown on the Problem Area Plan View (Sheet 2), eight (8) of the sixteen (16) gauges onsite achieved wetland success criteria of saturation for 8% of the growing season (15 days).

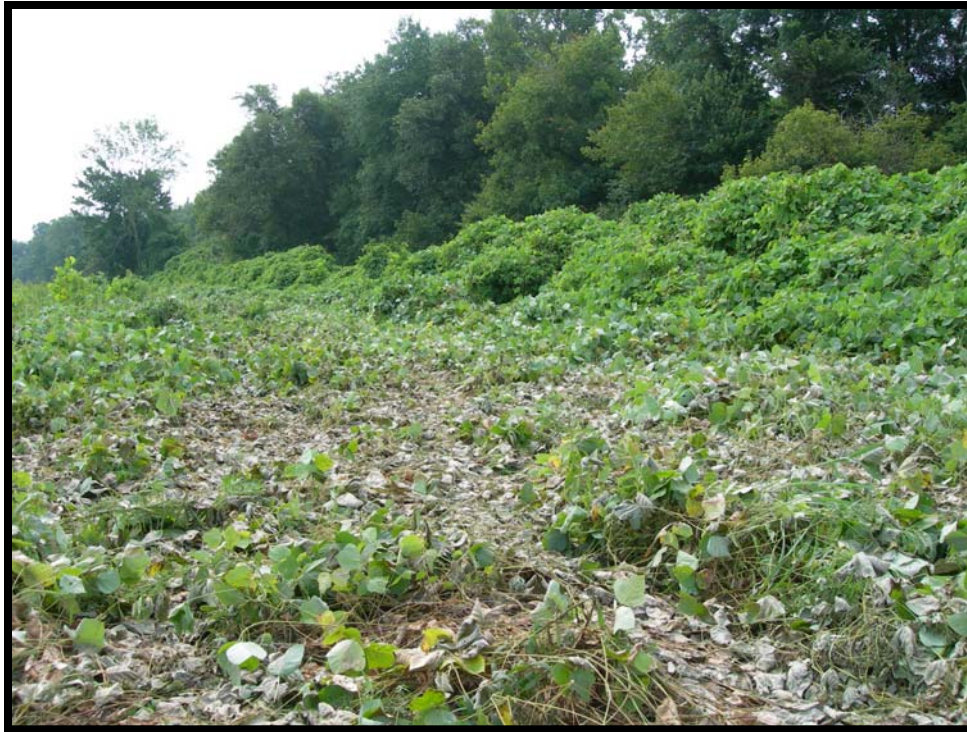
During a field inspection on July 28, 2005, vegetative problem areas were observed. A large infestation of *Kudzu*, the highly invasive exotic plant was located within the restoration site. Photos of the invasive are included in Appendix A.

<b>Feature Issues</b>	<b>Station numbers</b>	<b>Suspected Cause</b>	<b>Photo number</b>
<i>Kudzu</i>	N/A	Invasive population	Vegetative Problem Area Photos 1-2

Photo 1—*Kudzu* population

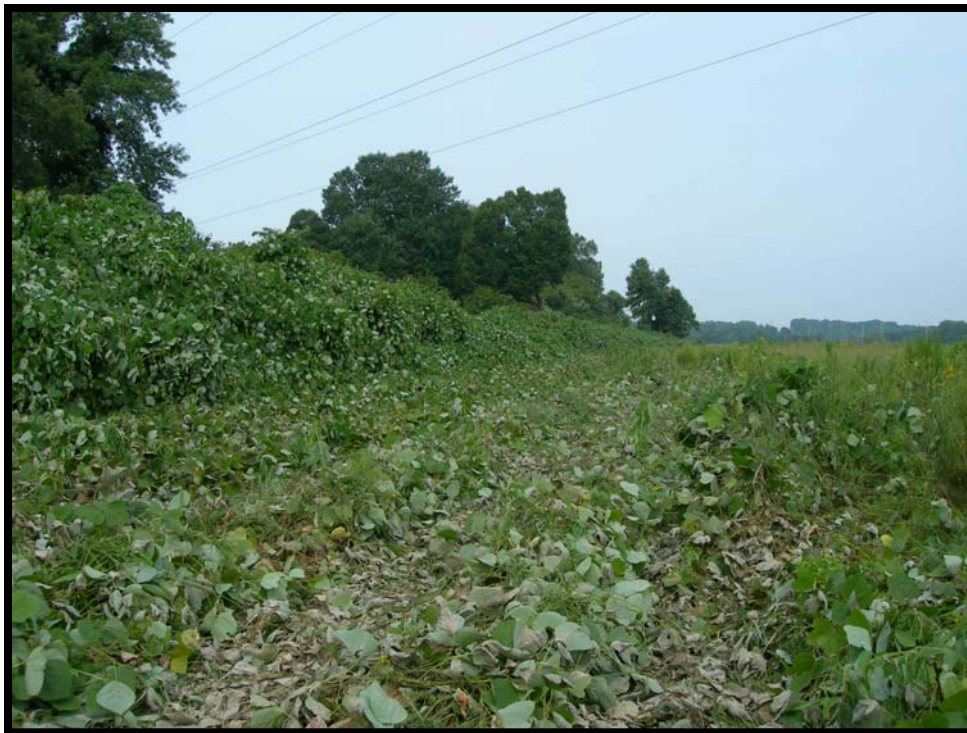
Photo 2—*Kudzu* population
