Shepherds Tree Stream and Wetland Restoration

EEP Project No. 333

2010 Monitoring Report: Year 6

Jordan, Jones and Goulding
309 East Morehead Street, Suite 110
Charlotte, NC 28202

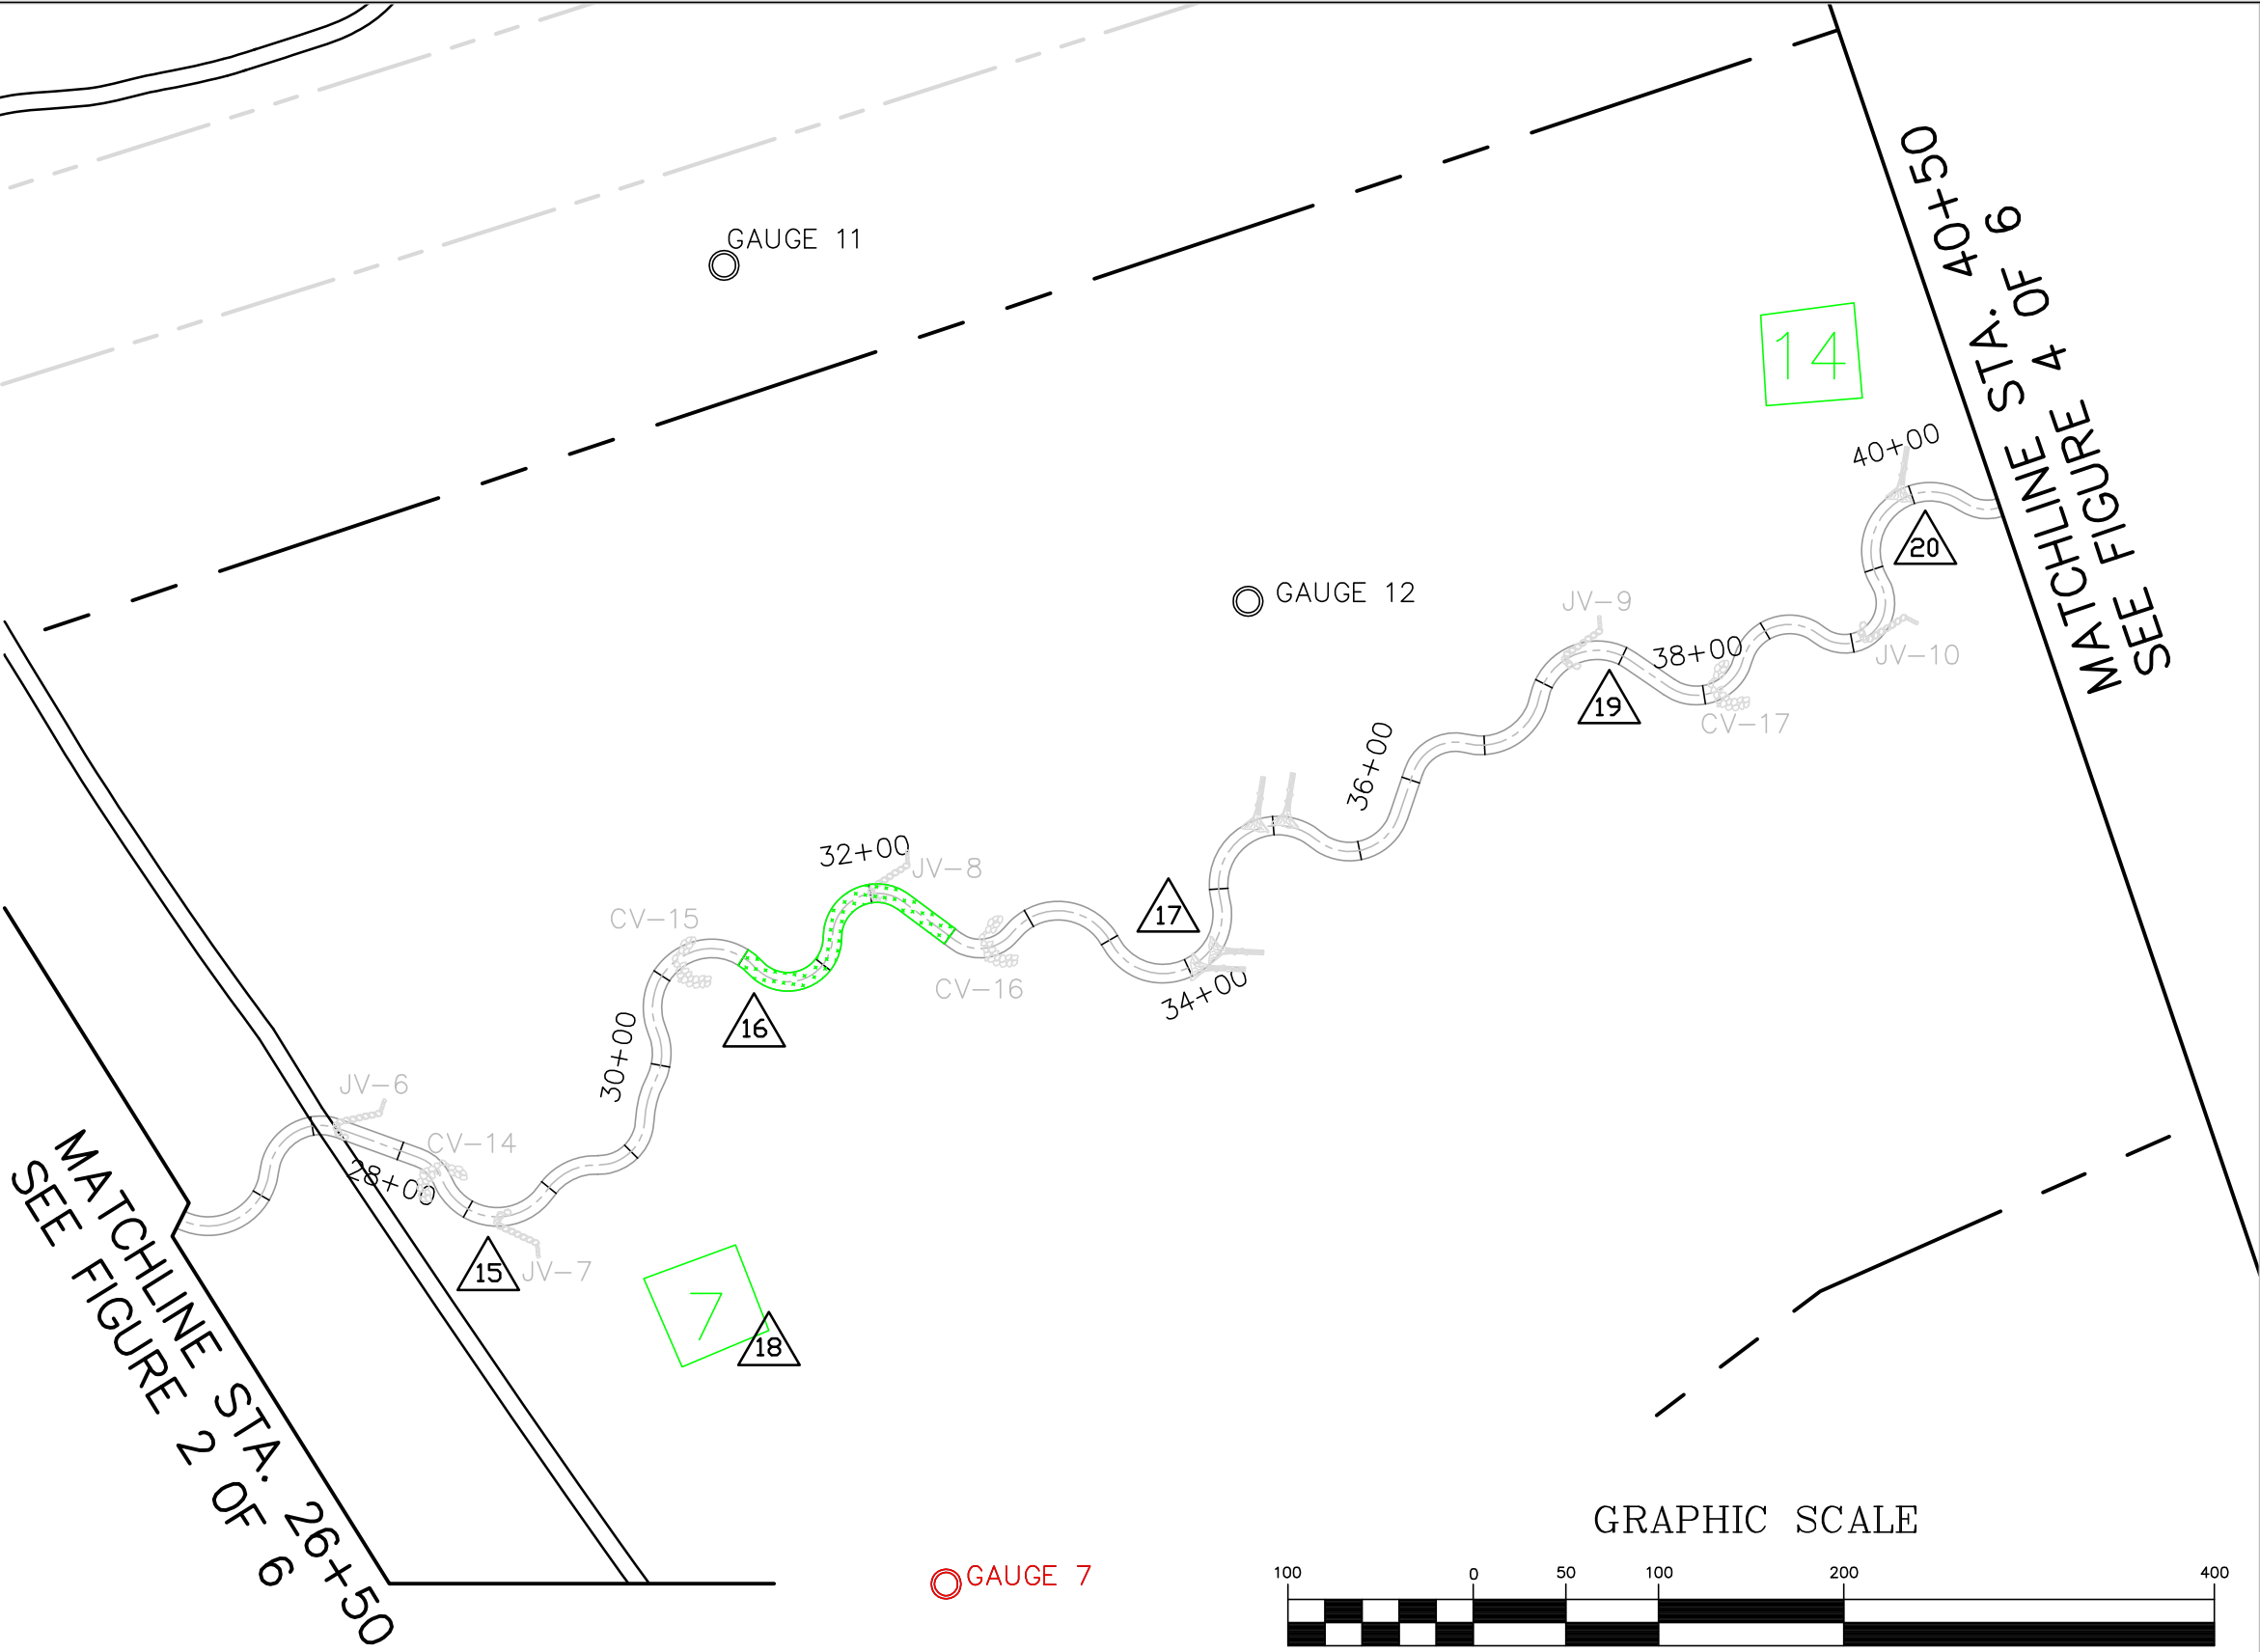
2010 CURRENT CONDITION

- IN-STREAM VEGETATION
- INVASIVE SPECIES-KUDZU
- VEGETATION PLOT-INVASIVE SPECIES
- GROUNDWATER GAUGE-FAILED

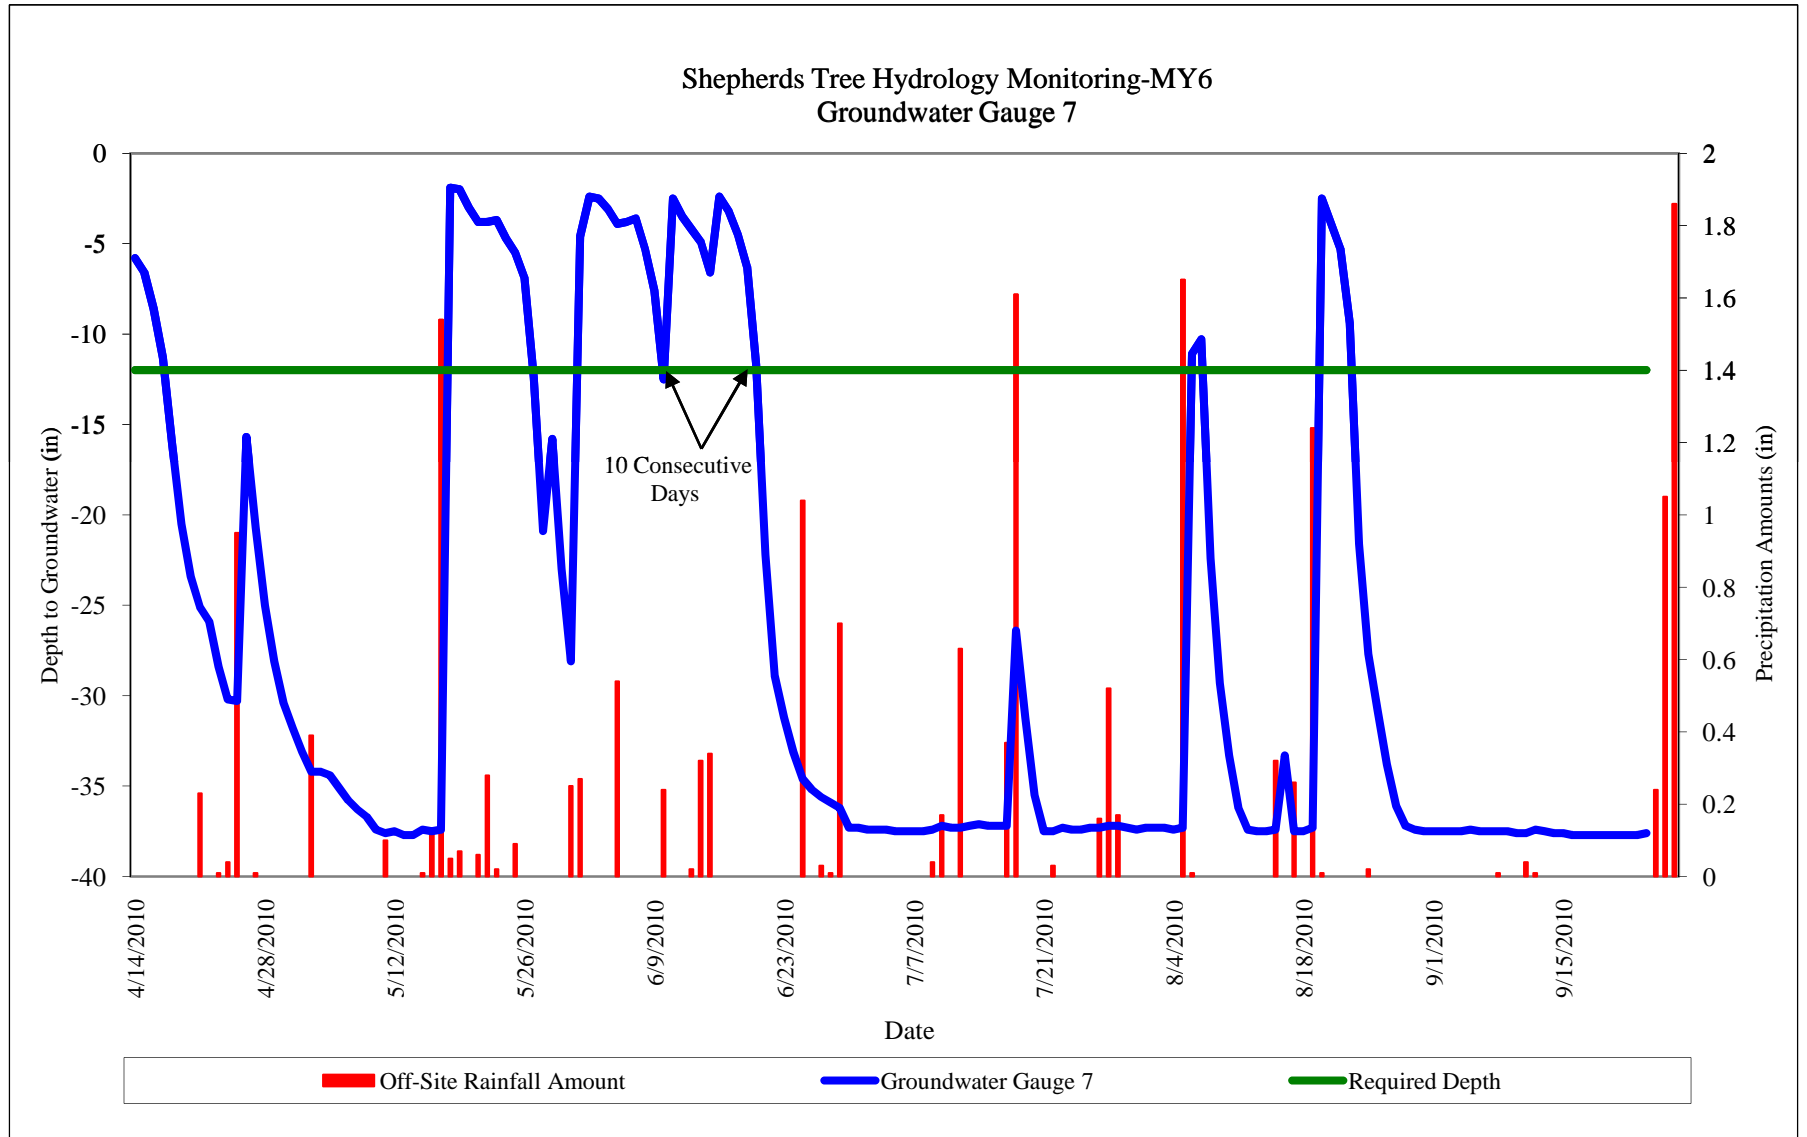
(Gauge malfunctioned 9/2010)
