Silas Creek Stream Restoration Project Year 1 Monitoring Report Winston Salem, North Carolina

North Carolina Department of Environment and Natural Resources
Ecosystem Enhancement Program

This is Year 1 of the 5-year monitoring plan for Silas Creek and Buena Vista Branch.

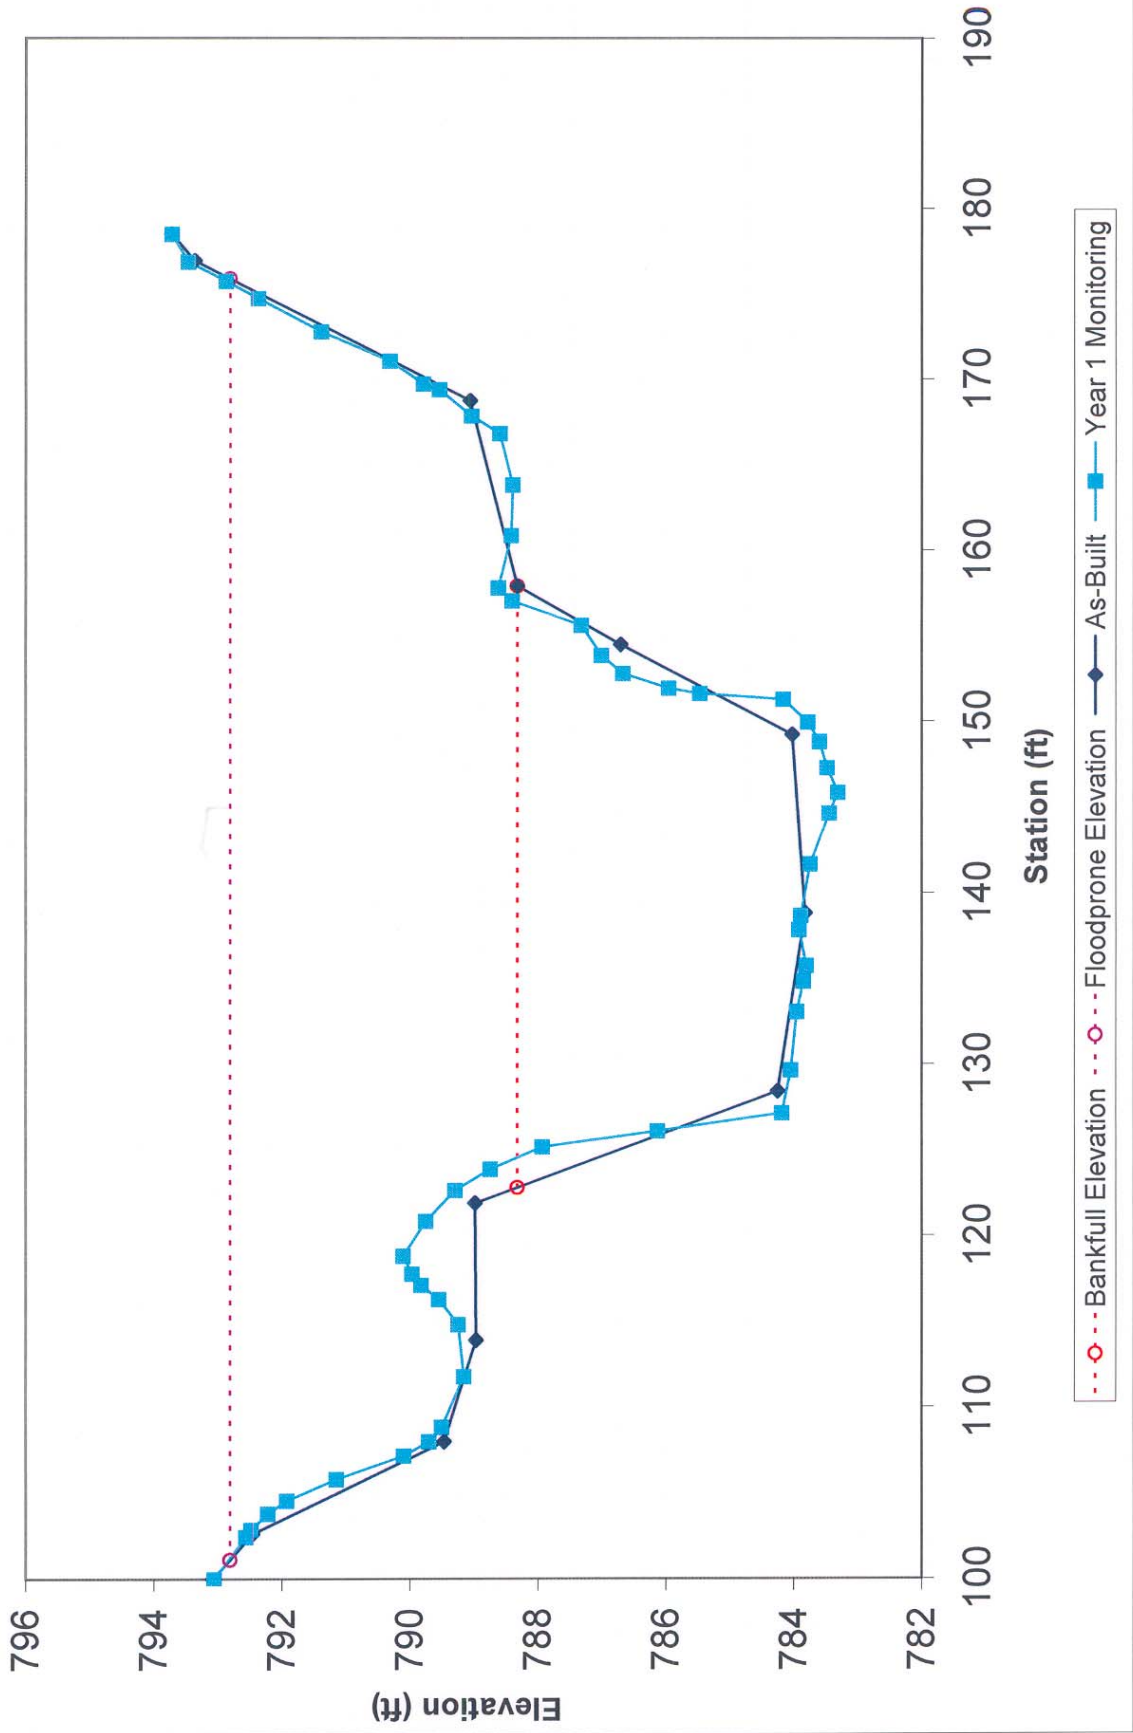
Silas Creek Cross-section X1 Riffle

X1 has narrowed from As-Built conditions by 2.7 feet due to what appears to be minor deposition on the left bench and channel. The right side of this cross section has also deepened by 0.5 feet, potentially indicating the development of a thalweg. No signs of instability were noted at this cross-section and these minor shifts are considered to be within a stable range. The change in depth at this cross section does not appear to be degradational but should be evaluated during future monitoring events.

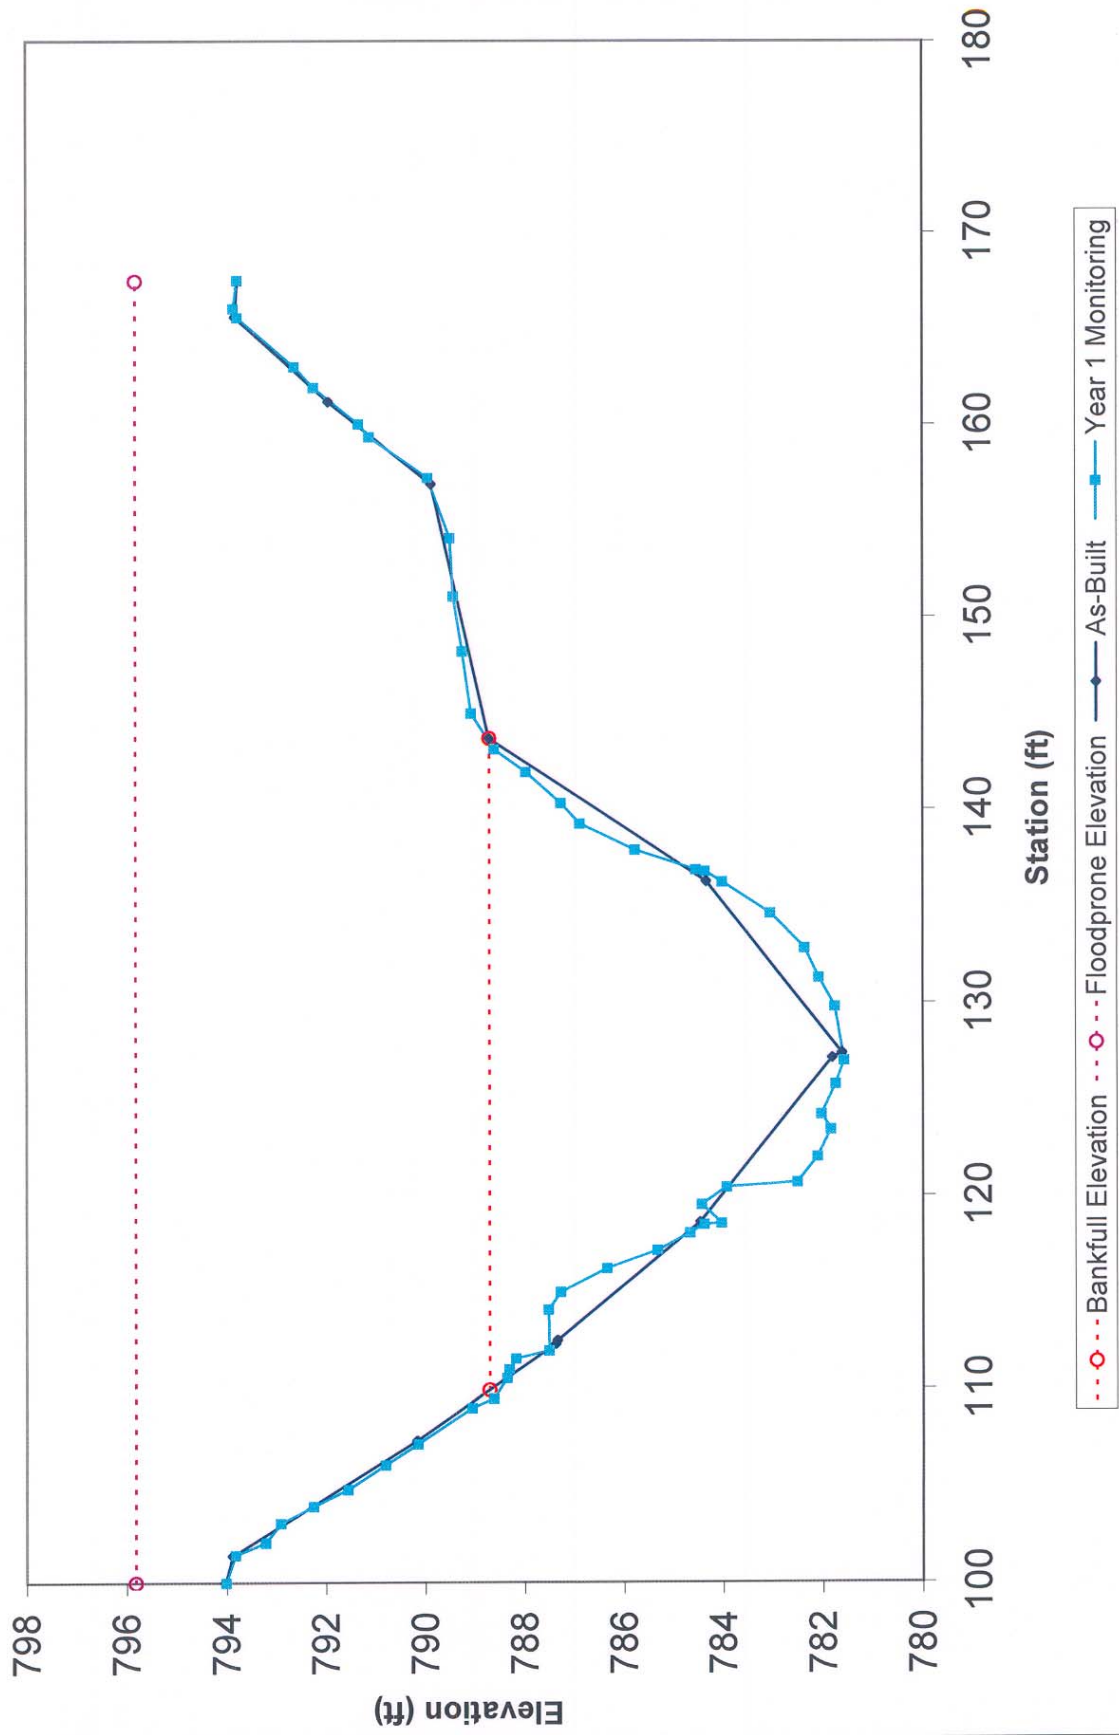
Silas Creek Cross-section X2 Pool

X2 has remained fairly stable since construction. Minor deposition has occurred along the left bank and variations in bankfull area is most likely attributed to more frequent survey shots taken in the Year 1 monitoring than during the As-Built survey.

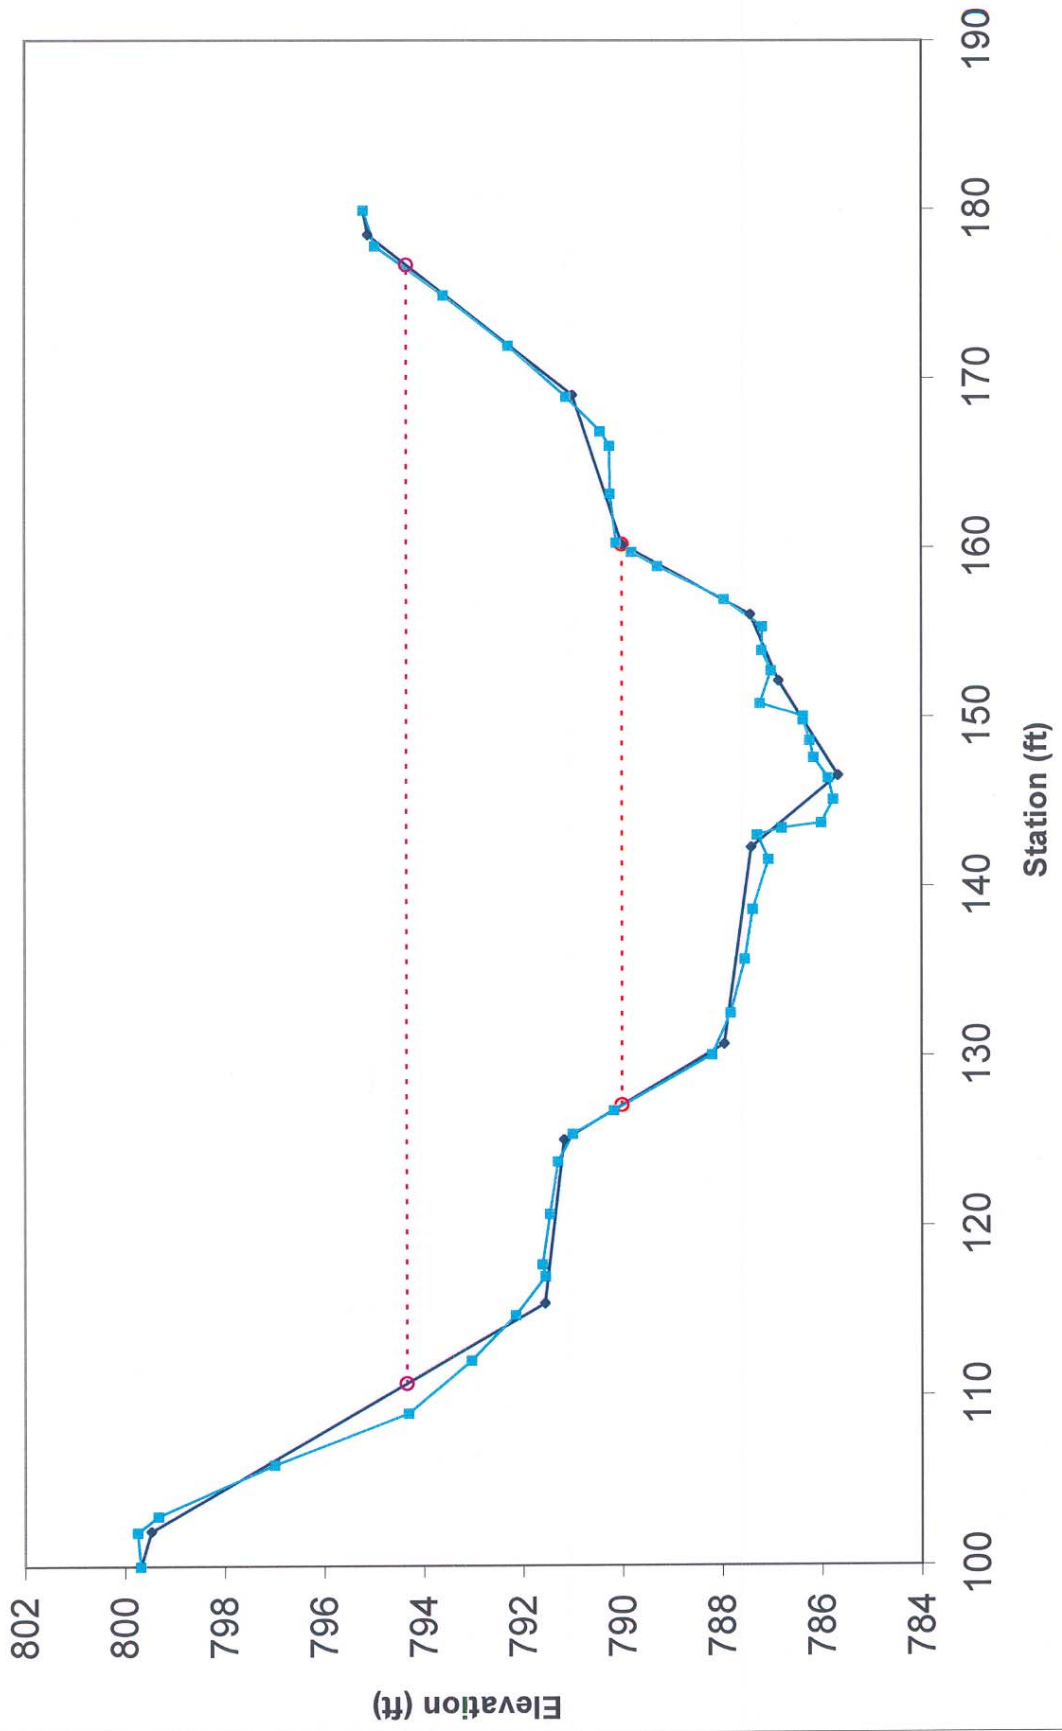
Silas Creek Cross-section X3 Riffle

Results for X3 indicate a stable width and some slight aggradation. Visual inspection of the constructed riffle cross-section did not indicate any instability and the slight shift in depth is considered well within the ranges of stable adjustment.

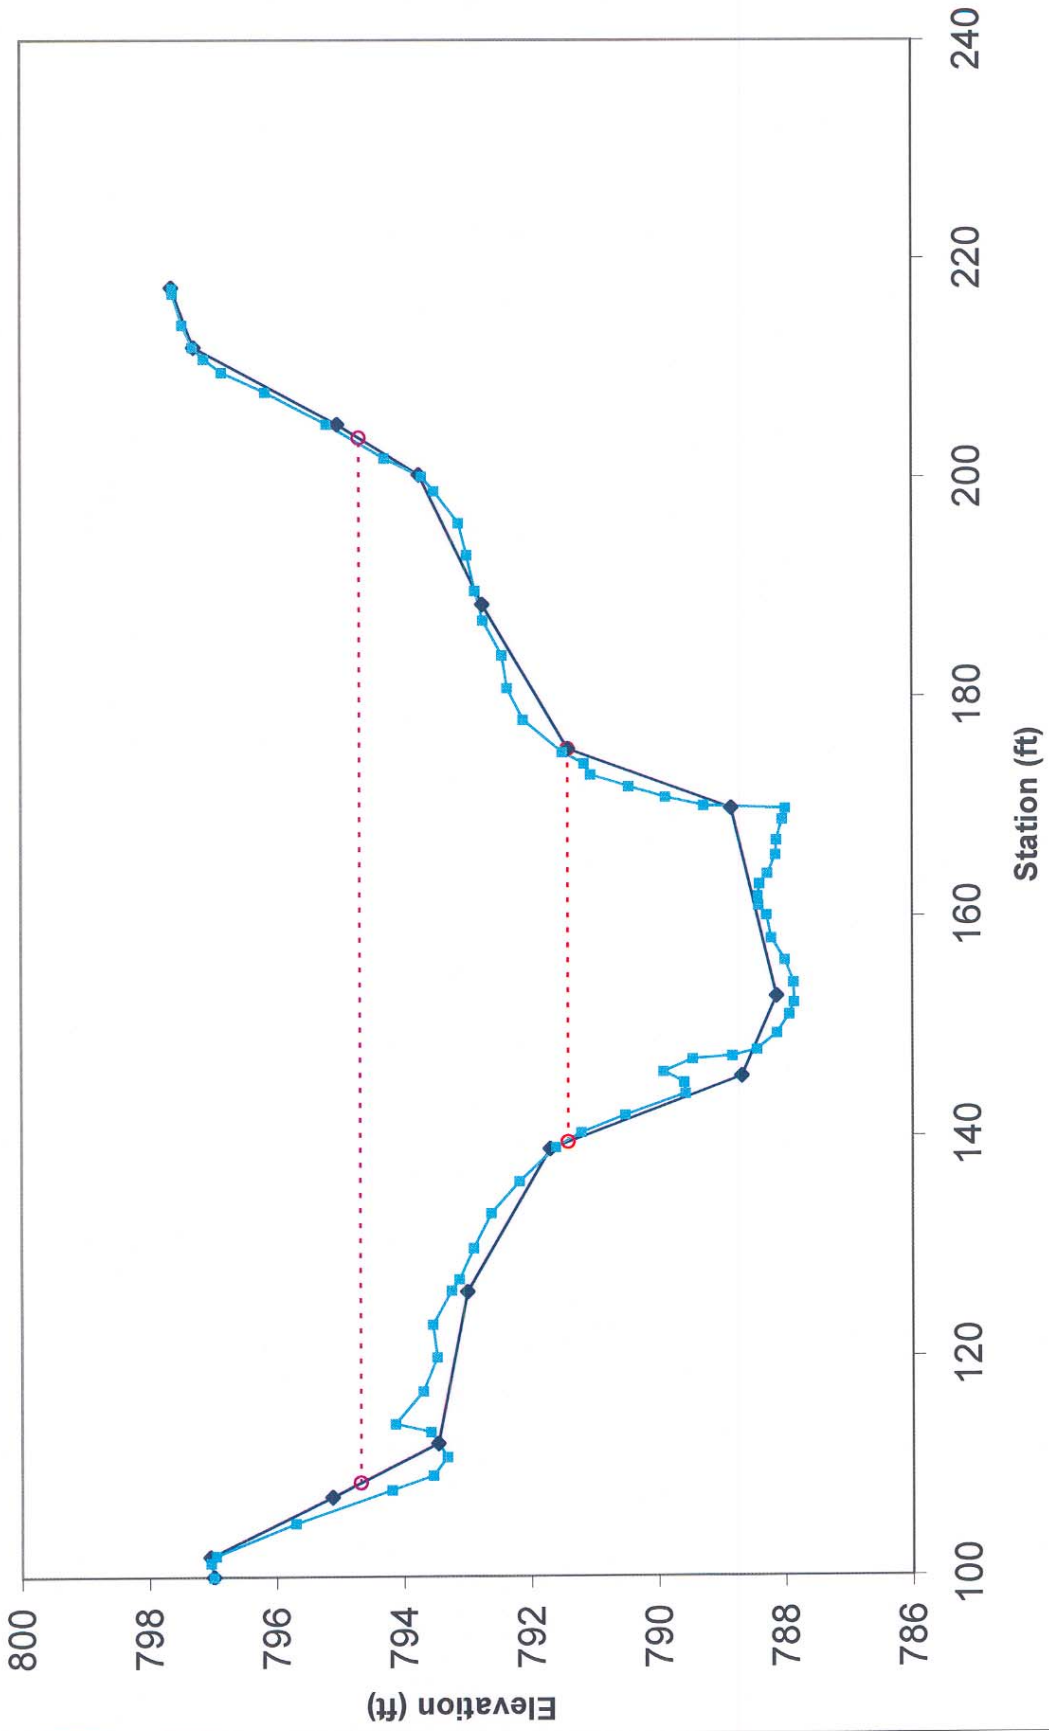
Silas Creek Cross-section X4 Riffle

X4 is 0.3 feet deeper than the As-Built condition. Minor deposition has also occurred on the right and left benches. The change in depth at this cross-section does not appear to be degradational but should be evaluated during future monitoring events.

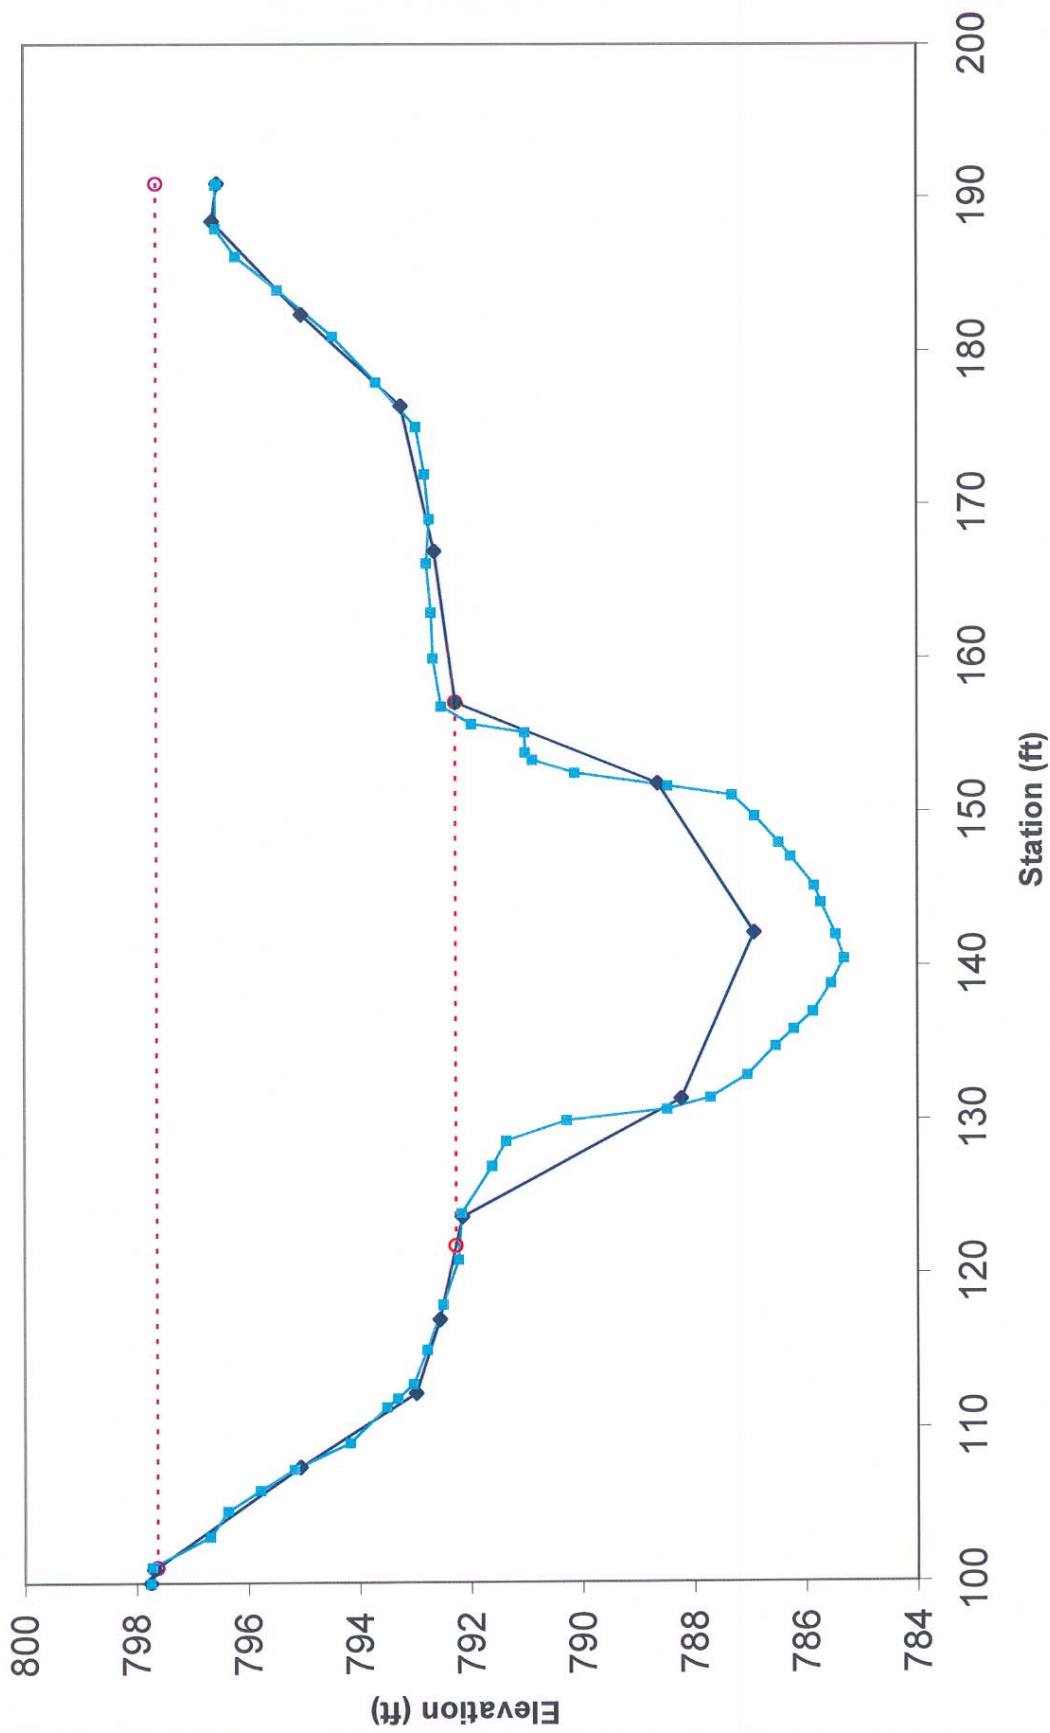
Silas Creek Cross-section X5 Pool

X5 has deepened by 1.6 feet, indicating the upstream cross vane is functioning well. This trend is consistent with the design intentions and indicates a positive trend in habitat enhancement and energy dissipation.

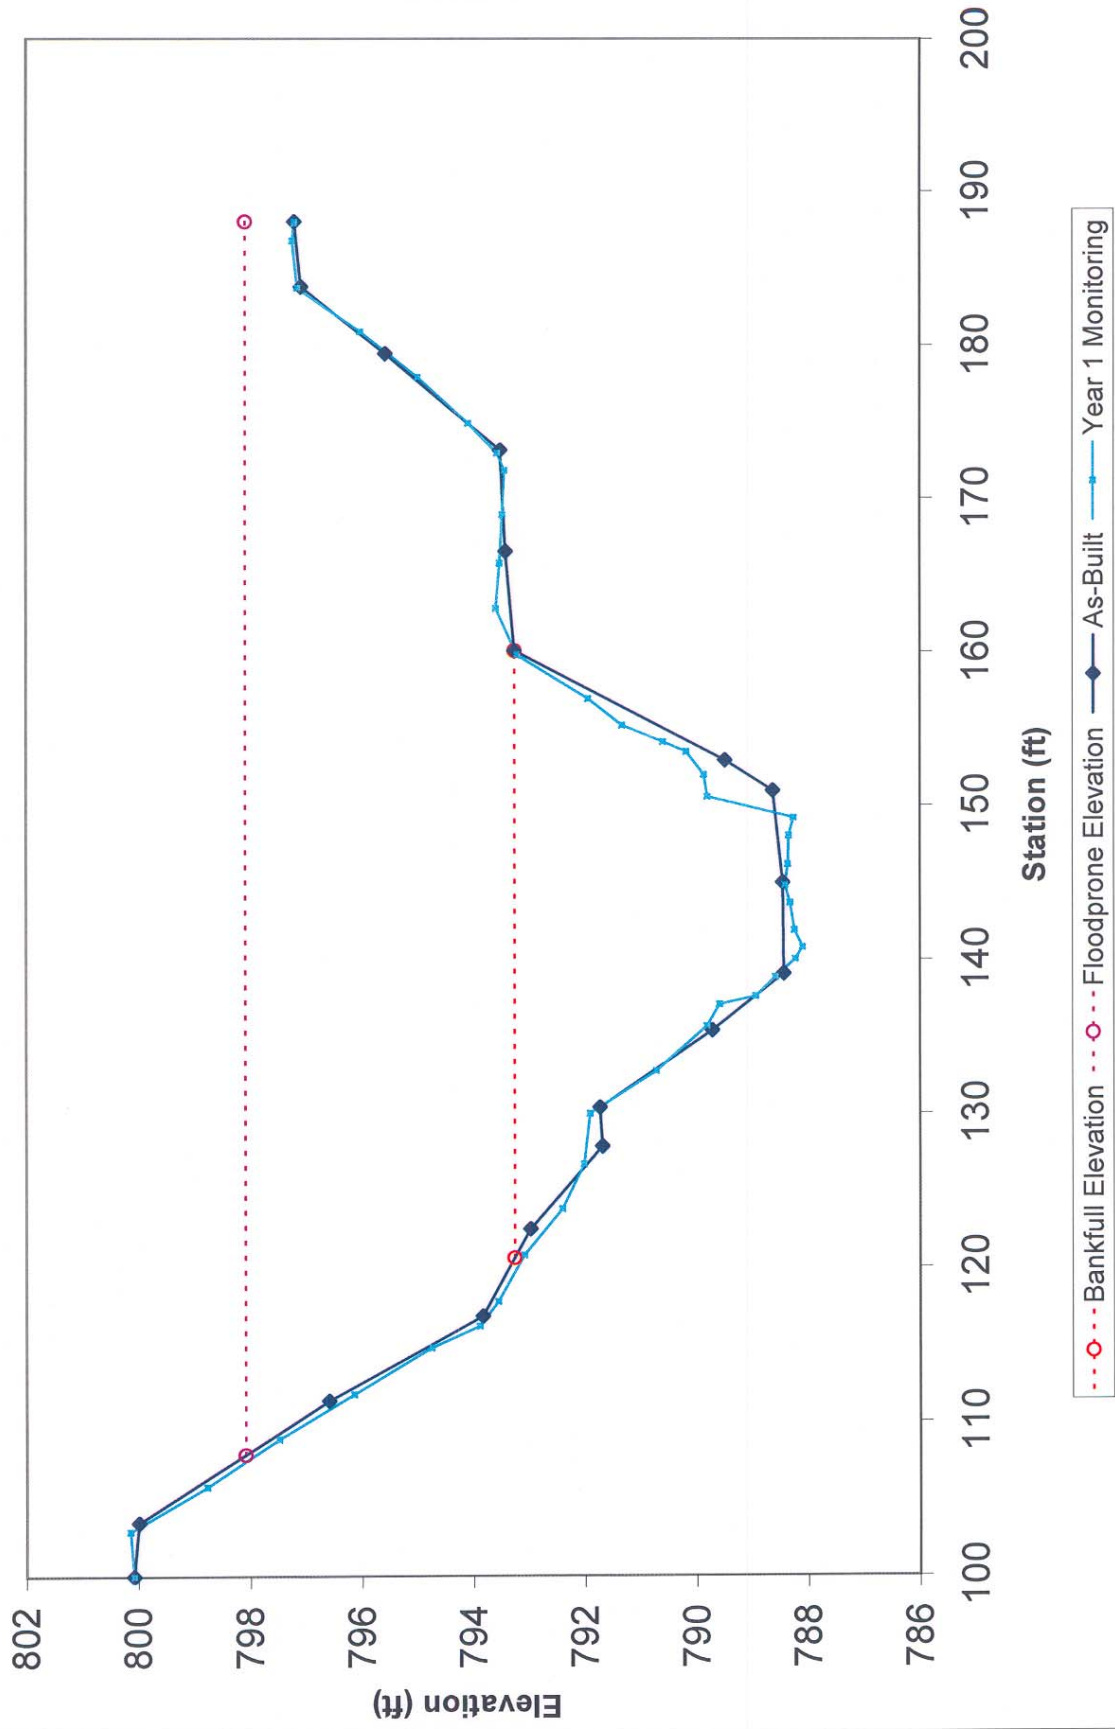
Silas Creek Cross-section X6 Riffle

X6 has deepened by 0.3 feet and the cross sectional area is 4.1 ft² less when compared to As-Built conditions. Part of this difference may be explained by differences in survey shot frequencies but it is plausible that this cross section may be adjusting. The change in depth at this cross section does not appear to be degradational but should be evaluated during future monitoring events.

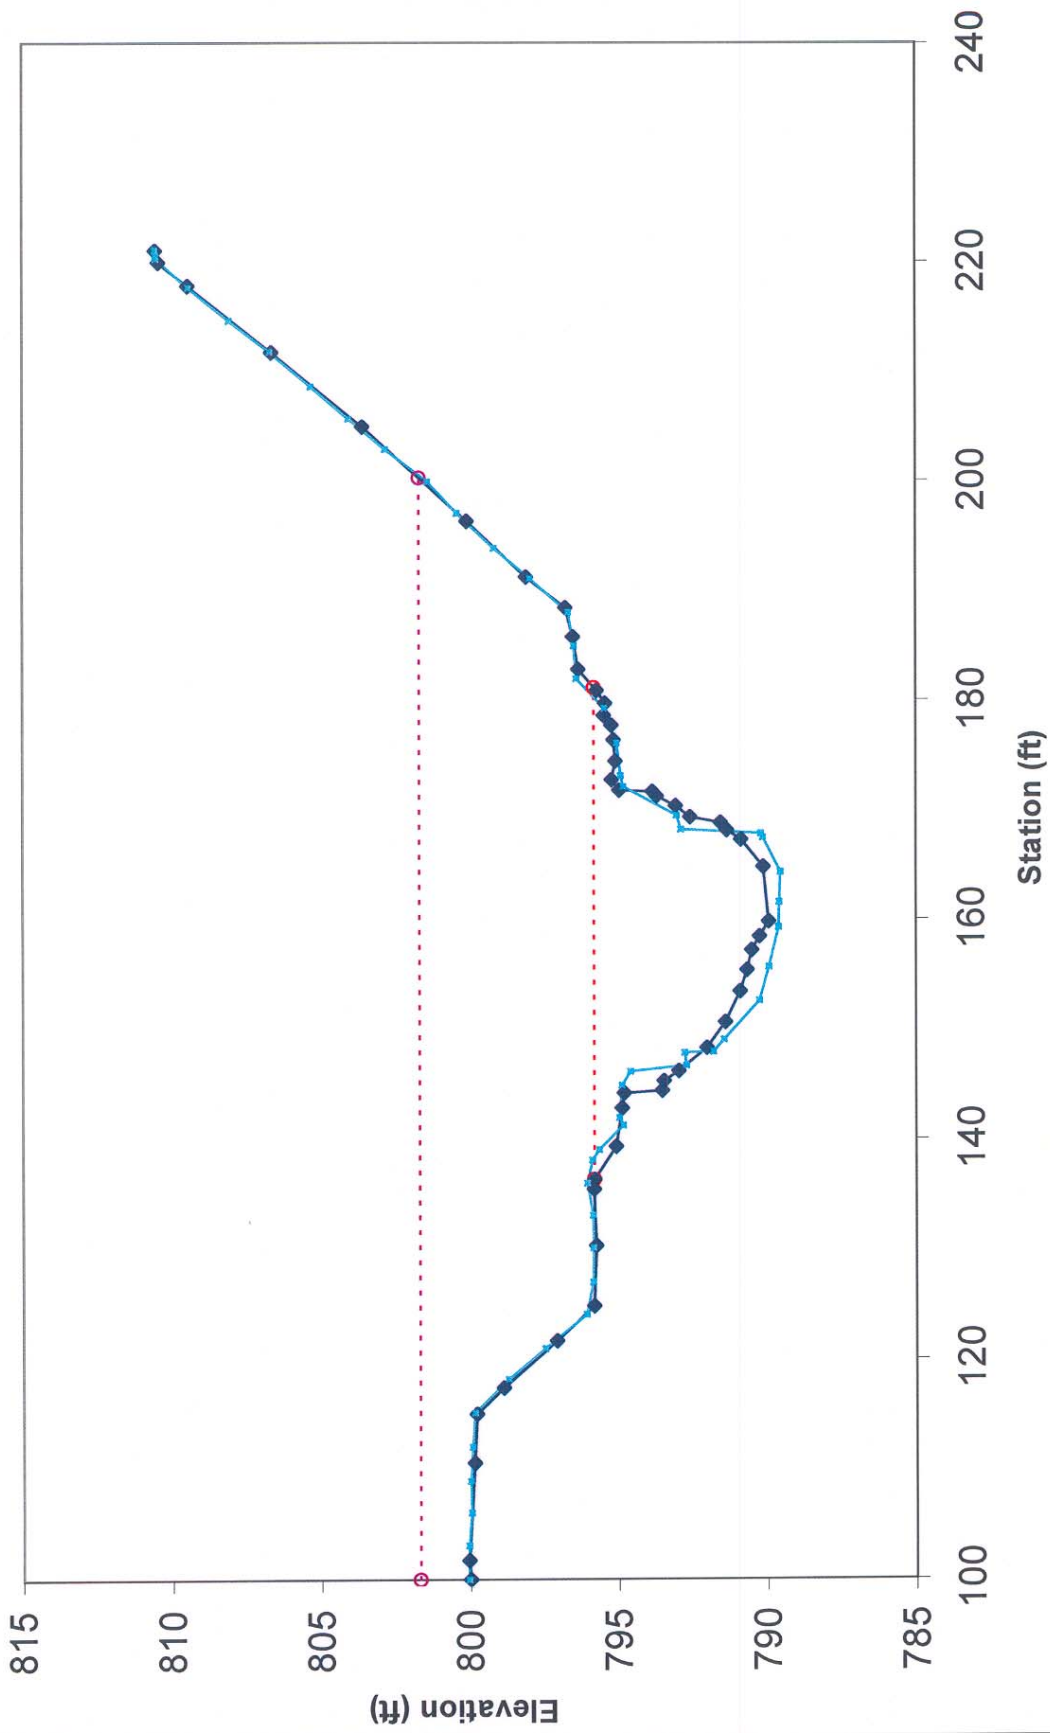
Silas Creek Cross-section X7 Pool

X7, like most of the pools, has deepened by 0.4 feet. Some slight narrowing is evident; sand deposition was apparent on the banks. Other minor changes in the cross-section are well within ranges of normal adjustment.

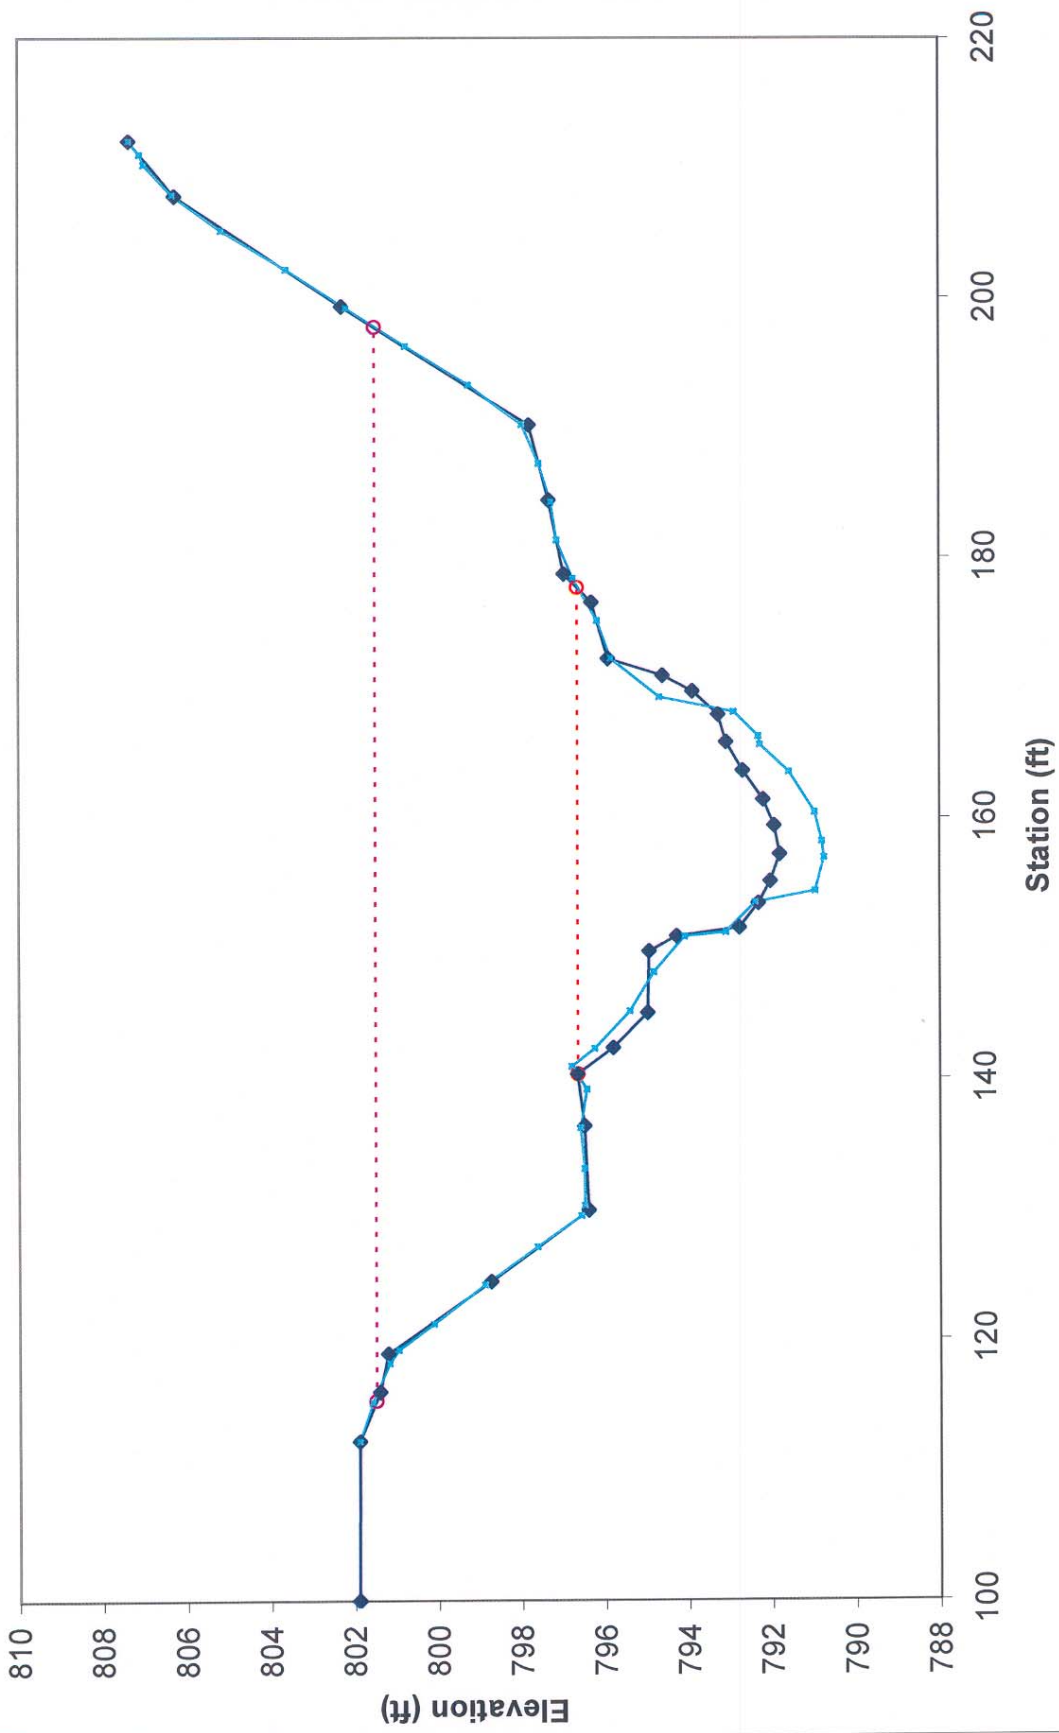
Silas Creek Cross-section X8 Pool

X8 has deepened by 1.1 feet, which is consistent with the trend noted in the X5 and X7 pool locations.

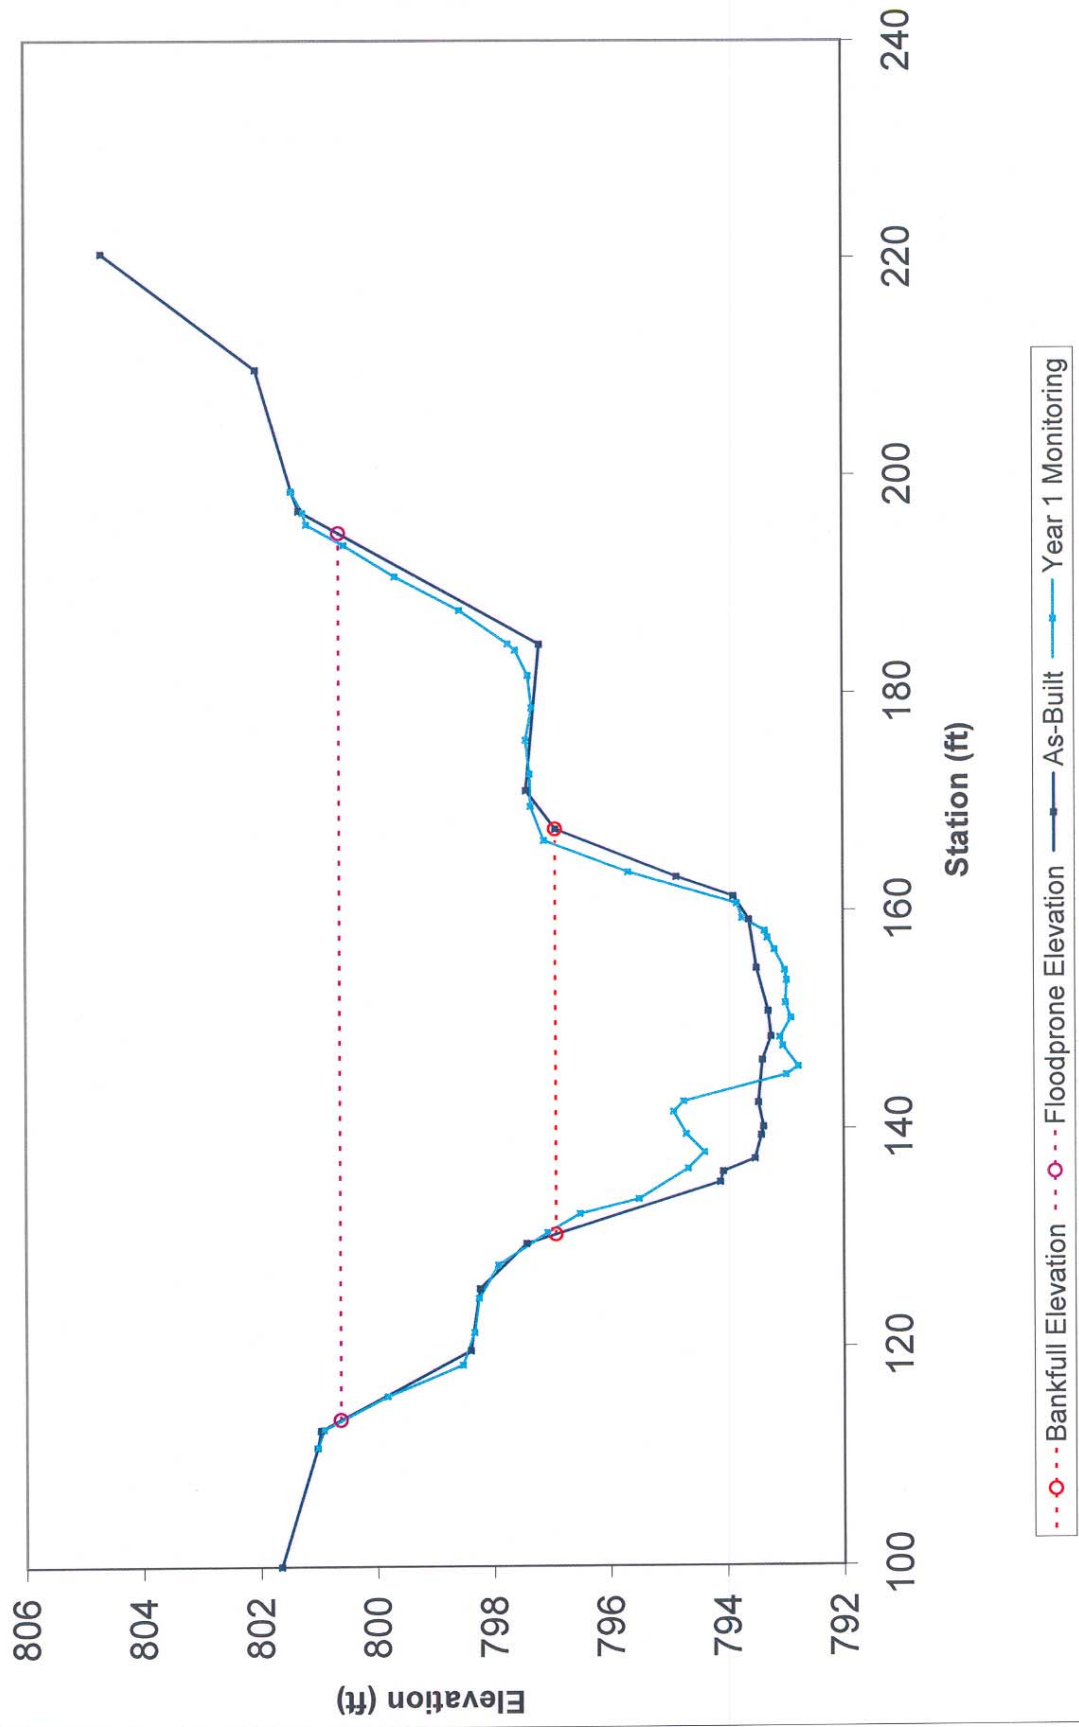
Silas Creek Cross-section X9 Riffle

X9 has narrowed by 2.0 feet and the bankfull area has decreased from 105.3 ft² to 95.8 ft². The maximum depth has increased by 0.5 feet. This cross-section is just upstream of a cross vane which is promoting channel narrowing. Although the channel has deepened considerably at this cross-section, incision is unlikely considering the cross vane located immediately downstream.

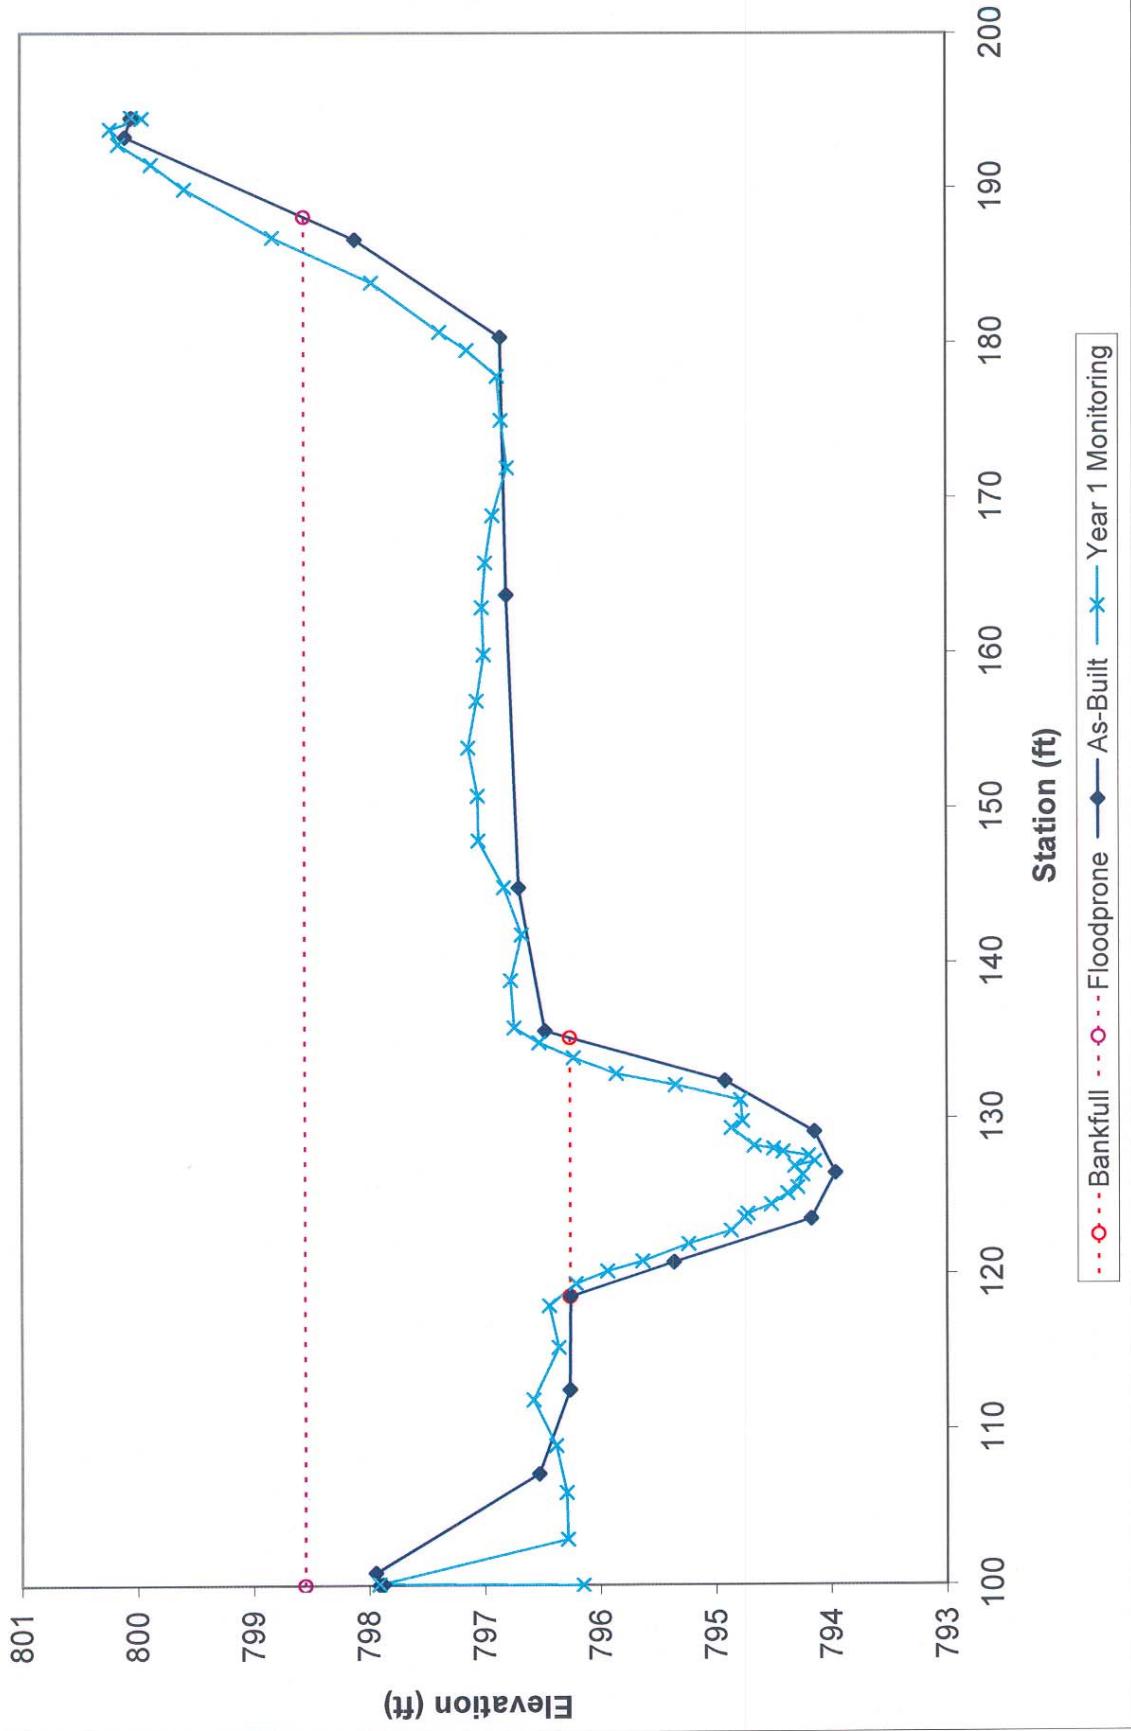
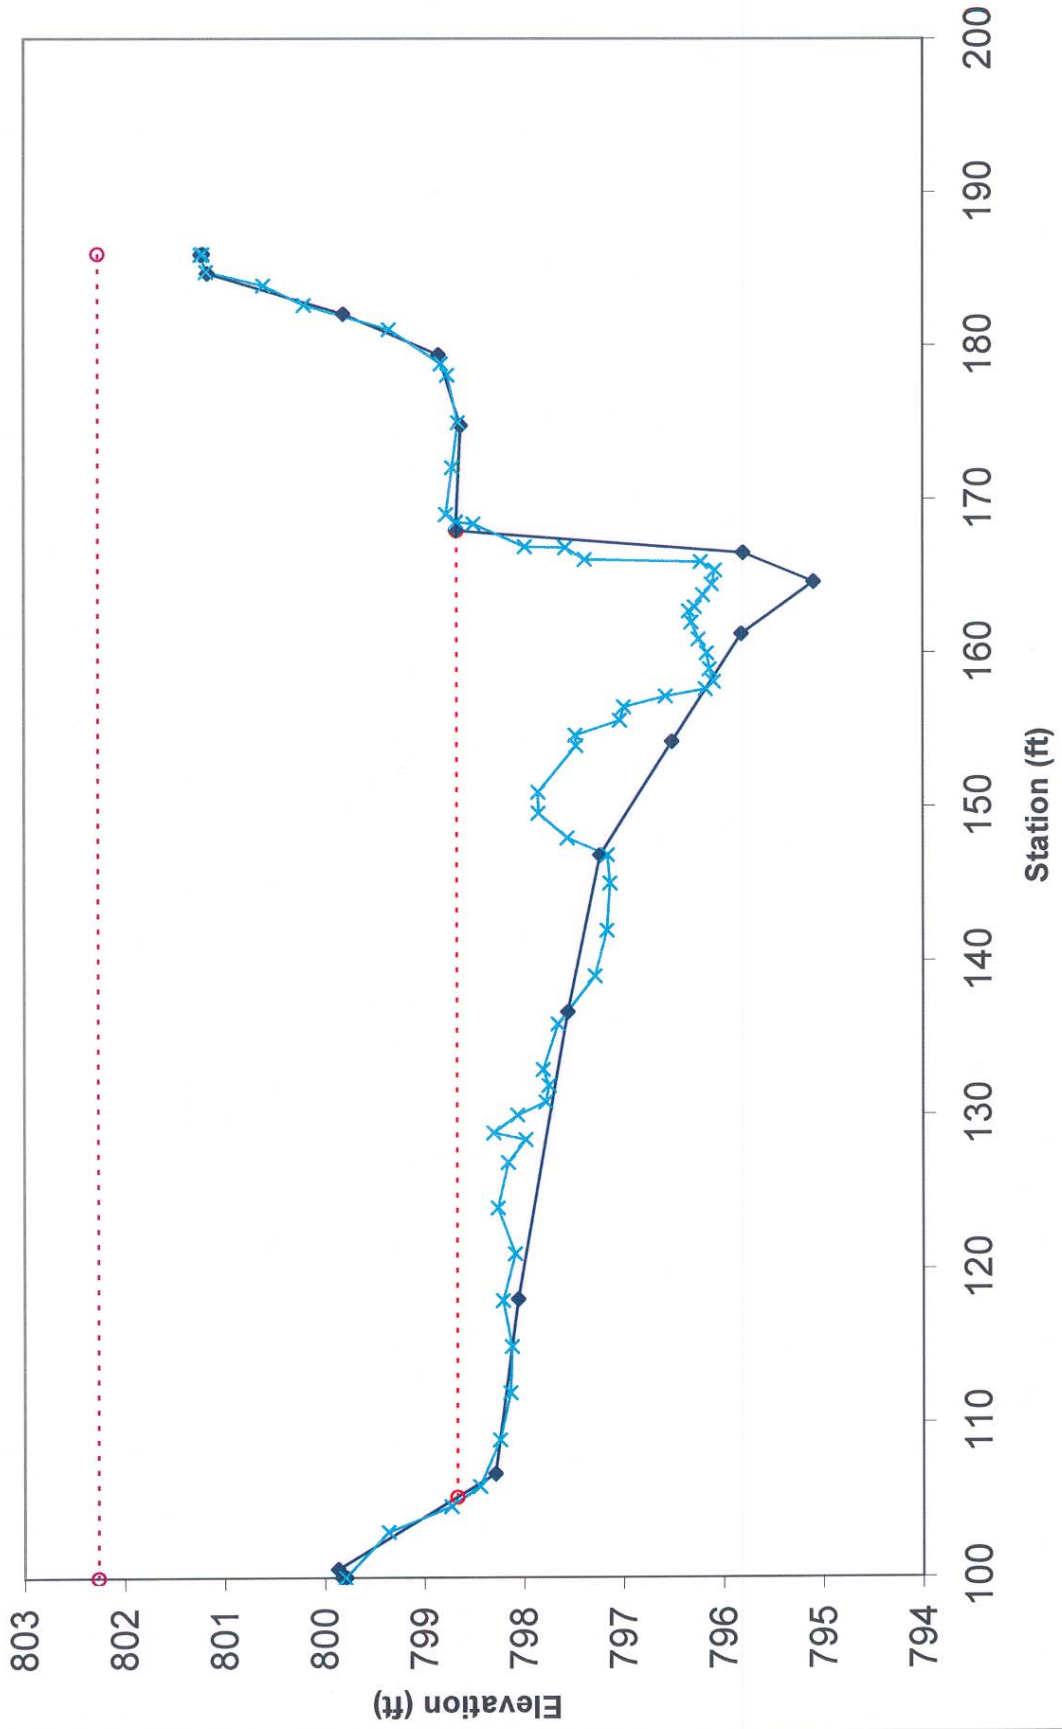
The pool cross-section (X2) is located within this upper section and is currently filling in (bankfull max depth has decreased from 3.6 feet to 2.6 feet) from the deposition. The riffle cross-section (X1) has narrowed (As-Built conditions measured 16.6 feet while 2004 results indicated 15.0 feet) and bankfull max depth has decreased slightly by 0.2 feet. Other than the excessive sedimentation, no signs of instability were noted throughout the reach and both cross sections are adjusting within normal parameters.
