Silas Creek Stream Restoration Project Year 1 Monitoring Report Winston Salem, North Carolina

North Carolina Department of Environment and Natural Resources
Ecosystem Enhancement Program

This is Year 1 of the 5-year monitoring plan for Silas Creek and Buena Vista Branch.

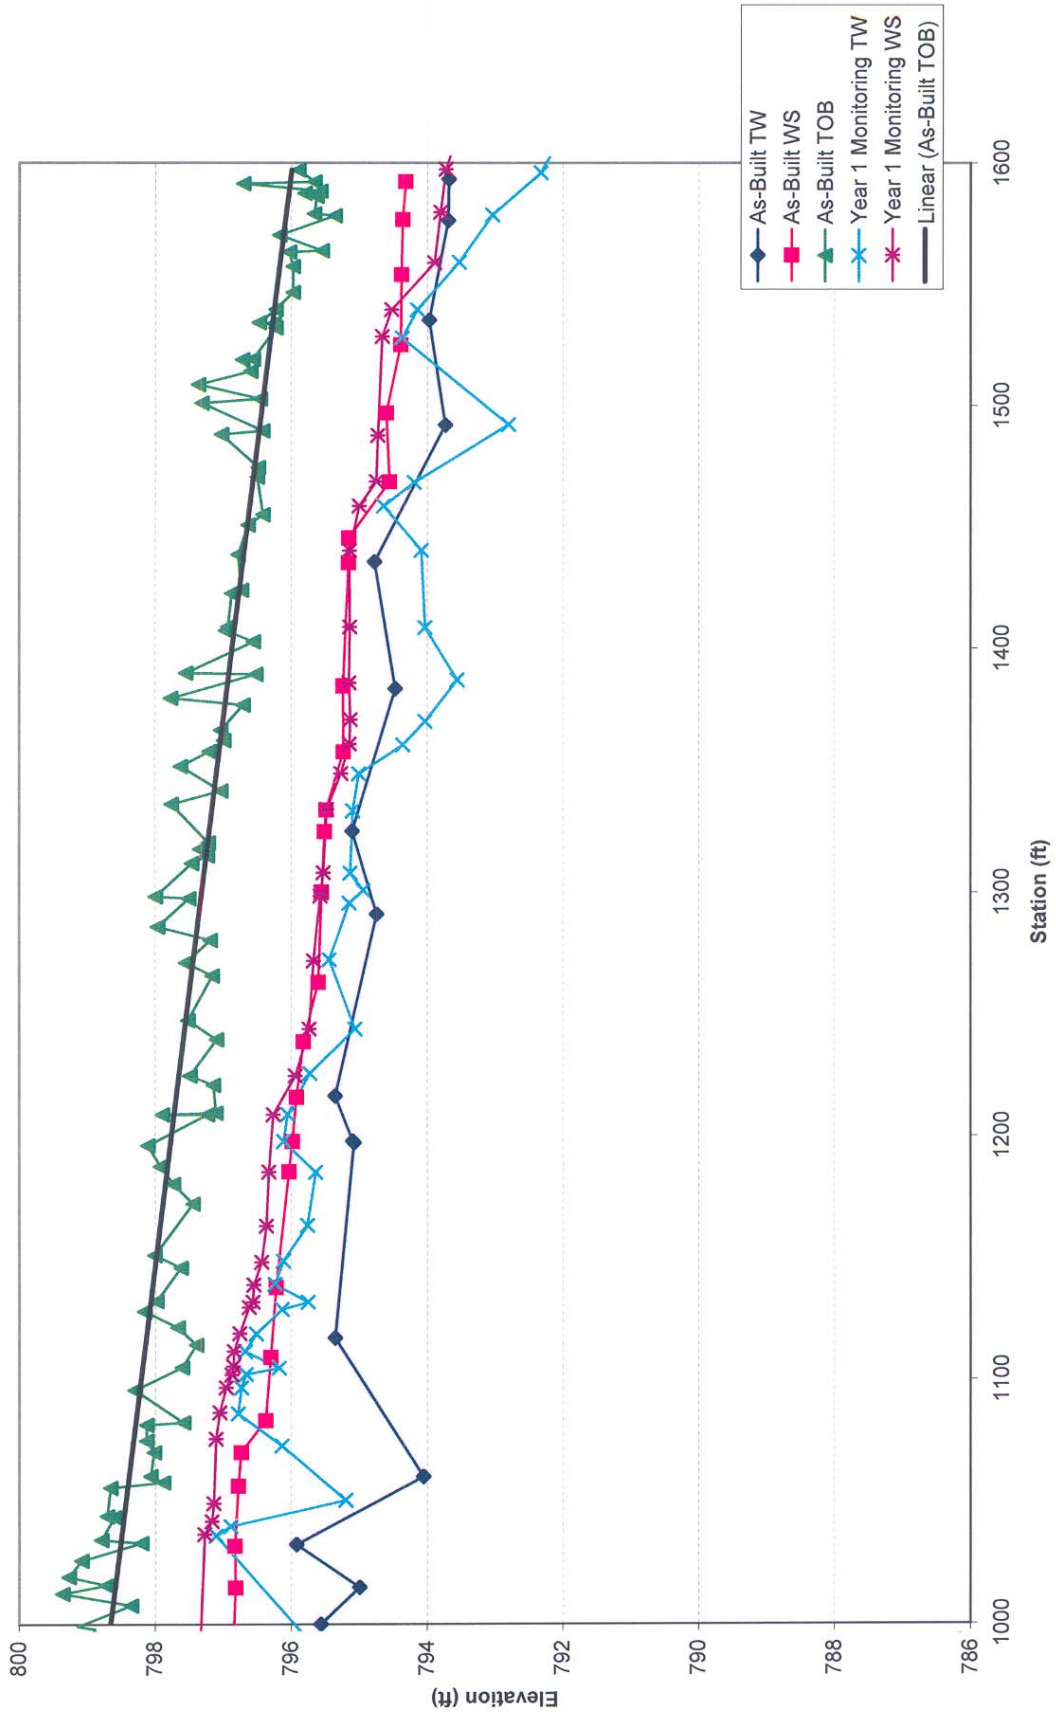
Buena Vista Profile

The stream profile depicts a higher streambed elevation and shallower pools from stations 10+00 to 13+00 as a result of the deposition occurring. Pools have deepened from stations 13+00 to 16+50. A large pool has formed at the end of the reach where the stream enters a culvert and goes through a series of step pools before entering Silas Creek. Riffle slopes have decreased on average. In some locations, the riffles have shortened and steepened and should be evaluated for stability in future monitoring events. These profile adjustments should be monitored in the future but do not indicate major instability at this time.

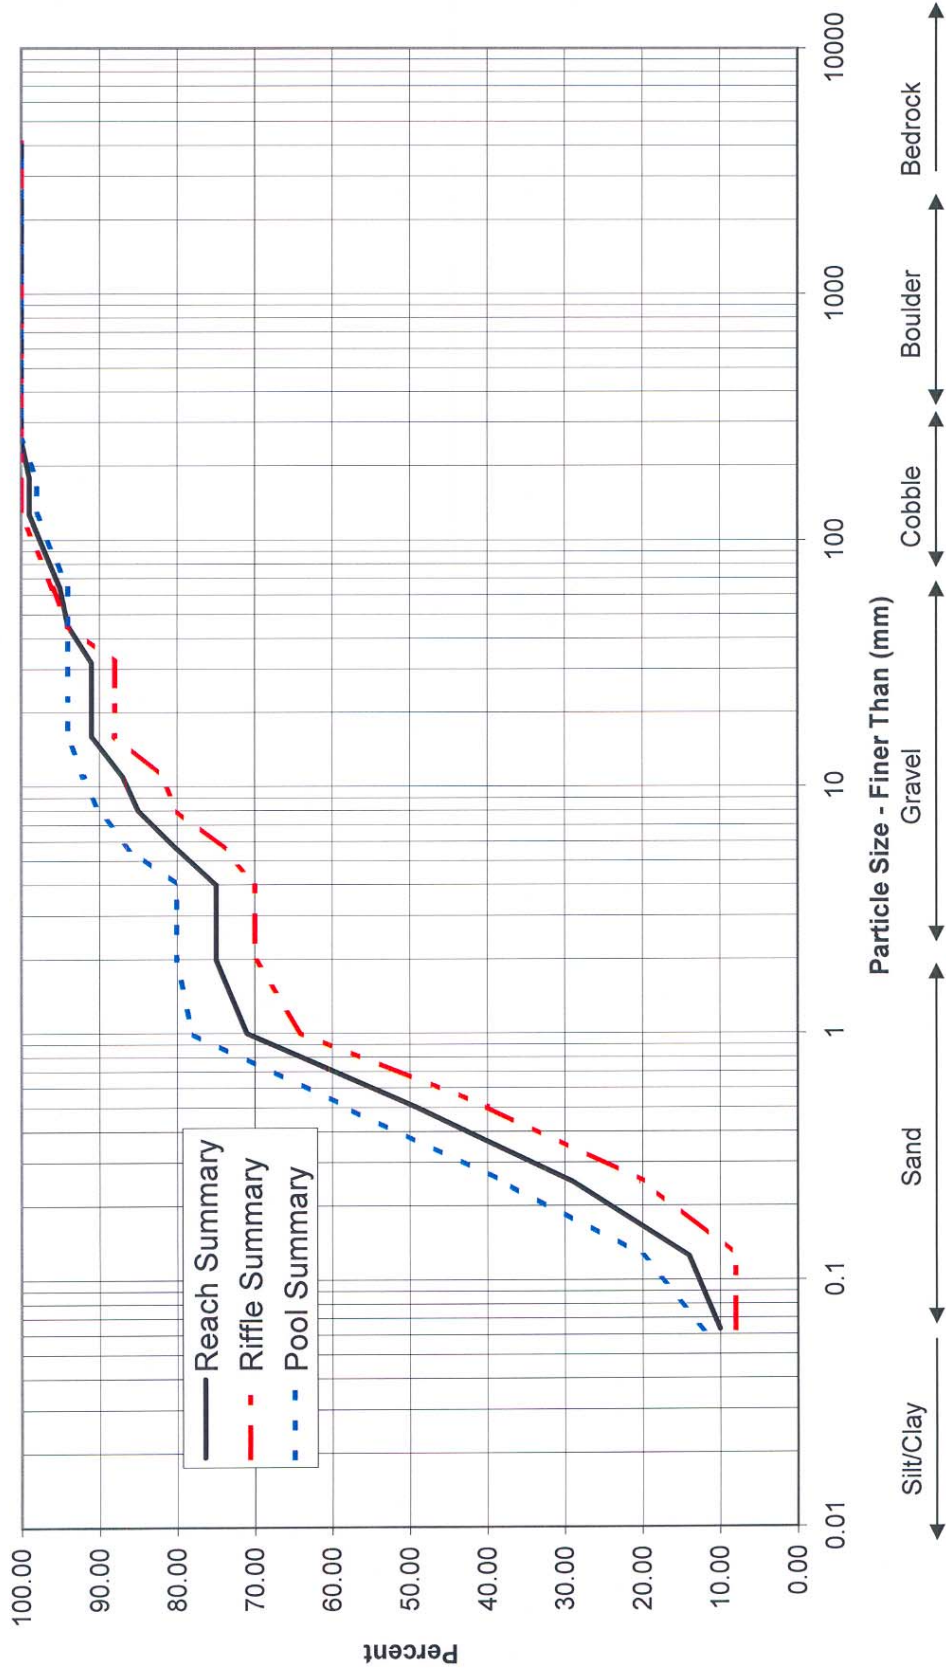
Year 1 Monitoring - Buena Vista Branch

Year 1 monitoring pebble counts indicate the sediment in riffles and pools are becoming finer. This condition may be a result of As-Built monitoring pebble counts including large, imported cobble in the riffle sections, but this condition is also a result of the large amounts of deposition occurring in the upstream section of stream.
