**Silas Creek Stream Restoration
2006 Monitoring Report
Monitoring Year Three**

Ecosystem Enhancement Program Project Number 00335

Submitted: January 19, 2007

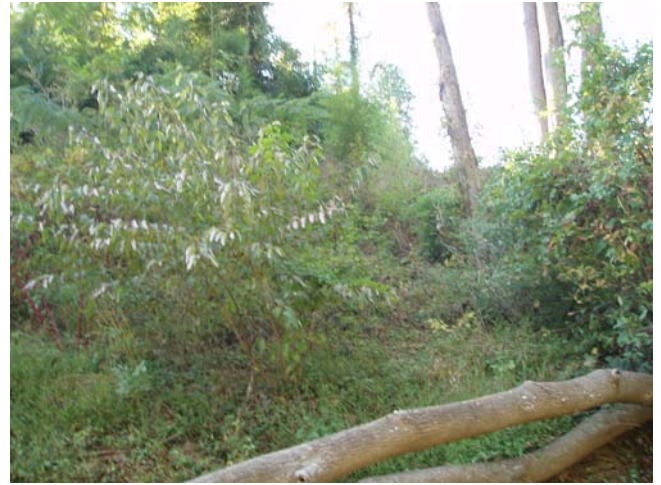
Table A6a. Vegetative Problem Areas – Reach 1			
Silas Creek			
EEP Project Number 00335			
Feature/Issue	Station #/Range	Probable Cause	Photo #
Invasive population	11+10	Privet, honeysuckle, rose	R1VPA1
Invasive population	11+50	Privet, honeysuckle, rose	R1VPA1
Invasive population	13+00	Bamboo	R1VPA3
Invasive population	13+00	Mimosa	R1VPA4
Bare Slope	13+80	Herbaceous veg. not established	R1VPA5
Bare Slope	13+90	Herbaceous veg. not established	R1VPA5
Bare Slope	17+10	Herbaceous veg. not established	R1VPA5
Invasive population	19+50	Japanese knotweed, honeysuckle	R1VPA8

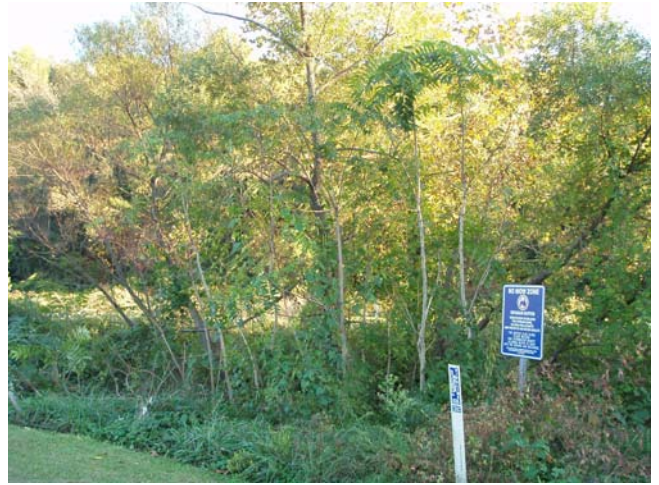
Table A6b. Vegetative Problem Areas – Reach 2			
Silas Creek			
EEP Project Number 00335			
Feature/Issue	Station #/Range	Probable Cause	Photo #
Invasive population	21+90	Mimosa	R2VPA1
Invasive population	22+00	Mimosa	R2VPA1
Invasive population	36+00	Mimosa	R2VPA1
Invasive population	26+50	Mimosa	R2VPA3

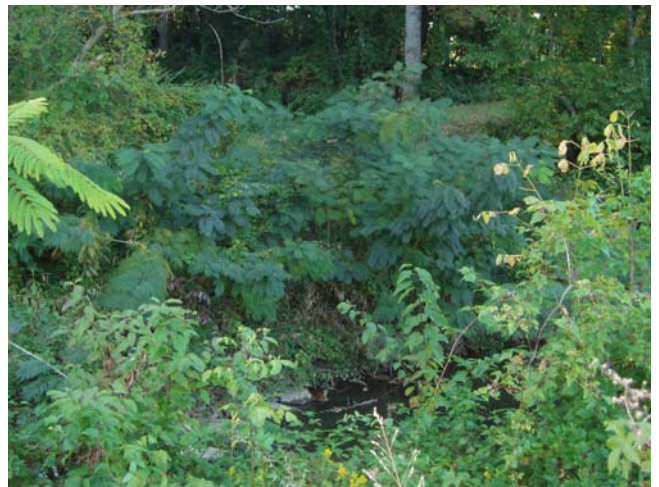
Table A6c. Vegetative Problem Areas – Reach 3			
Silas Creek			
EEP Project Number 00335			
Feature/Issue	Station #/Range	Probable Cause	Photo #
Invasive population	33+80 to 34+80	Kudzu	R3VPA1
Invasive population	39+00	Mimosa	R3VPA2
Invasive population	39+00	Rose	R3VPA2
Invasive population	33+90 to 34+80	Mimosa	R3VPA2
Bare bank	42+50	No woody vegetation	R3VPA5
Bare bank	44+00	No woody vegetation	R3VPA6

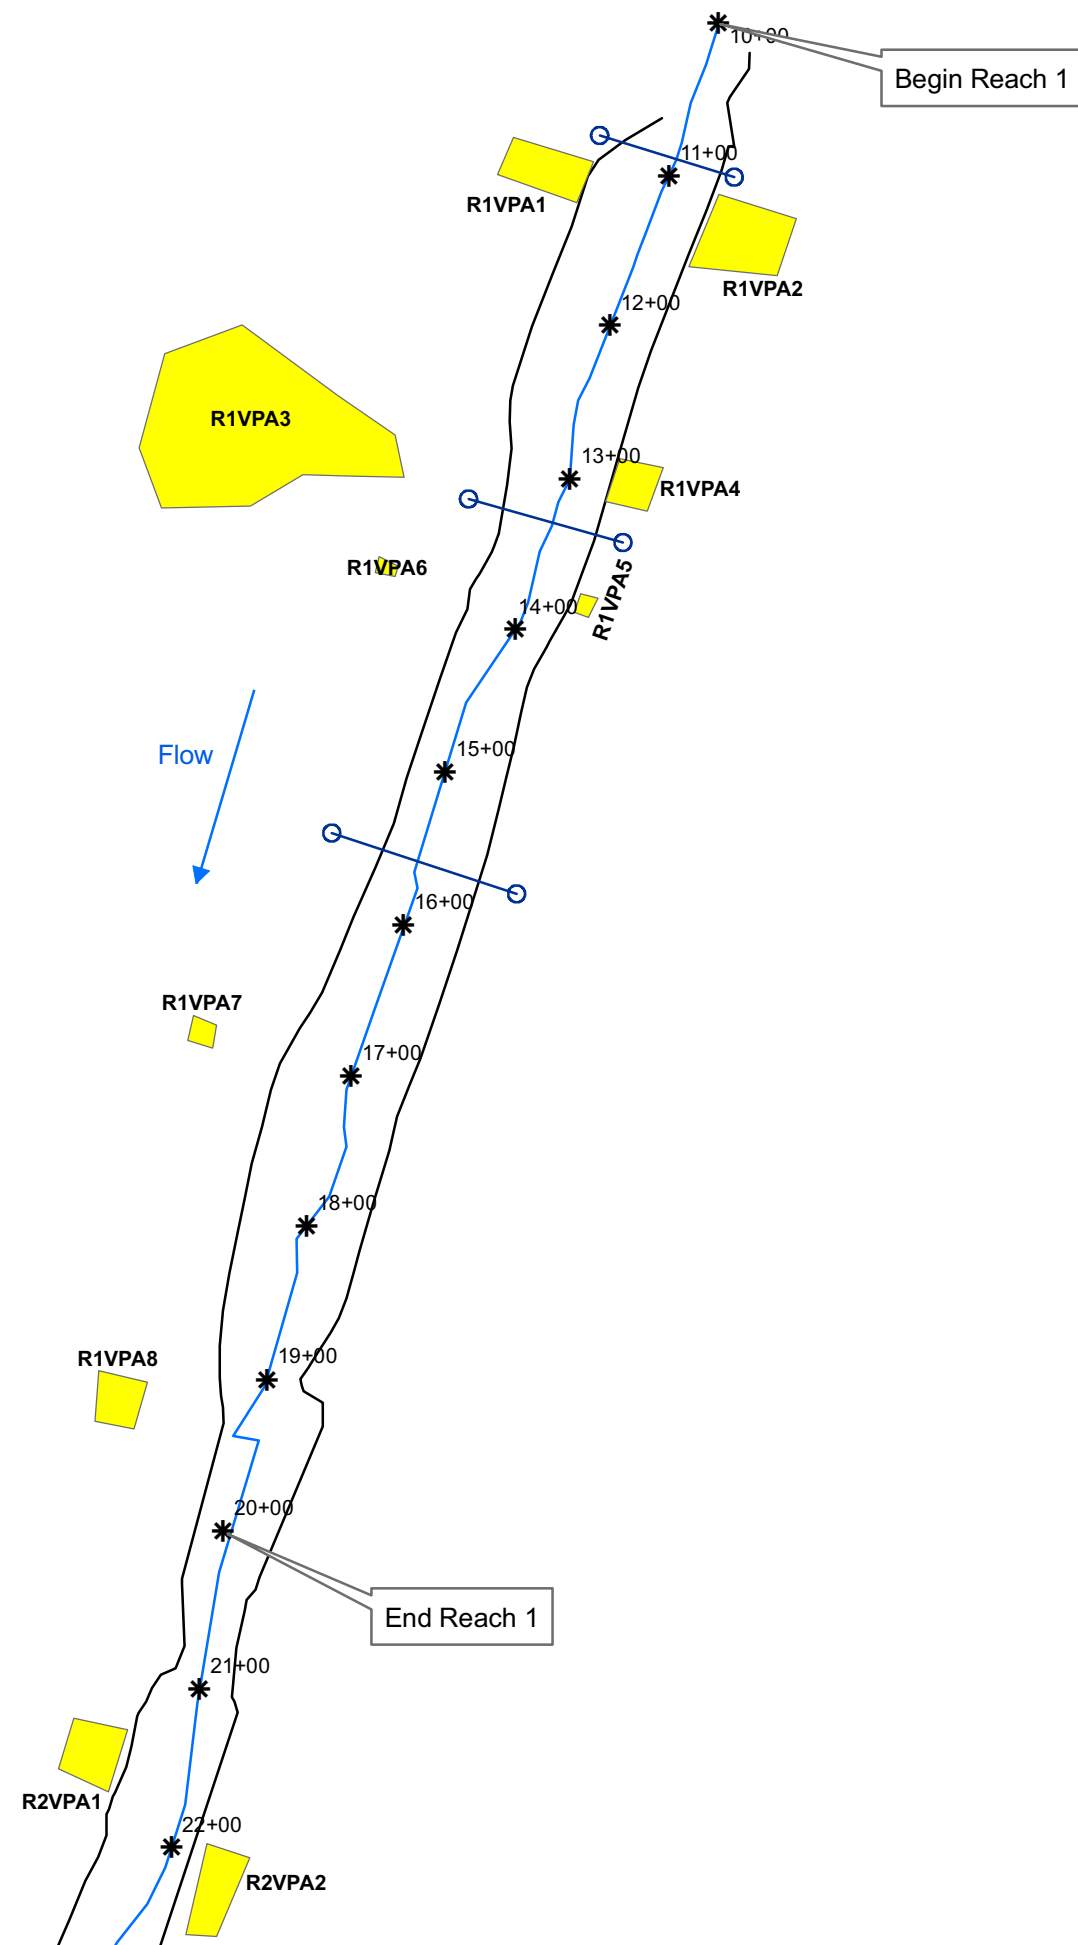
**Figure 3a.Reach 1
 Vegetative
 Problem Areas
 Plan View**

Vegetative Problem Areas – Reach 1			
Silas Creek 00335			
2006 Problem #	Feature/Issue	Station #/Range	Probable Cause
R1VPA1	Invasive population	11+10	Privet, honeysuckle, rose
R1VPA1	Invasive population	11+50	Privet, honeysuckle, rose
R1VPA3	Invasive population	13+00	Bamboo
R1VPA4	Invasive population	13+00	Mimosa
R1VPA5	Bare Slope	13+80	Herbaceous veg. not established
R1VPA5	Bare Slope	13+90	Herbaceous veg. not established
R1VPA5	Bare Slope	17+10	Herbaceous veg. not established
R1VPA8	Invasive population	19+50	Japanese knotweed, honeysuckle

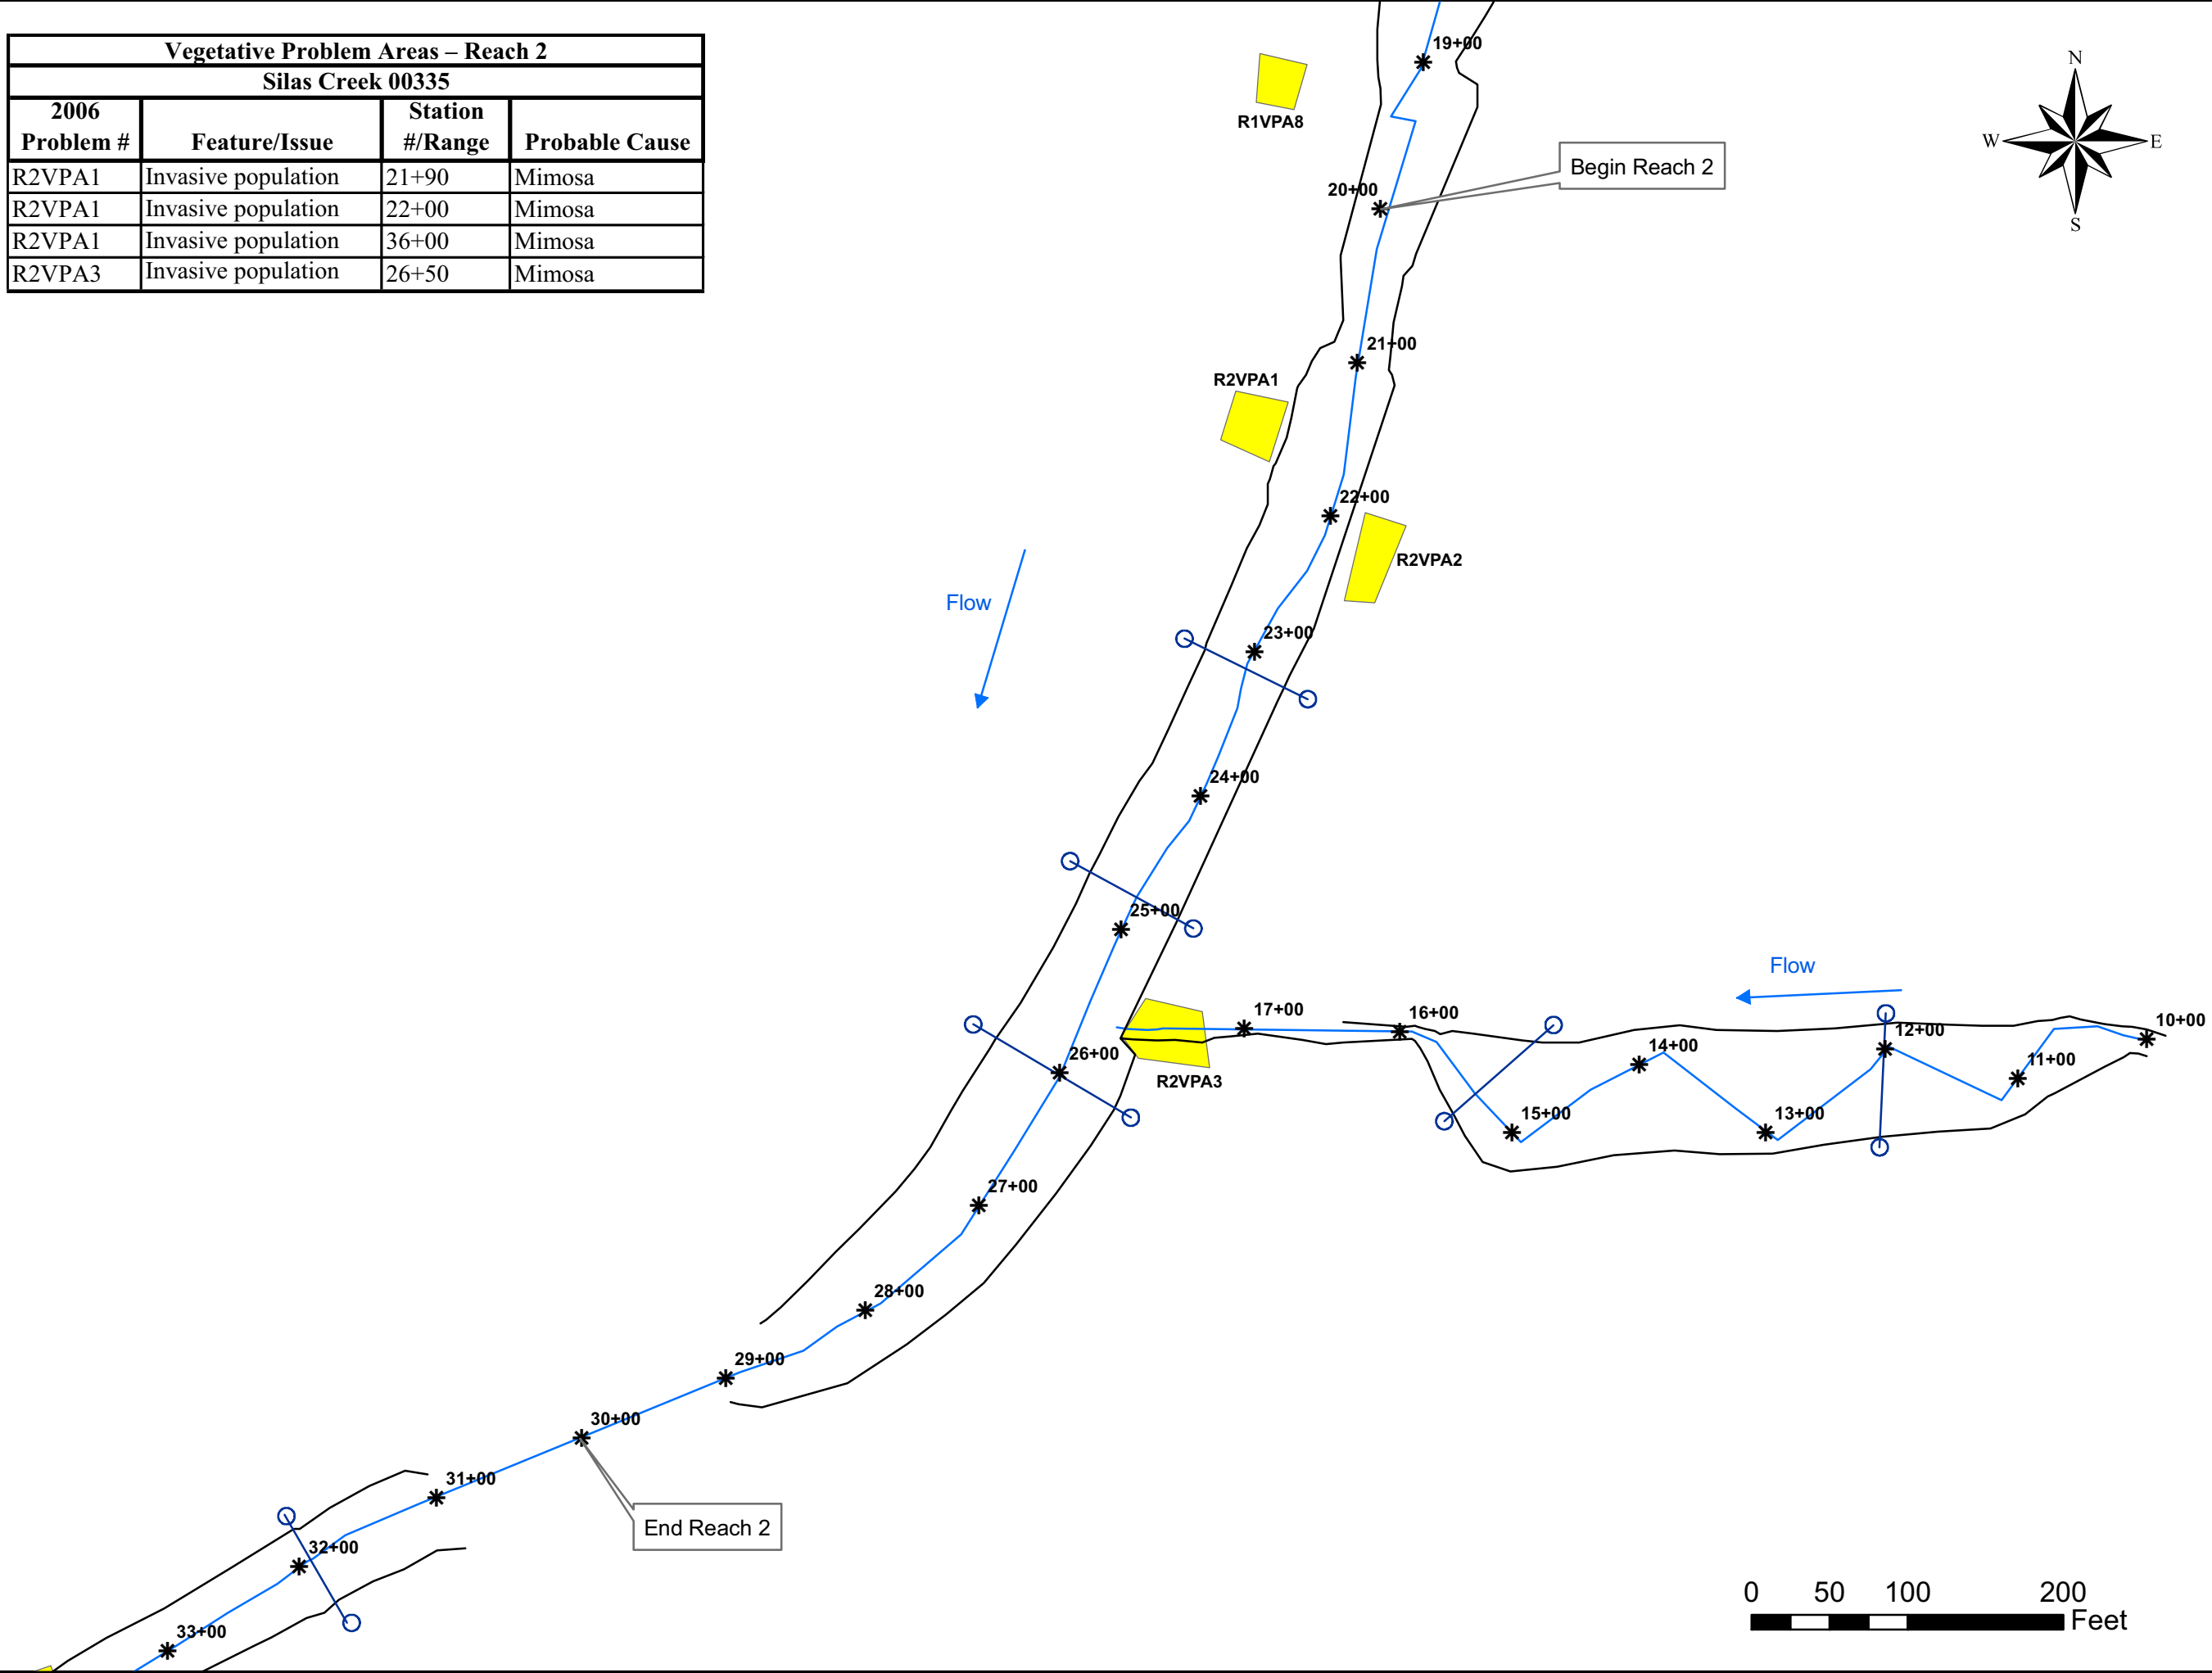
Vegetative Problem Areas – Reach 2			
Silas Creek 00335			
2006 Problem #	Feature/Issue	Station #/Range	Probable Cause
R2VPA1	Invasive population	21+90	Mimosa
R2VPA1	Invasive population	22+00	Mimosa
R2VPA1	Invasive population	36+00	Mimosa
R2VPA3	Invasive population	26+50	Mimosa

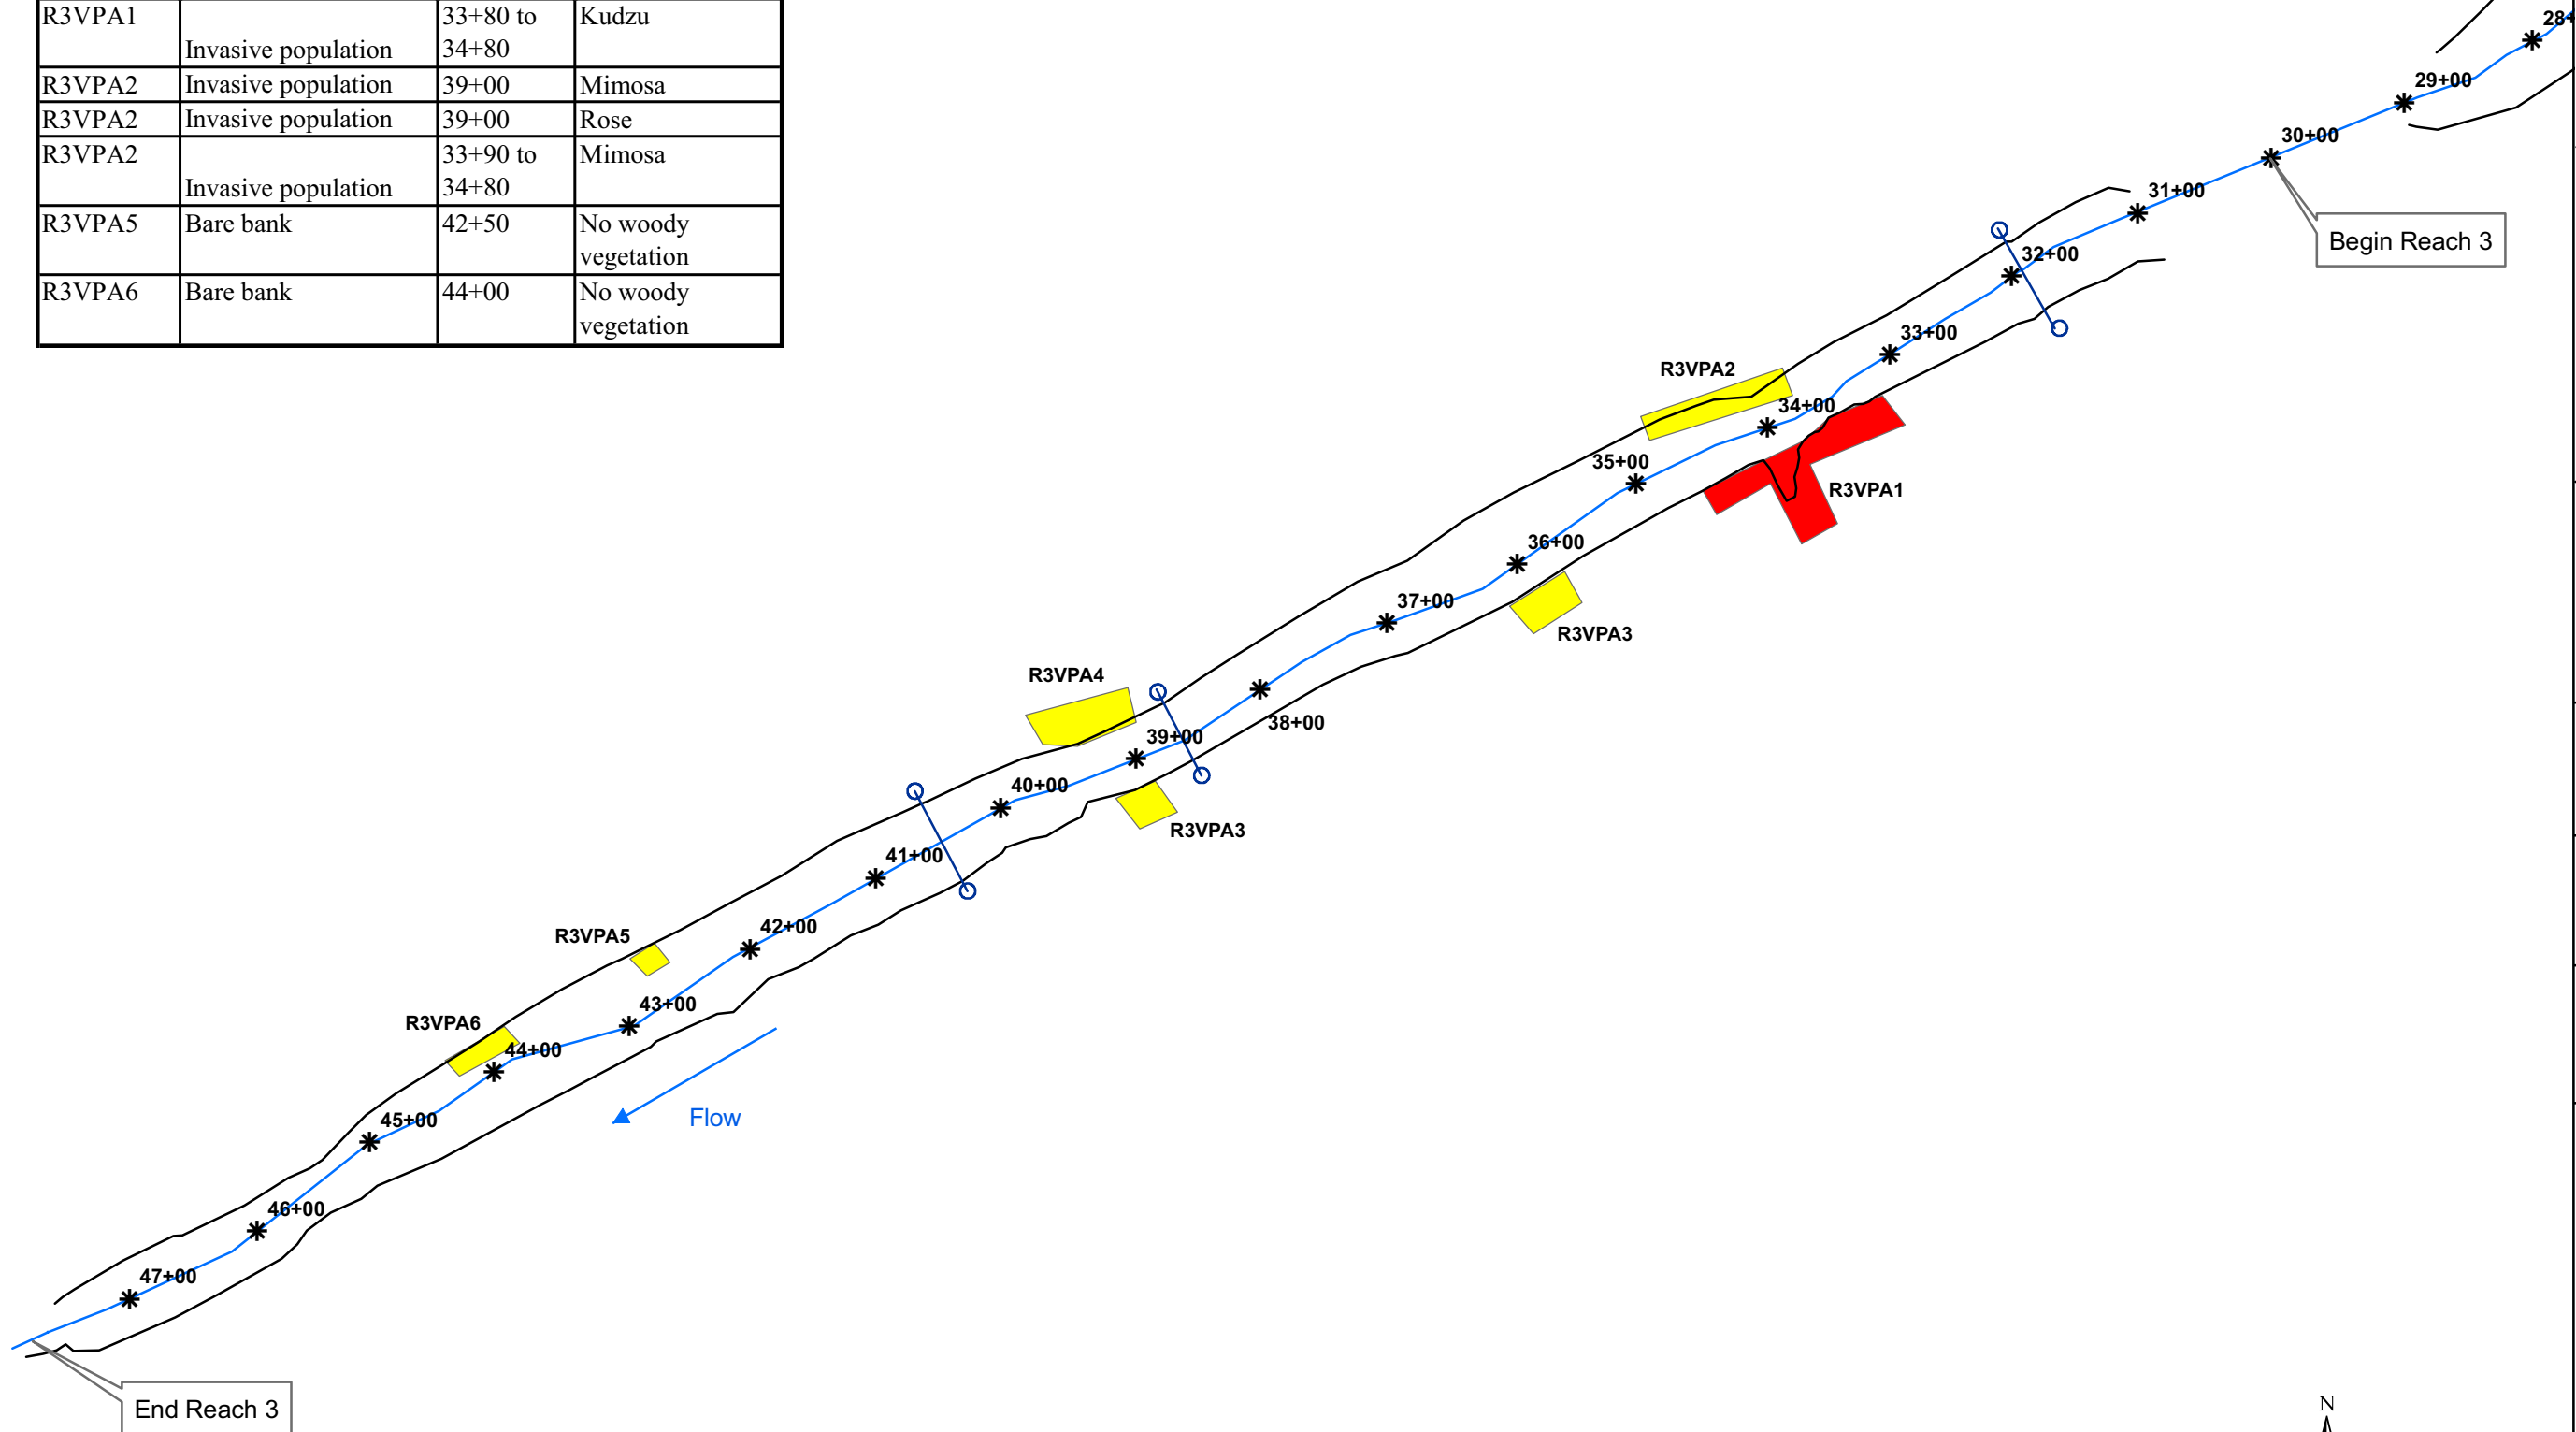
**Figure 3c. Reach 3
Vegetative
Problem Areas
Plan View**

2006 Problem #	Feature/Issue	Station #/Range	Probable Cause
R3VPA1	Invasive population	33+80 to 34+80	Kudzu
R3VPA2	Invasive population	39+00	Mimosa
R3VPA2	Invasive population	39+00	Rose
R3VPA2	Invasive population	33+90 to 34+80	Mimosa
R3VPA5	Bare bank	42+50	No woody vegetation
R3VPA6	Bare bank	44+00	No woody vegetation

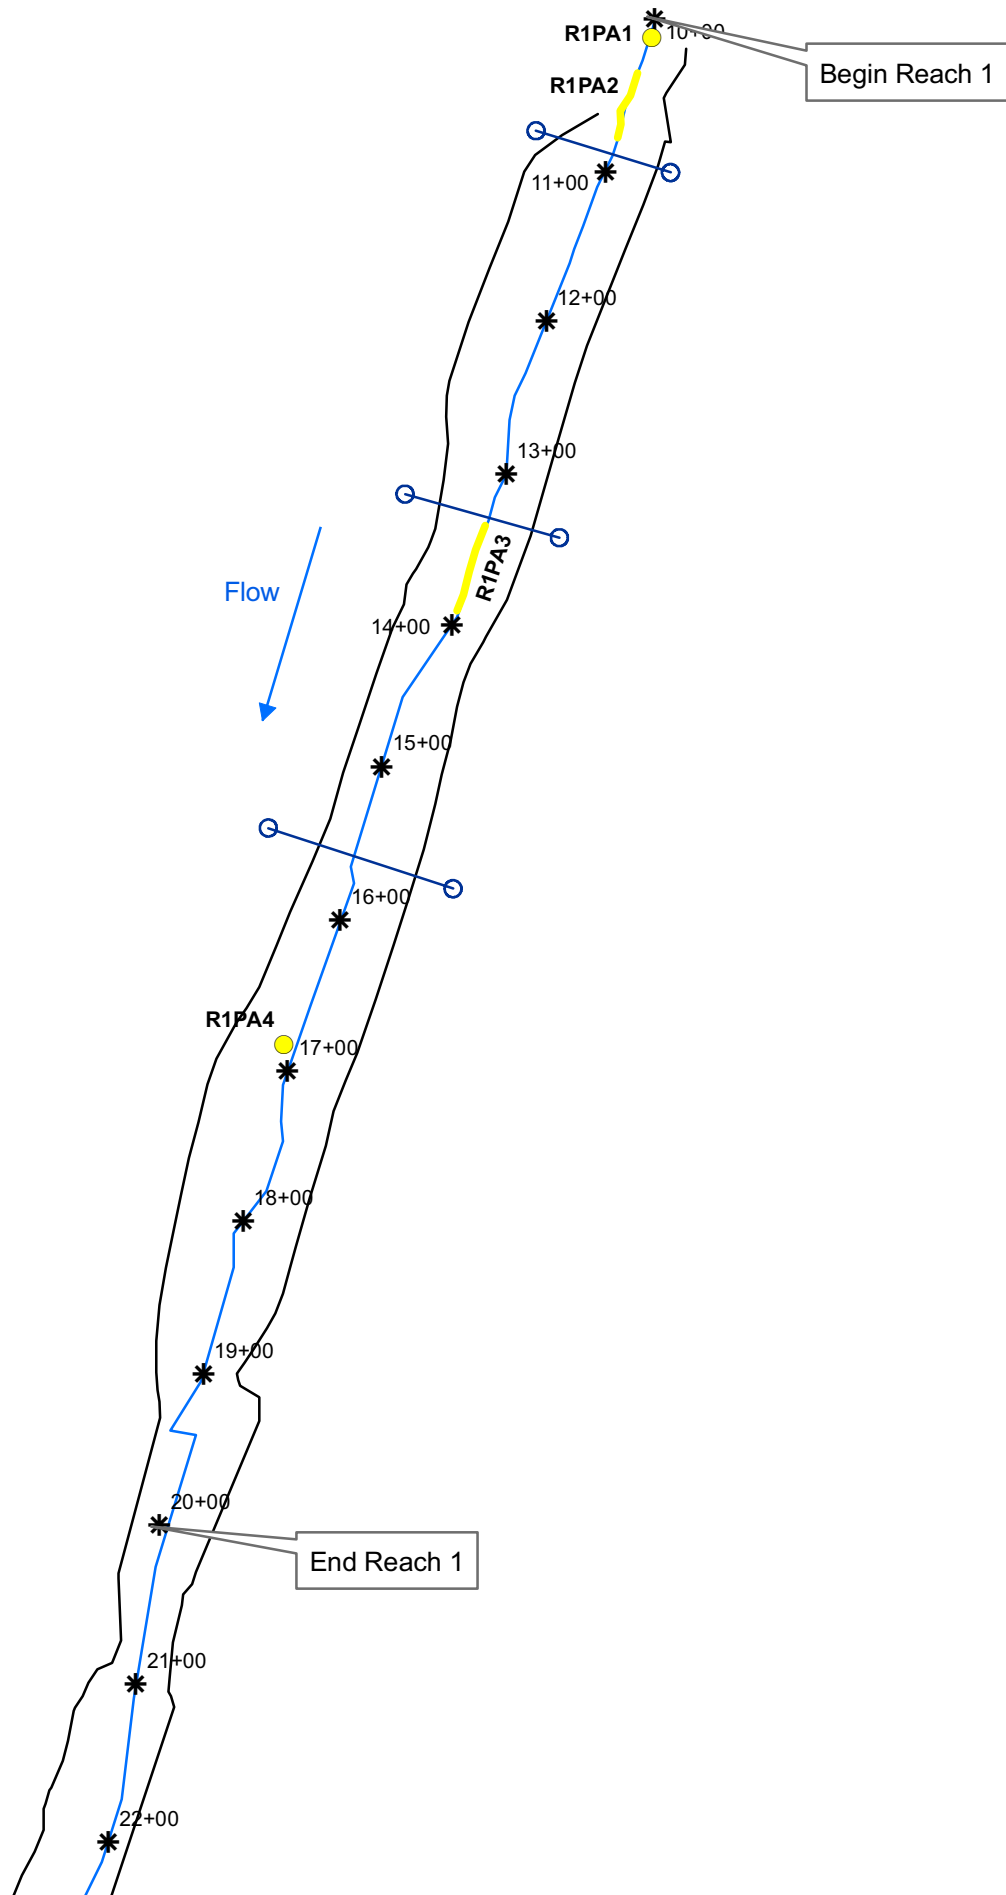
Stream Problem Areas – Reach 1			
Silas Creek 00335			
2006 Problem #	Feature Issue	Station	Suspected Cause
R1PA1	Vane failure	10+00	Improper design and/or construction
R1PA2	Bar formation/Aggradation	10+70	Inability to transport sediment
R1PA3	Bar formation/Aggradation	14+10	Inability to transport sediment
R1PA4	Vane failure	16+80	Improper design and/or construction

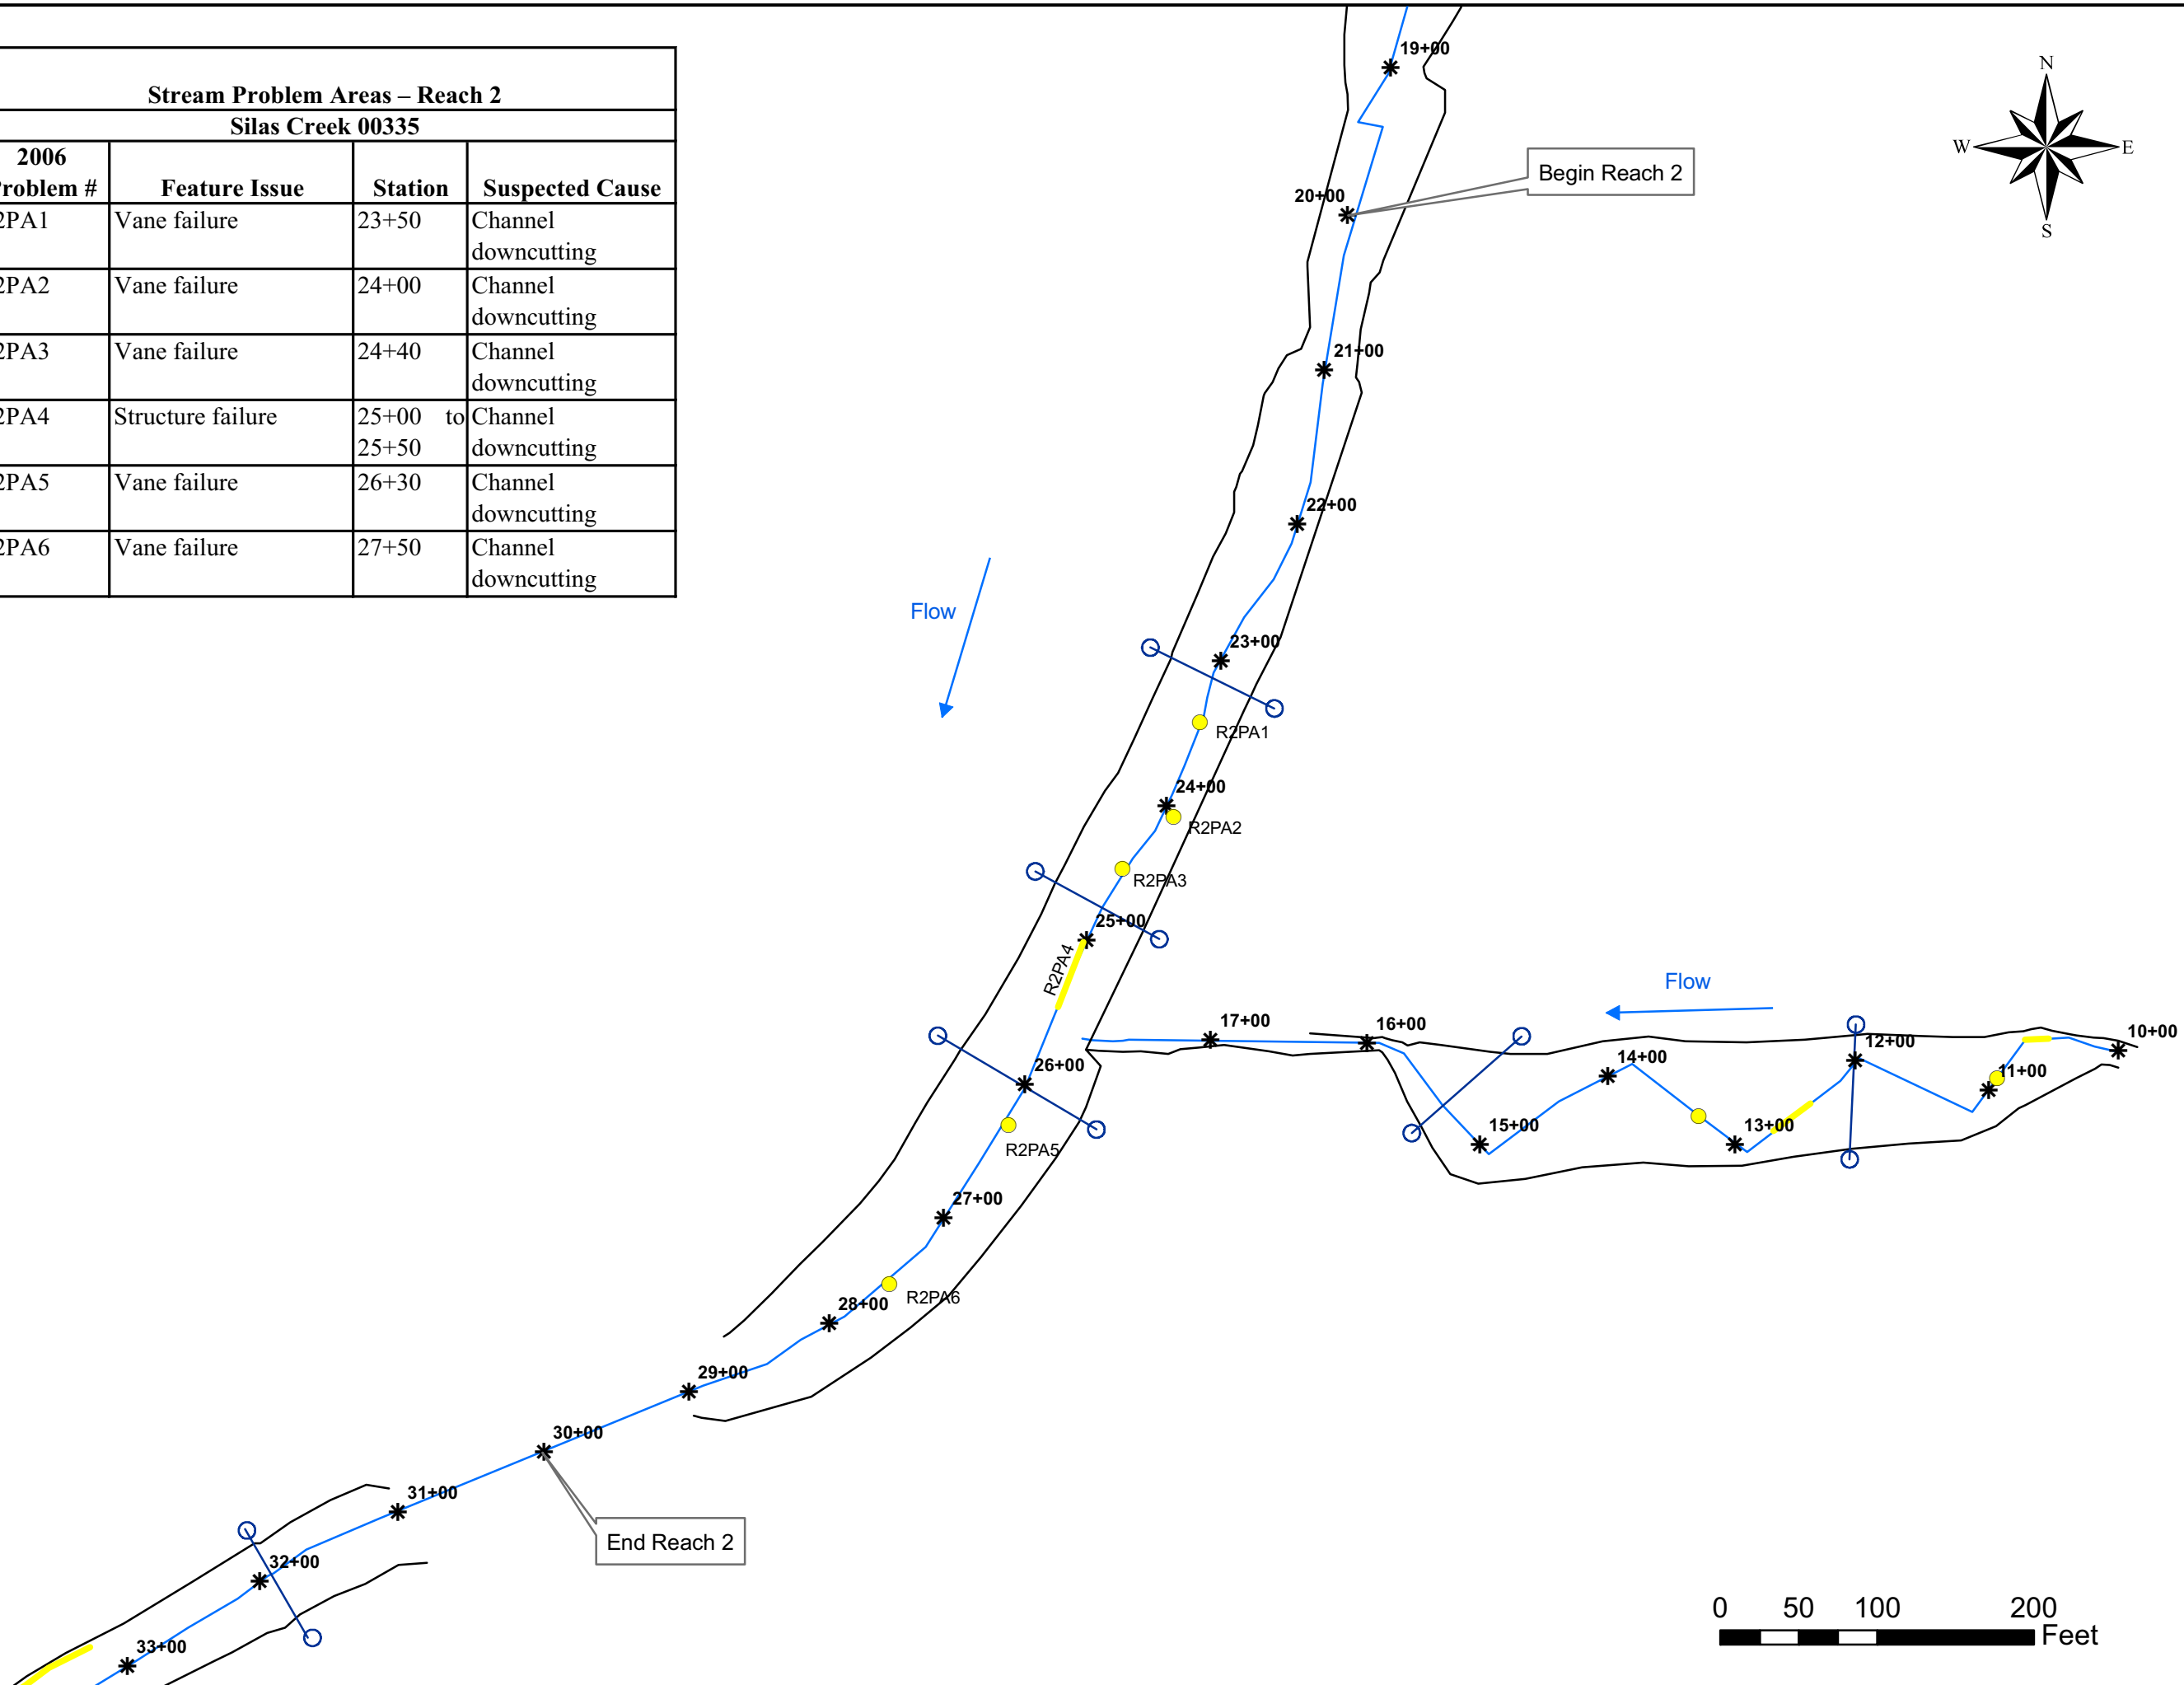
Stream Problem Areas – Reach 2			
Silas Creek 00335			
2006 Problem #	Feature Issue	Station	Suspected Cause
R2PA1	Vane failure	23+50	Channel downcutting
R2PA2	Vane failure	24+00	Channel downcutting
R2PA3	Vane failure	24+40	Channel downcutting
R2PA4	Structure failure	25+00 to 25+50	Channel downcutting
R2PA5	Vane failure	26+30	Channel downcutting
R2PA6	Vane failure	27+50	Channel downcutting

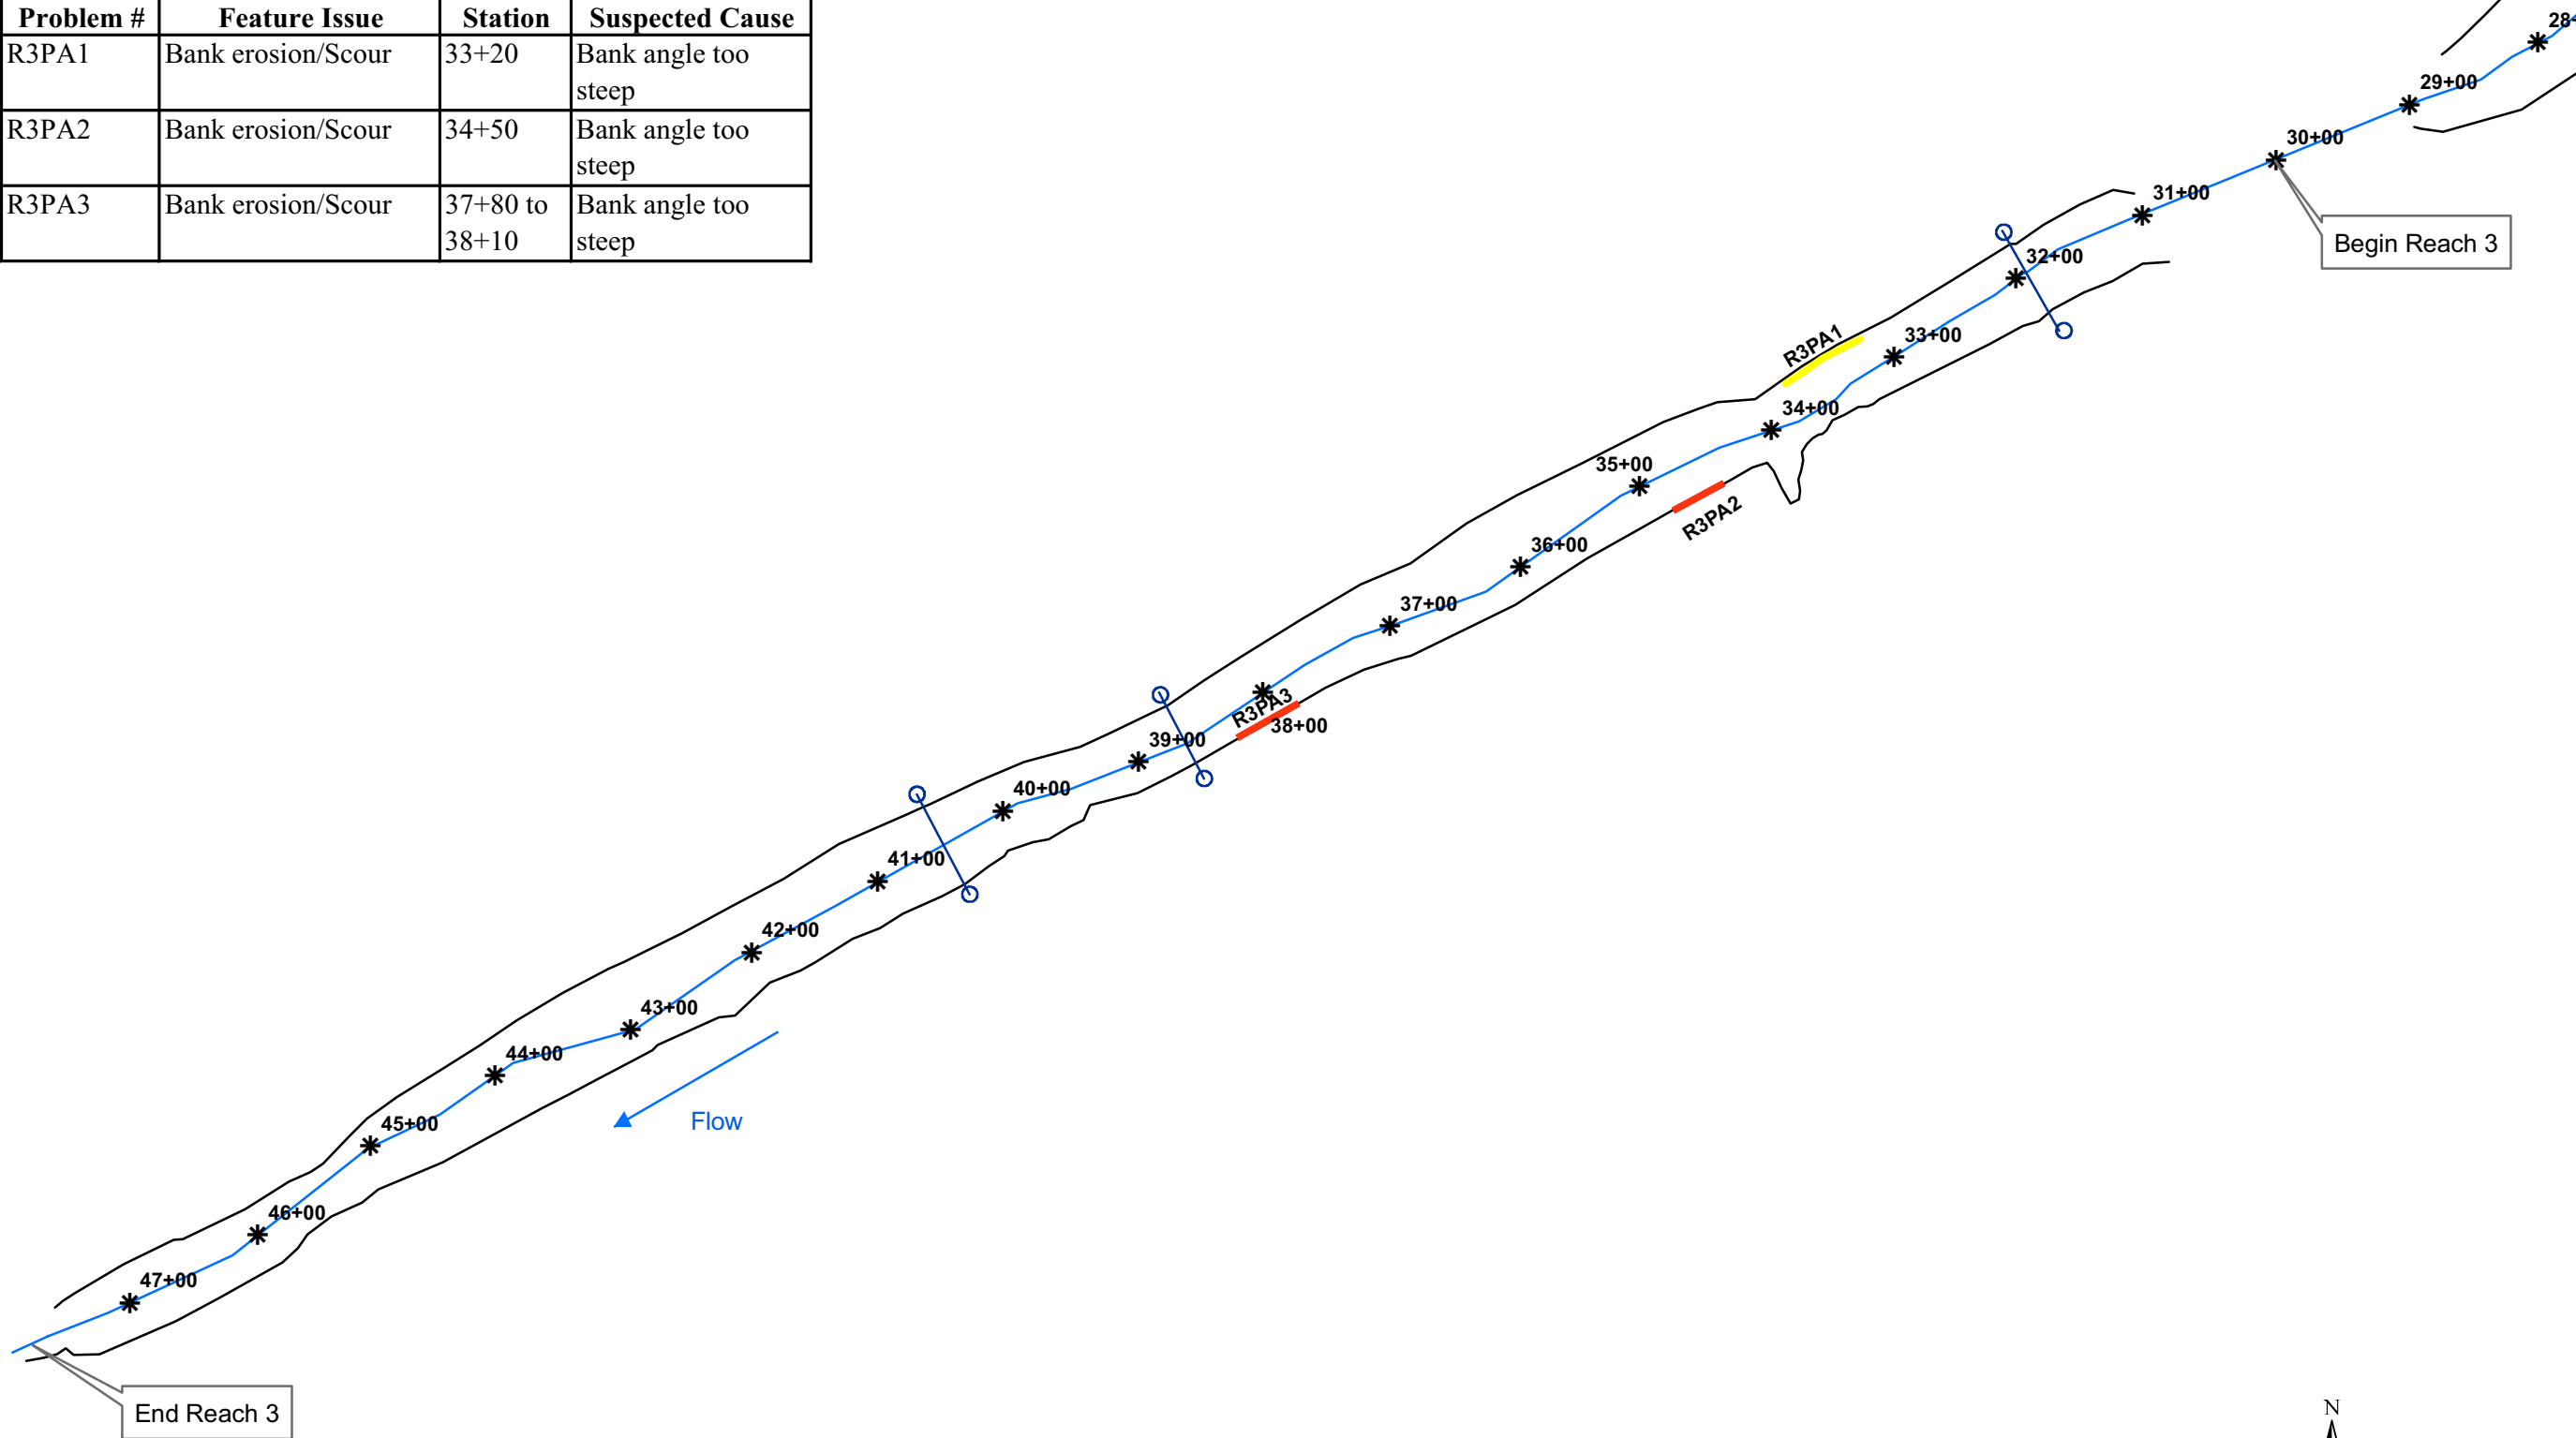
Figure 4c.
 Reach 3 Stream
 Problem Areas
 Plan View

2006 Problem #	Feature Issue	Station	Suspected Cause
R3PA1	Bank erosion/Scour	33+20	Bank angle too steep
R3PA2	Bank erosion/Scour	34+50	Bank angle too steep
R3PA3	Bank erosion/Scour	37+80 to 38+10	Bank angle too steep
