**Silas Creek Stream Restoration
2006 Monitoring Report
Monitoring Year Three**

Ecosystem Enhancement Program Project Number 00335

Submitted: January 19, 2007

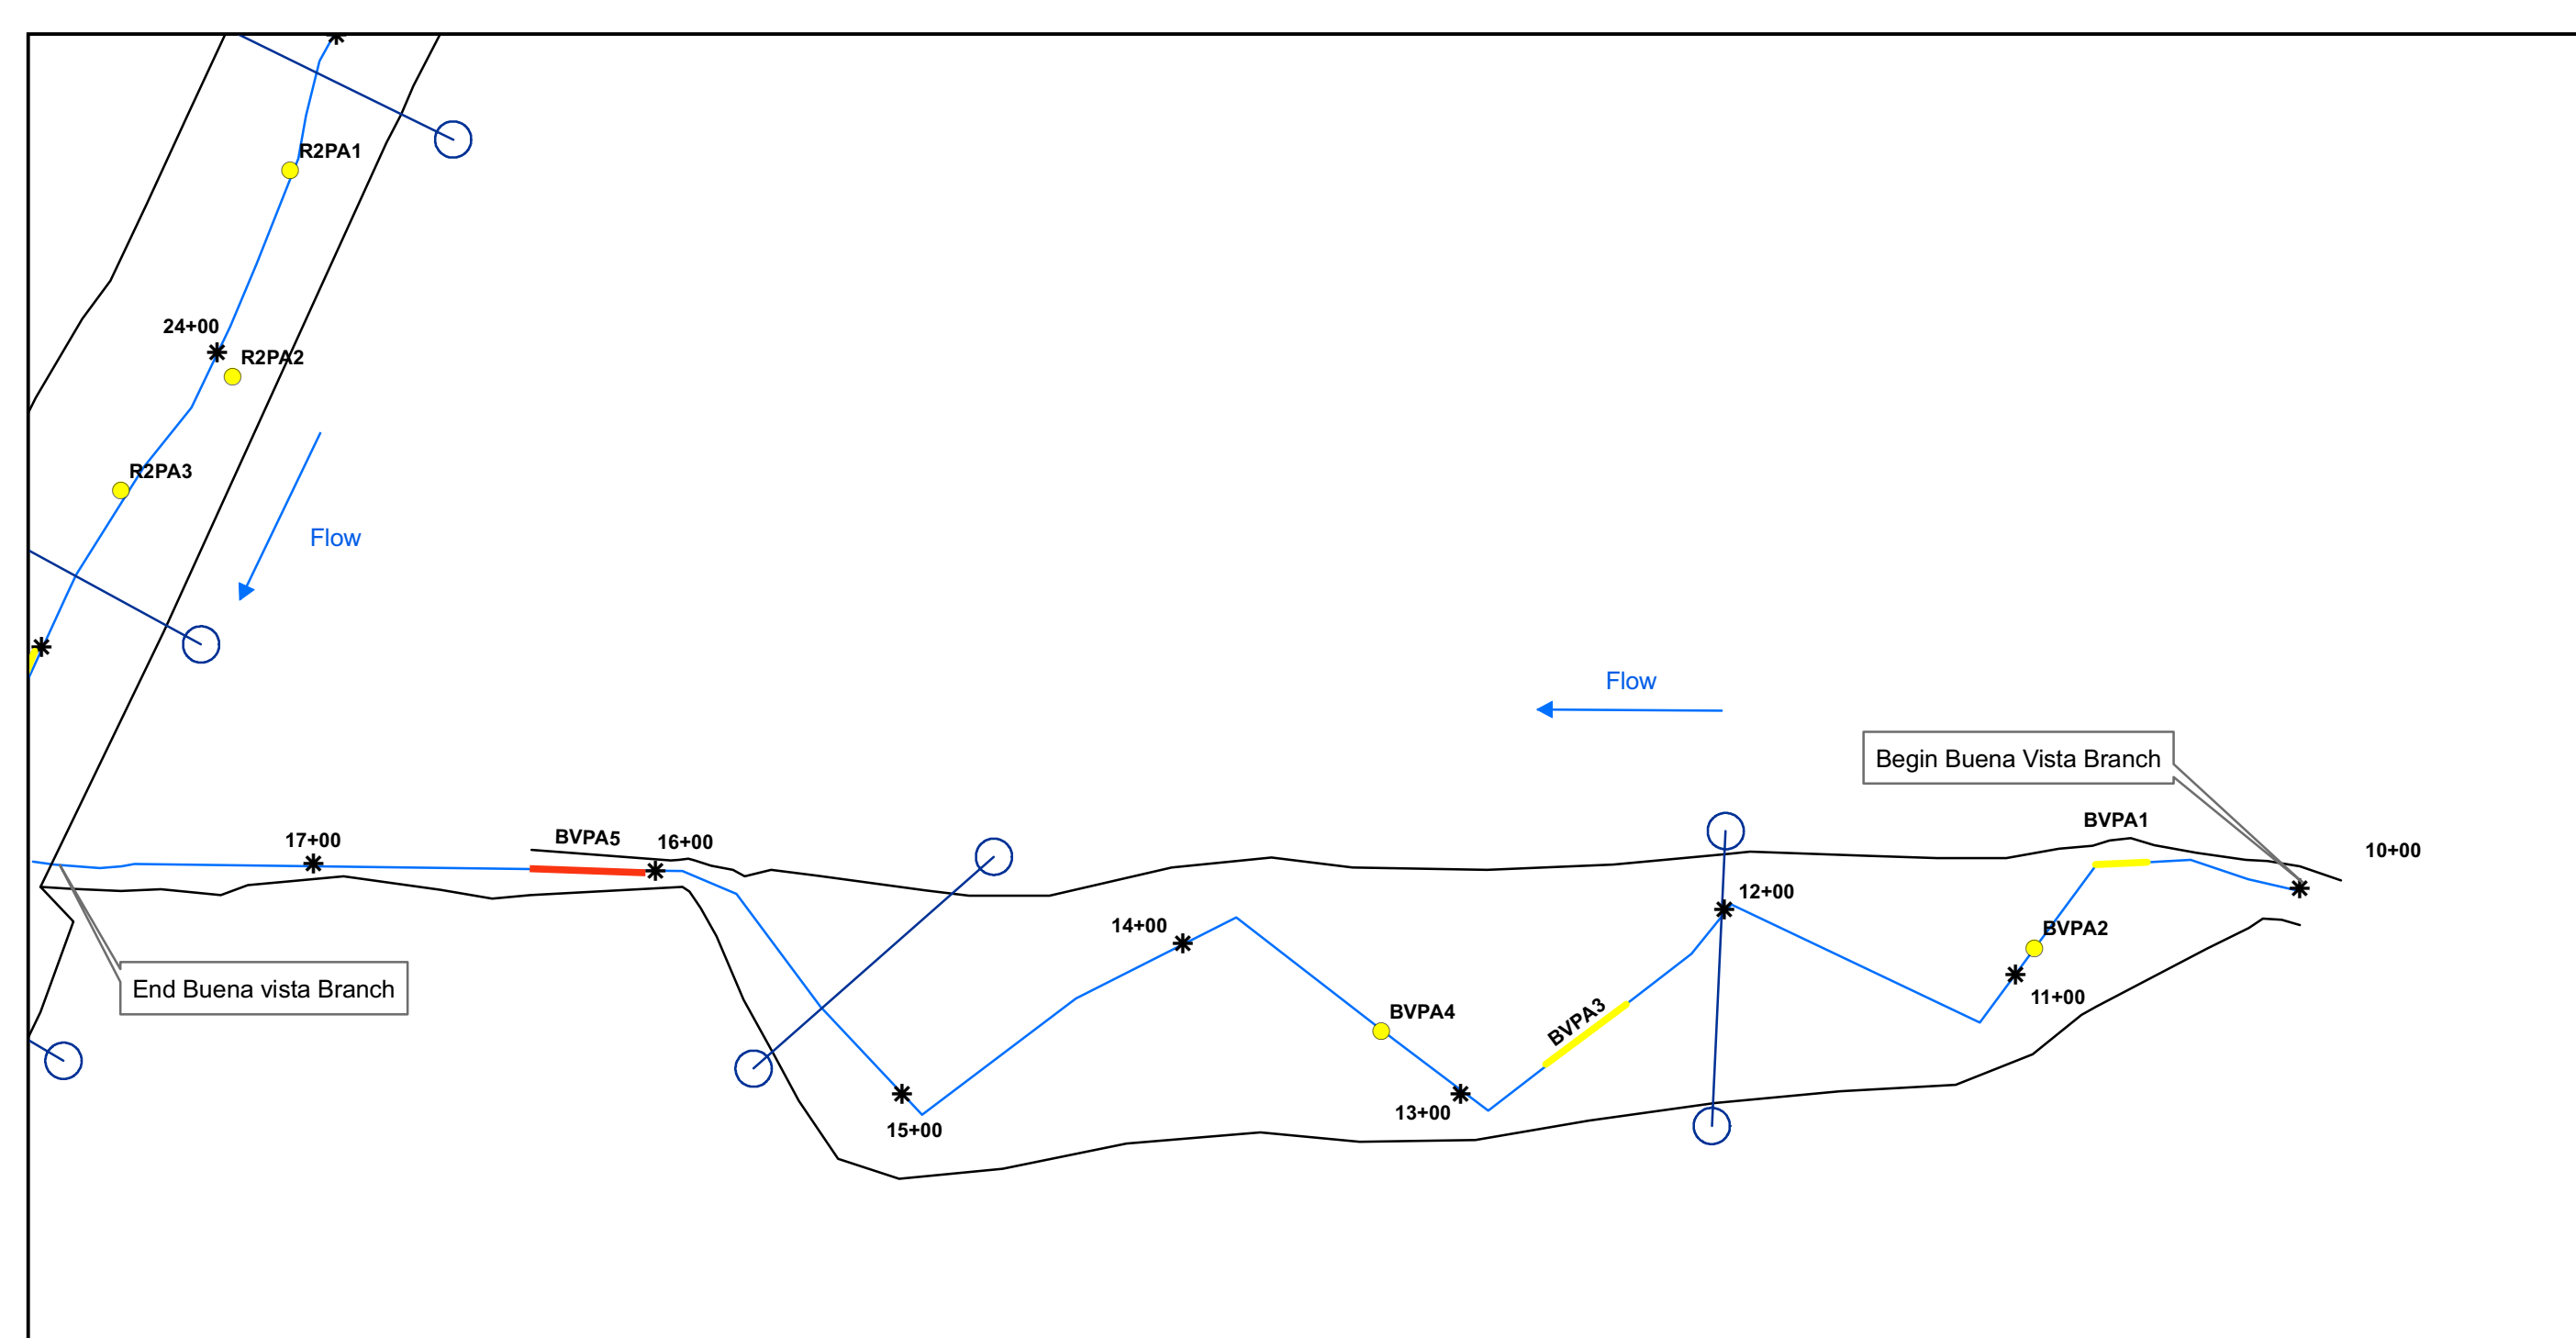
Figure 4d.
 Buena Vista Branch
 Stream Problem Areas
 Plan View

Stream Problem Areas – Buena Vista Branch			
Silas Creek 00335			
2006 Problem #	Feature Issue	Station	Suspected Cause
BVPA1	Bar formation/Aggradation	10+50	Inability to transport sediment
BVPA2	Bar formation/Aggradation	10+90	Inability to transport sediment
BVPA3	Bank erosion	12+50	Bank angle too steep
BVPA4	Bar formation/Aggradation	13+30	Inability to transport sediment
BVPA5	Bar formation/Aggradation	16+00	Inability to transport sediment

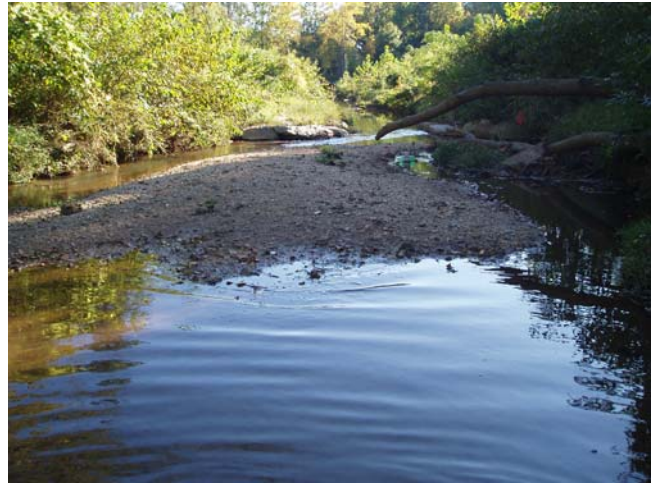
Table B1a. Stream Problem Areas – Reach 1			
Silas Creek			
EEP Project Number 00335			
Feature Issue	Station	Suspected Cause	Photo #
Vane failure	10+00	Improper design and/or construction	R1PA1
Bar formation/Aggradation	10+70	Inability to transport sediment	R1PA2
Bar formation/Aggradation	14+10	Inability to transport sediment	R1PA3
Vane failure	16+80	Improper design and/or construction	R1PA4

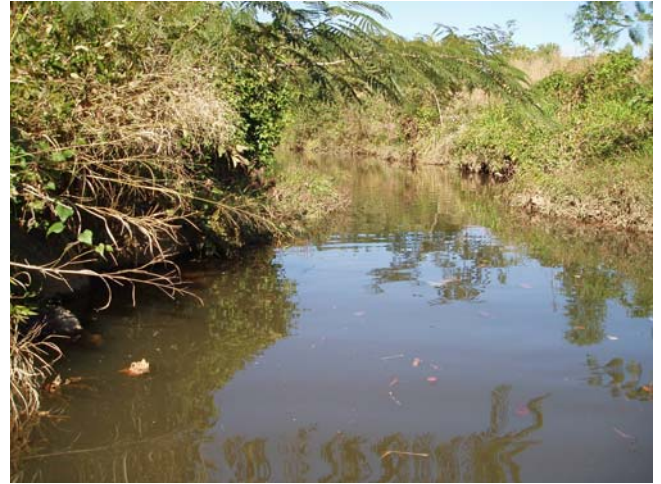
Table B1b. Stream Problem Areas – Reach 2			
Silas Creek			
EEP Project Number 00335			
Feature Issue	Station	Suspected Cause	Photo #
Vane failure	23+50	Channel downcutting	R2PA1
Vane failure	24+00	Channel downcutting	R2PA2
Vane failure	24+40	Channel downcutting	R2PA3
Structure failure	25+00 to 25+50	Channel downcutting	R2PA4
Vane failure	26+30	Channel downcutting	R2PA5
Vane failure	27+50	Channel downcutting	R2PA6
