**Silas Creek Stream Restoration  
Final 2007 Monitoring Report  
Monitoring Year Four**

**Ecosystem Enhancement Program Project Number 00335**

Submitted: February 22, 2008

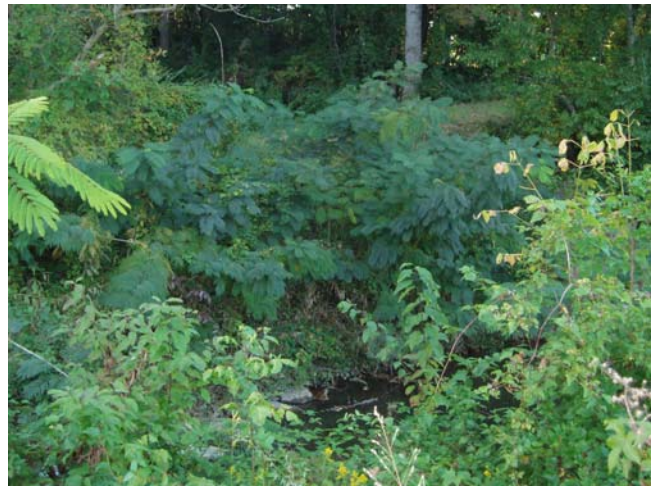
<b>Table A6c. Vegetative Problem Areas – Reach 3</b>			
<b>Silas Creek</b>			
<b>EEP Project Number 00335</b>			
<b>Feature/Issue</b>	<b>Station #/Range</b>	<b>Probable Cause</b>	<b>Photo #</b>
Invasive population	33+80 to 34+80	Kudzu	R3VPA1
Invasive population	39+00	Mimosa	R3VPA2, R2VPA3, R2VPA4
Invasive population	39+00	Rose	R3VPA2, R2VPA3, R2VPA4
Invasive population	33+90 to 34+80	Mimosa	R3VPA2, R2VPA3, R2VPA4
Bare bank	42+50	No woody vegetation	R3VPA5
Bare bank	44+00	No woody vegetation	R3VPA6

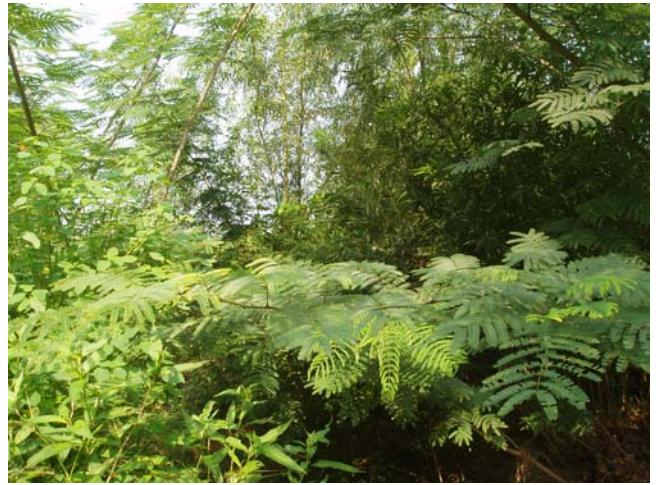
Planted vegetation along Buena Vista Branch has been impacted by the presence of beavers. Two large beaver dams were observed along the reach (one damaged, the other in-tact). Beaver activity is evident along the entirety of the upstream portions of Buena Vista Branch. Beaver are taking both planted and non-planted stems for use in dams.

<b>Table A6d. Vegetative Problem Areas – Buena Vista Branch Silas Creek EEP Project Number 00335</b>			
<b>Feature/Issue</b>	<b>Station #/Range</b>	<b>Probable Cause</b>	<b>Photo #</b>
Vegetation mortality	10+00 to 15+00	Beaver	BVNVPA1
Invasive population	10+00 to 18+00	Mimosa	BVNVPA2

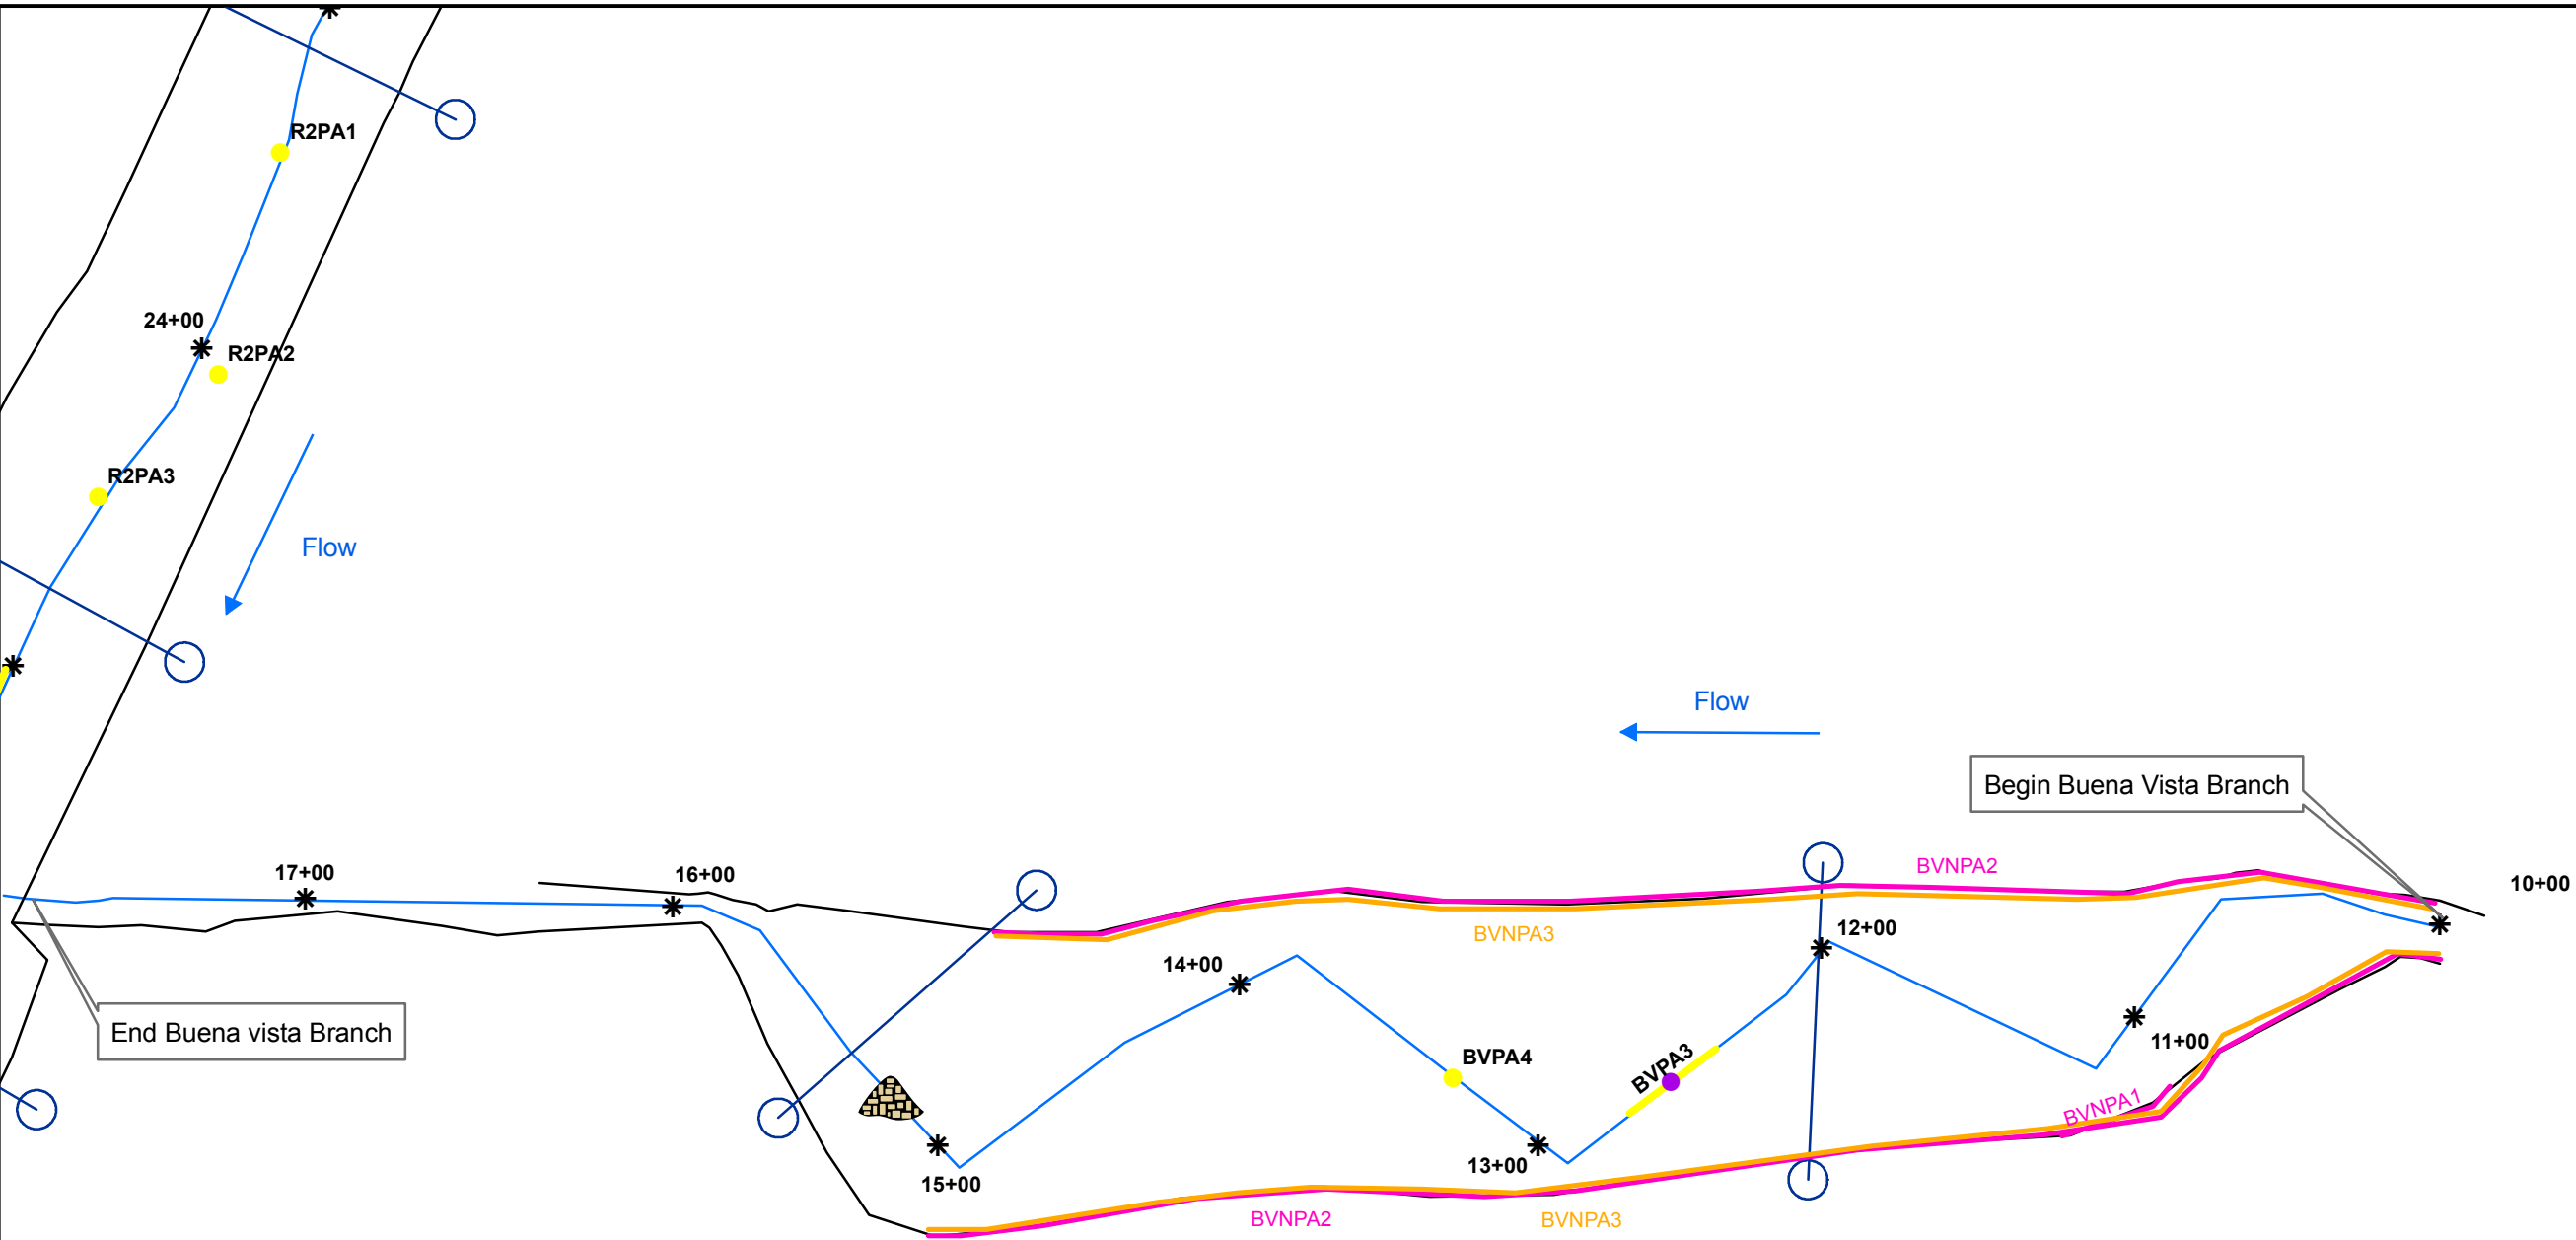
Stream Problem Areas – Buena Vista Branch			
Silas Creek 00335			
Problem #	Feature Issue	Station	Suspected Cause
BVPA1*	Bar formation/Aggradation	10+50	Inability to transport sediment
BVPA2*	Bar formation/Aggradation	10+90	Inability to transport sediment
BVPA3	Bank erosion	12+50	Bank angle too steep
BVPA4	Bar formation/Aggradation	13+30	Inability to transport sediment
BVPA5	Bar formation/Aggradation	16+00	Inability to transport sediment
BVNPA1	Bank erosion	11+10	Improper design and/or construction
BVNPA2	Channel widening, deepening, beaver slides	10+00 to 15+00	Beaver presence
BVNPA3	Sedimentation on banks	10+00 to 15+00	Beaver dam downstream

\* Problem areas have been removed. Beaver presence has widened and deepened the channel. No bars are apparent.

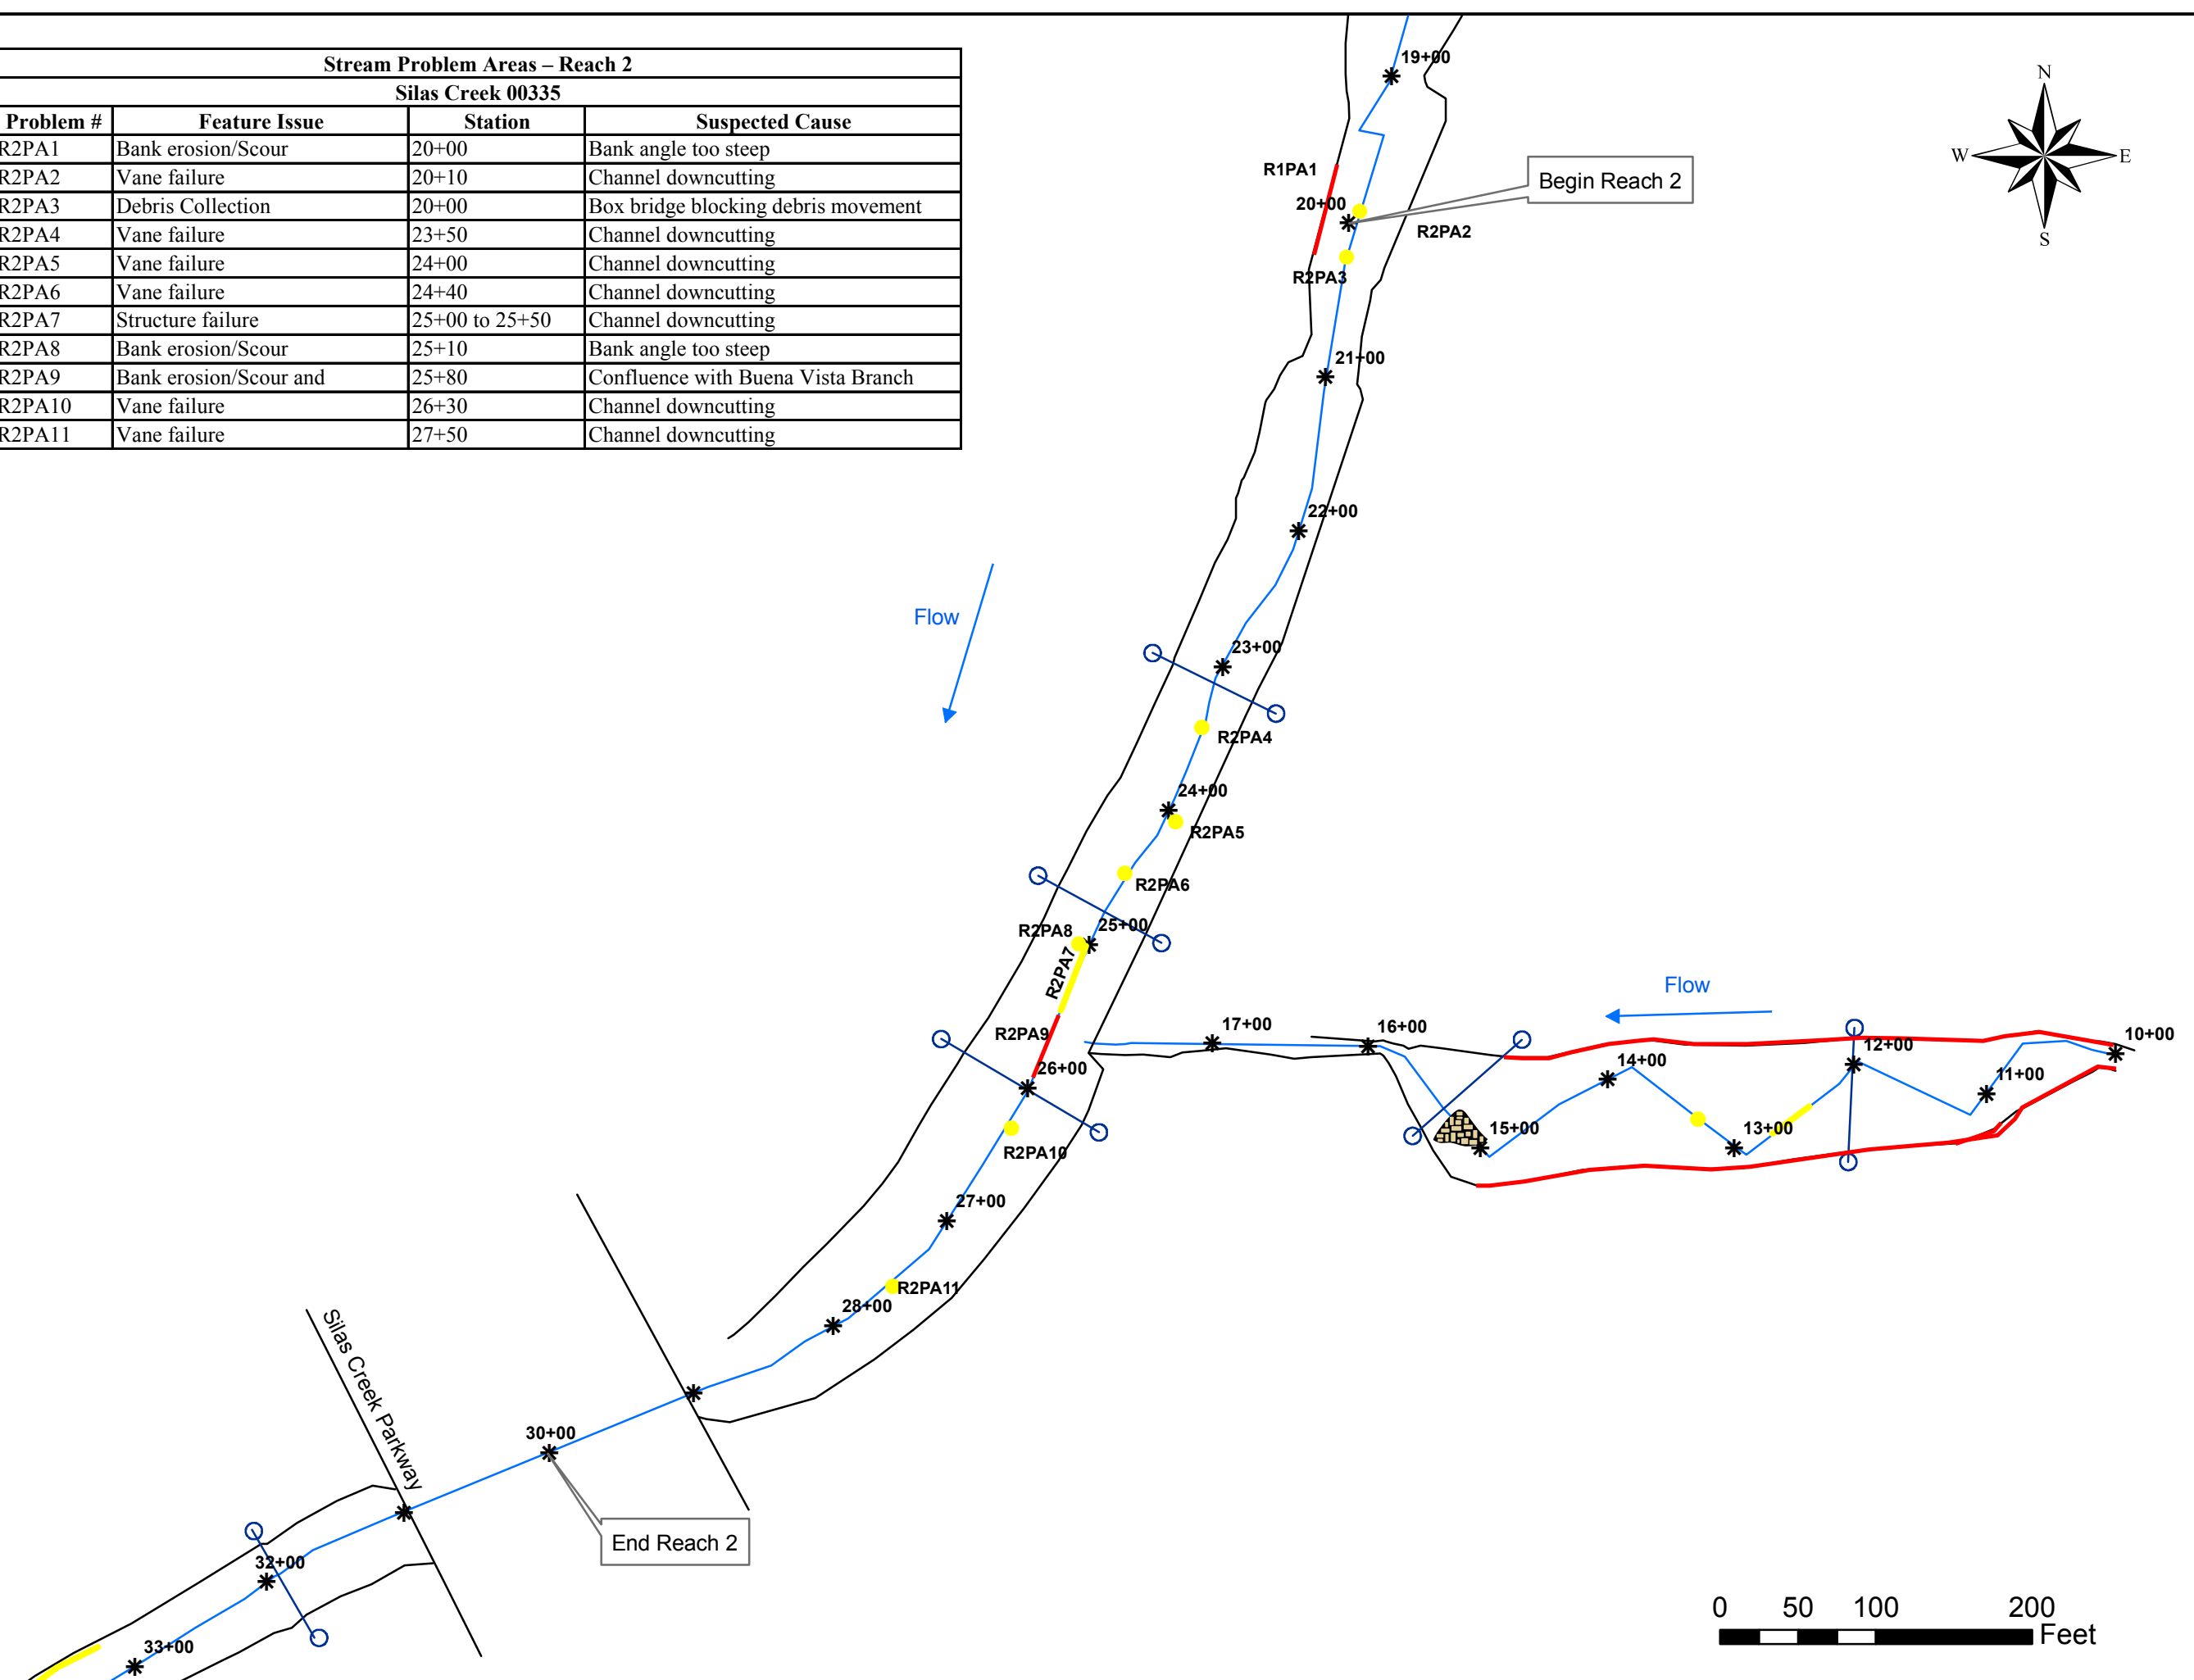
**Reach 2 Stream  
 Current Condition  
 Plan View**

Stream Problem Areas – Reach 2			
Silas Creek 00335			
Problem #	Feature Issue	Station	Suspected Cause
R2PA1	Bank erosion/Scour	20+00	Bank angle too steep
R2PA2	Vane failure	20+10	Channel downcutting
R2PA3	Debris Collection	20+00	Box bridge blocking debris movement
R2PA4	Vane failure	23+50	Channel downcutting
R2PA5	Vane failure	24+00	Channel downcutting
R2PA6	Vane failure	24+40	Channel downcutting
R2PA7	Structure failure	25+00 to 25+50	Channel downcutting
R2PA8	Bank erosion/Scour	25+10	Bank angle too steep
R2PA9	Bank erosion/Scour and	25+80	Confluence with Buena Vista Branch
R2PA10	Vane failure	26+30	Channel downcutting
R2PA11	Vane failure	27+50	Channel downcutting

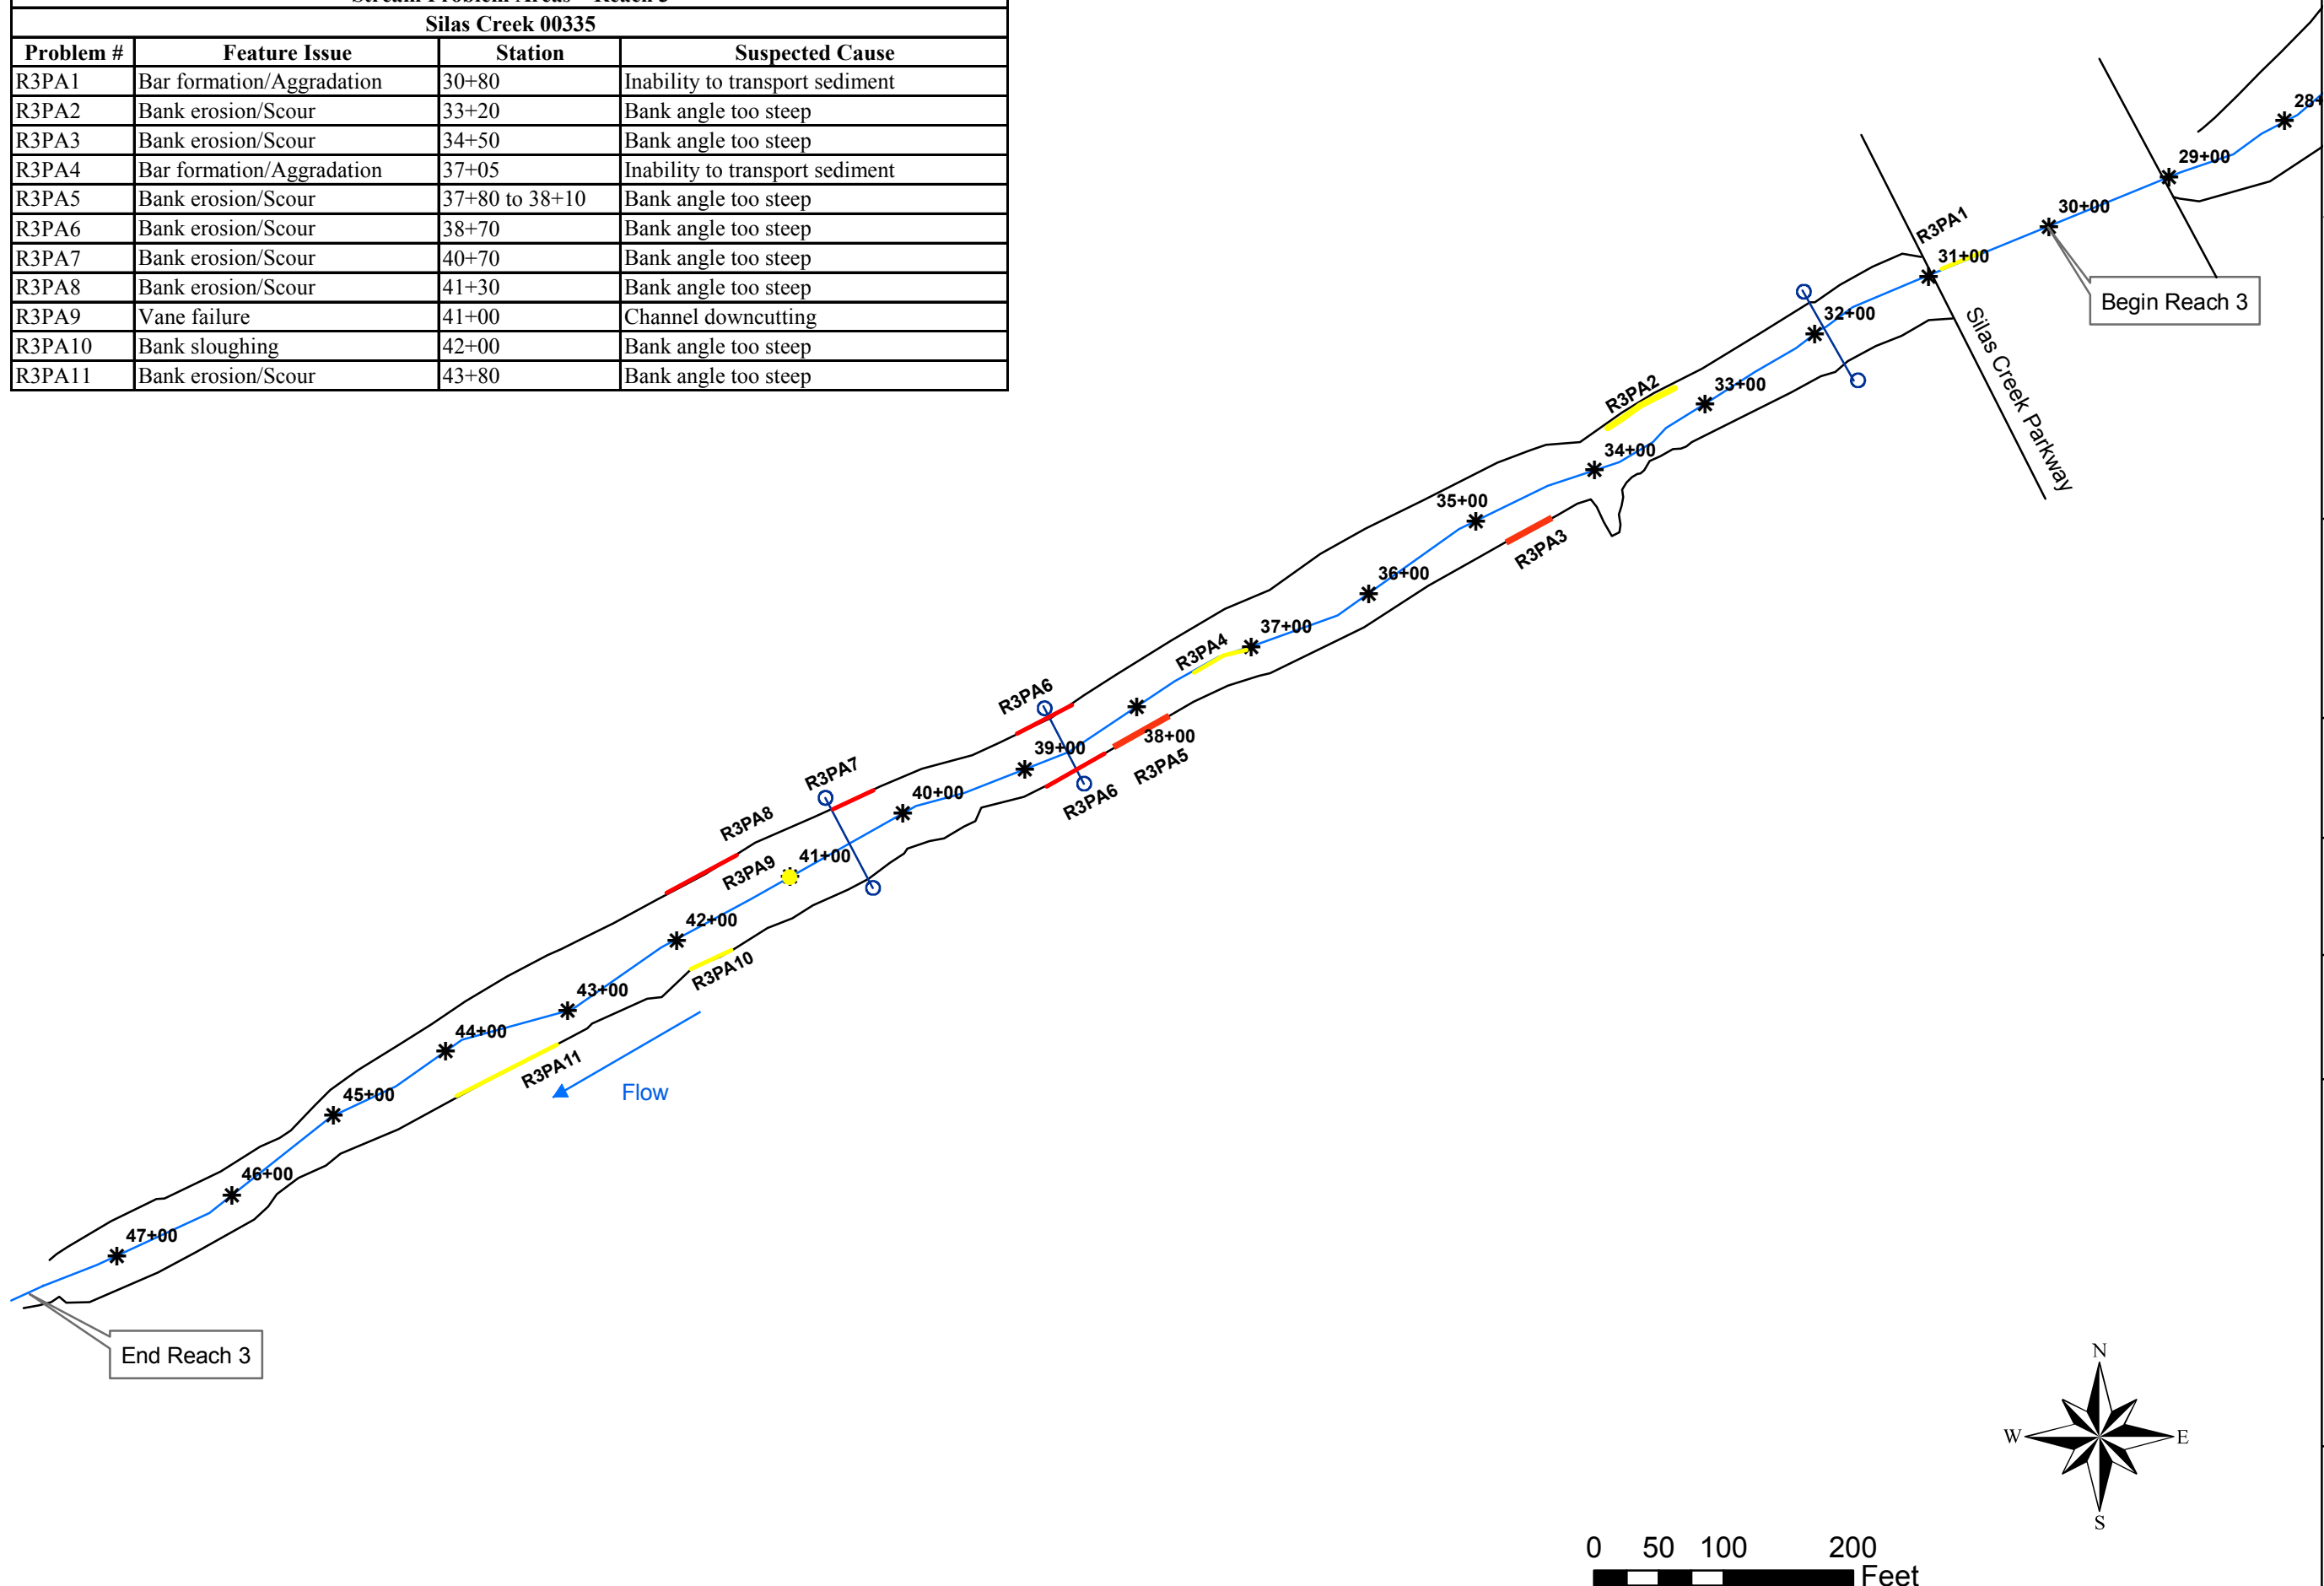
**Reach 3 Stream  
 Current Condition  
 Plan View**

Stream Problem Areas – Reach 3			
Silas Creek 00335			
Problem #	Feature Issue	Station	Suspected Cause
R3PA1	Bar formation/Aggradation	30+80	Inability to transport sediment
R3PA2	Bank erosion/Scour	33+20	Bank angle too steep
R3PA3	Bank erosion/Scour	34+50	Bank angle too steep
R3PA4	Bar formation/Aggradation	37+05	Inability to transport sediment
R3PA5	Bank erosion/Scour	37+80 to 38+10	Bank angle too steep
R3PA6	Bank erosion/Scour	38+70	Bank angle too steep
R3PA7	Bank erosion/Scour	40+70	Bank angle too steep
R3PA8	Bank erosion/Scour	41+30	Bank angle too steep
R3PA9	Vane failure	41+00	Channel downcutting
R3PA10	Bank sloughing	42+00	Bank angle too steep
R3PA11	Bank erosion/Scour	43+80	Bank angle too steep

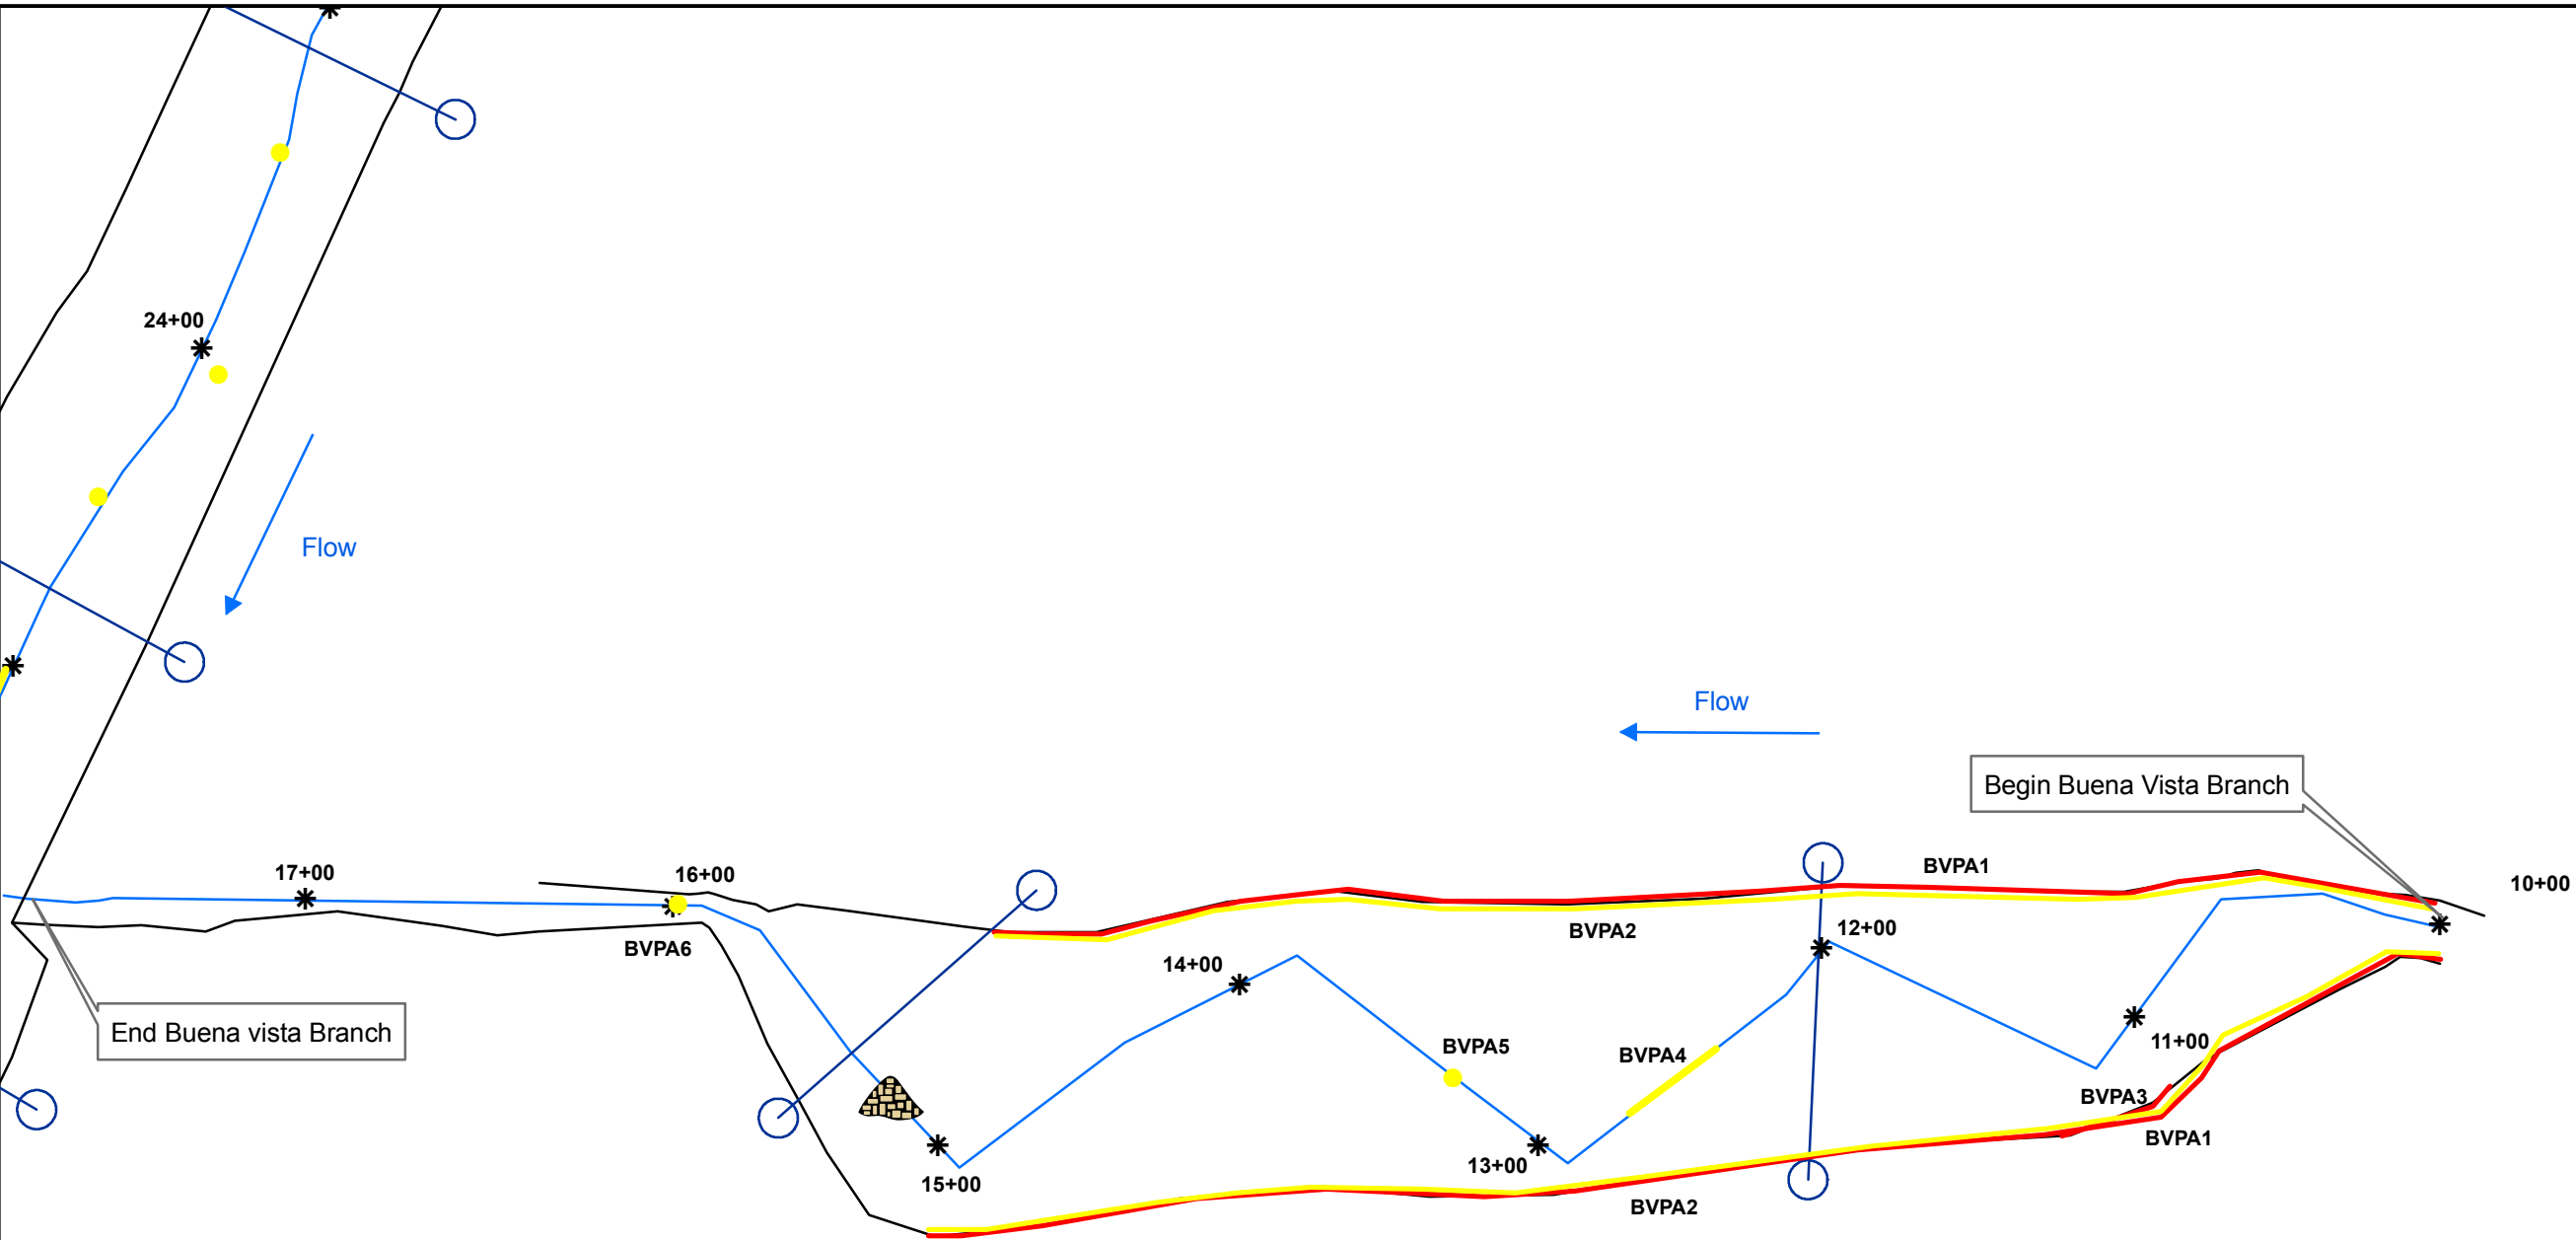
**Buena Vista  
 Branch Stream  
 Current Condition  
 Plan View**

Stream Problem Areas – Buena Vista Branch			
Silas Creek 00335			
Problem #	Feature Issue	Station	Suspected Cause
BVPA1	Channel widening, deepening,	10+00 to 15+00	Beaver presence
BVPA2	Sedimentation on banks	10+00 to 15+00	Beaver dam downstream
BVPA3	Bank erosion	11+10	Improper design and/or construction
BVPA4	Bank erosion	12+50	Bank angle too steep
BVPA5	Bar formation/Aggradation	13+30	Inability to transport sediment
BVPA6	Bar formation/Aggradation	16+00	Inability to transport sediment

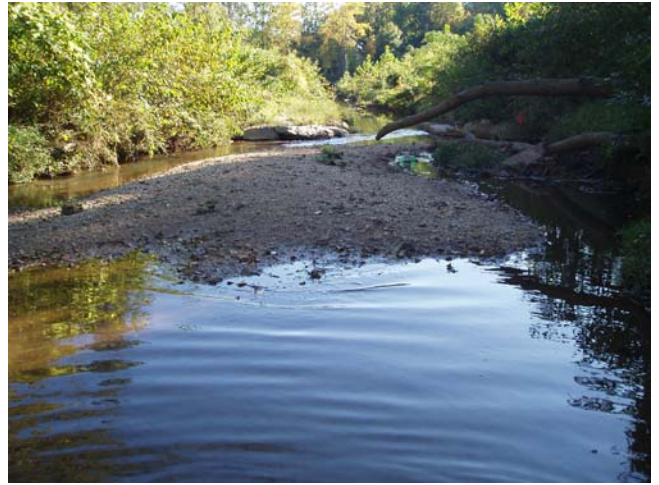
Problem #	Feature Issue	Station	Suspected Cause
R1PA1	Vane failure	10+00	Improper design and/or construction
R1PA2	Bar formation/Aggradation	10+70	Inability to transport sediment
R1PA3	Vane erosion/failure	14+10	Improper design and/or construction
R1PA4	Bar formation/Aggradation	14+10	Inability to transport sediment
R1PA5	Vane failure	16+80	Improper design and/or construction
