SILVER CREEK RESTORATION PROJECT

ANNUAL MONITORING REPORT FOR 2008 (YEAR 3)

Project Number D04006-5

December 2008

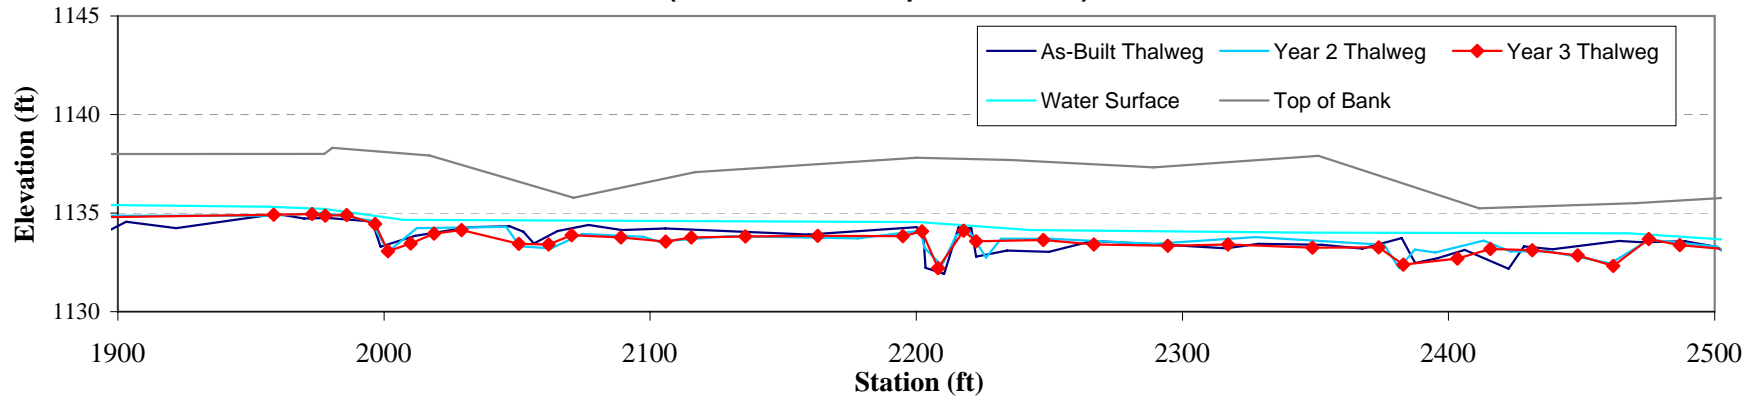
**Silver Creek M3 - Year 2 Station 19+00 to 25+00
(Data Collected September 2008)**

The longitudinal profile of M3 shows that the stream repairs conducted in early 2008 are stable. Areas of noted channel adjustments on UT1 and M3 will be monitored during future site visits.

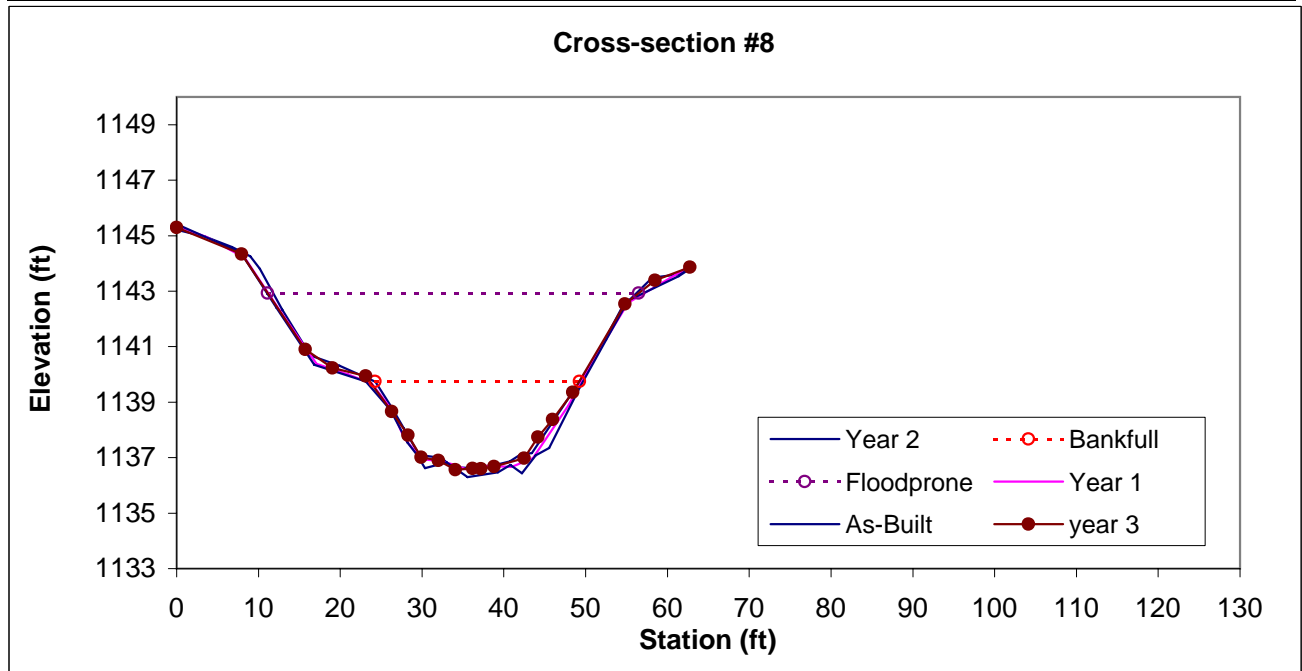
Permanent Cross-section #8 M3
 (Year 3 Data - Collected September 2008)

Feature	Stream Type	BKF Area	BKF Width	BKF Depth	Max BKF Depth	W/D	BH Ratio	ER	BKF Elev	TOB Elev
Riffle	Bc	55.4	25.63	2.16	3.18	11.85	1.1	1.8	1139.75	1139.94

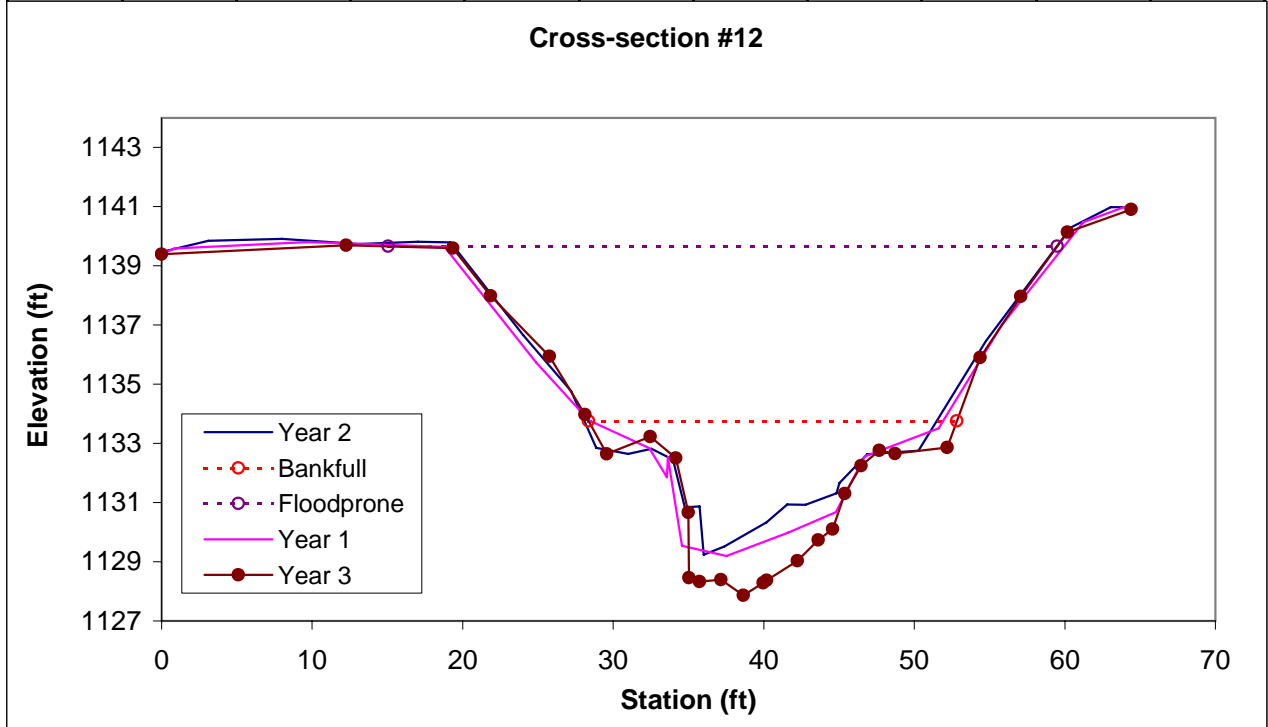
Permanent Cross-section #12 M4

Feature	Stream Type	BKF Area	BKF Width	BKF Depth	Max BKF Depth	W/D	BH Ratio	ER	BKF Elev	TOB Elev
Pool		66.2	24.47	2.7	5.9	9.05	2	1.8	1133.76	1139.6

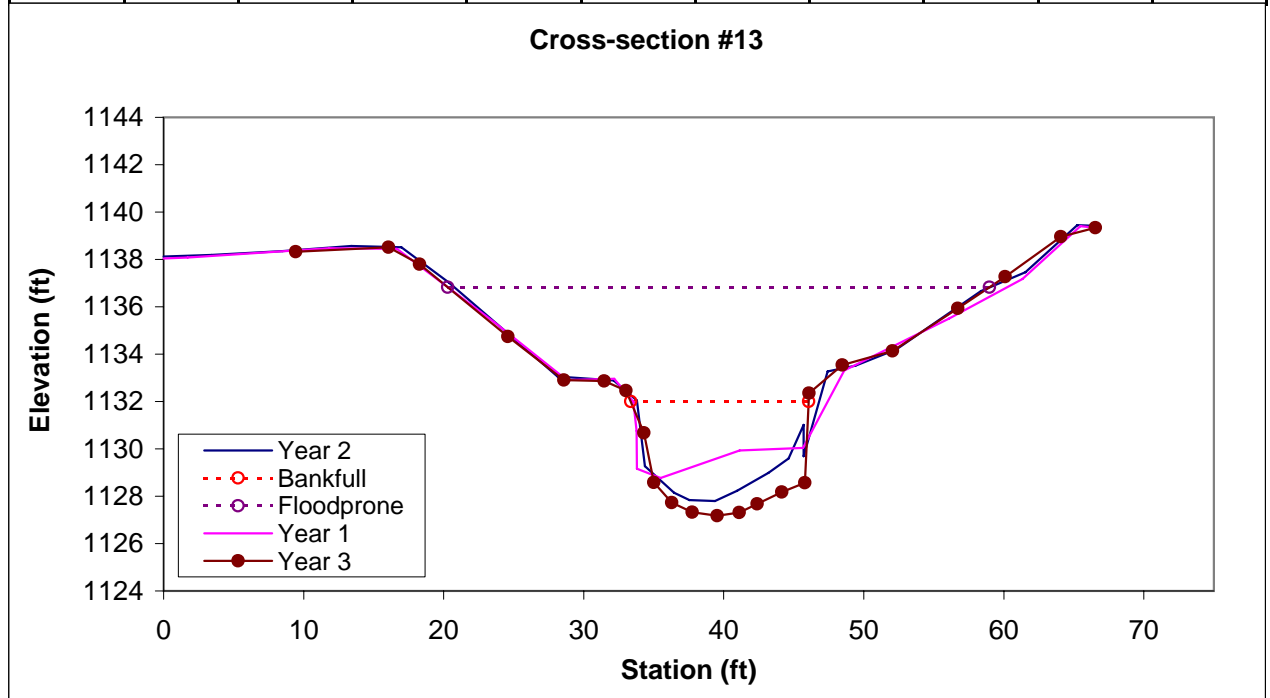
Permanent Cross-section #13 M4

Feature	Stream Type	BKF Area	BKF Width	BKF Depth	Max BKF Depth	W/D	BH Ratio	ER	BKF Elev	TOB Elev
Pool		49.1	12.72	3.86	4.82	3.29	2.1	3	1132	1137.27

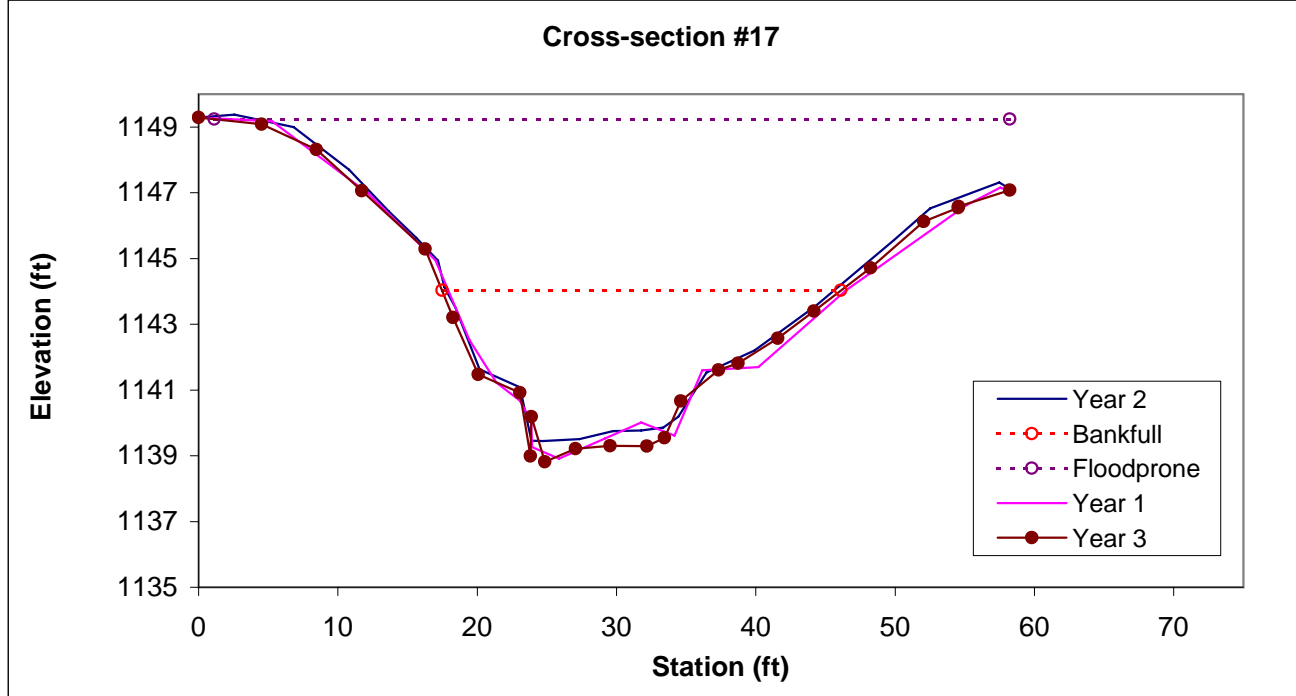
Permanent Cross-section M1 #17
 (Year 3 Data - Collected September 2008)

Feature	Stream Type	BKF Area	BKF Width	BKF Depth	Max BKF Depth	W/D	BH Ratio	ER	BKF Elev	TOB Elev
Pool		85	28.64	2.97	5.21	9.65	1.6	2	1144.03	1147.08
