# SILVER CREEK RESTORATION PROJECT (FINAL) ANNUAL MONITORING REPORT FOR 2010 (YEAR 5)

Project Number D04006-5

**Prepared for:** EBX Neuse-I, LLC      **Prepared by:** Michael Baker Engineering, Inc.

January 2011

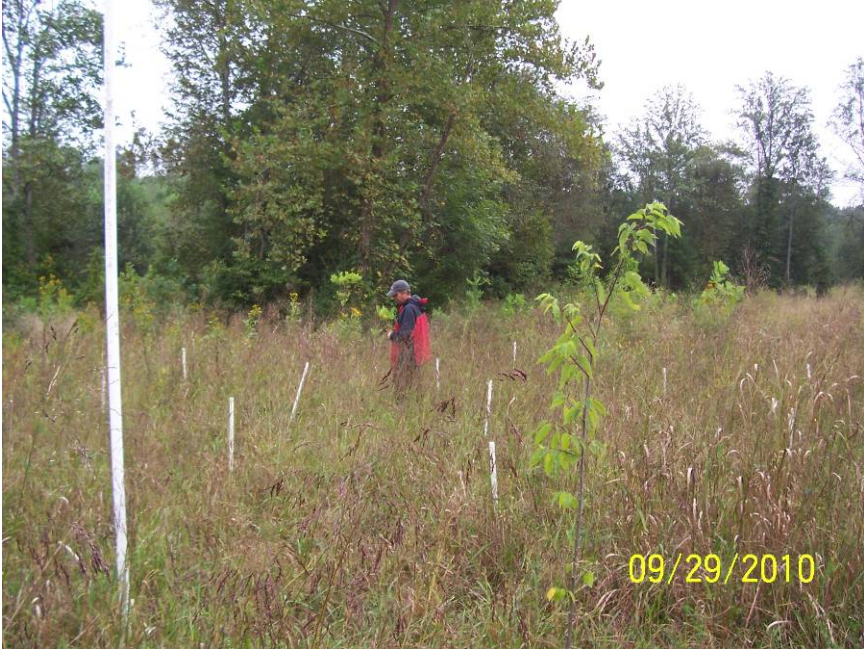
Silver Creek Vegetation Monitoring Plot #6

Supplemental planting of four-year-old stems was conducted in early 2010 around Plot 6 due to mortality from previous drought conditions. The low end survival rate found around Plot 6 was particularly affected by the last two dry summers leaving many stems dead from lack of moisture. Plot 6 yielded 200 stems per acre at the end of Year 5, which is below the minimum success criteria of 260 stems per acre stated in the Restoration Plan

In fall of 2010, the area around Plot 6 was evaluated to determine overall success and to determine the likely causes for low survival. Two test plots, each 10 meters x 10 meters square, were established immediately north and south of the existing Plot 6 to validate observations. Both plots yielded 280 stems per acre. The average of the three square plots, including Plot 6, is 260 stems per acre. Achievement of the success criteria was further validated by establishing two, 0.25 acre circular plots in the vicinity of Plot 6. One plot yielded 360 stems per acre and the other 320 stems per acre. It was determined that Plot 6 is an anomaly based on the four additional plots and lack of discernable differences with other parts of the mitigation area.

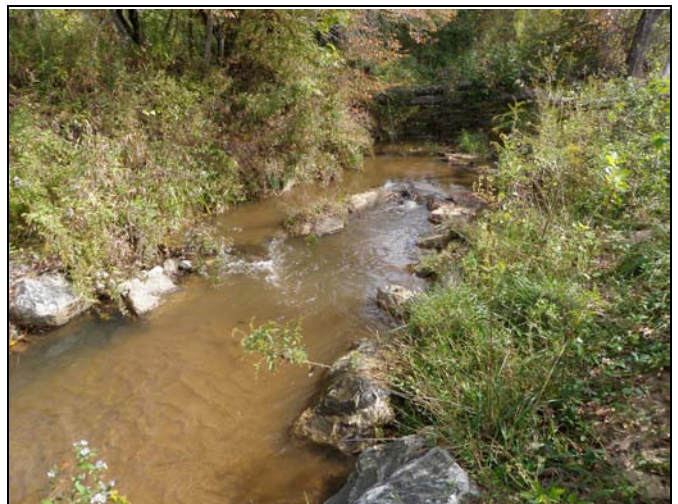
During Year 4 monitoring, two rock cross vanes located on M4 were noted to have stability issues. The first cross vane is located approximately at station 66+75 on M4. The problem noted was that the right arm of the cross vane appeared to have subsided slightly and low to moderate stream levels were flowing over the arm. To re-center the thalweg with the invert of the structure, repairs to this cross vane were completed on September 10, 2010. During an on-site inspection in October 2010, the repaired cross vane was stable and functioning as designed.

M4 Photo Point 2 – Problem cross-vane at station 66+75
