Year 1 Monitoring Report for Stream Restoration of Silver Creek and Unnamed Tributaries

Burke County, NC
SCO # D05016-01

Submitted: January 2008

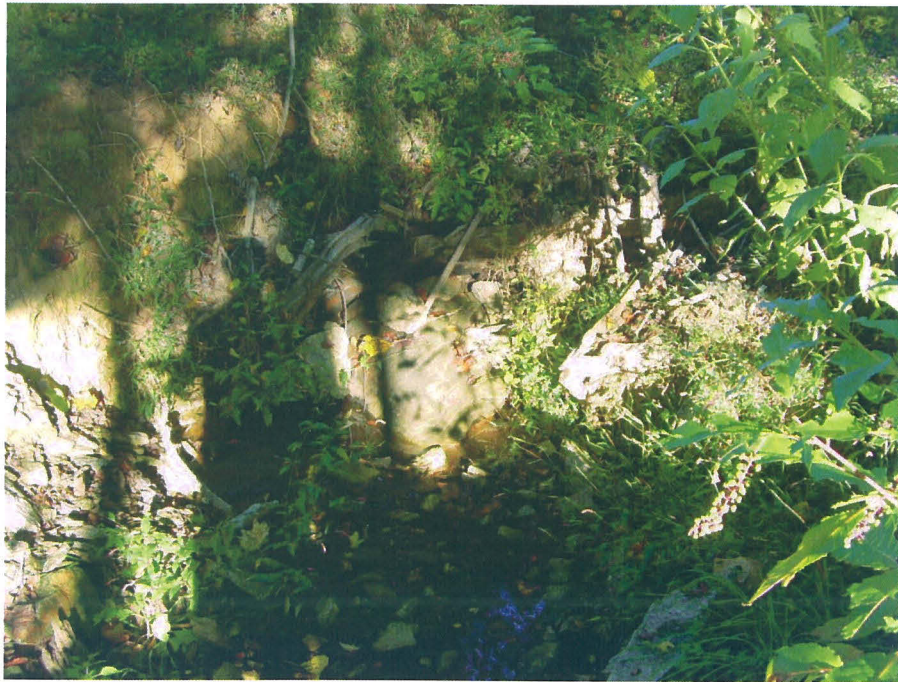
Table IX. Stream Problem Areas Silver Creek Stream Restoration / EEP Project No. D05016-1			
Feature Issue	Station Numbers	Suspected Cause	Photo Number
Stressed/failing structure	5+75 UT-A	Natural log sill - concern for long-term stability	SPA 1
Other	11+00 - 13+00 UT-A	Nearly vertical banks - need to be stabilized with matting and vegetation	SPA 2

Areas of instability were not observed along the Silver Creek Mainstem. On UT-A, a natural log sill was preserved during construction; the long-term stability of this feature was a noted concern during a site visit with the EEP. This structure will be monitored to further assess stream stability in this area. An additional area of concern exists along UT-A concerning the steep slopes of the stream banks. These banks are in need of reshaping to decrease the slopes and need revegetating to further enhance stability, as requested by EEP. Erosion control matting should be applied to protect the stream banks along this stream segment while vegetation is reestablished.

SPA 1
Natural log sill along Unnamed Tributary A near station 5+75.
(EMH&T, Inc. 10/22/07)

sand to fine gravel. Despite extreme drought and low flow conditions during 2007, the active channels are appropriately sized to entrain their bedload. Repairs requested by EEP, as documented in the Stream Problem Areas, will be addressed during Year 2 maintenance of project reaches.

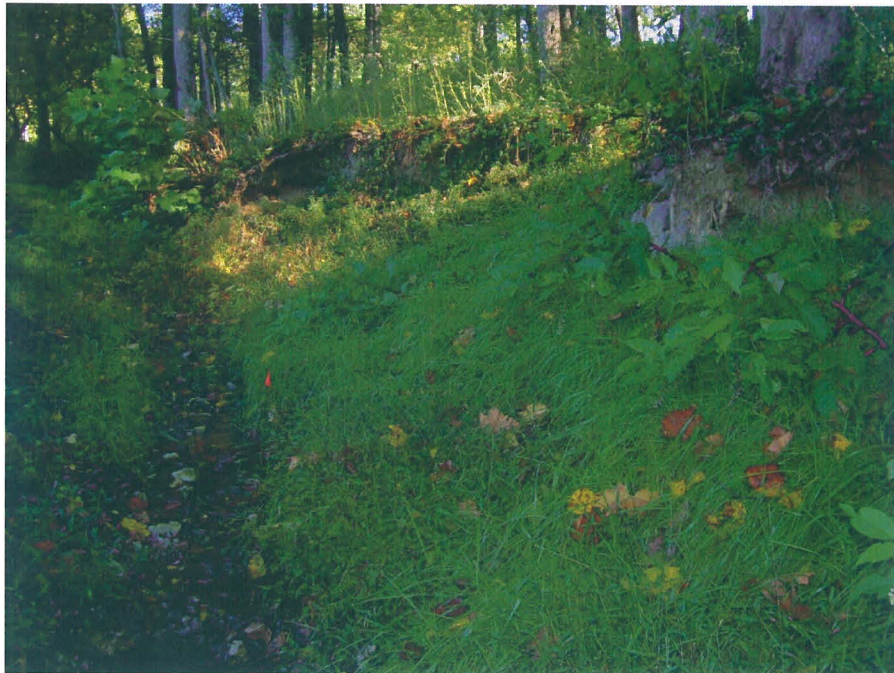
SPA 2
Steep banks in need of stabilization along Unnamed Tributary A near station 13+00.
(EMH&T, Inc. 10/22/07)
