Year 2 Monitoring Report for Stream Restoration of Silver Creek and Unnamed Tributaries

Burke County, NC
SCO # D05016-01

Submitted: December 2008

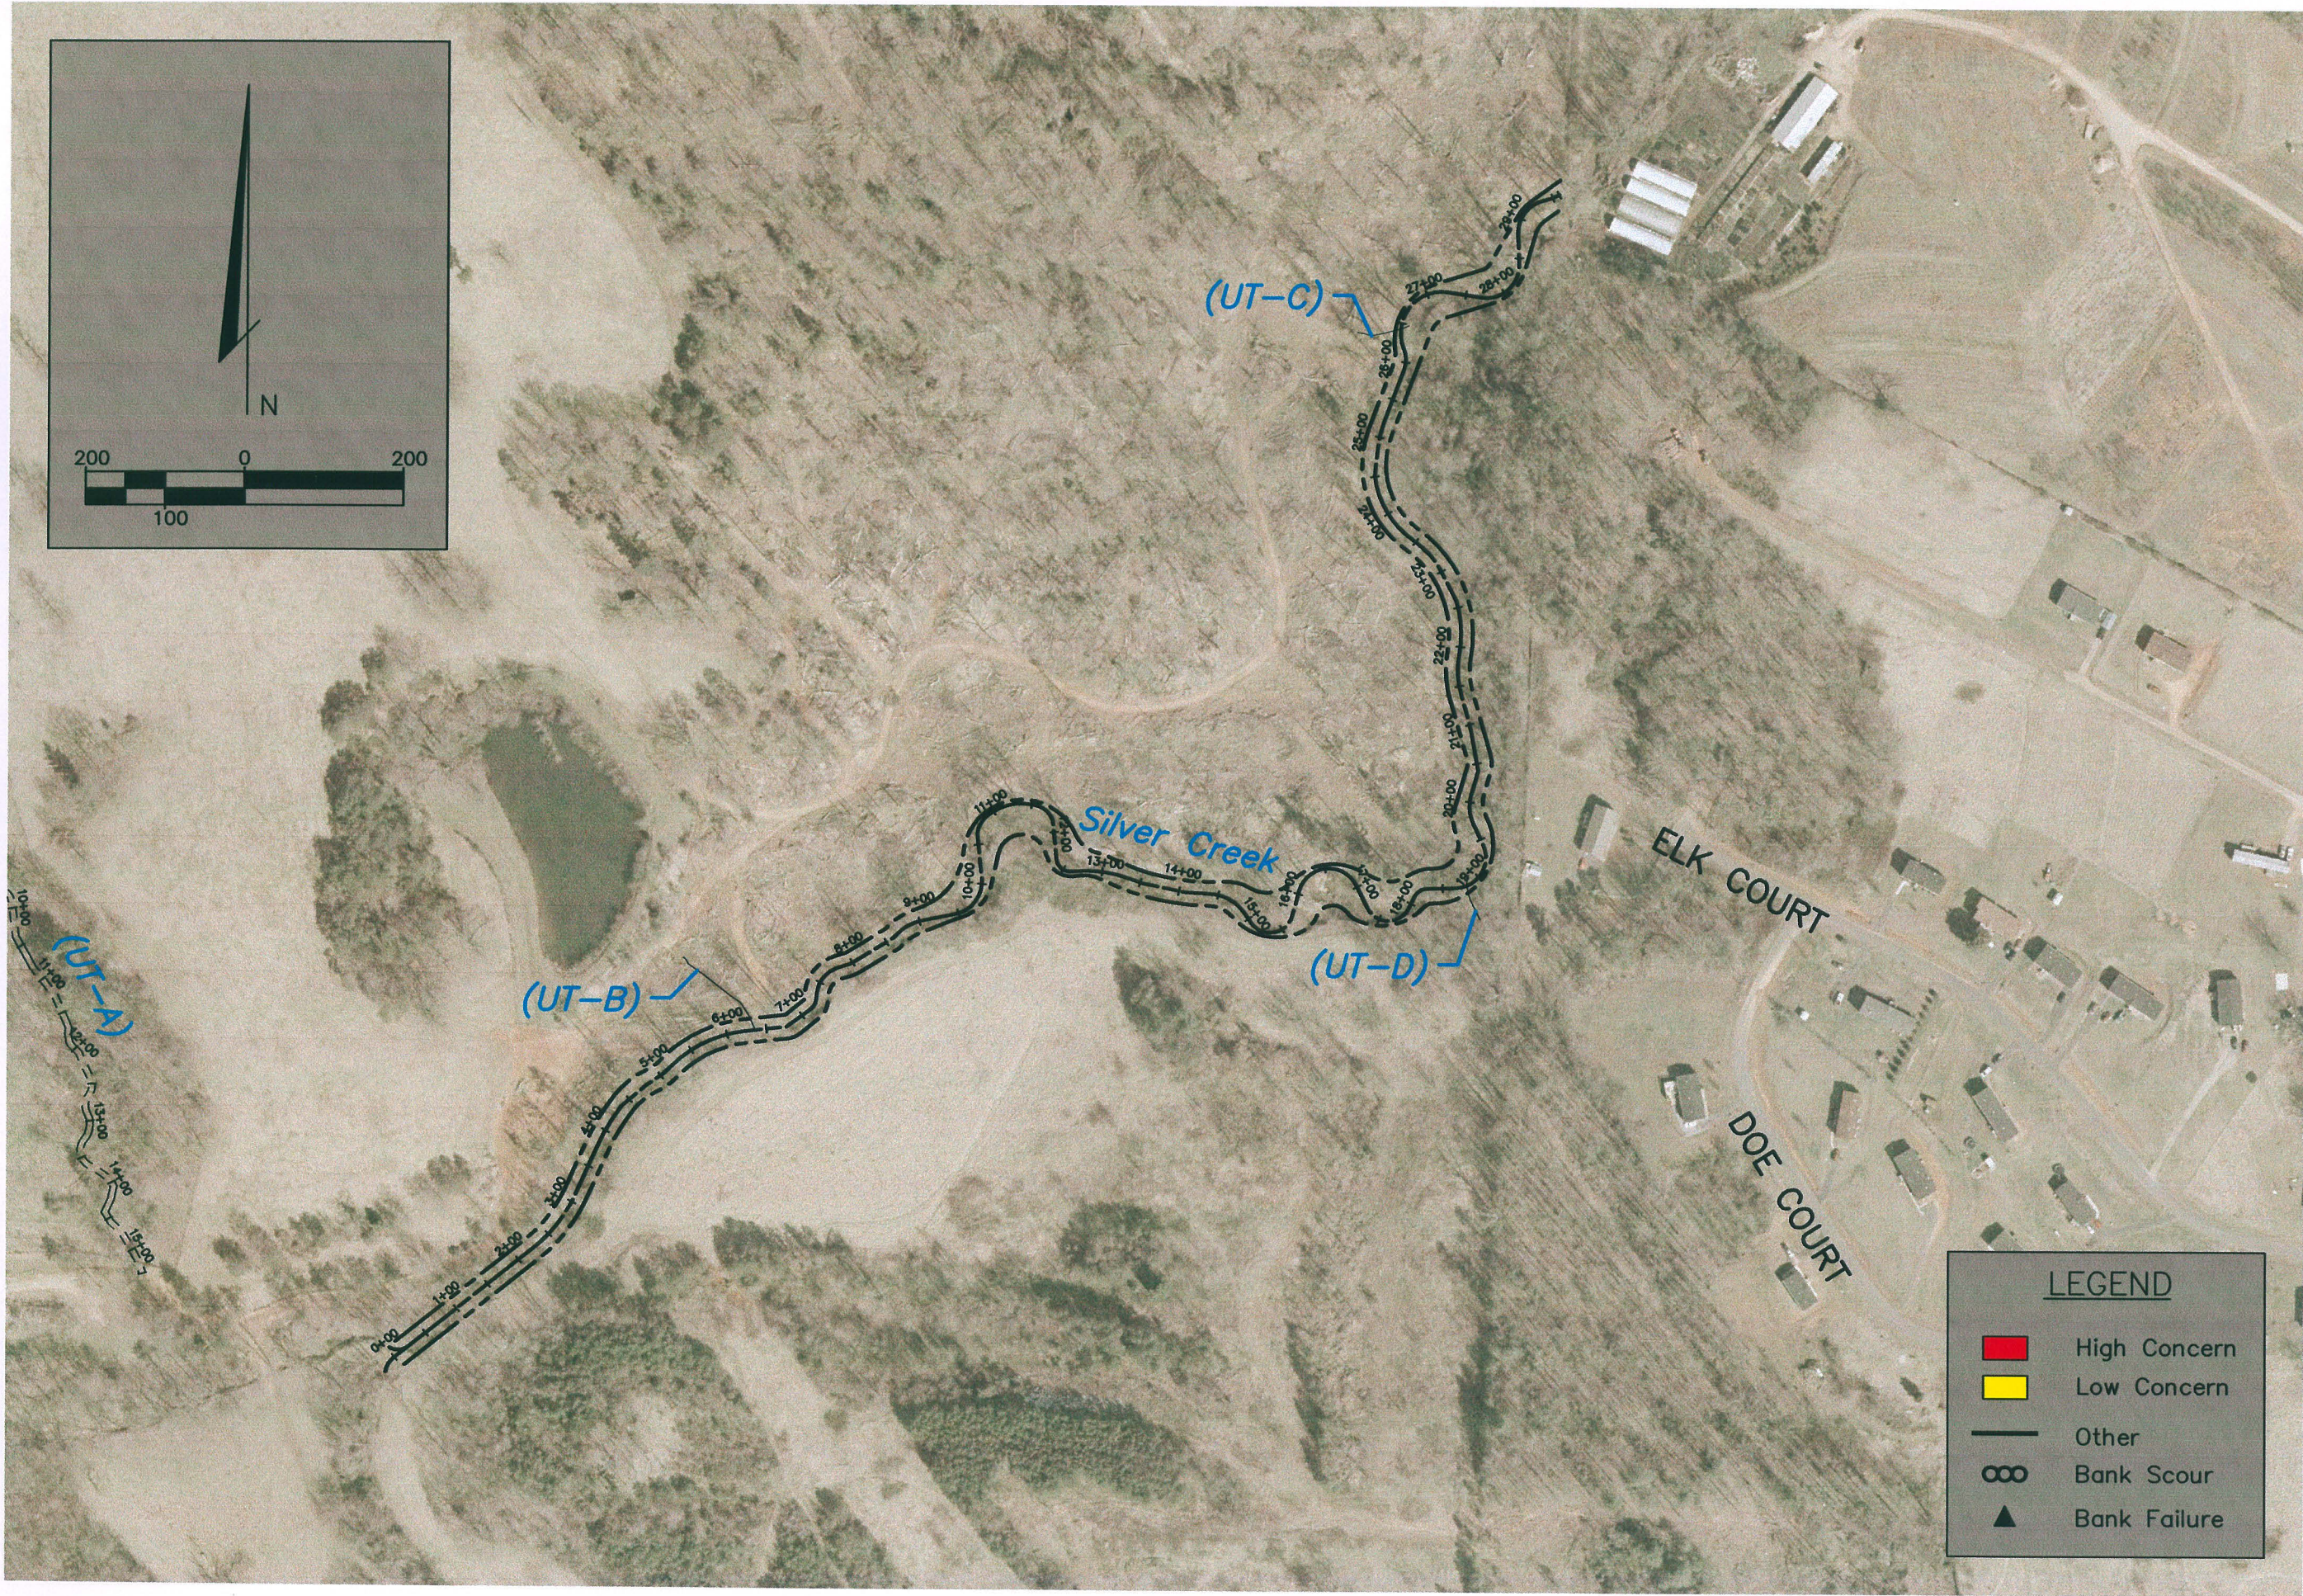
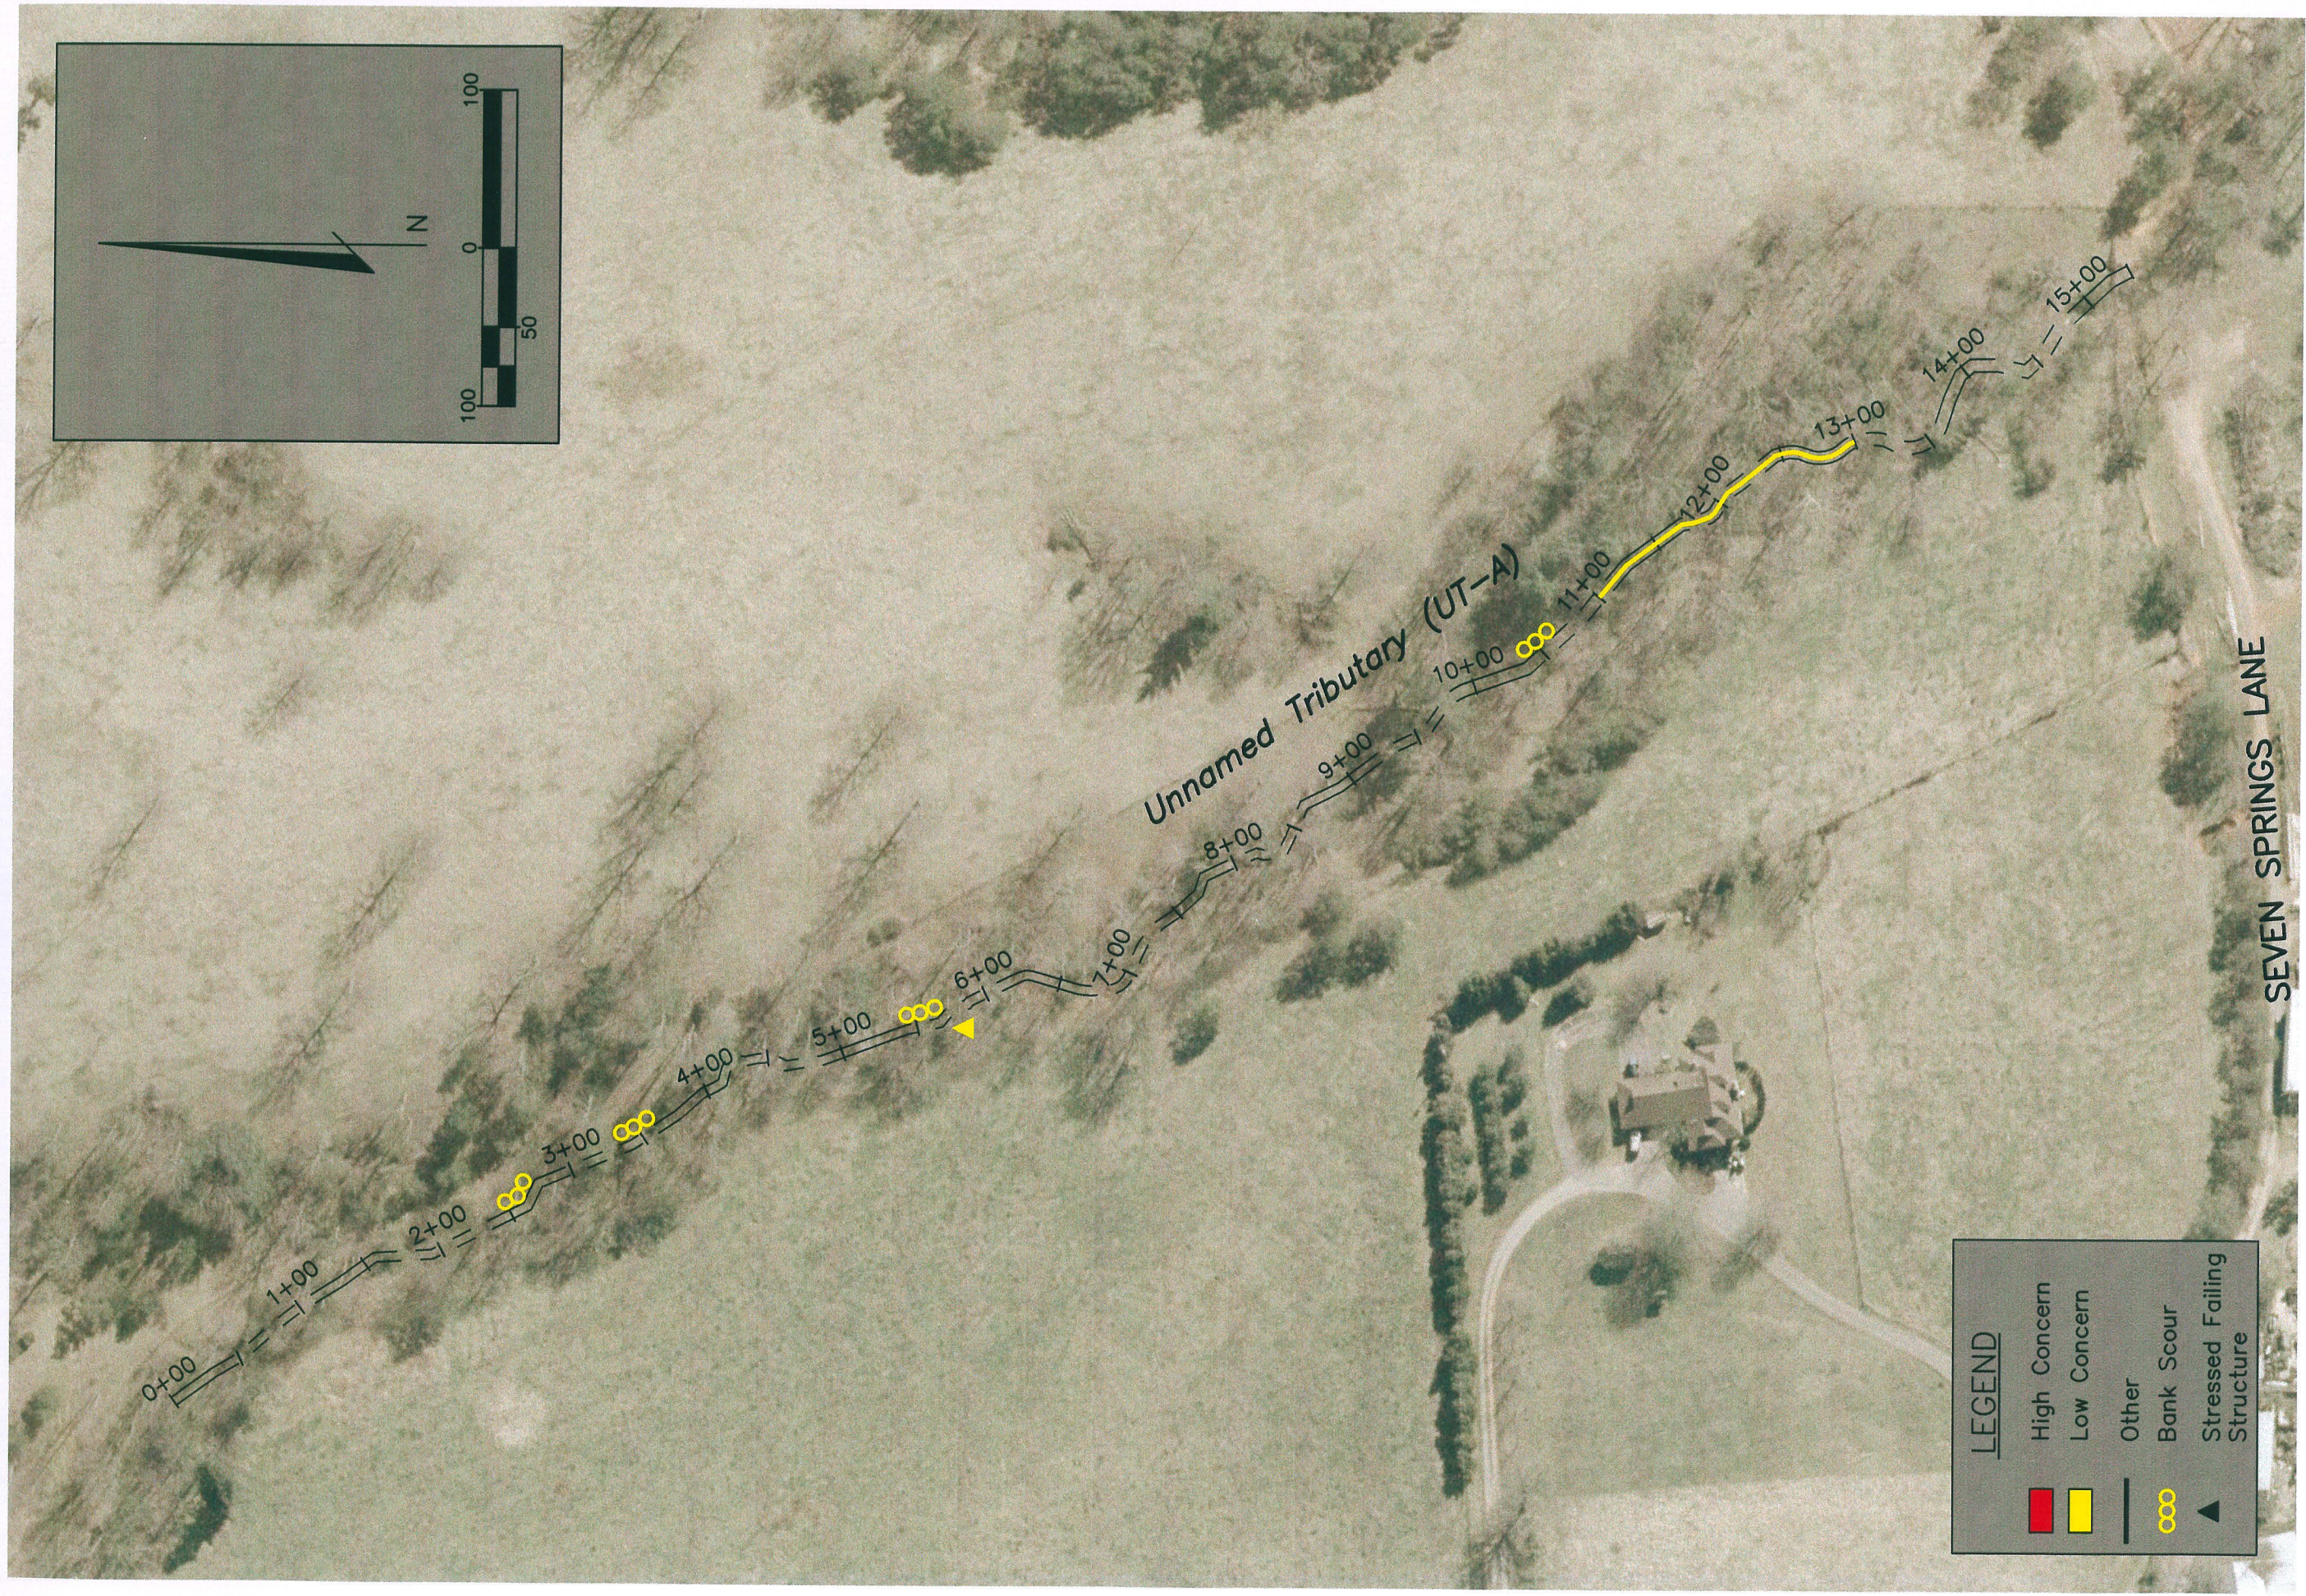
BURKE COUNTY, NORTH CAROLINA
SILVER CREEK AND UNNAMED TRIBUTARY
 MONITORING
 APPENDIX B
 STREAM PROBLEM AREA PLAN VIEW

Table IXa. Stream Problem Areas – Year 1 Silver Creek Stream Restoration / EEP Project No. D05016-1			
Feature Issue	Station Numbers	Suspected Cause	Photo Number
Stressed/failing structure	5+75 UTA	Natural log sill - concern for long-term stability	SPA 1
Other	11+00 - 13+00 UTA	Nearly vertical banks - need to be stabilized with matting and vegetation	SPA 2

Table Xb. Stream Problem Areas – Year 2 Silver Creek Stream Restoration / EEP Project No. D05016-1			
Feature Issue	Station Numbers	Suspected Cause	Photo Number
Stressed/failing structure	5+75 UTA	Natural log sill – removed due to concern for long-term stability; channel stabilized	SPA 1
Bank scour	2+50 UTA	Bank scour/ sloughing on left bank	SPA 2
	3+55 UTA	Bank scour/ sloughing on right bank	
	5+60 UTA	Bank scour/ sloughing on left bank	
	10+50 UTA	Bank scour/ sloughing	
Other	11+00 - 13+00 UTA	Nearly vertical banks – have been reshaped, still in need of matting and revetment	SPA 3

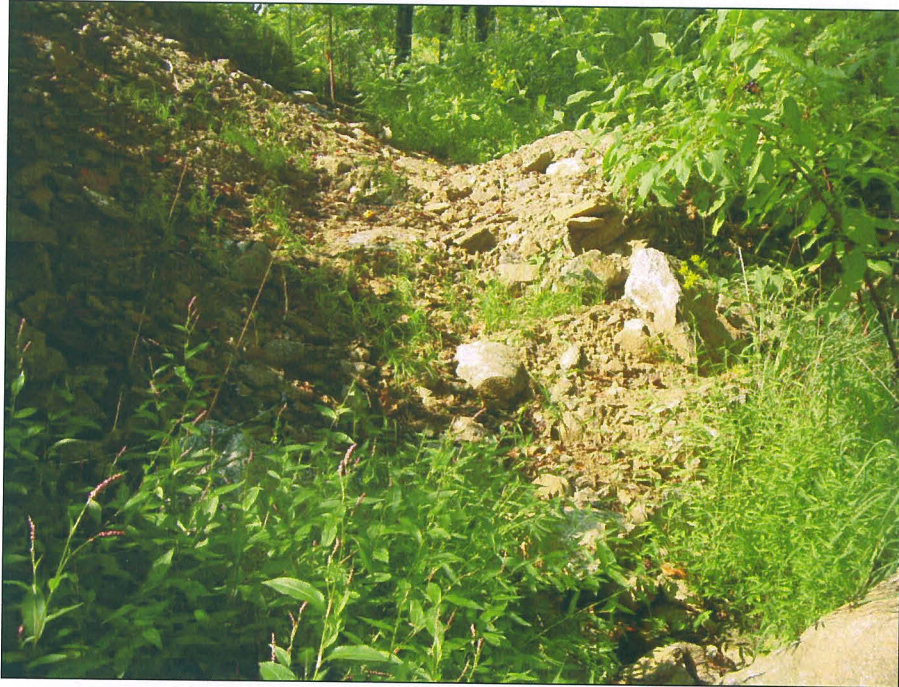
Areas of instability were not observed along the Silver Creek Mainstem. On UTA, a natural log sill was preserved during construction. The long-term stability of this feature was a noted concern during the EEP scheduled site visit upon completion of restoration. This structure has been removed, and the channel has been stabilized with appropriately size rock quarried on site. This area remains on the problem area table to ensure it is closely monitored in the following years of monitoring to document the success of the channel stabilization activities. An additional area of concern exists along UTA concerning the steep slopes of the stream banks, also noted by EEP during the construction completion site visit. These banks have been regraded to stable slope conditions and will be revegetated with live stakes to further enhance stability.

SPA 1
Natural log sill on Unnamed Tributary A near station 5+75. Log sill was removed and channel stabilized with rock.
(EMH&T, September 8, 2008)

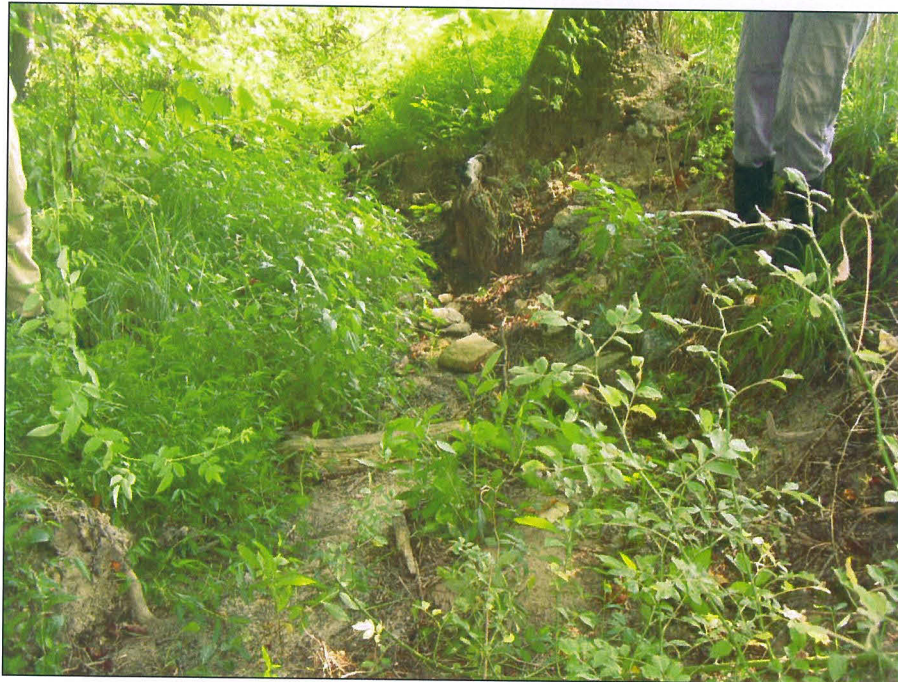
Areas of bank scour noted on UTA include a few small areas of minor streambank erosion. Because these areas are small, the use of mechanical means to regrade the banks is not warranted. The areas noted are located in short, narrow channel reaches surrounded by existing forested cover. Any areas deemed to require maintenance to improve stability will be stabilized using vegetative means using live stakes, which provide rapid growth and dense root systems for soil stabilization.

SPA 2
Right streambank scour on Unnamed Tributary A near station 3+55.
(EMH&T, September 8, 2008)

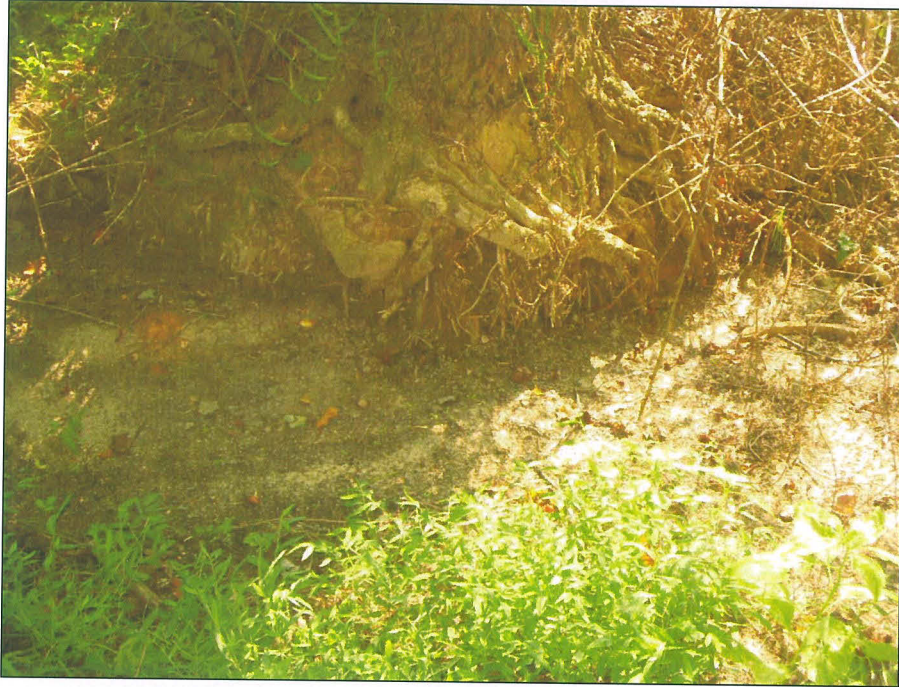
SPA 3
Close-up of right streambank scour on Unnamed Tributary A near station 3+55.
(EMH&T, September 8, 2008)

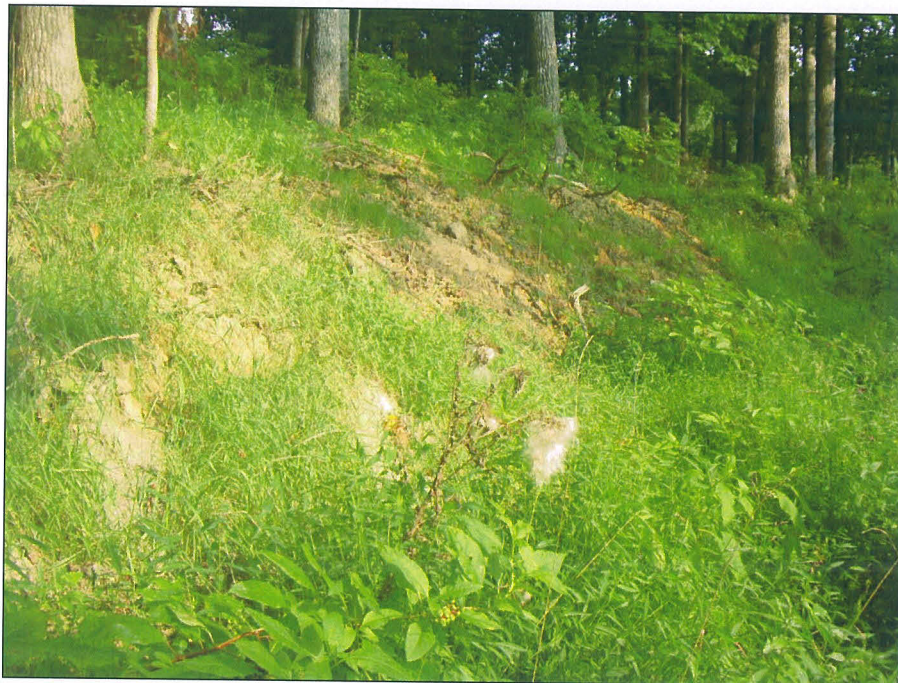
SPA 4
Steep streambanks on Unnamed Tributary A, looking downstream near station 12+00. The streambanks have been mechanically reshaped; the remaining stabilization will occur using vegetative means.
(EMH&T, September 8, 2008)

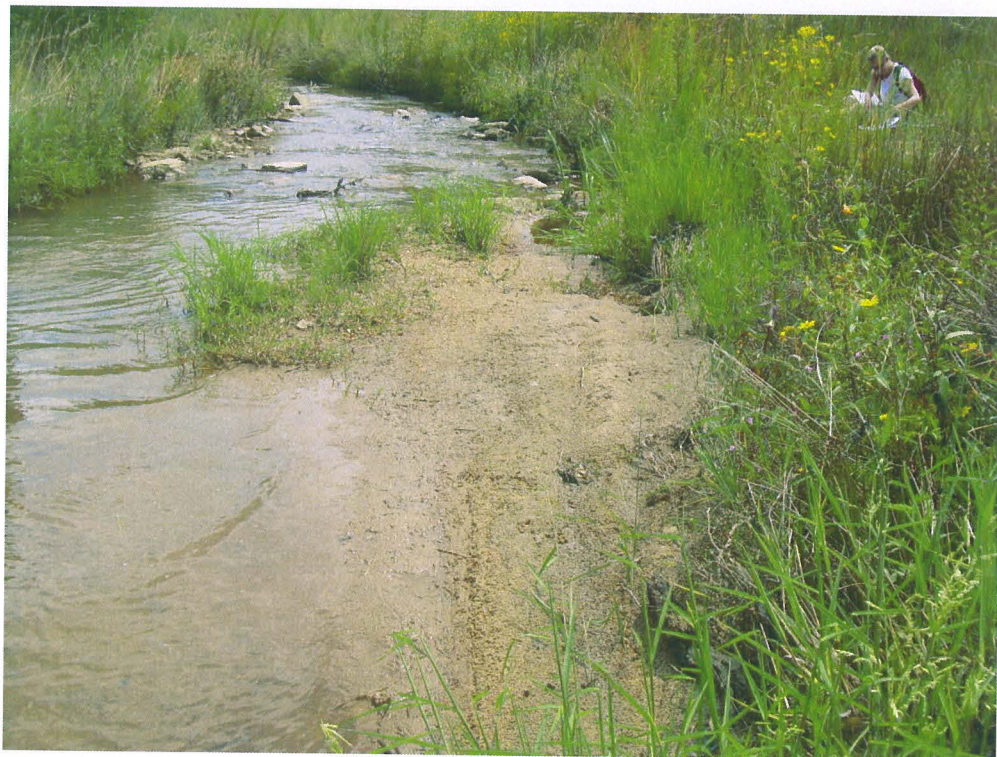
Riffle Cross-Section 4, looking upstream, from top to bottom: Riffle, run, pool sequence with sand and gravel point bar formation (September 8, 2008)
