Year 3 Monitoring Report for Stream Restoration of Silver Creek and Unnamed Tributaries

Burke County, NC
SCO # D05016-01

Submitted: December 2009

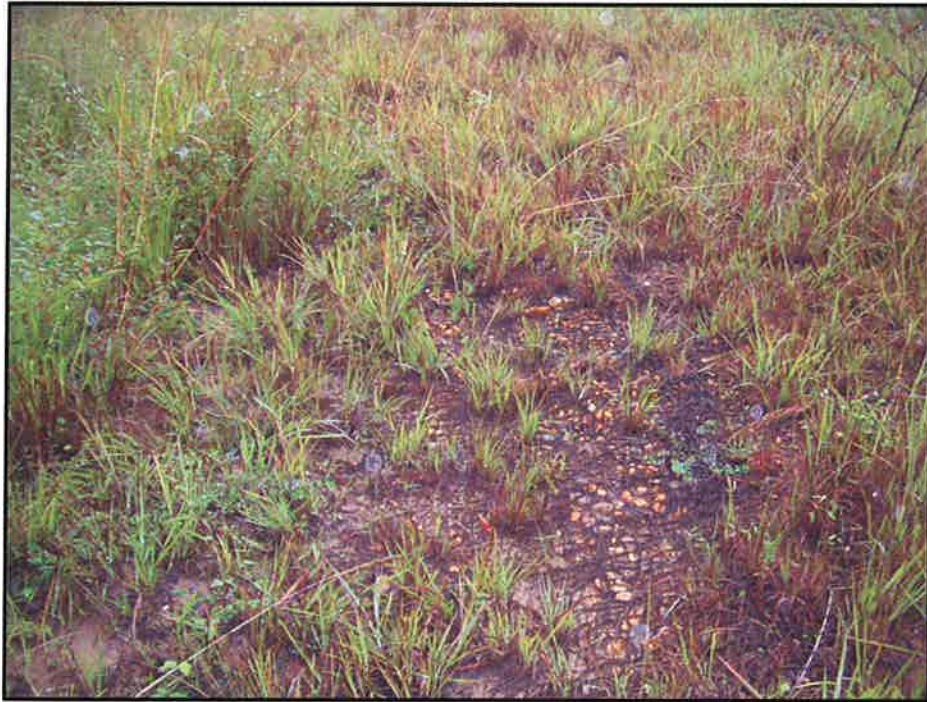
VPA 1

Several areas along the Silver Creek Mainstem were noted to have low overall herbaceous cover along the riparian corridor on the right bank. These areas are patchy and scattered throughout the corridor, with none of the areas showing banks that are completely bare. The soil along this project is a mix of sand and gravel, and as such, provides very dry conditions in which seed must germinate and grow. In addition to the poor soil conditions, evidence of previous cattle intrusion was also noticed along the areas of sparse vegetation. Early in the year, cattle had accessed a restoration project upstream of this site, and subsequently moved down the stream corridor into the fenced riparian easement. Fencing has been placed across the stream to prevent cattle access from the offsite project. Now that the cattle have been excluded, it is expected the permanent ground cover growing in the corridor will spread to fill the bare areas.

**View of sparse vegetation in the floodplain along the mainstem.
(EMH&T, Inc. 9/17/09)**

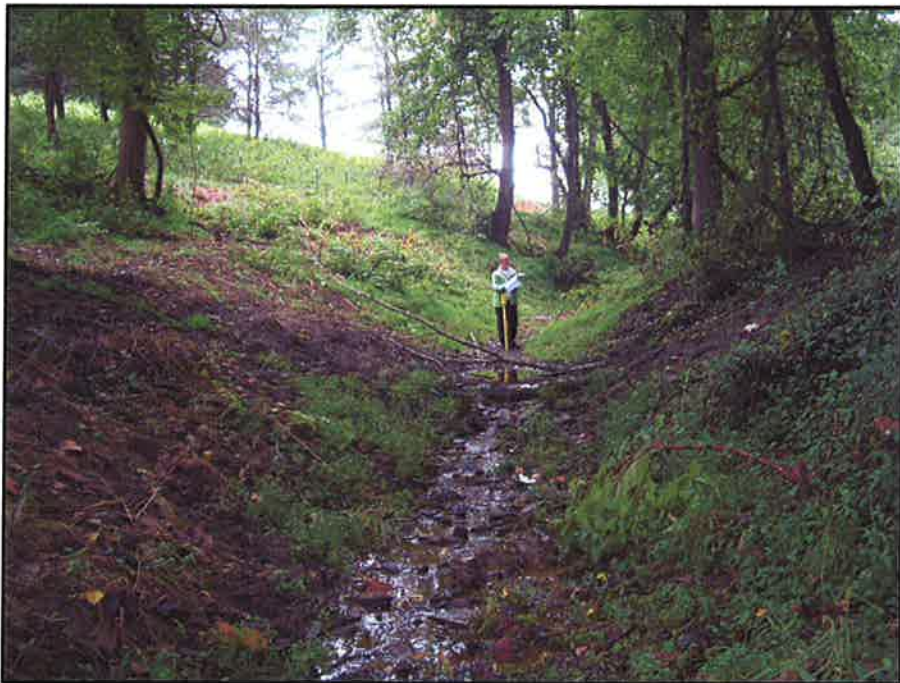
VPA 2

Cattle had unintentional access to UTA through the early part of September 2009 due to a fallen tree across the protective fencing. The cattle intrusion into the riparian corridor resulted in several areas of bare ground and sparse vegetation. These areas were reseeded in the fall of 2009 using a seed mix appropriate for shady, partial canopied woodland areas. Cattle damage to planted woody species and stream stability are discussed under subsequent sections of this report.

**Overview of the sparse vegetation and bare banks along UT1 in an area of cow damage.
(EMH&T, Inc. 9/17/09)**

To address the issue of low plant stem counts on those plots affected by cattle intrusion, specific areas will be targeted for replanting within the Silver Creek and Unnamed Tributary riparian corridors, which will include the deficient sample plots and surrounding areas within the buffer. All deficient portions of the riparian corridors will be supplemented with additional native tree and shrub plantings. These supplemental plantings will follow the specifications of the project proposed in the project Restoration Plan and Mitigation Plan documents. Consideration will be given to using larger woody stock, such as three-gallon potted material versus bare root specimen in performing the remedial plantings. These larger saplings should have a more developed root system and thus be better able to compete with the existing vegetation. Species more suitable for full or partial shade will also be included in the species mix to provide better survivability under the existing canopy. Supplemental replanting will occur during spring 2010. The subsequent Year 4 (2010) monitoring report will contain specific documentation of this remedial planting effort including the specific locations of replanting, and the quantity and species of tree and shrub material installed.

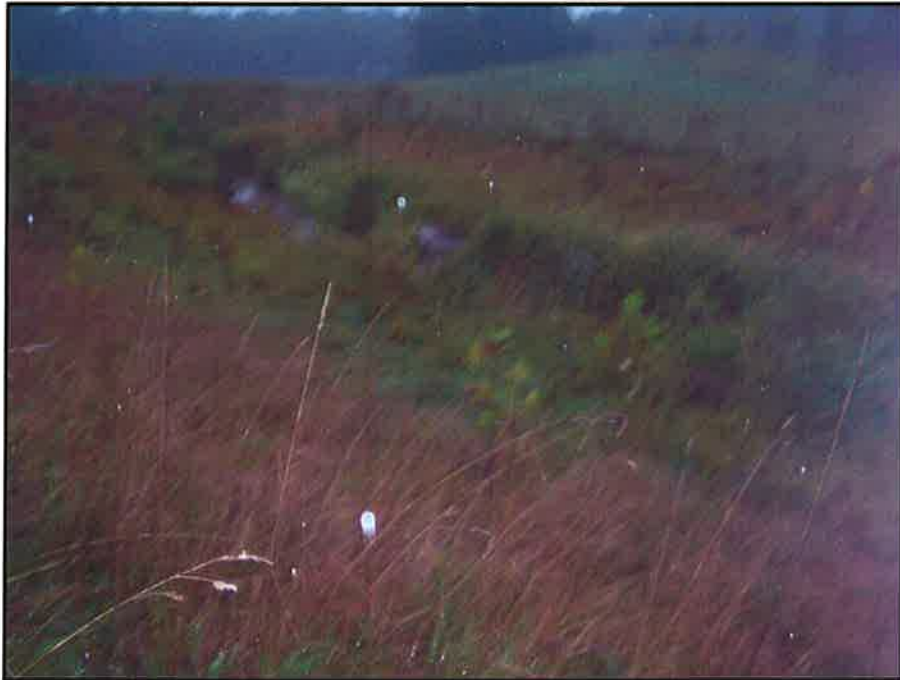
**Vegetation Plot 2 on Mainstem
Monitoring Year 3
Photo blurred due to rainstorm.
(EMH&T, Inc. 9/17/09)**

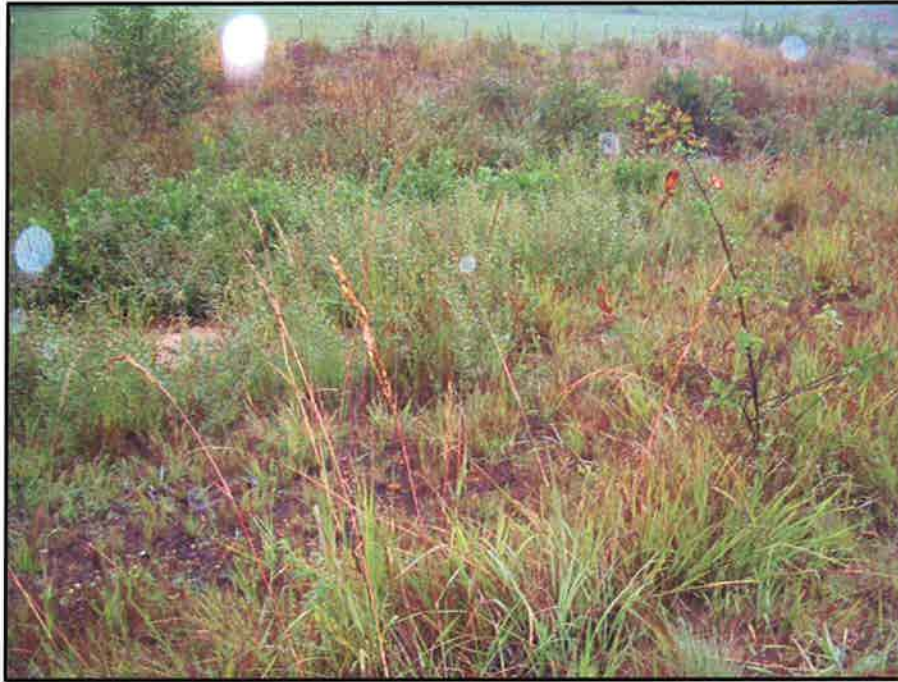
**Vegetation Plot 3 on Mainstem
Monitoring Year 3
Photo blurred due to rainstorm.
(EMH&T, Inc. 9/17/09)**

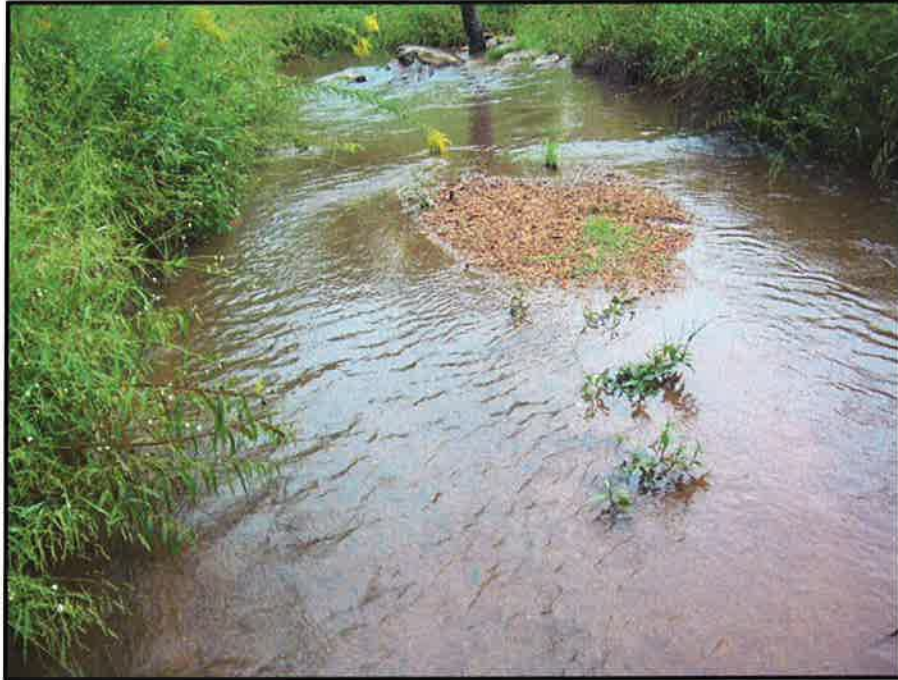
SPA 1

Two small areas of aggradation were noted along the Silver Creek Mainstem. The mid-channel bars that have formed downstream of J-hook features are small and are not posing a threat to stream stability. These features are noted as problem areas of low concern in order that they be watched in future years of monitoring.

**Area of aggradation (mid-channel bar) near station 19+50 on Silver Creek.
(EMH&T, Inc. 9/16/09)**

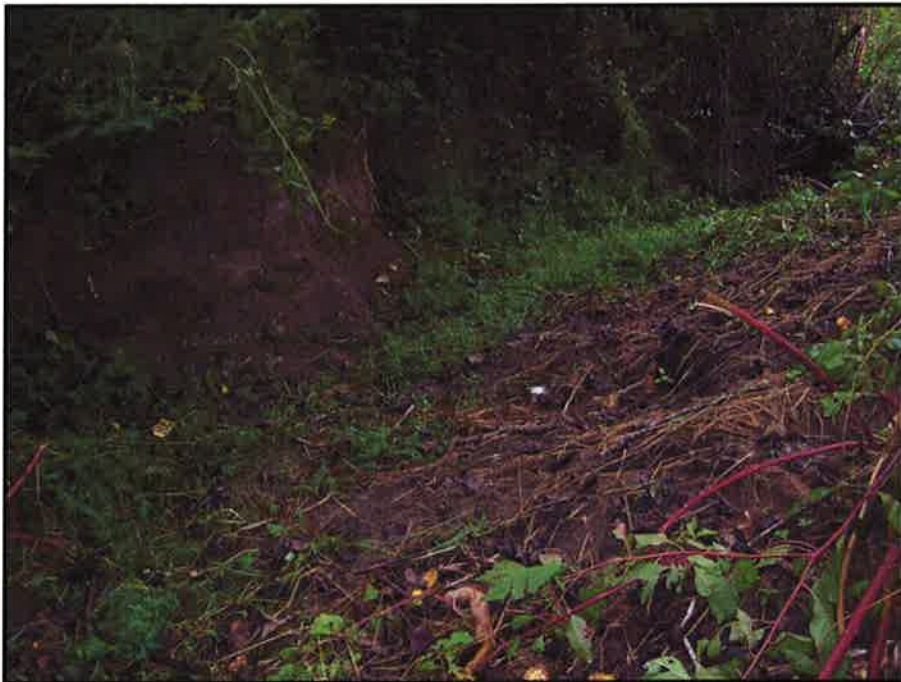
SPA 2

Areas of bank scour noted on UTA include a few small areas of minor streambank erosion. Because these areas are small, the use of mechanical means to regrade the banks is not warranted. The areas noted are located in short, narrow channel reaches surrounded by existing forested cover. Any areas deemed to require maintenance to improve stability will be stabilized using vegetative means by seeding with a mix appropriate for partial shade conditions. Erosion matting will be placed on any exposed ground to protect the slopes until the seed established appropriate cover. Live stakes may be installed to enhance stability in areas of nearly vertical banks.

**Bank scour along Unnamed Tributary A near station 2+60.
(EMH&T, Inc. 9/17/09)**

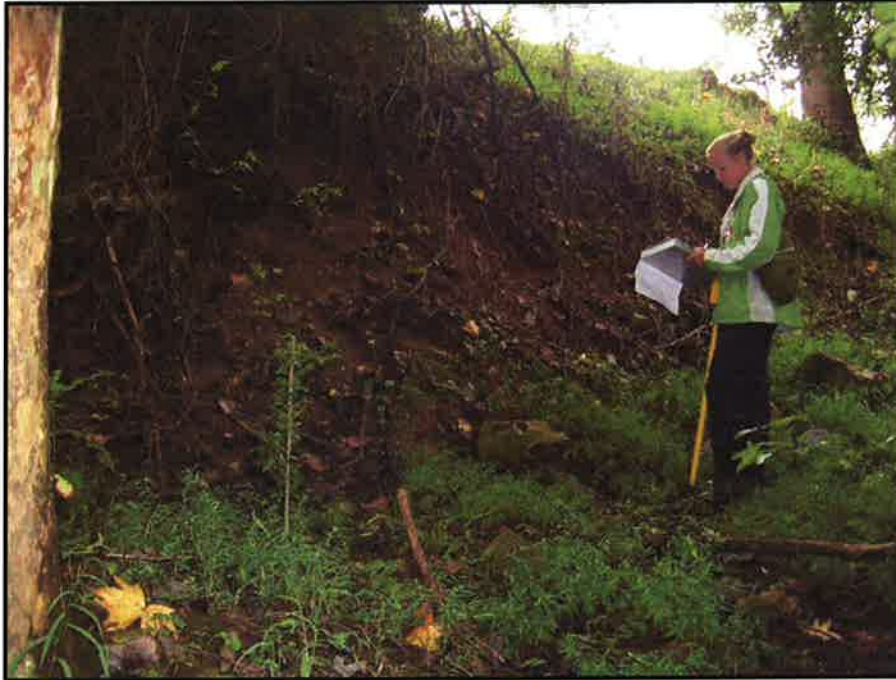
An additional area of concern exists along UTA concerning the steep slopes of the stream banks, also noted by EEP during the construction completion site visit. These banks had been regraded to stable slope conditions; however, this is one of the areas impacted by the cattle intrusion. These slopes will be reseeded with a mix of grass and forb seeds appropriate for steep slope and partially shaded conditions. Erosion matting will be placed on any exposed ground to protect the slopes until the seed established appropriate cover. Live stakes may be added where necessary to enhance stability.

SPA 3
Vertical bank along Unnamed Tributary A near station 8+50.
(EMH&T, Inc. 9/17/09)

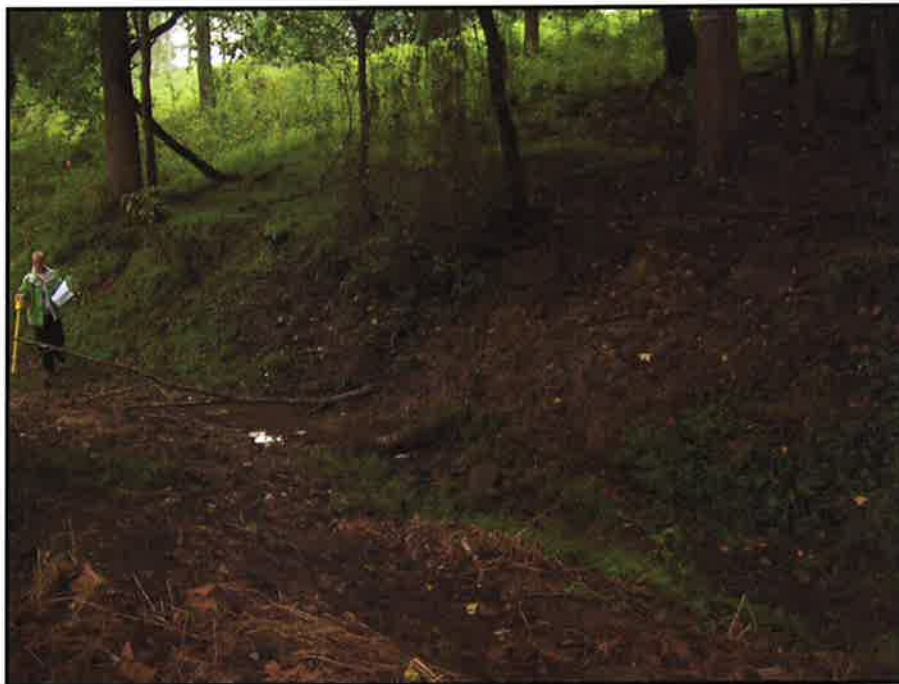
In the late summer of 2009, a tree fell across the protective easement fencing and provided an avenue for cattle access into both the channel and riparian corridor along UTA. The cattle damage along the riparian corridor resulted in mortality to planted woody stems, damage to native woody species, and trampling of the herbaceous understory vegetation. Seeding has been placed on areas of bare ground exposed by the cattle. Tree and shrub species appropriate for partial shade conditions will be planted in the spring of 2010 to replace those woody species damaged by the cattle. The cattle also accessed the stream channel itself, causing hoof shear along the downstream portion of the restored channel. Minor repairs of the bed and bank of the channel were made to address the disturbance. One riffle has been rebuilt to restore the designed grade.

SPA 4
Cattle damage along vertical banks along Unnamed Tributary A near station 11+50.
(EMH&T, Inc. 9/17/09)

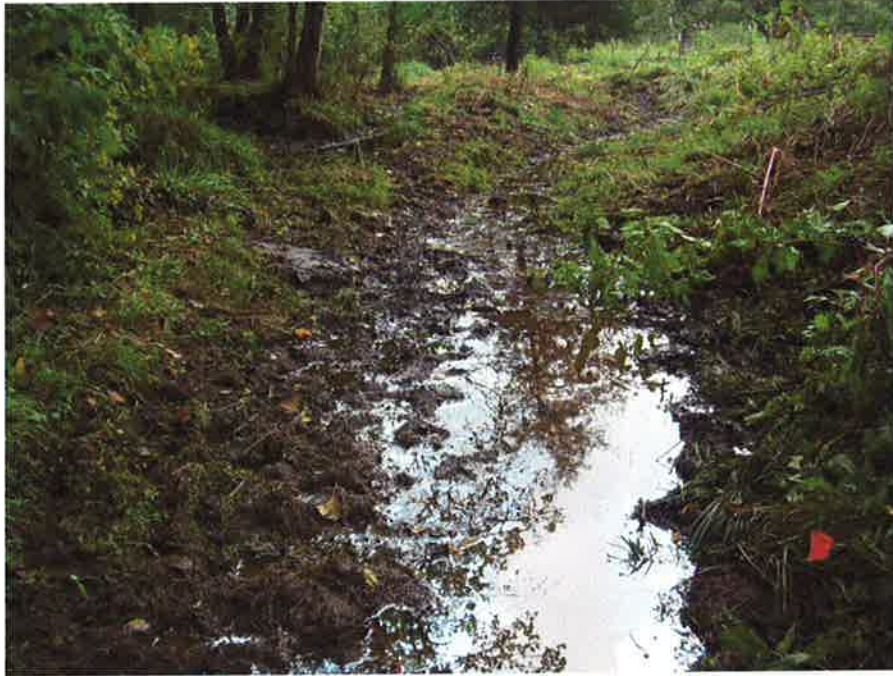
SPA 5

**Cattle intrusion into channel of Unnamed Tributary A near station 13+00.
(EMH&T, Inc. 9/17/09)**
