Year 4 Monitoring Report for Stream Restoration of Silver Creek and Unnamed Tributaries

Burke County, NC
SCO # D05016-01

Submitted: February 2011

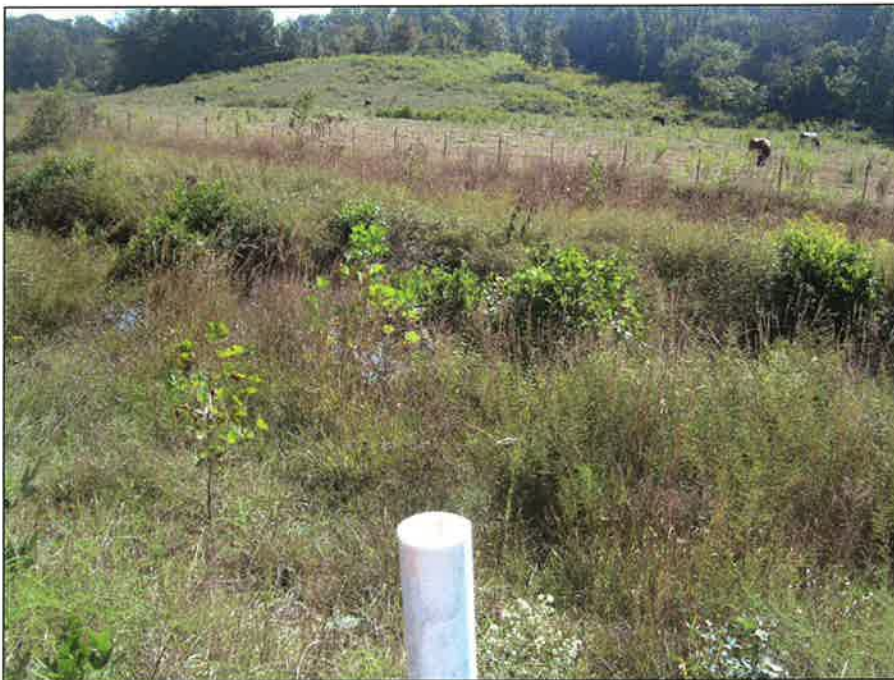
**Vegetation Plot 2 on Mainstem
Monitoring Year 4
Photo blurred due to rainstorm.
(EMH&T, Inc. 9/17/10)**

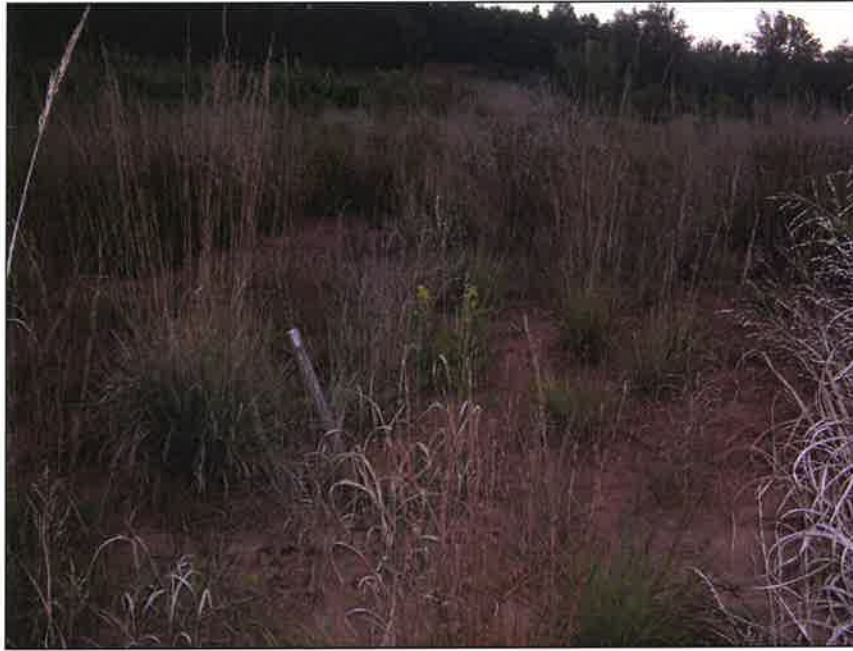
Table VII. Vegetative Problem Areas Silver Creek Stream Restoration / EEP Project No. D05016-1			
Feature/Issue	Station # / Range	Probable Cause	Photo #
Bare Floodplain	Mainstem: 12+00-16+50	Sparse vegetation along riparian corridor; likely due to poor soil	VPA 1

A few areas along the Silver Creek Mainstem were noted to have low overall herbaceous cover along the riparian corridor. These areas are patchy and scattered throughout the corridor, with none of the areas showing banks that are completely bare. Along the majority of the riparian corridor, vegetation cover has increased since Year 3 monitoring, as is depicted in the fixed station photos (Appendix B). Because of extensive vegetation growth, all other areas along the riparian corridor have been removed from Table VII and the Vegetation Problem Area Plan view (Appendix A). Between stations 12+00 and 16+50, bare soil remains evident on both sides of the corridor. It is fully expected that vegetation will continue to spread into this section over the next year. Accordingly, this stretch of the mainstem remains on Table VII and is mapped on the Vegetation Problem Area Plan View as an area of low concern.

The soil along this project is a mix of sand and gravel, and as such, provides very dry conditions in which seed must germinate and grow. In 2009, fencing was placed across the stream to prevent cattle access from the offsite project. Now that the cattle have been excluded, it is expected the permanent ground cover growing in the corridor will spread to fill the bare areas.

View of sparse vegetation in the floodplain along the mainstem.
(EMH&T, Inc. 9/17/10)

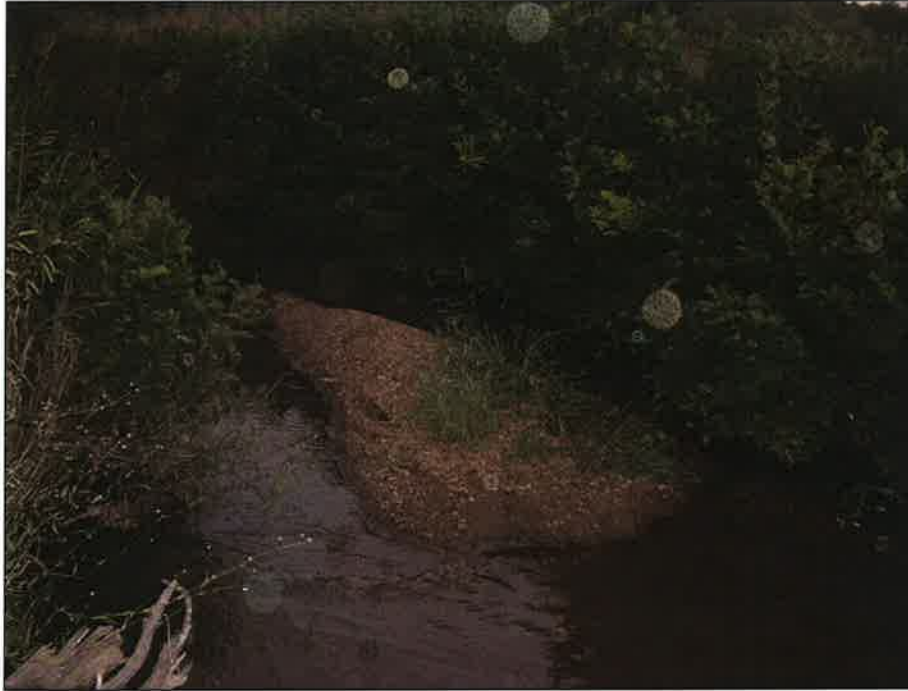
Table Xd. Stream Problem Areas – Year 4			
Silver Creek Stream Restoration / EEP Project No. D05016-1			
Feature Issue	Station Numbers	Suspected Cause	Photo Number
Aggradation	19+50 Mainstem	Mid-channel bar downstream of J-hook	SPA 1
Scour	28+ 50Mainstem	Bank scour hole- left bank	SPA 2

One small area of aggradation was noted along the Silver Creek Mainstem. The mid-channel bar that has formed downstream of a J-hook feature is small and is not posing a threat to stream stability. A small scour hole has also formed at station 28+50 on the mainstem. This left-bank scour is minor and appears to be well vegetated and stable. Both features are noted as problem areas of low concern and will be checked in Year 5 to reassess stability.

**Area of aggradation (mid-channel bar) near station 19+50 on Silver Creek.
(EMH&T, Inc. 9/17/10)**
