Subject: Year 5 Monitoring Report for Stream Restoration of Silver Creek and Unnamed Tributaries
SCO# D05016-01

Year 5 Monitoring Report for Stream Restoration of Silver Creek and Unnamed Tributaries

Burke County, NC
SCO # D05016-01

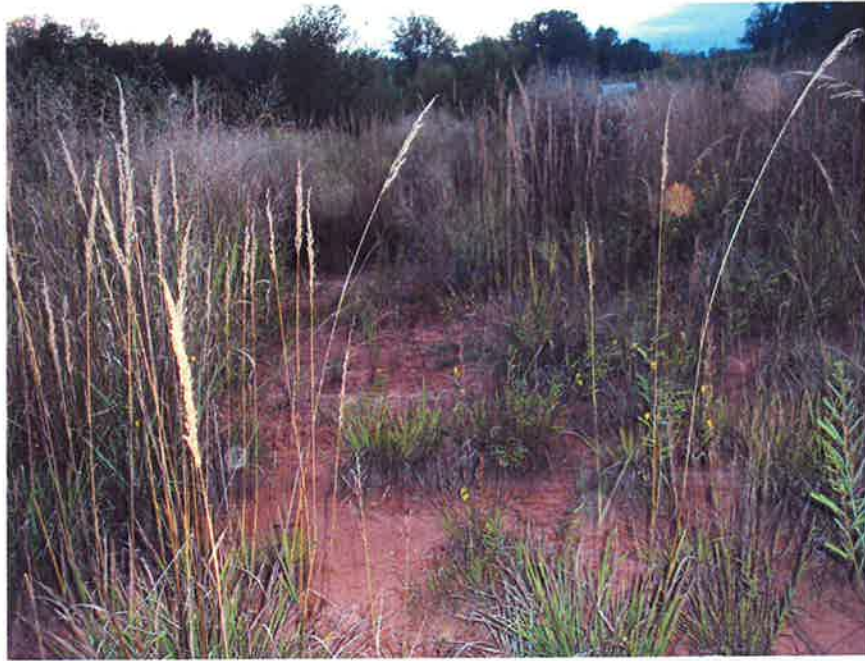
VPA 1

A few areas along the Silver Creek mainstem were noted to have low overall herbaceous cover along the riparian corridor. These areas are patchy and scattered throughout the corridor, with none of the areas showing banks that are completely bare. Along the majority of the riparian corridor, vegetation cover has increased since Year 4 monitoring, as is depicted in the fixed station photos (Appendix B). Because of extensive vegetation growth, all other areas along the riparian corridor have been removed from Table VII and the Vegetation Problem Area Plan view (Appendix A). Between stations 12+00 and 16+50, bare soil remains evident on both sides of the corridor. It is apparent that the density of vegetation in this area has increased since 2010 monitoring, however. It is fully expected that vegetation will continue to spread into this section in future years. Accordingly, this stretch of the mainstem remains on Table VII and is mapped on the Vegetation Problem Area Plan View as an area of low concern.

The soil along this project is a mix of sand and gravel, and as such, provides very dry conditions in which seed must germinate and grow. In 2009, fencing was placed across the stream near the upstream terminus of the project in order to prevent cattle access from the adjoining property. Now that the cattle have been excluded, it is expected the permanent ground cover growing in the corridor will spread to fill the bare areas.

**View of sparse vegetation in the floodplain along the mainstem at station 13+50.
(EMH&T, 9/16/11)**

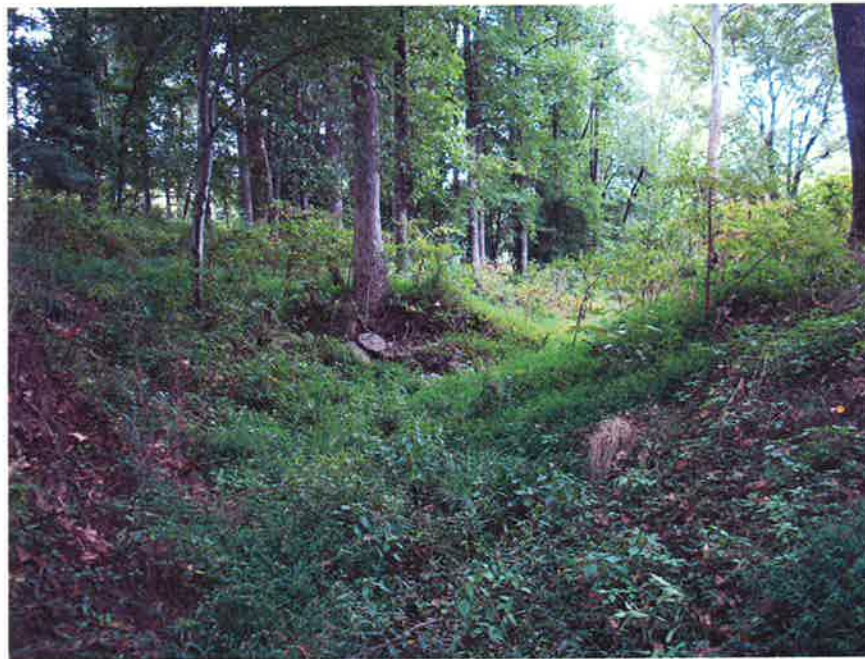
VPA 2

In Year 5, it was observed that Japanese stiltgrass had infiltrated the corridor along the majority of UT-A. Shade from the secondary growth canopy along UT-A allows soil on the floodplain to remain damp and periodic downpours provide an avenue for natural disturbance. These conditions are prime for Japanese stiltgrass because it prefers moist and disturbed soils. Although it is invasive, its spread along UT-A does not appear to be affecting the survival of planted species. It

is also providing a moderate amount of bank stabilization for many of the naturally steep banks of the tributary. Herbicide treatment has been recommended to help control the spread of this plant. Spraying is scheduled for the spring of 2012. The stiltgrass population along UT-A is mapped on the Vegetation Problem Area Plan View (Appendix A) as a problem area of low concern.

**View of Japanese stiltgrass (*Microstegium vimineum*) infiltration along the Unnamed Tributary 1 (UT-1) at station 8+25.
Photo direction faces downstream.
(EMH&T, 9/16/11)**

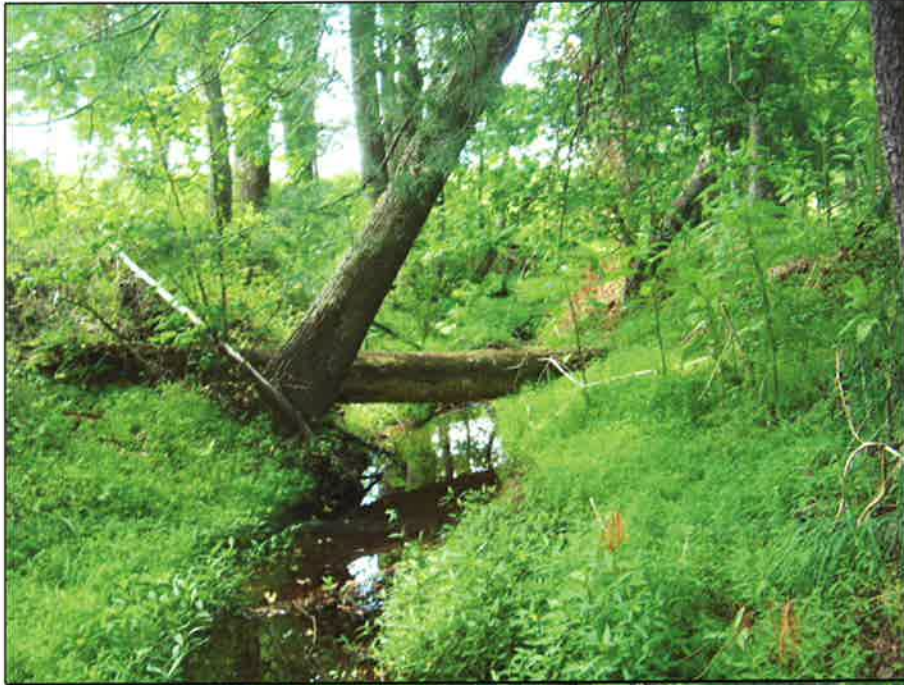
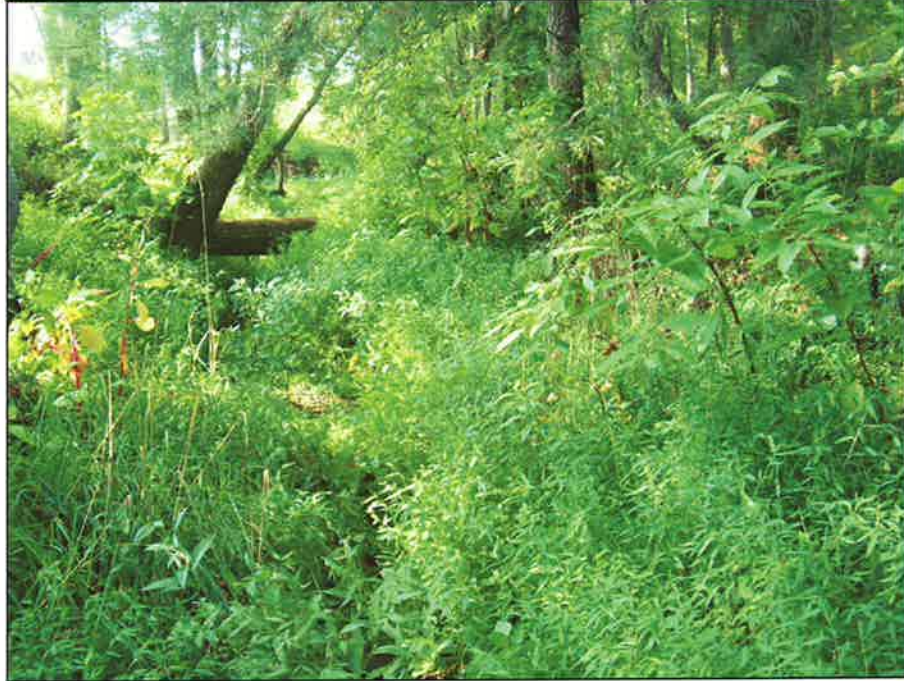
Fixed Station 7
Overview of UT-A, facing upstream near station 8+00.
Year 5 – top photo (EMH&T, 9/16/11)
Year 2- bottom photo (EMH&T, 8/8/08)

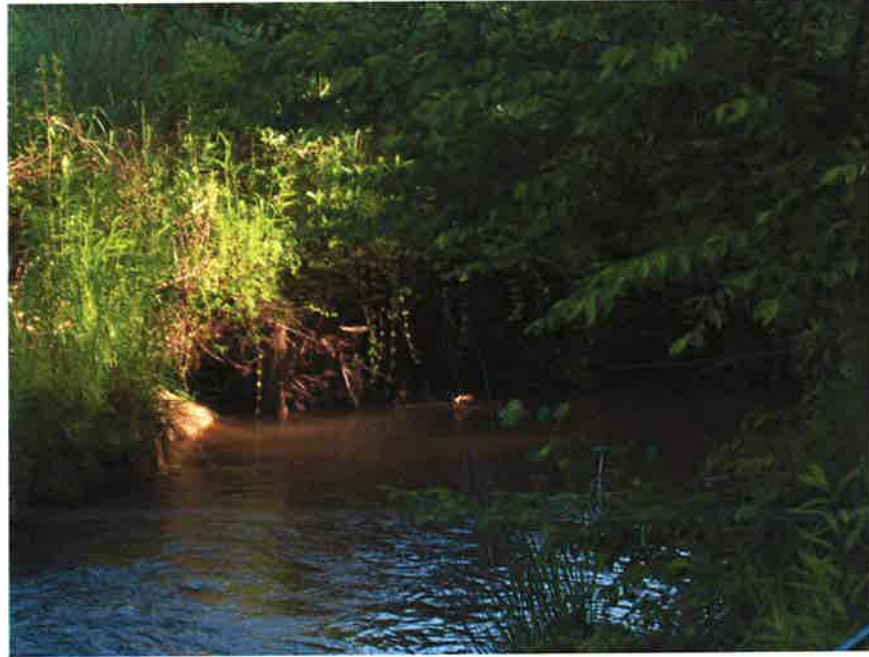
SPA 1

**Area of scour on the right bank of Silver Creek near station 28+50.
(EMH&T, 9/16/11)**

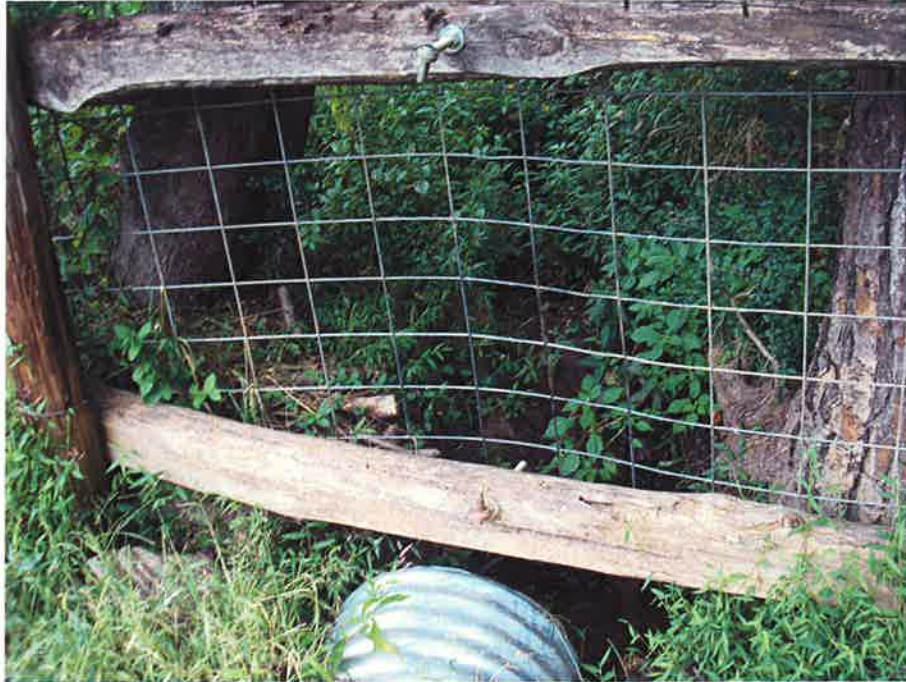
Cattle Crossing Photo - 1
UT1 as it enters culvert of newly constructed cattle crossing.
(EMH&T, 9/16/11)

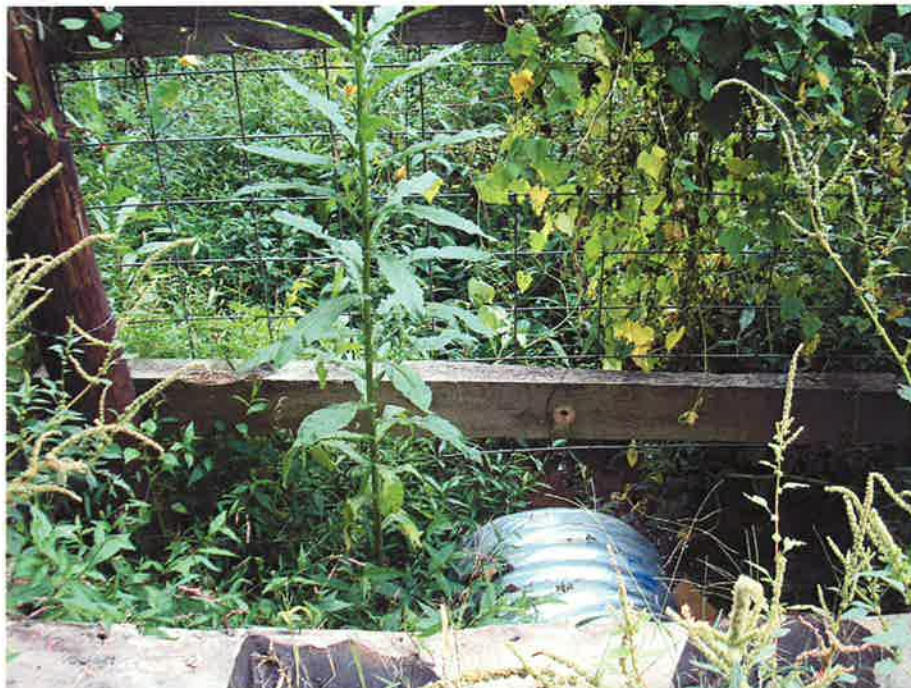
Cattle Crossing Photo - 2
UT1 as it exits culvert of newly constructed cattle crossing.
(EMH&T, 9/16/11)
