Sink Hole Creek Mitigation Project

Year 5 Monitoring Report

Mitchell County, North Carolina

Date Submitted: November, 2015

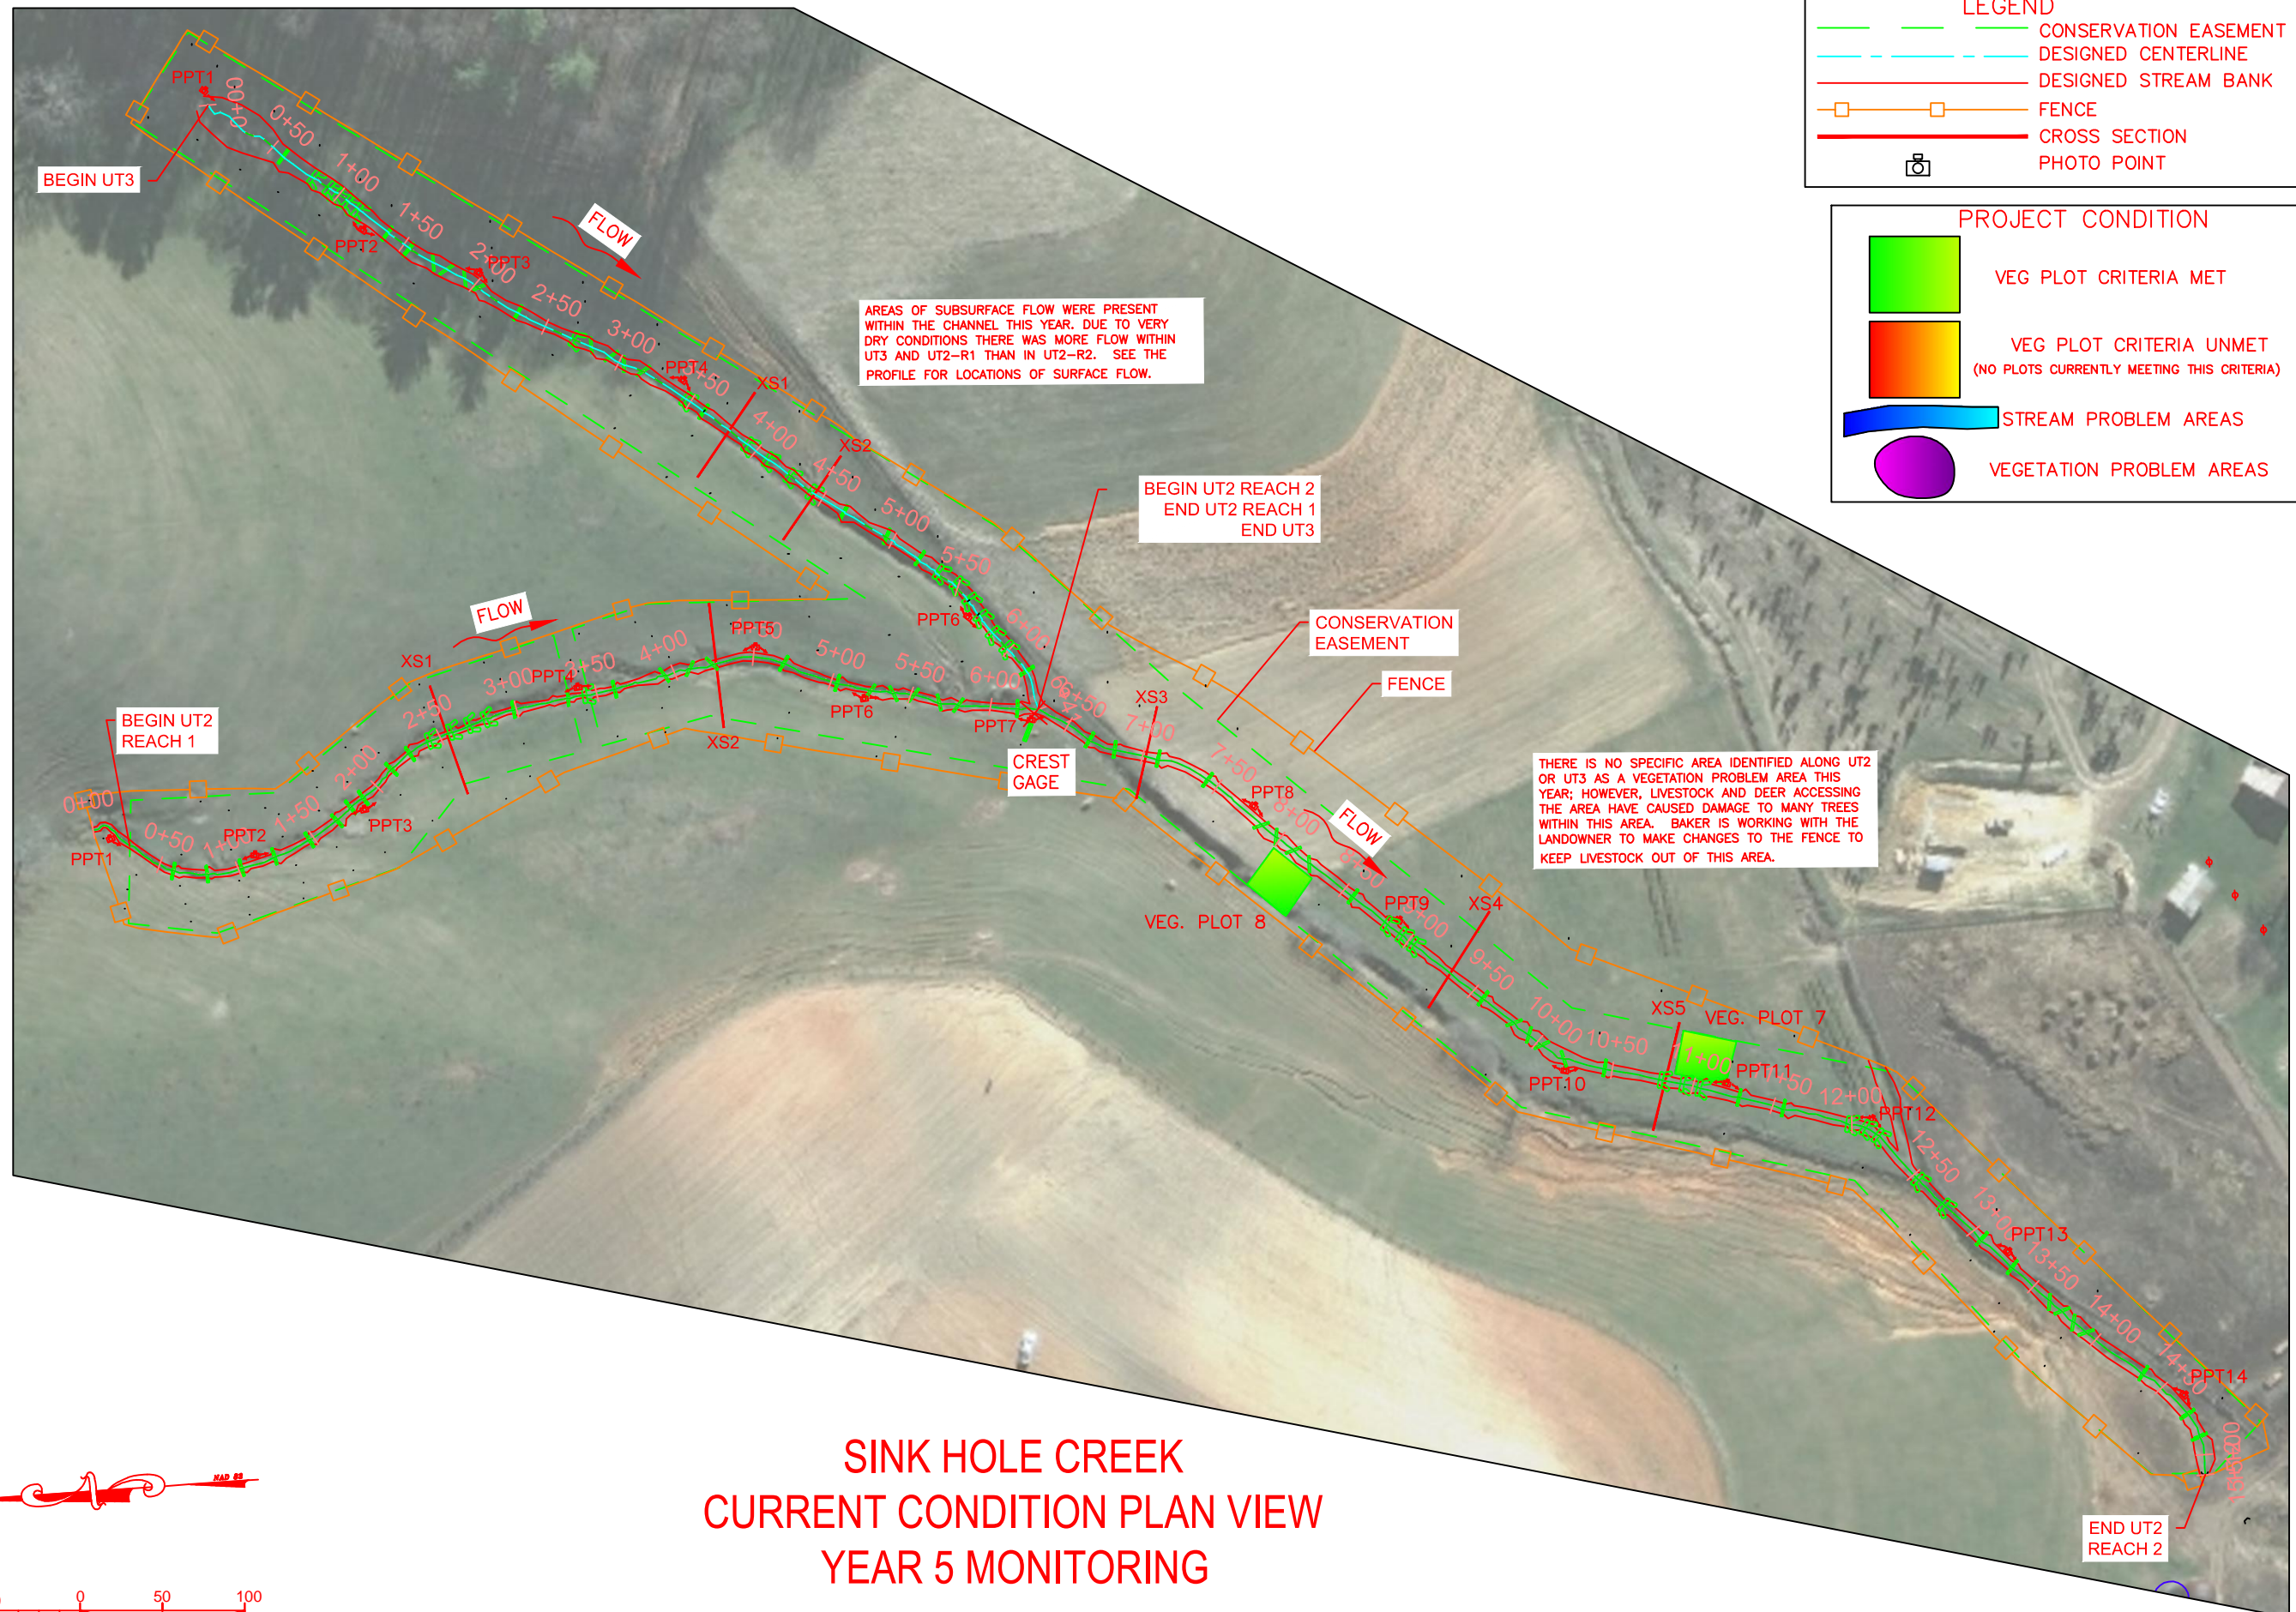
AREAS OF SUBSURFACE FLOW WERE PRESENT WITHIN THE CHANNEL THIS YEAR. DUE TO VERY DRY CONDITIONS THERE WAS MORE FLOW WITHIN UT3 AND UT2-R1 THAN IN UT2-R2. SEE THE PROFILE FOR LOCATIONS OF SURFACE FLOW.

THERE IS NO SPECIFIC AREA IDENTIFIED ALONG UT2 OR UT3 AS A VEGETATION PROBLEM AREA THIS YEAR; HOWEVER, LIVESTOCK AND DEER ACCESSING THE AREA HAVE CAUSED DAMAGE TO MANY TREES WITHIN THIS AREA. BAKER IS WORKING WITH THE LANDOWNER TO MAKE CHANGES TO THE FENCE TO KEEP LIVESTOCK OUT OF THIS AREA.
