# **FINAL (MYO) BASELINE MONITORING REPORT** **SIX RUNS STREAM AND WETLAND MITIGATION PROJECT**

Sampson County, North Carolina  
Cape Fear River Basin  
HUC 03030006

NCDMS Project #100170  
DMS Contract #0303-01  
RFP: 16-20190303 (Issued 12/20/2019)  
USACE Action ID: SAW-2020-01964 | DWR Project #20201798 v1

**August 2023**

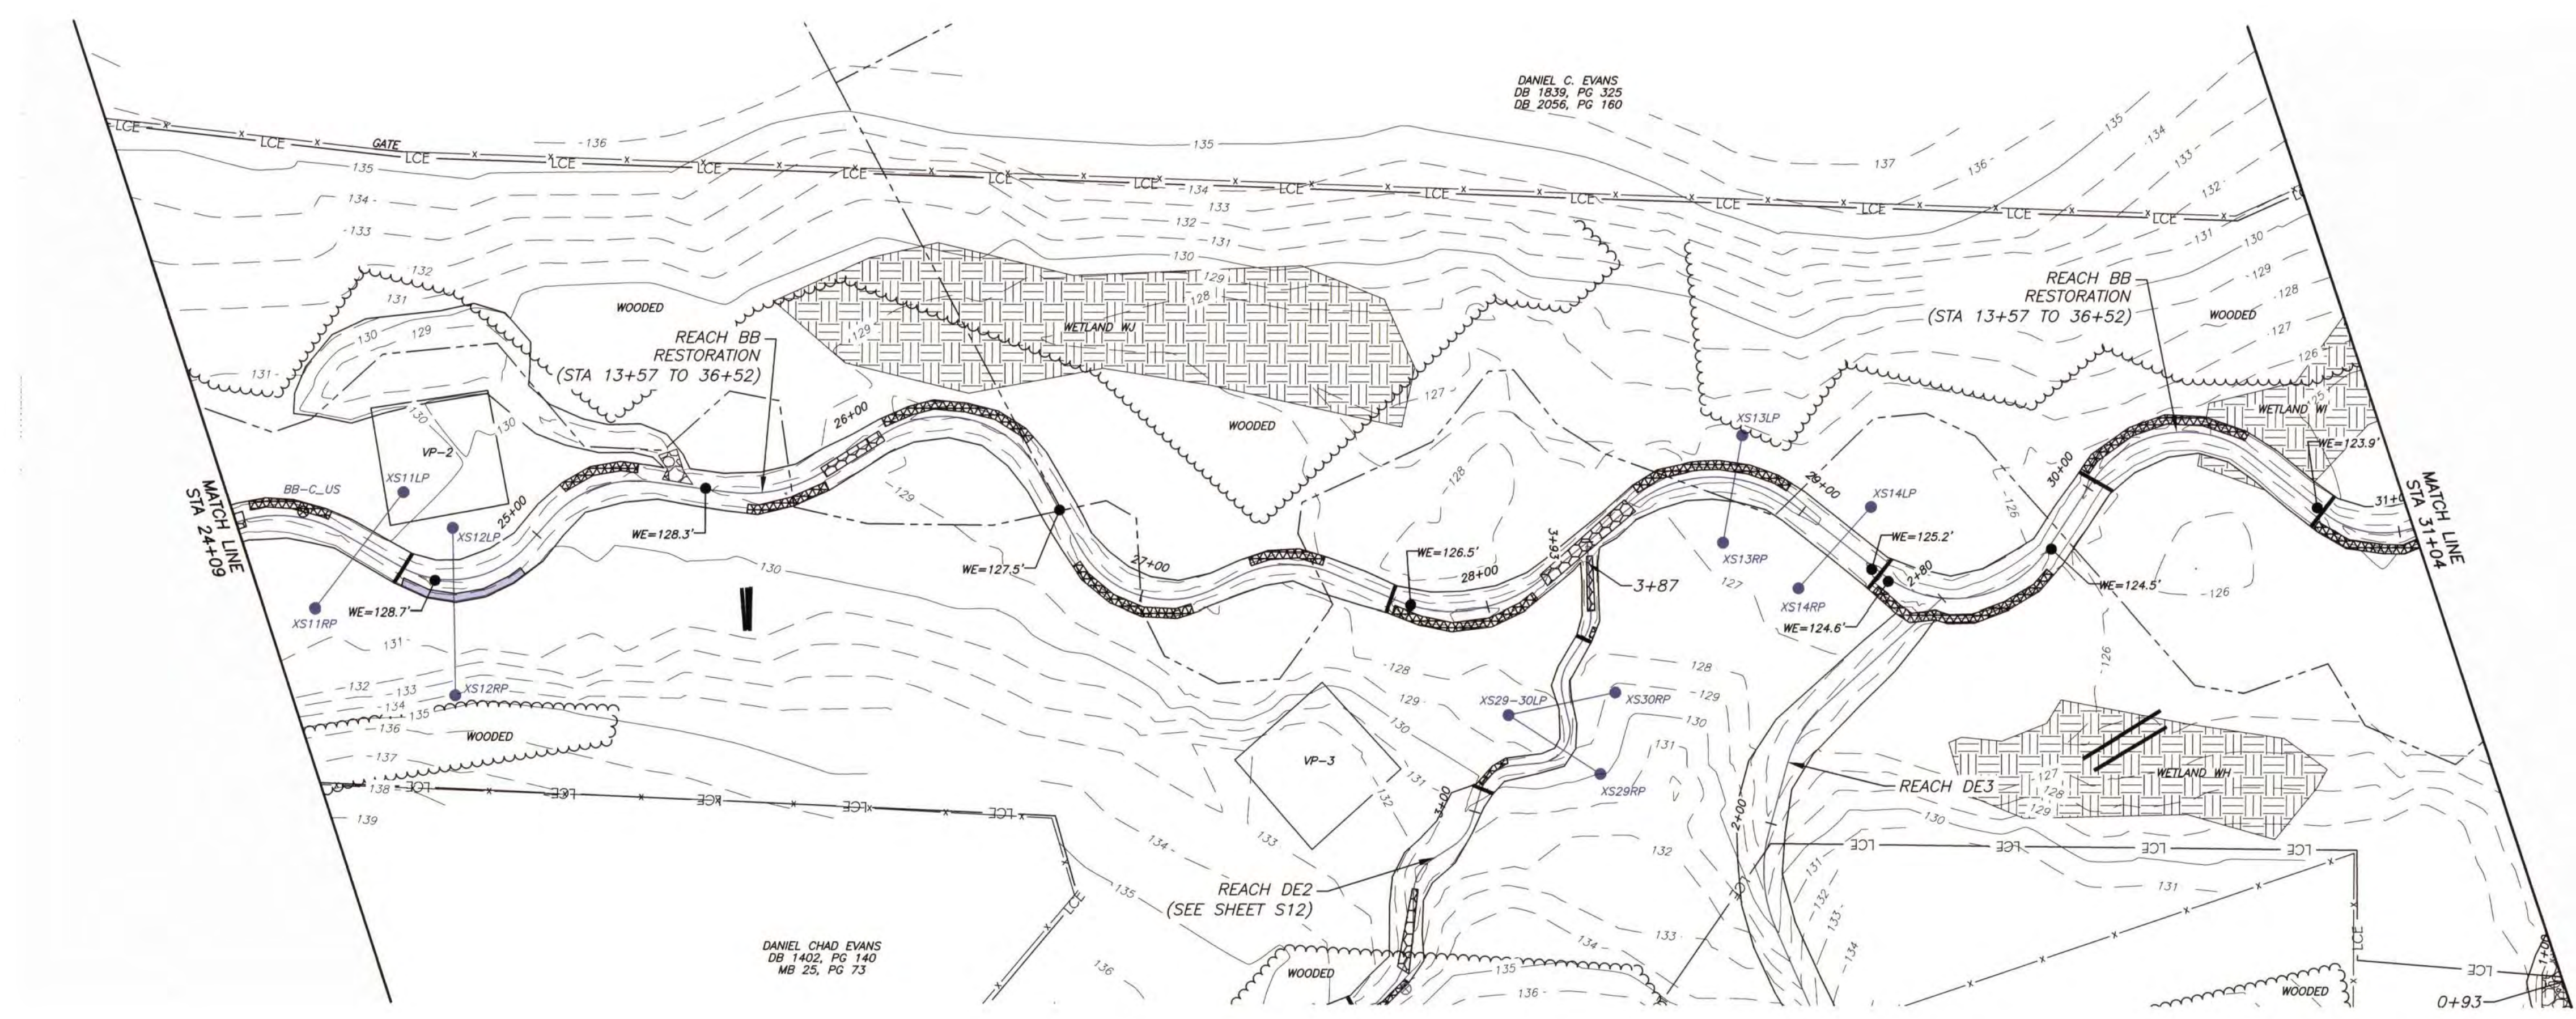
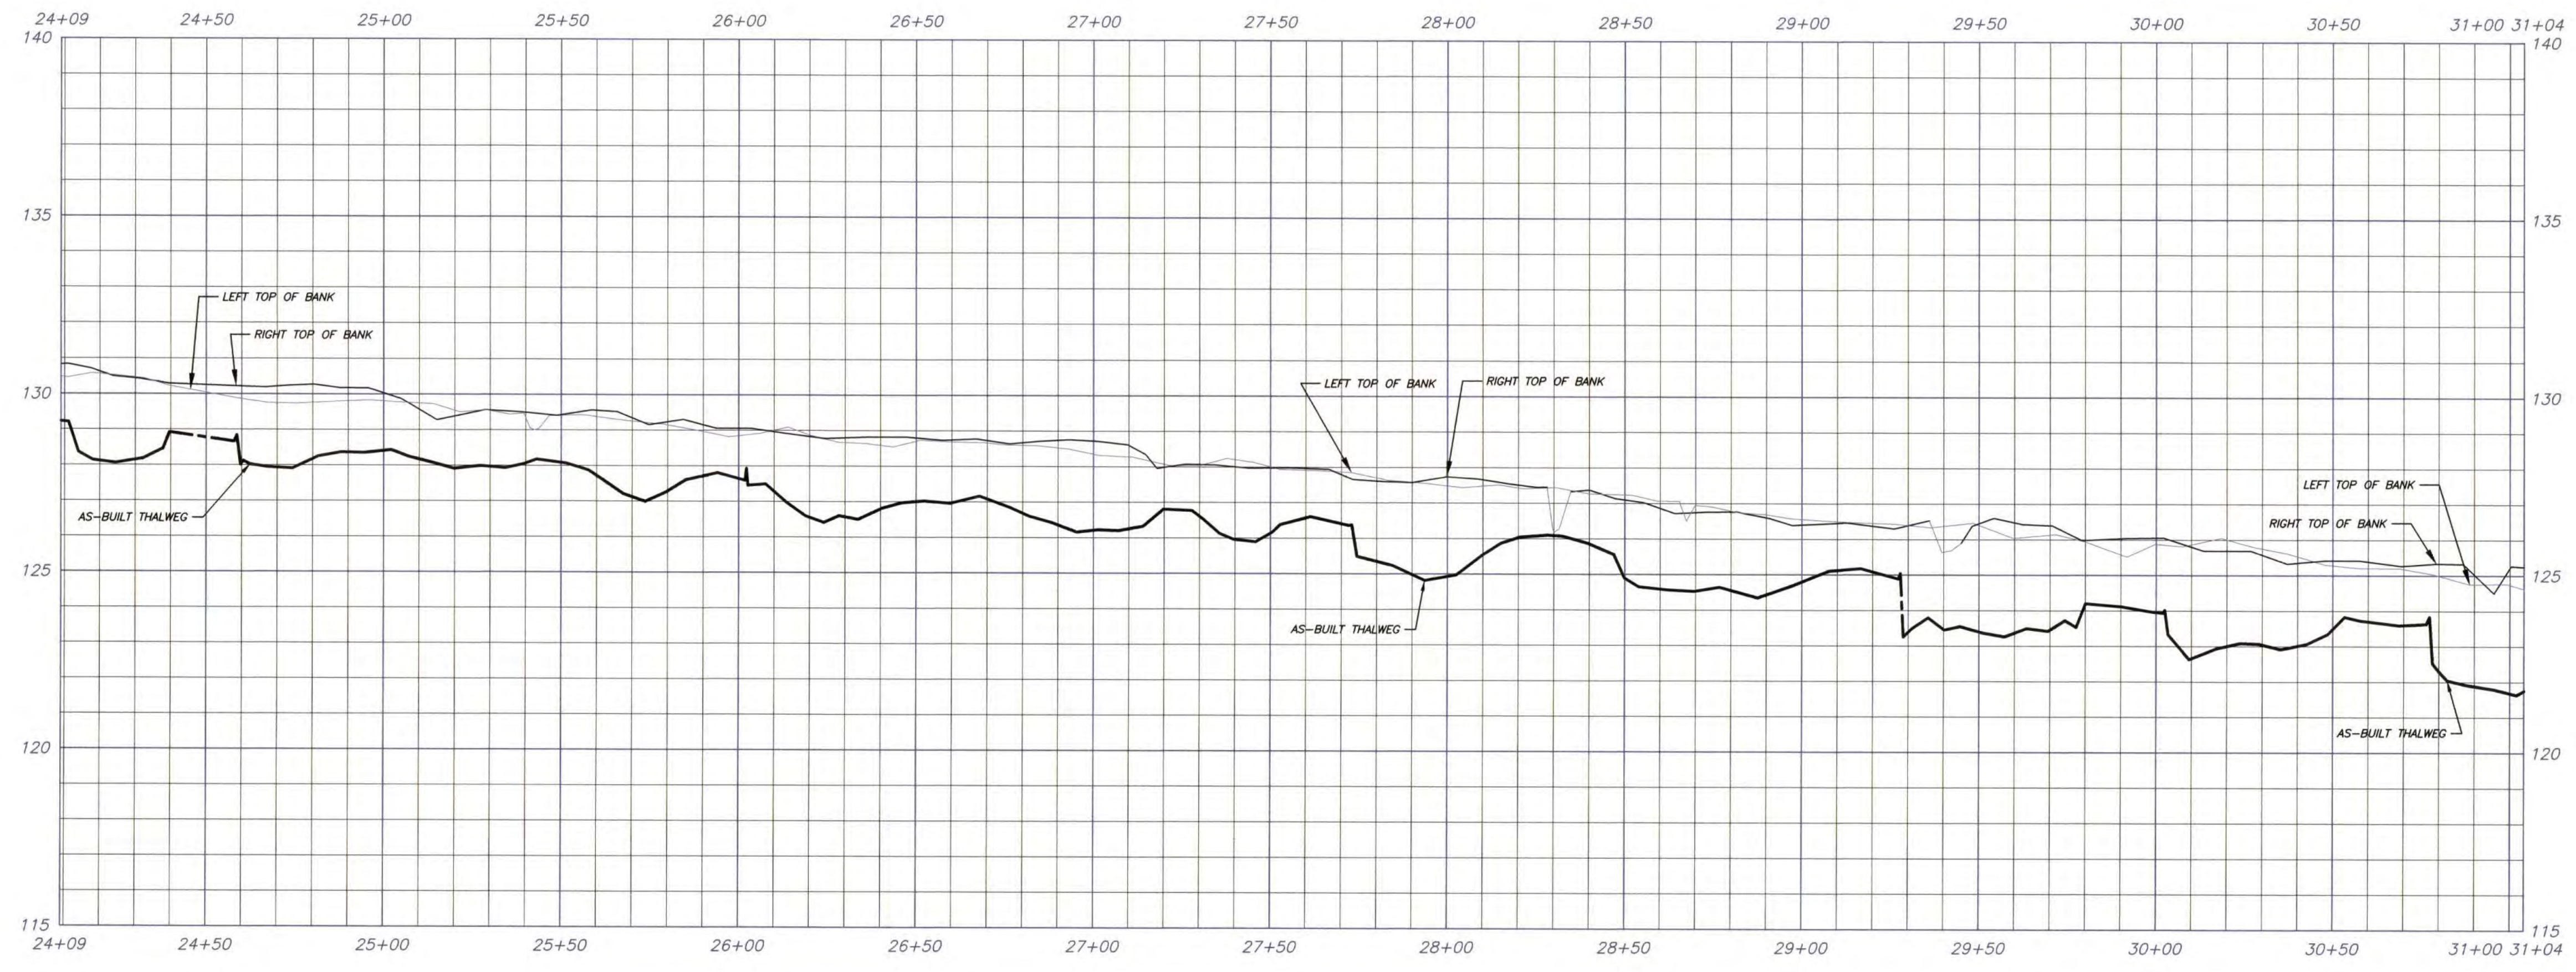
11. Sheet S6 – Log structure upstream of Sta. 35+00 was not surveyed but was found in the field. Also, log structure at Sta. 30+00 is shown as surveyed in as-built survey drawings (S7), but not the record drawings.  
Log sill upstream of Sta. 35+00 has been added along with a red callout.  
The surveyed log sill at Sta. 30+00 has been added to the record drawing sheets.
