FINAL
MONITORING REPORT (MY1)

SLINGSHOT MITIGATION SITE
Rockingham County, North Carolina

DMS Project ID No. 100058
Full Delivery Contract No. 7525
USACE Action ID No.SAW-2018-01170
DWR #20180795 RFP No. 16-007330

Data Collection: May - November 2020
Submission: January 2021

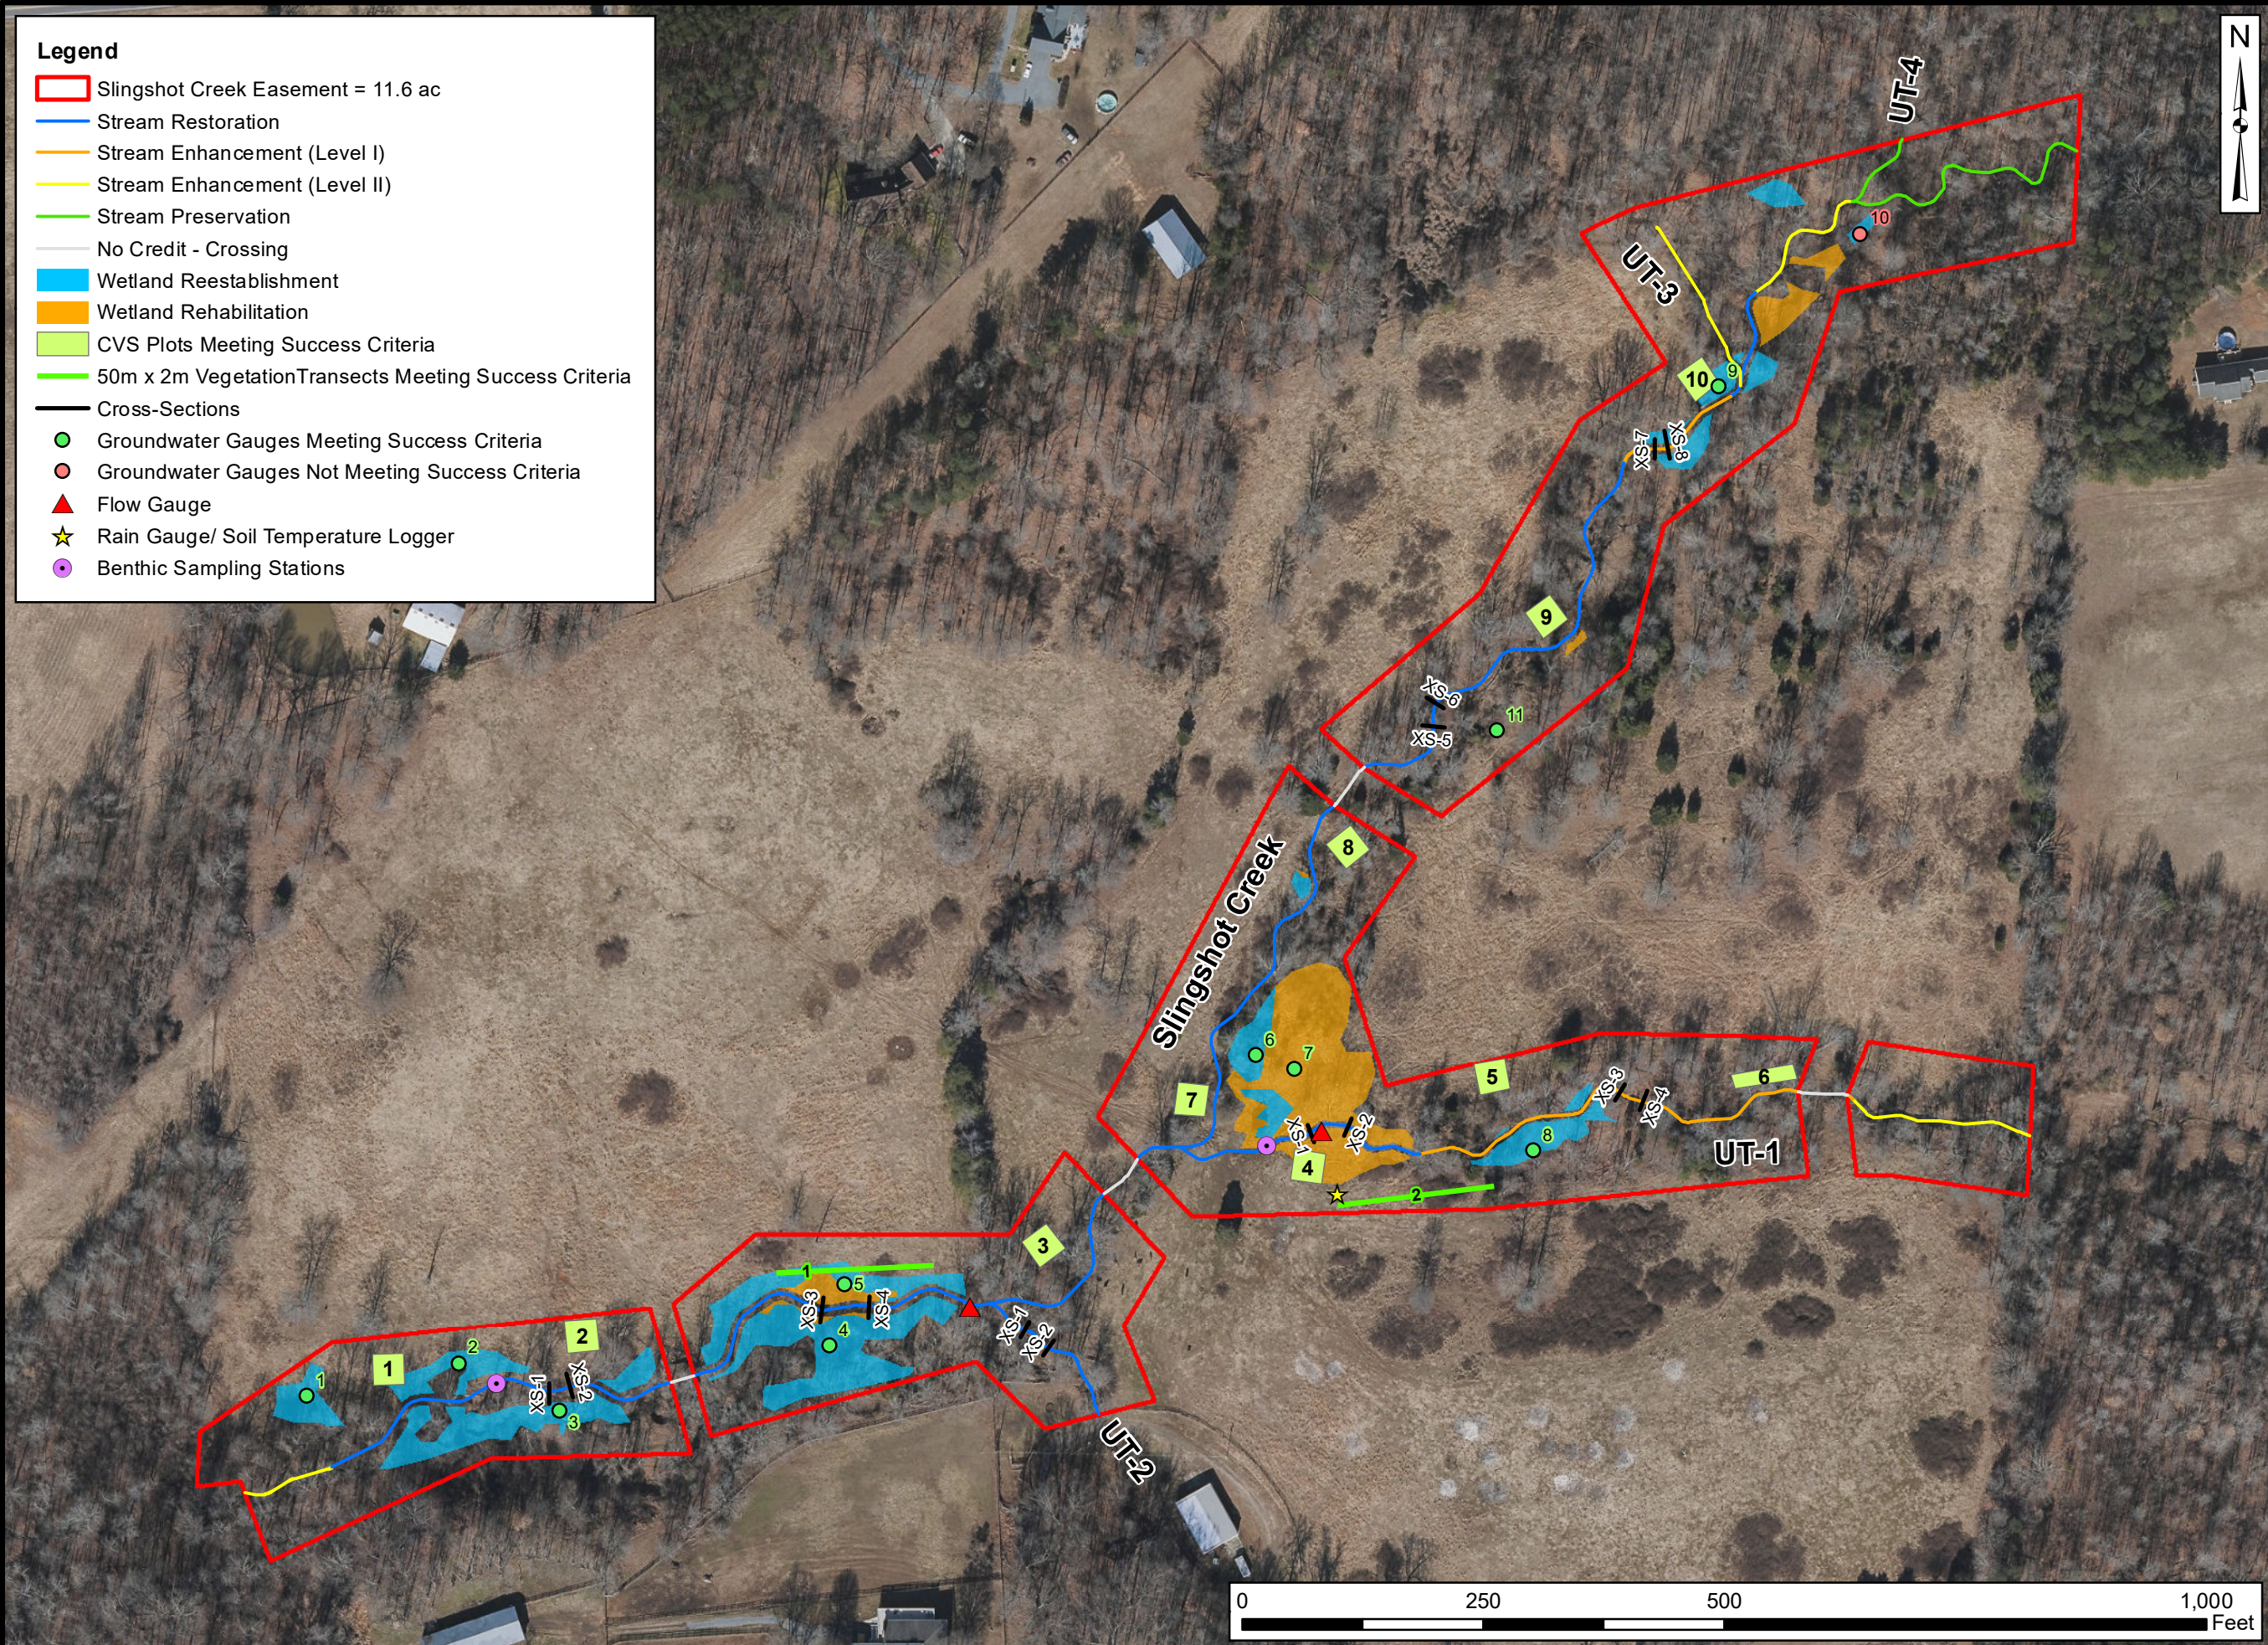
**CURRENT
CONDITIONS
PLAN VIEW**

2. Appendix B – Please include a feature depicting the 40 ft. of bank erosion in the CCPV (Figure 2), and include this feature in the digital submittal.
The bank erosion in Table 5 was misidentified by field personnel and mistakenly included in the draft Y1 Report. It has been removed from the document. All site reaches are stable and there are no areas of concern.

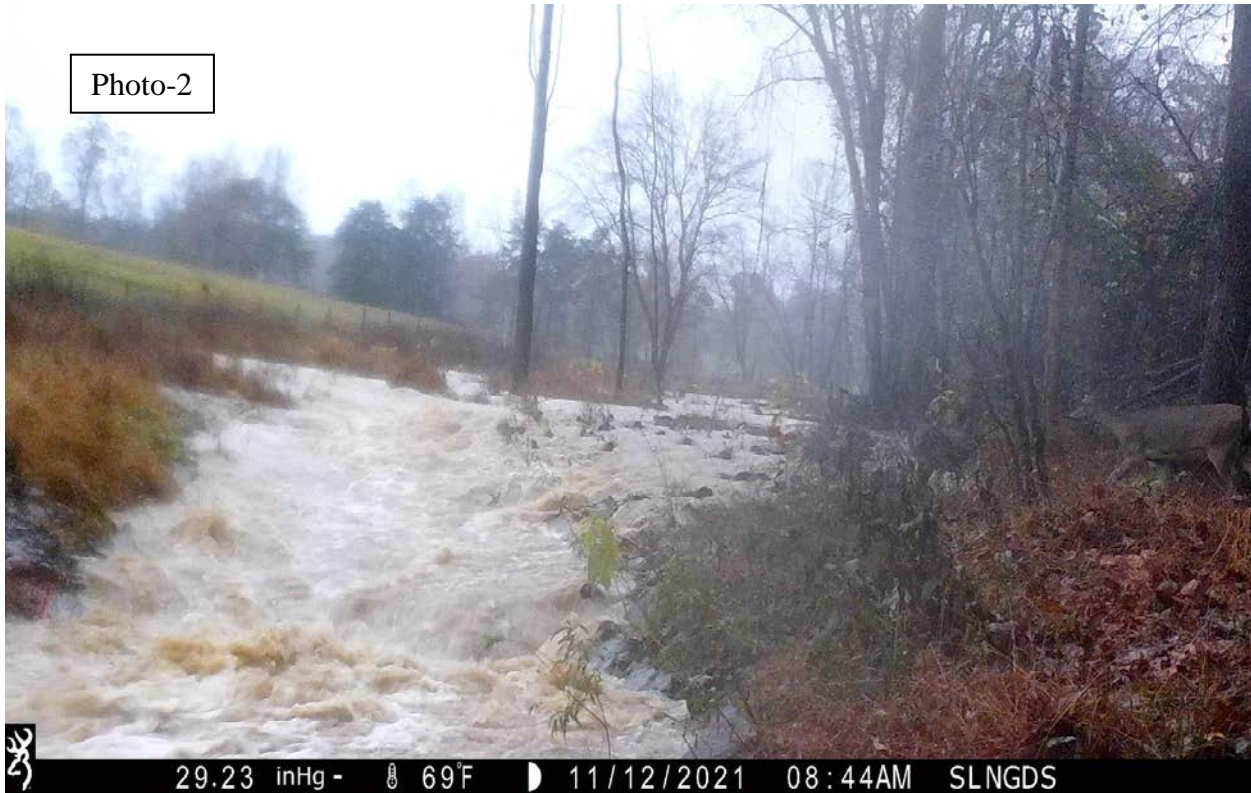
Photo-2

Date of Data Collection	Date of Occurrence	Method	Photo (if available)
June 3, 2020	May 21, 2020	Stream gauges and trail cameras captured a bankfull event after 5.37 inches of rain was documented between May 20th and 22nd, 2020 at an onsite rain gauge. Flow gauge recorded a stream stage of 2.15 feet.	1
November 18, 2020	November 12, 2020	Stream gauges and trail cameras captured a bankfull event after 3.1 inches of rain was documented between November 10th and 13th, 2020 at an onsite rain gauge. Flow gauge recorded a stream stage of 2.94 feet.	2, 3

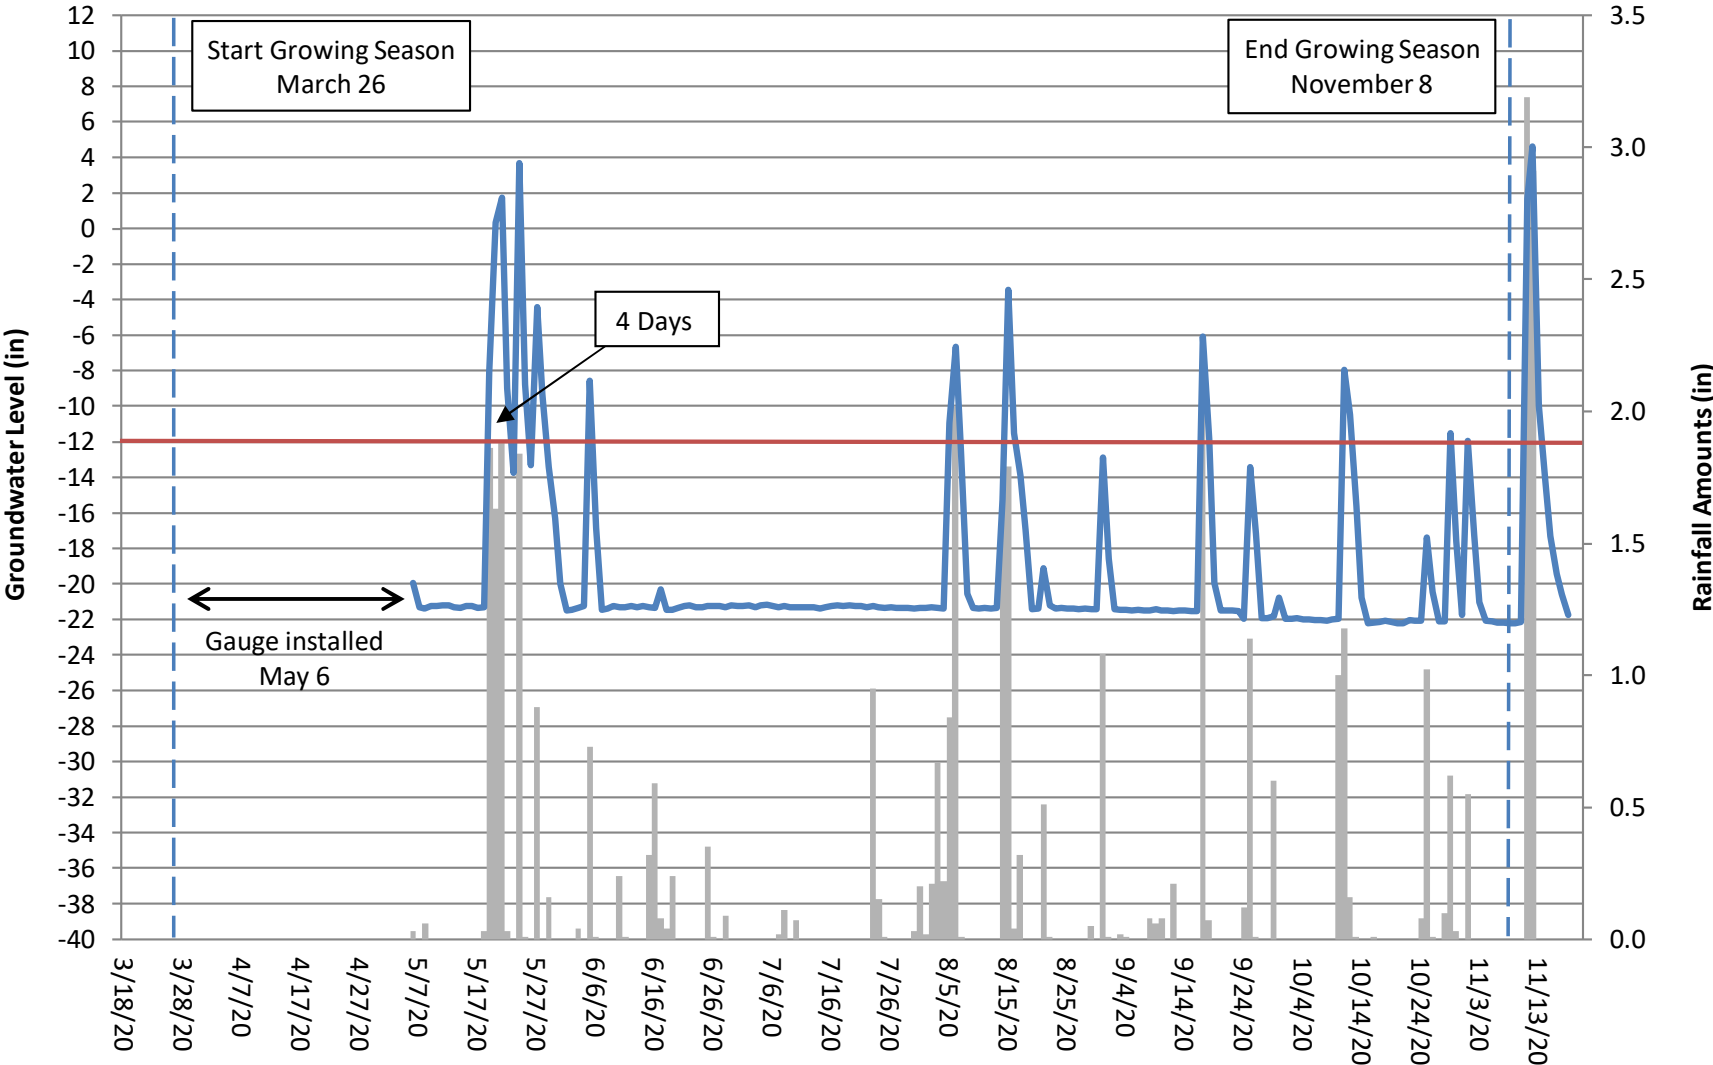
Slingshot Groundwater Gauge 10 Year 1 (2020 Data)

- Ten of Eleven groundwater gauges met success for the Year 1 (2020) monitoring period. Wetland hydrology data is in Appendix E.
