FINAL
MONITORING REPORT (MY2)

SLINGSHOT MITIGATION SITE
Rockingham County, North Carolina

DMS Project ID No. 100058
Full Delivery Contract No. 7525 USACE
Action ID No. SAW-2018-01170
DWR ID 20180795
RFP No. 16-007330

Data Collection: January - October
2021 Submission: January 2022

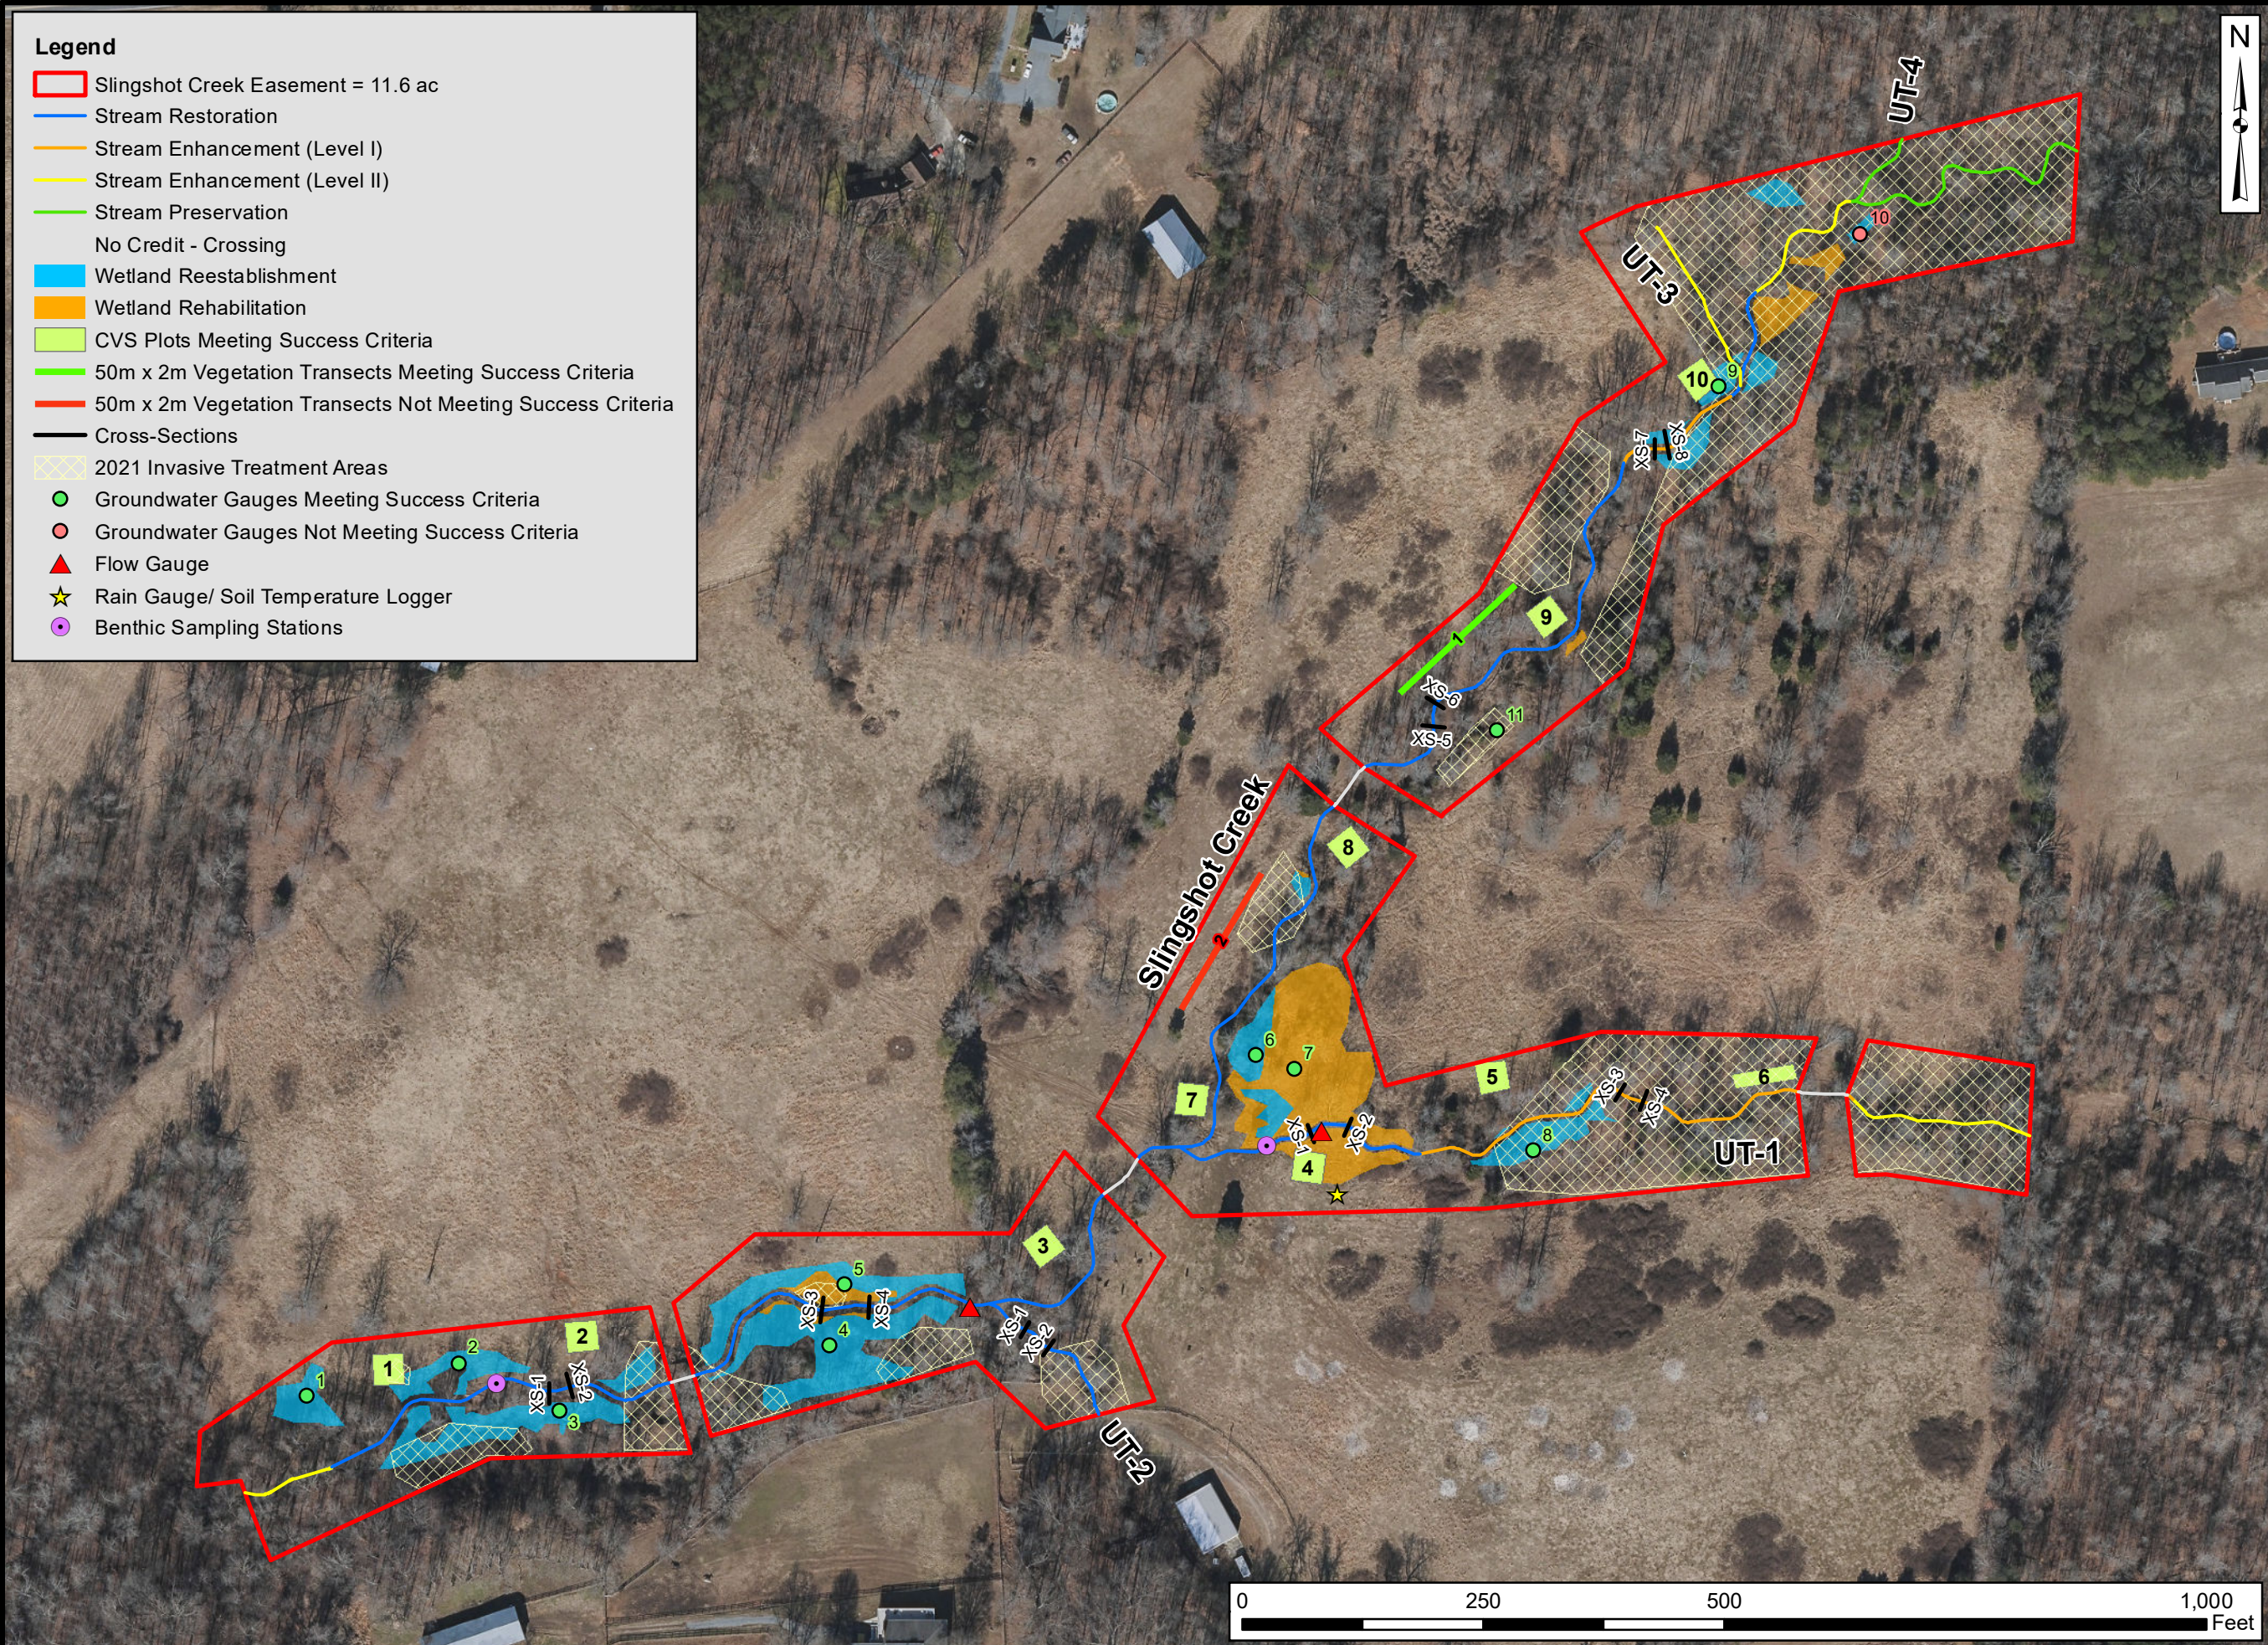
**CURRENT
CONDITIONS
PLAN VIEW**

1. The monitoring summary's Site Maintenance Report table shows three instances of invasive and nuisance vegetation management during the monitoring period. The treatment locations should be shown on the CCPV as points or polygons and areas shown on Table 6.
[Response: Invasive treatment areas have been included on the CCPV and Table 6.](#)

Vegetation Category	Definitions	Mapping Threshold	CCPV Depiction	Number of Polygons	Combined Acreage	% of Easement Acreage
4. Invasive Areas of Concern ⁴	Populations of cattail, kudzu, privet, multiflora rose, princess tree, and tree of heaven observed within the easement. All populations were treated during MY2 (2021).	1000 SF	yellow hatched polygons	13	4.57	39.4%
5. Easement Encroachment Areas ³	None	none	none	0	0.00	0.0%

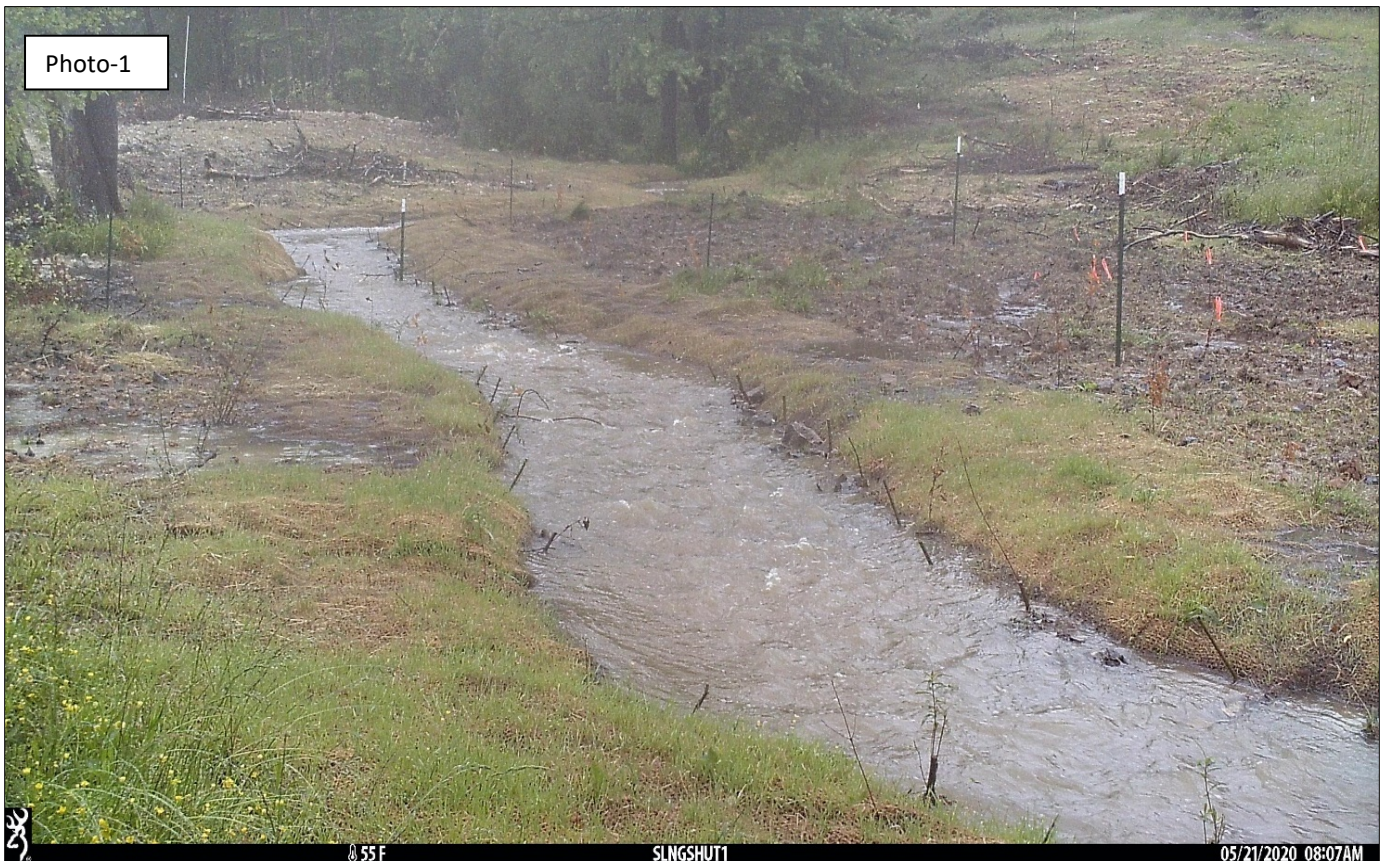
Date of Data Collection	Date of Occurrence	Method	Photo (if available)
June 3, 2020	May 21, 2020	Stream gauges and trail cameras captured a bankfull event after 5.37 inches of rain was documented between May 20th and 22nd, 2020 at an on-site rain gauge. Flow gauge recorded a stream stage of 2.15 feet.	1
November 18, 2020	November 12, 2020	Stream gauges and trail cameras captured a bankfull event after 3.1 inches of rain was documented between November 10th and 13th, 2020 at an on-site rain gauge. Flow gauge recorded a stream stage of 2.94 feet.	2, 3
February 25, 2021	February 15, 2021	Wrack was observed along the floodplain of Slingshot Creek and the crest gauge captured a bankfull event after 2.31 inches of rain was documented between February 12th and 15th, 2021 at an on-site rain gauge. The trail camera was damaged by the accompanying ice storm. Flow gauge recorded a stream stage of 1.45 feet.	4

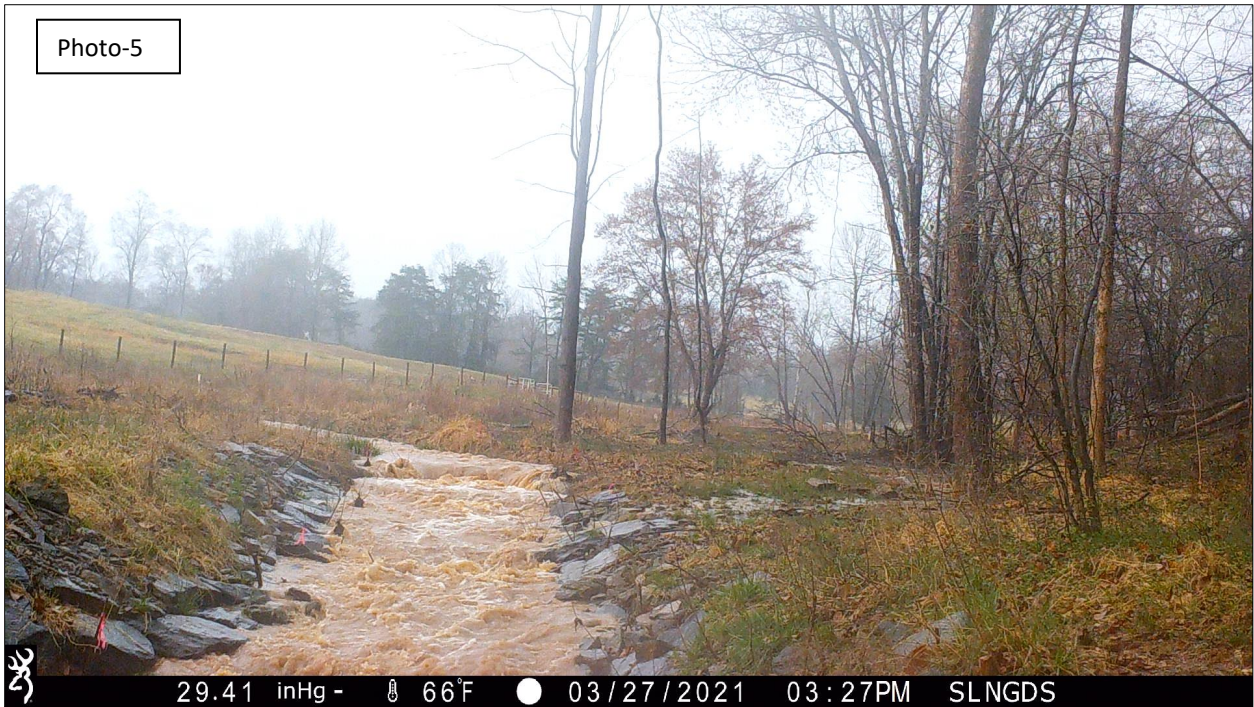
Photo-5

March 27, 2021	March 2, 2021	Stream gauges and trail cameras captured Slingshot Creek receding from a bankfull event after 1.45 inches of rain was documented between March 26th and 27th, 2021 at an on-site rain gauge. Flow gauge recorded a stream stage of 1.10 feet.	5

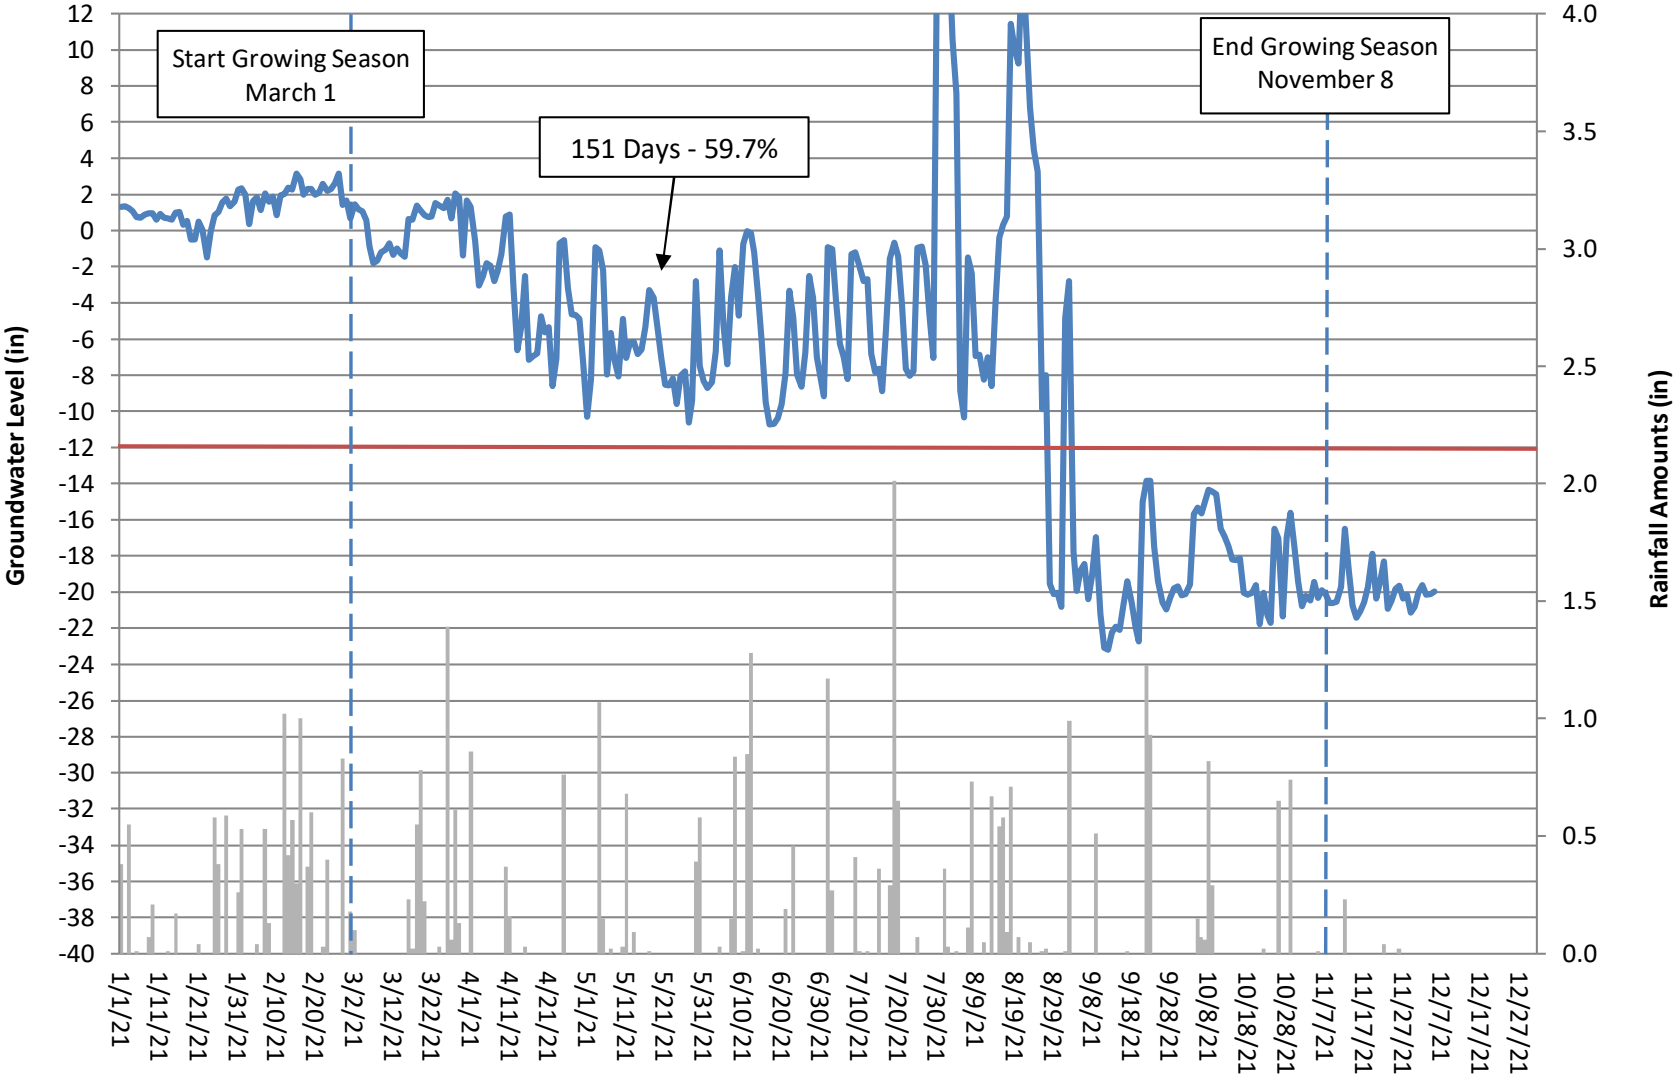
Slingshot Groundwater Gauge 11 Year 2 (2021 Data)

*Gauge 11 was installed in an area not previously identified for wetland reestablishment but appeared to be exhibiting wetland characteristics post-construction. During 2021 monitoring, the additional wetlands surrounding gauge 11 were delineated, resulting in approximately 0.52 acres of wetlands on-site that were not previously accounted for (Appendix F).

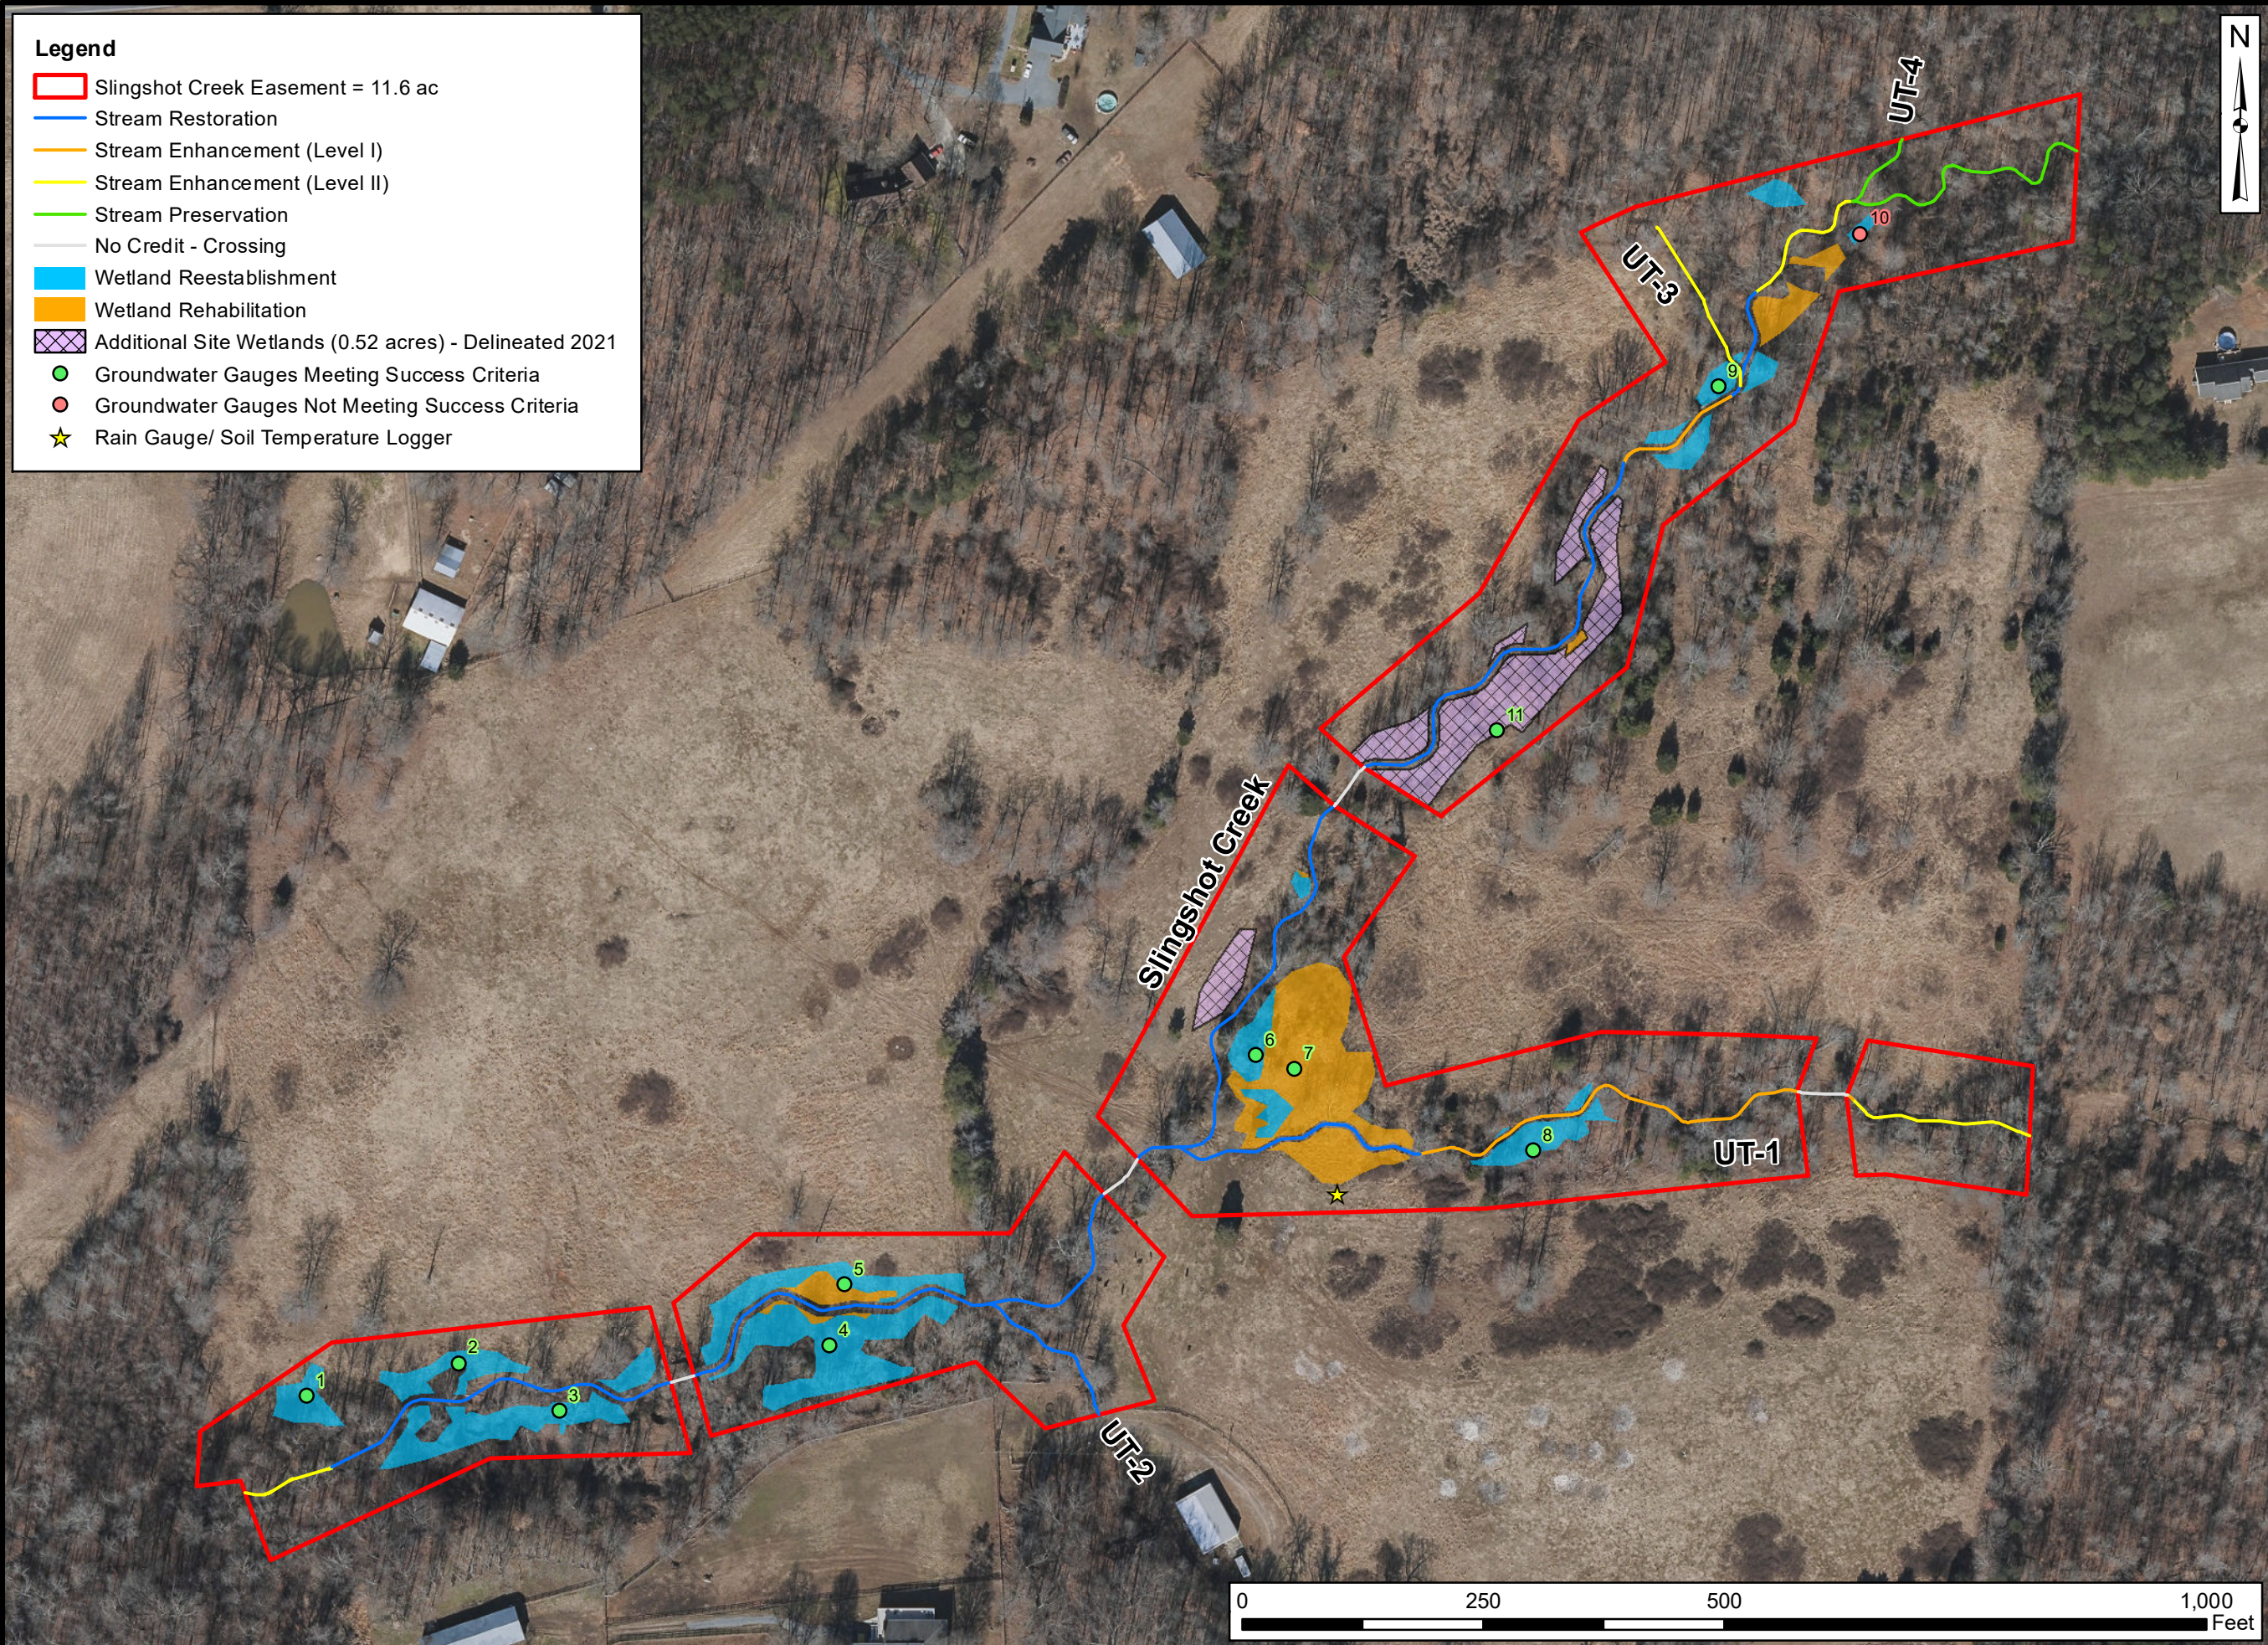
Figure F-1. Site Wetlands Overview

To further provide an understanding of the Site's wetland mitigation assets, RS mapped the additional wetland areas in the vicinity of Gauge 11 and along Slingshot Creek in the middle portion of the Site. Gauge 11 was installed in an area that was not previously identified for wetland reestablishment but appeared to be exhibiting wetland characteristics post-construction. Groundwater data for monitoring years 1 and 2 indicate that this area is trending toward successful wetland reestablishment of 0.52 acres.
