FINAL
MONITORING REPORT (MY4)

SLINGSHOT MITIGATION SITE
Rockingham County, North Carolina

DMS Project ID No. 100058
Full Delivery Contract No. 7525
USACE Action ID No. SAW-2018-01170
RFP No. 16-007330
DWR Project No. 20180795

Data Collection: January - November 2023
Submission: February 2024

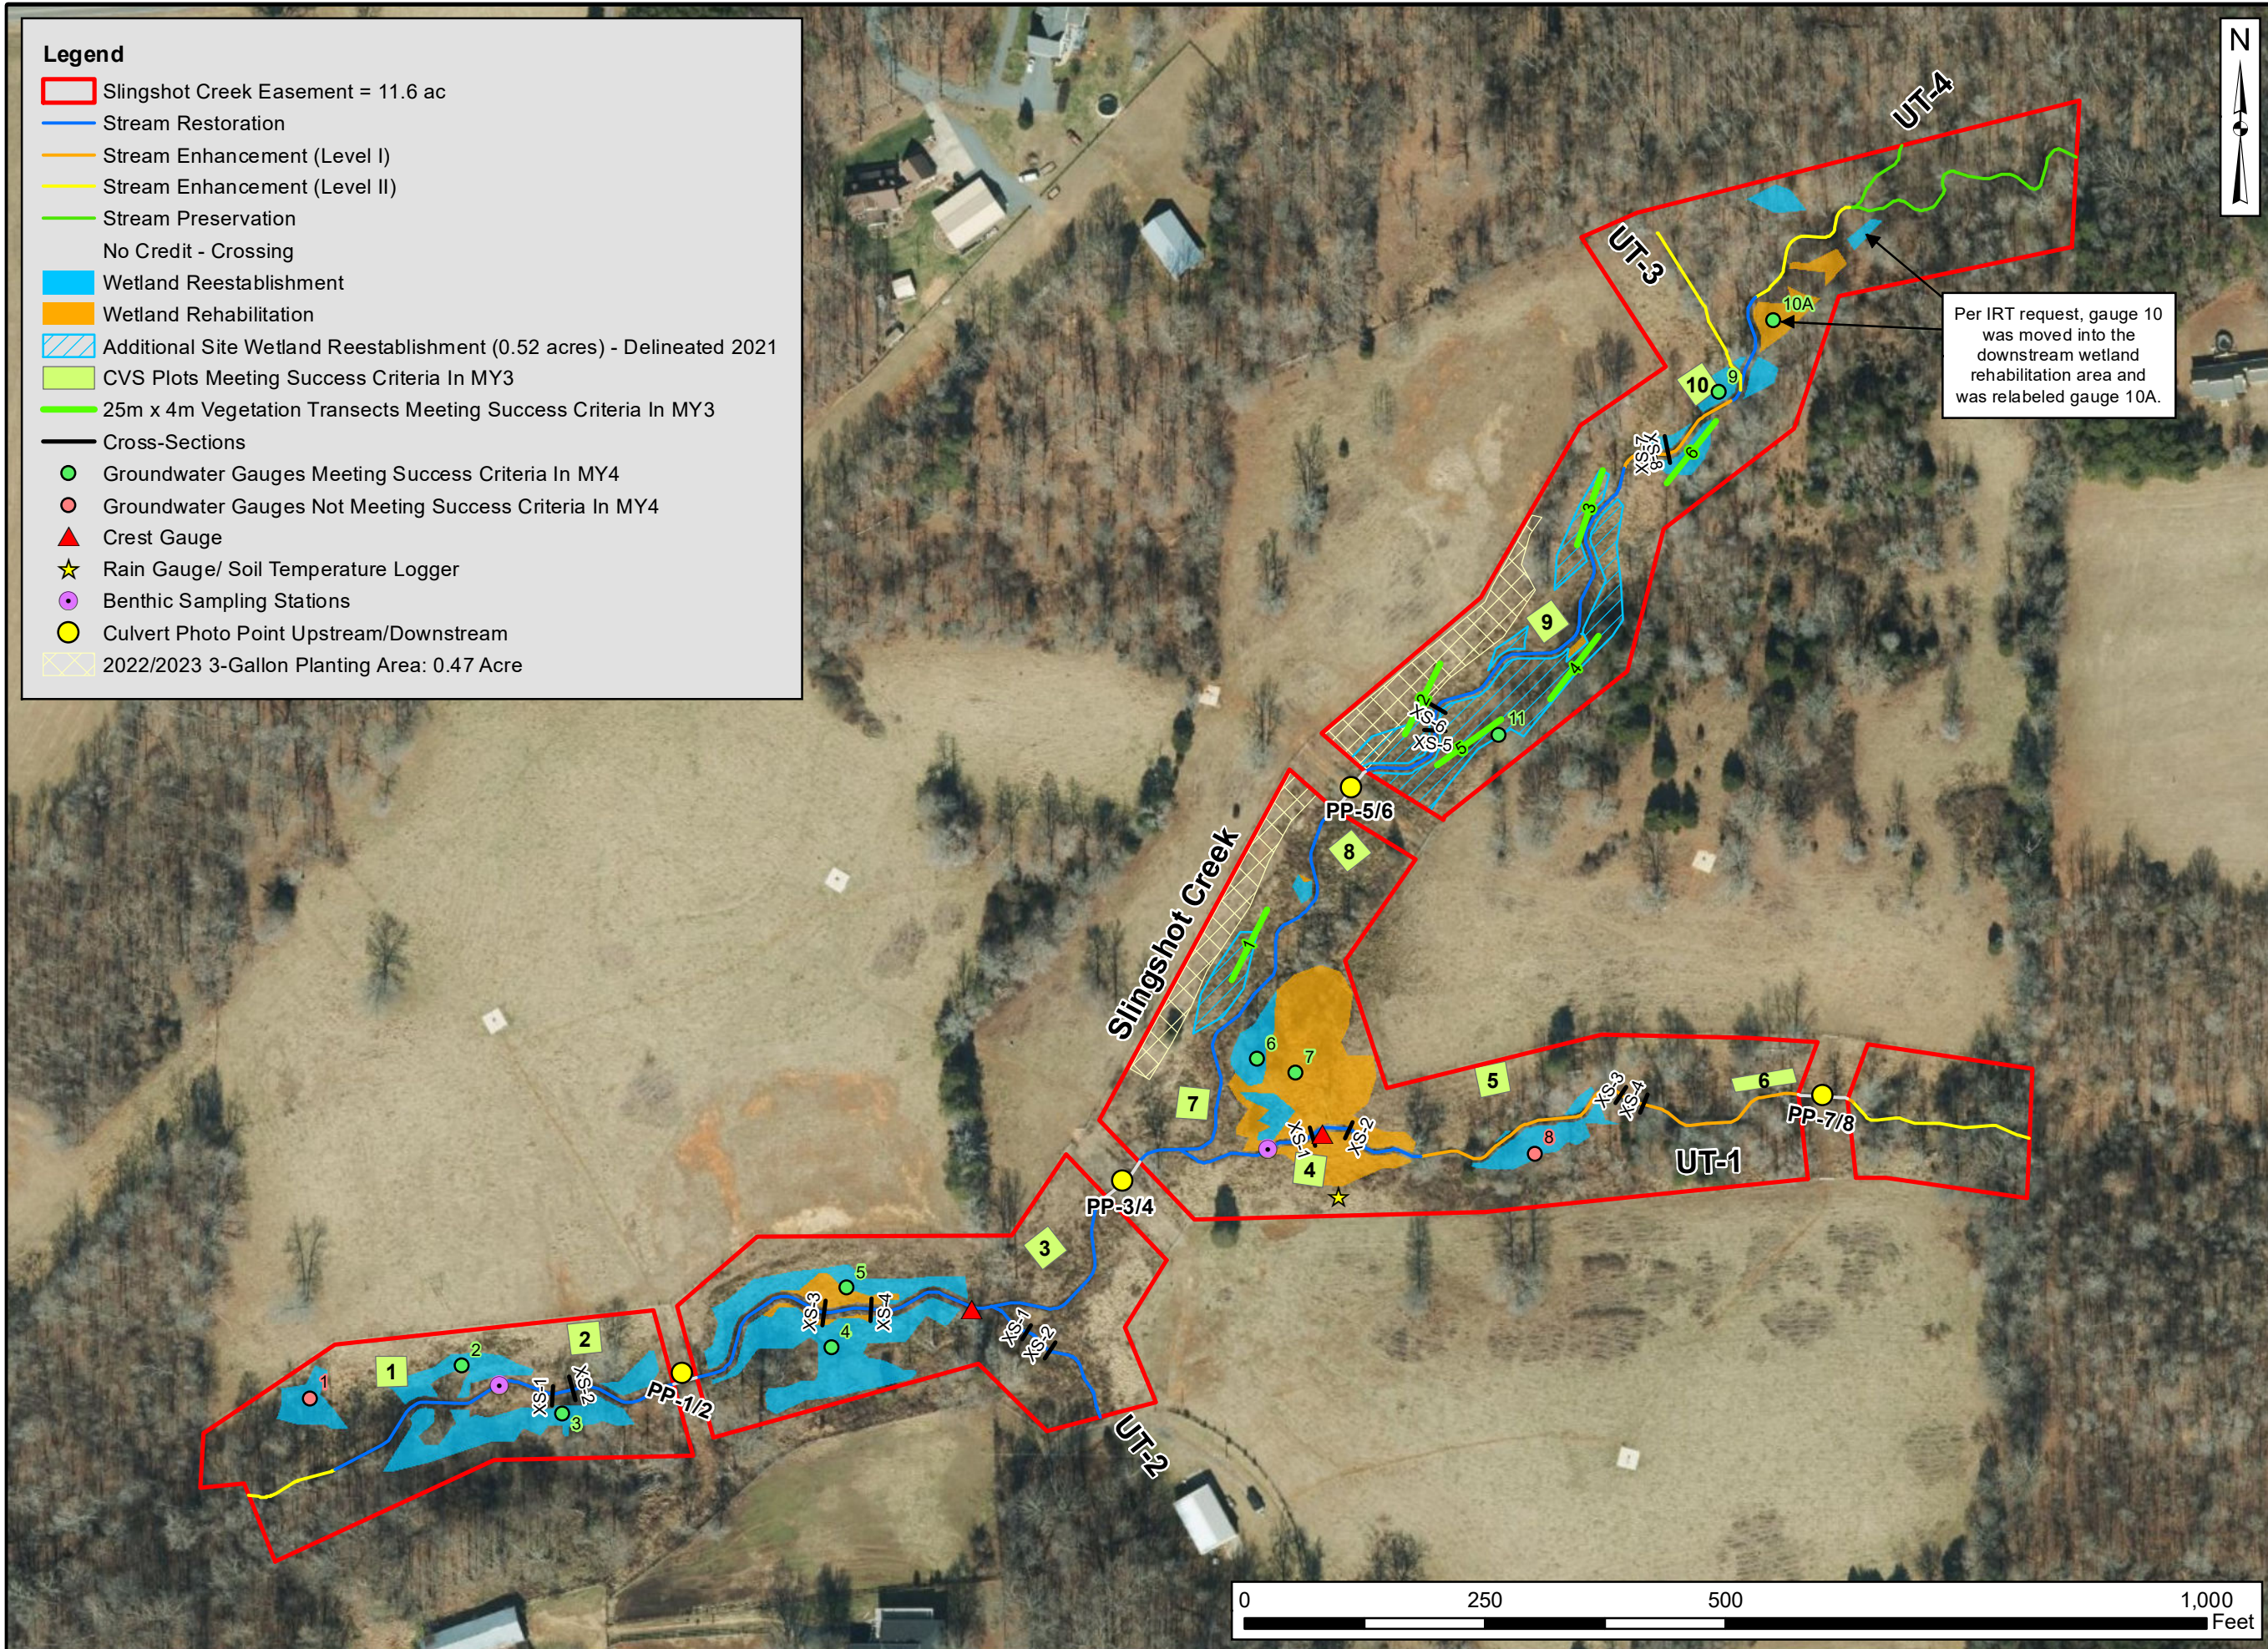
Title:
**CURRENT
 CONDITIONS
 PLAN VIEW**

Per IRT request, gauge 10 was moved into the downstream wetland rehabilitation area and was relabeled gauge 10A.

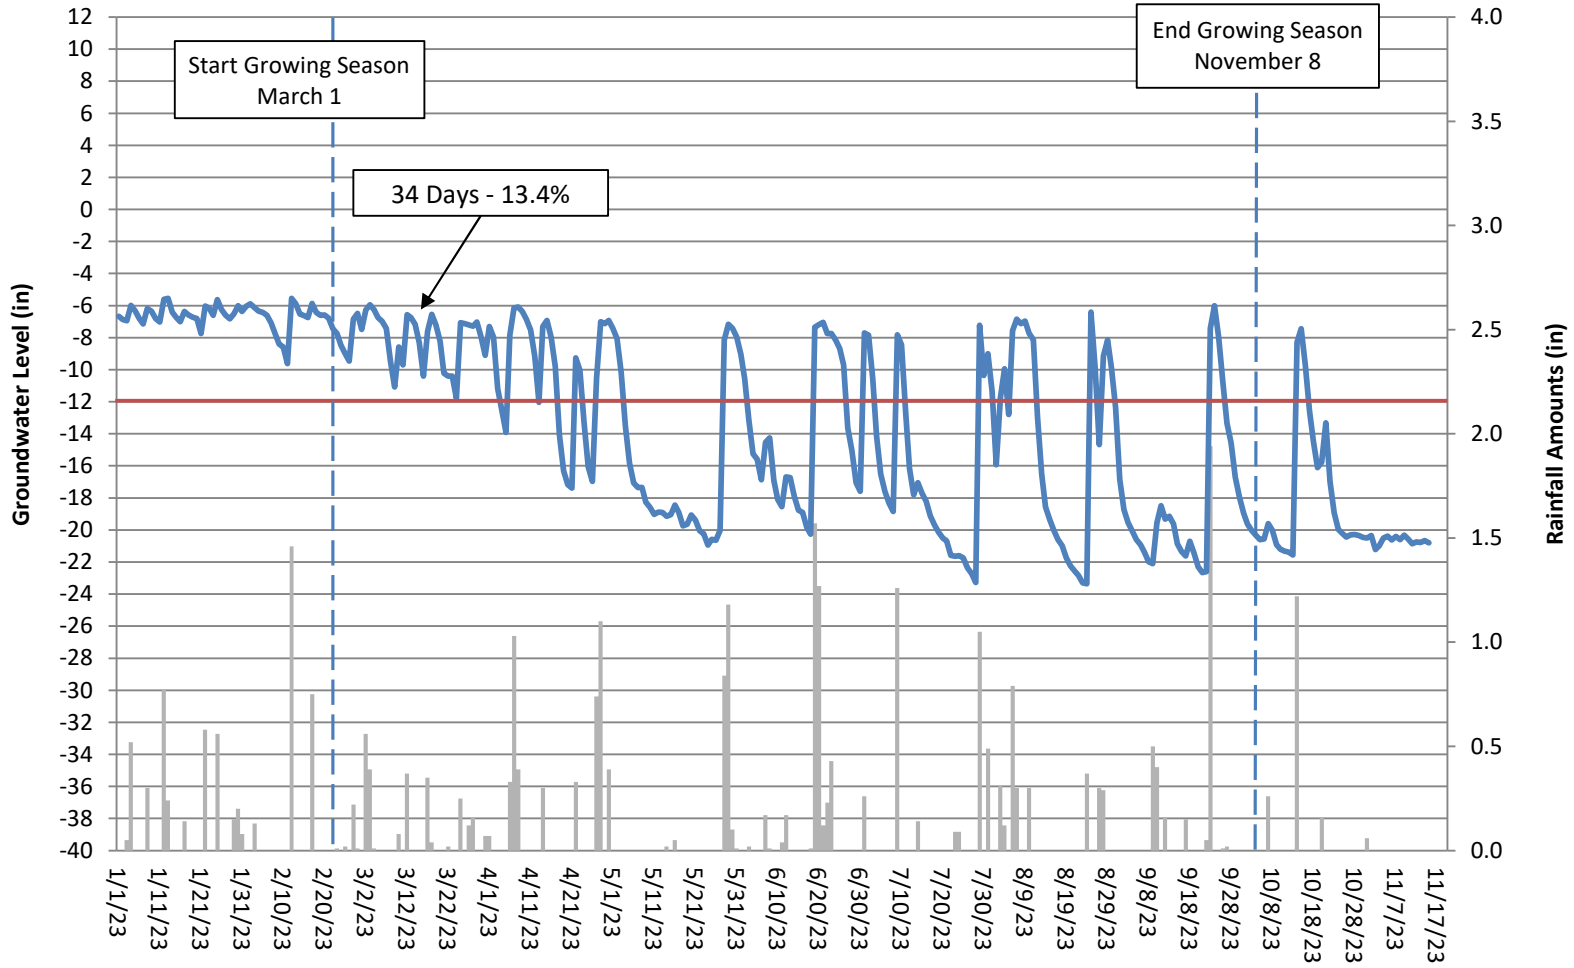
Slingshot Groundwater Gauge 10A Year 4 (2023 Data)

At request of the IRT during the MY3 field visit, this gauge was moved into a new location on 7/27/2022 and relabeled gauge 10A for MY4 (2023).
