# Smith and Austin Creeks Year One Monitoring

Wake Forest, North Carolina

January 2004

# Smith and Austin Creeks Year 1 Monitoring Report Wake Forest, North Carolina

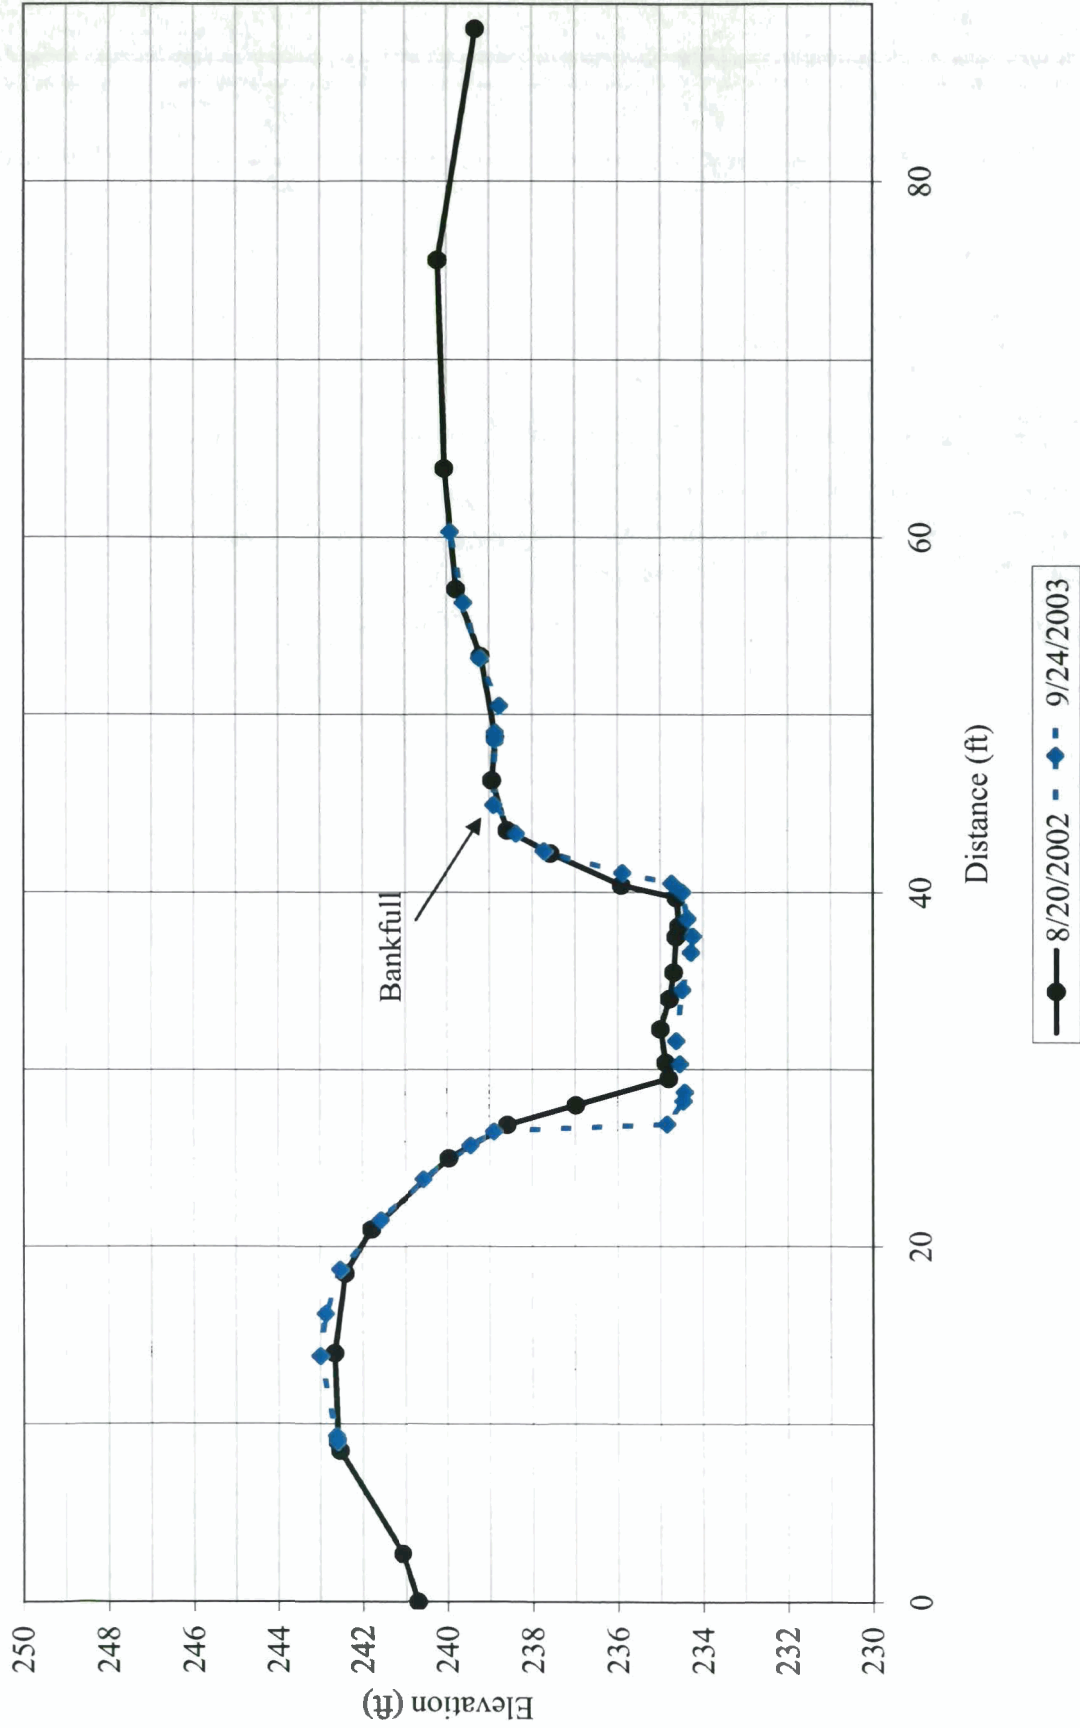
Smith and Austin - SR1  
Cross Section 1 - 42' Upstream of Project Start -- Riffle

Cross section 1 is the reference riffle cross section 42' above the project start. It shows a slight down cutting and erosion of both banks. The W/D ratio was low to begin with and decreased slightly along with a corresponding increase in cross sectional area and maximum depth. The stream above the project is moving towards a more unstable condition. Cross section 2 is the first riffle in Reach SR1b in the new channel. It shows some adjustment on the right edge of the channel, slight deposition on the right bankfull bench, and a slight increase in the W/D ratio and decrease in cross sectional area. The same holds true for cross section 3 with deposition on both benches of this riffle. Cross sections 4 and 5 are pools that show deposition on the point bars and have maintained the pool on the outside of the bend, although they are not as deep as the as-built. Both have decreased W/D ratios and cross sectional areas.

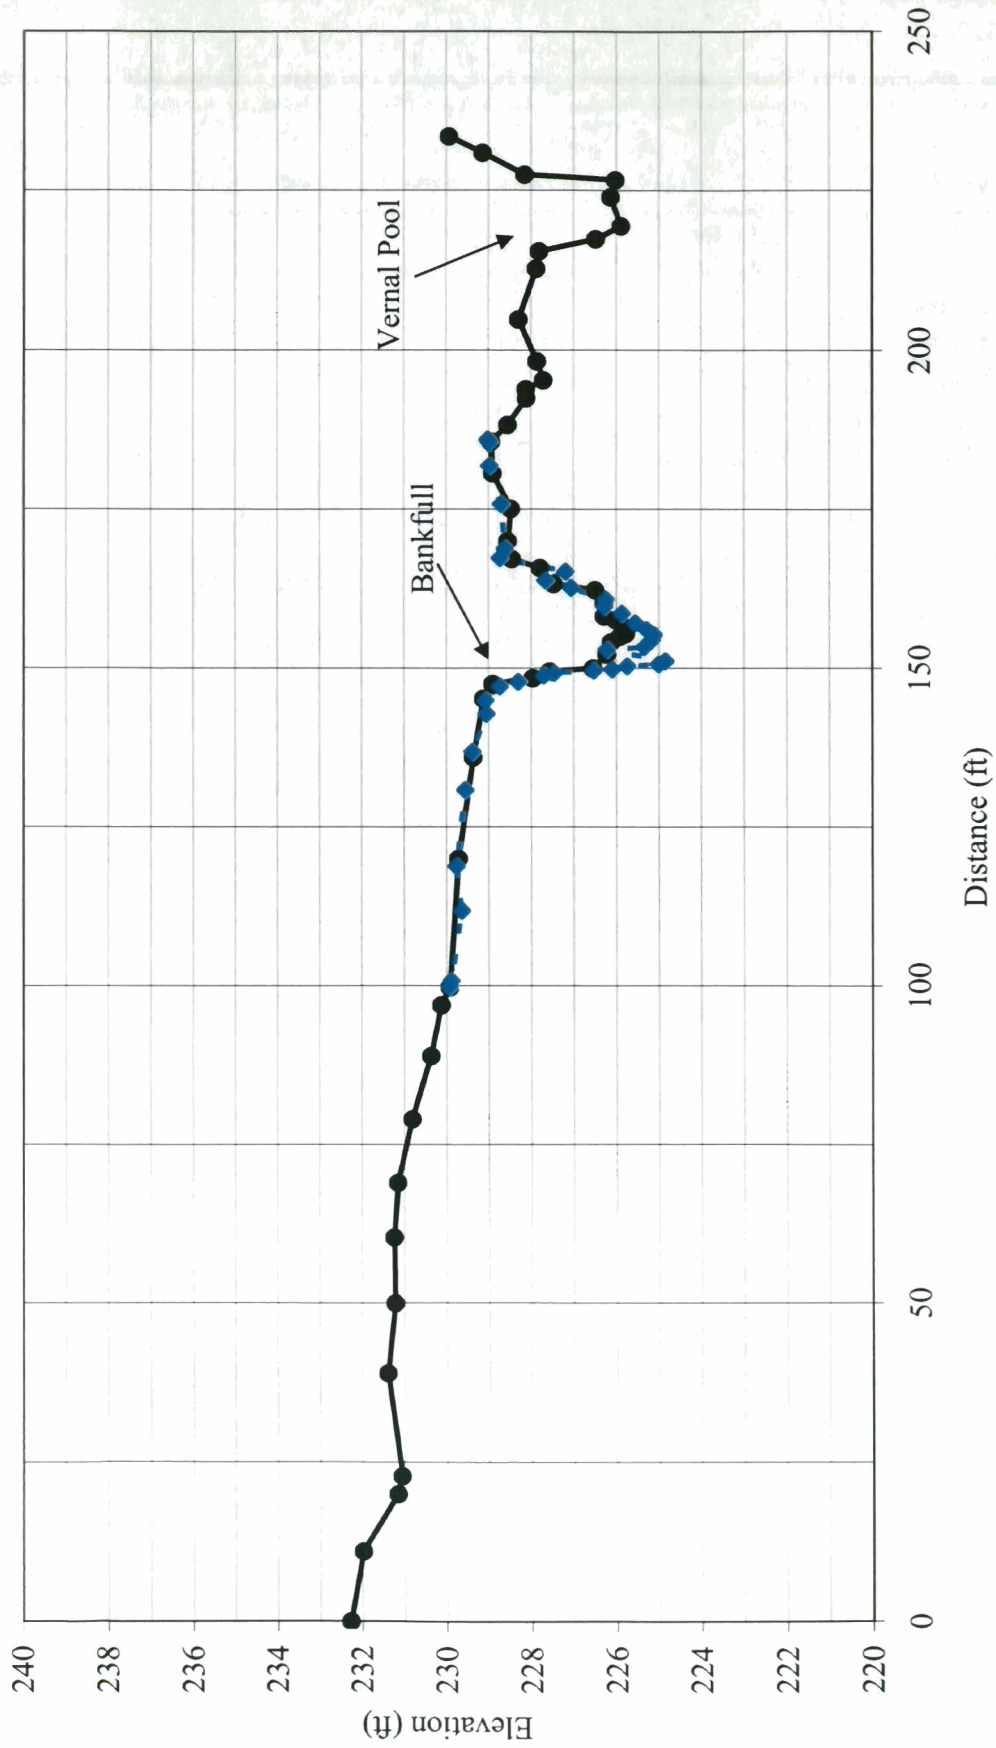
Smith and Austin - SR2  
Cross Section 1 - Station 24+30 -- Riffle

Cross sections 1 and 4 are in constructed riffles. In cross section 1, the TW has moved to the left toe by cutting around the cobble and boulders used in the constructed riffle. We will watch this cross section for any further destabilization. Cross section 4 is slightly larger on the right bank slope, but that area has stabilized with vegetation. Cross section 5 is the final riffle cross section in this reach. It shows deposition on the right bank and bench with a corresponding decrease in cross sectional area and W/D ratio. This represents movement towards increased stability. Cross sections 2 and 3 are pools. Cross section 2 is showing a good scour pool under the rootwads in this meander bend. The max depth has increased along with the cross sectional area. Cross section 3 is maintaining its pool on the outside of the meander bend, but shows deposition in the pool and on both banks. The cross sectional area is slightly smaller and the W/D ratio is the same.

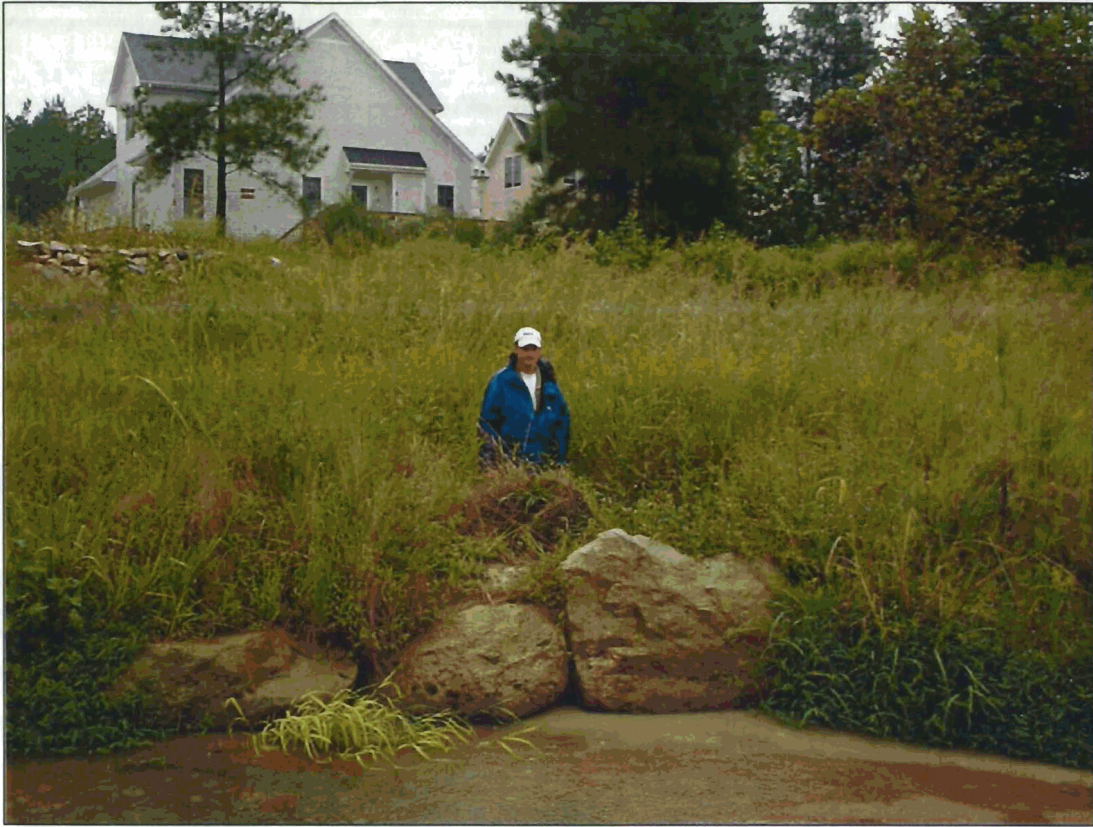
The storm water outlet that flows into AR3 near Station 37+15 has failed. This was fixed under a separate contract and was not a part of the WRP project. The rock dikes designed to spread water over a series of tiers above the bankfull bench on the left are undercut. Water flows under the dikes in two areas and has begun a headcut that starts behind the left arm of the cross vane at this spot. There are two pictures in Tab 6 showing this site during a light rain storm. Note the silt entering the stream from behind and underneath the cross vane arm. The main portion of the storm water outfall is visible in the top left of the picture. If this is not corrected, the headcut will continue to move to the left and up the bankfull bench.

**Erosion behind CV on AR3 STA 37+15 due to storm water outlet**

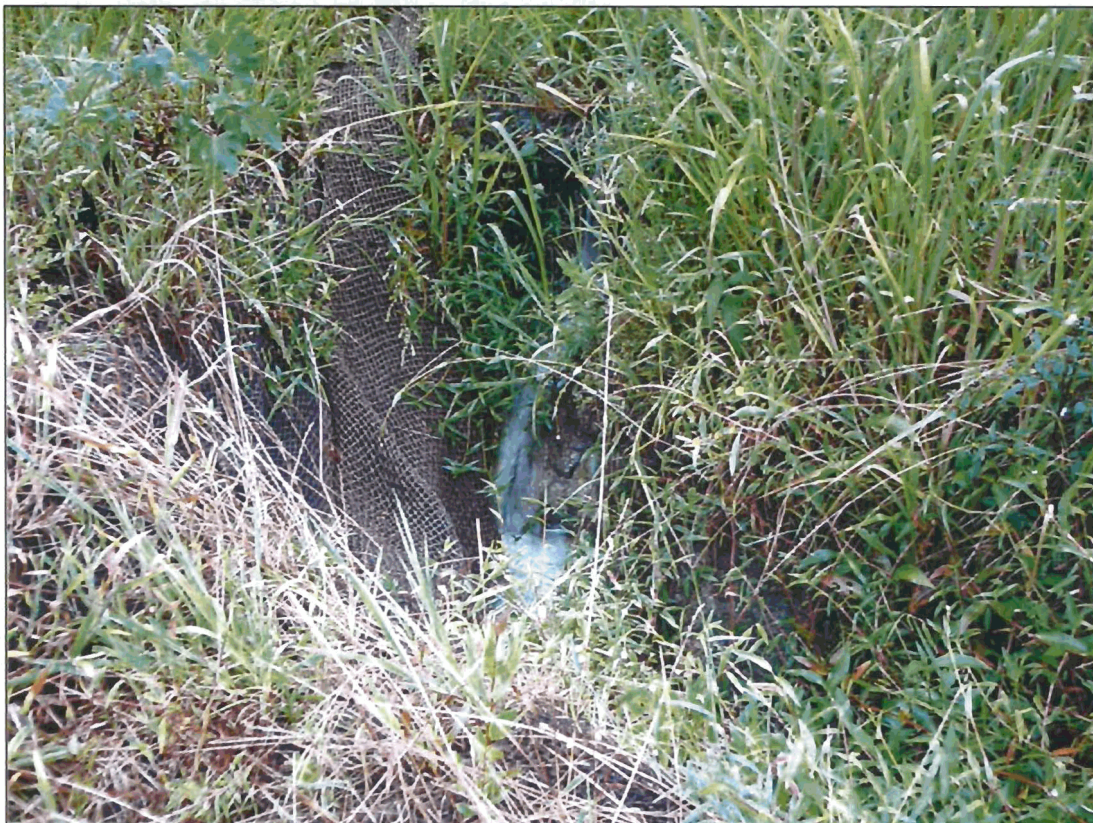
**Close-up of erosion behind CV**

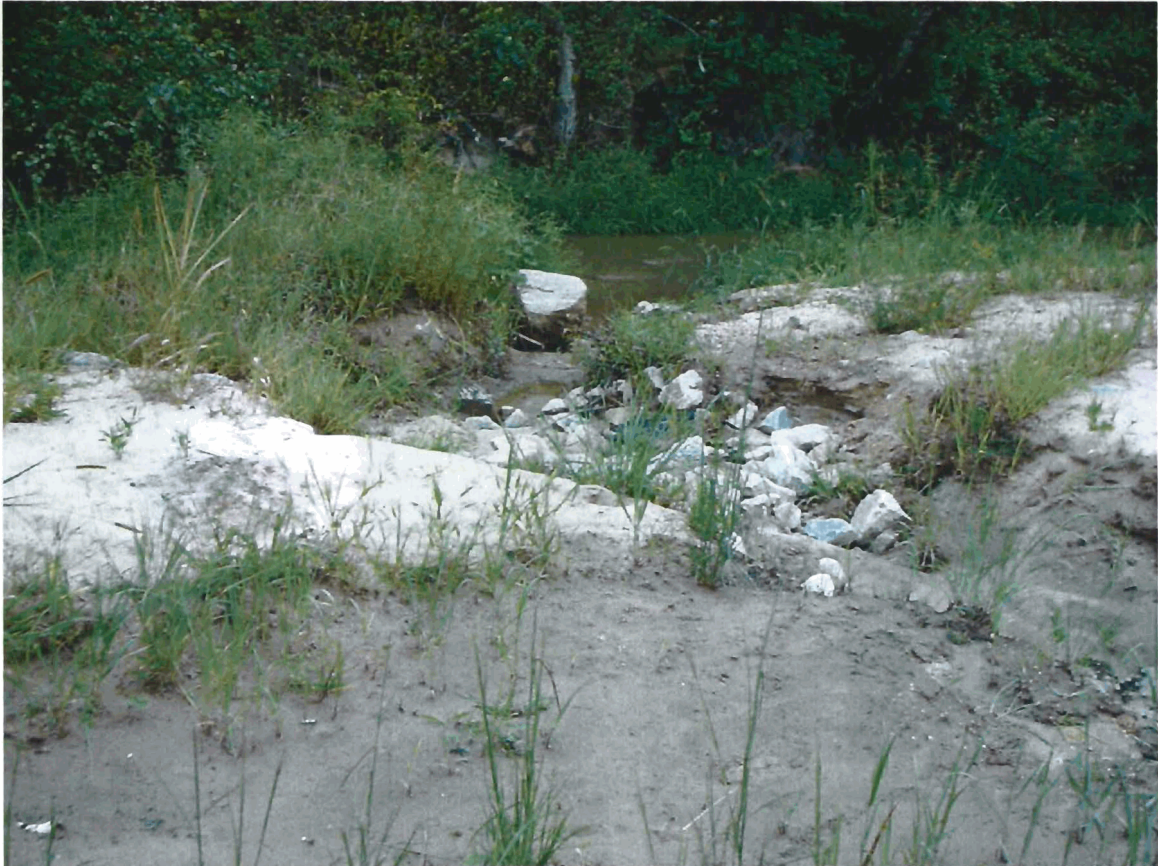
The soccer complex is now in use. Most of the parking lot located between SR2 and AR2/3 is still not paved. The handicap spaces located closet to SR2 are the only portion that have been permanently paved. The parking lot run off still flows down the right terrace of AR2 and flows into the channel at about Station 29+55. This area was worked on in January 2003. However, the water bypassed the rootwad/brush mat structure and runs into AR2 just downstream (see picture in Tab 6). The outlet into AR2 is beginning to show signs of stabilization. Buck Engineering recommends continued monitoring of this area for further instability. In addition, the hydrology of the parking lot will change if and when it is paved. There is an asphalt access road/greenway that originates by paved portion of the parking lot and runs down the left terrace of SR2 between the soccer fields and SR2. There is no evidence that this impacts at all on the project and is a part of the overall plan for the area.

**Smith Creek Soccer Complex  
Parking Lot Run off into Austin Creek  
Year 1 Monitoring**

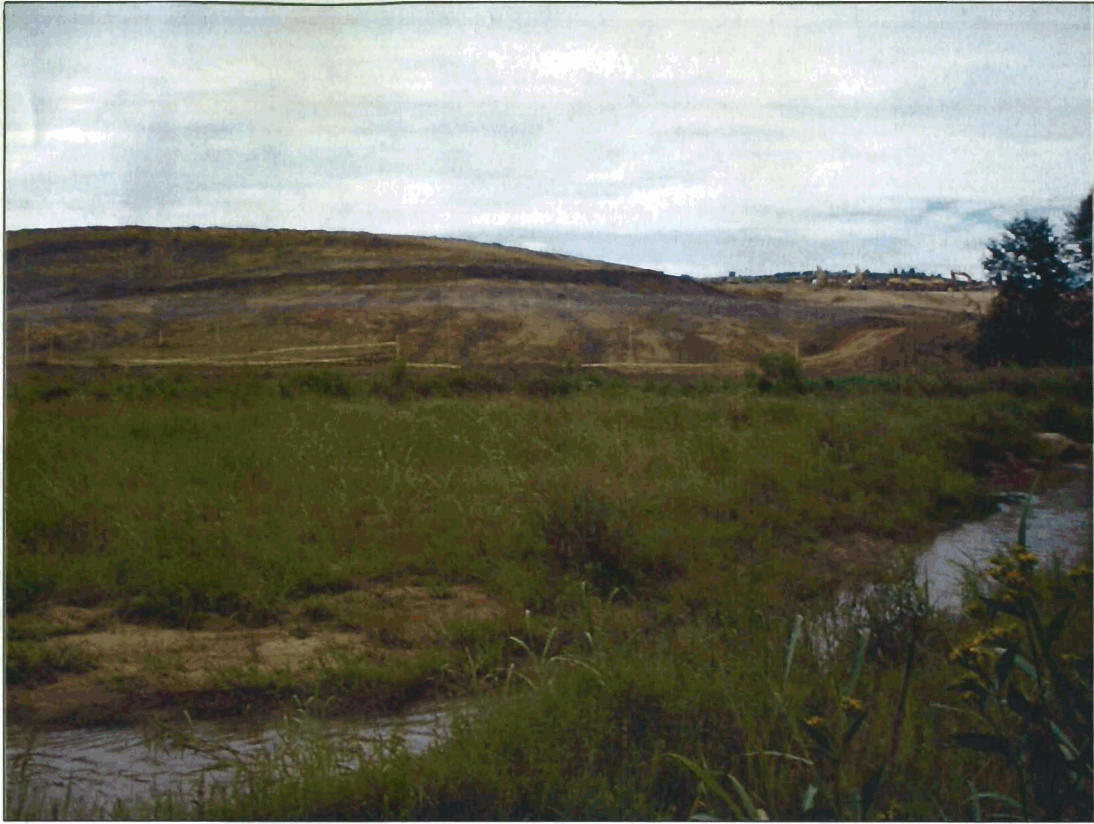
Construction continues at heritage Wake Forest. Most notable, the entire right side of SR1b and SR2 outside the conservation easement has been cleared (pictures in Tab 6). The entire hillside is cleared and they are grading for continued development. The sediment and erosion control structures appear to be functioning. There is no evidence of any direct discharge into Smith Creek.

Development on right side of SR1b

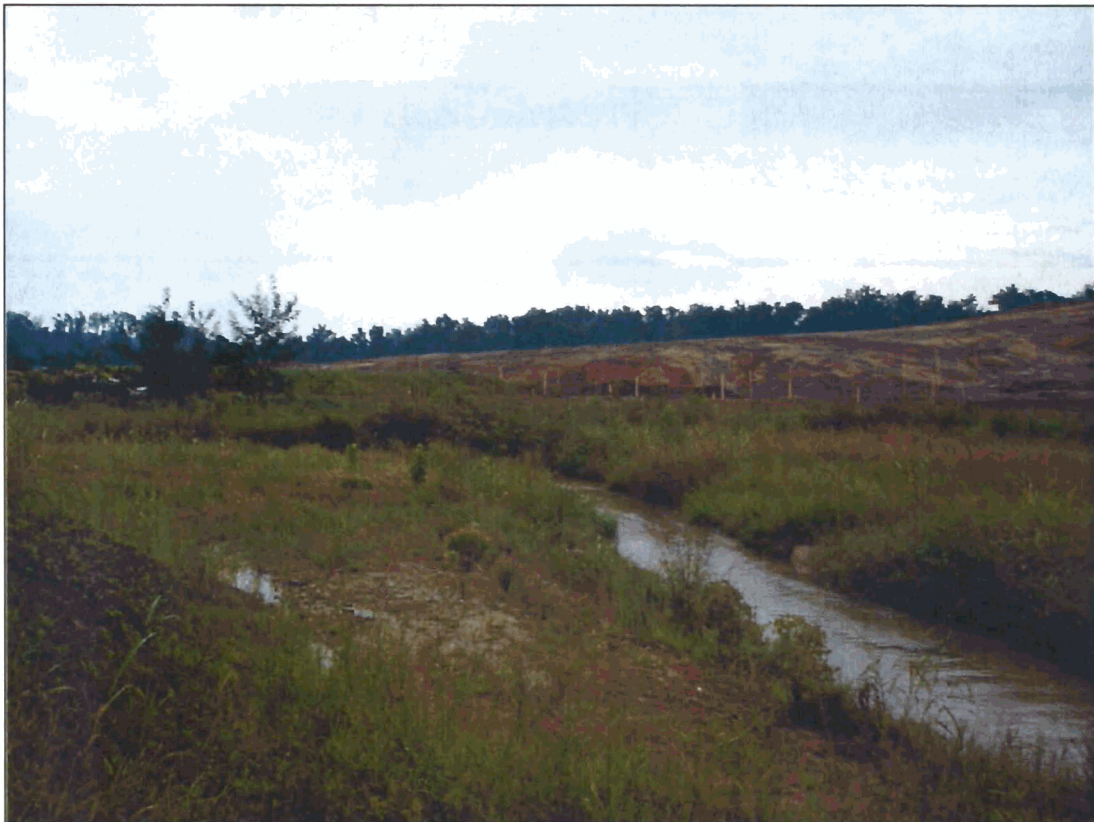
Development on right side of SR1b and SR2
