ANNUAL MONITORING REPORT SMITH AND AUSTIN CREEKS

**STREAM RESTORATION
WAKE COUNTY, NORTH CAROLINA
(EEP Project Number 343)
Monitoring Year 5 of 5 (2007)**

February 2008

Prepared by:
Axiom Environmental, Inc.
2126 Rowland Pond Drive
Willow Spring, North Carolina 27592

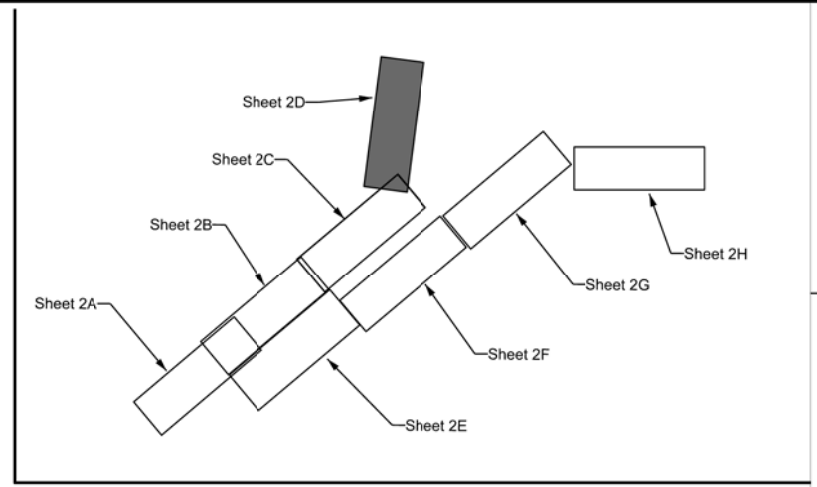
Scale: 1 in = 95 m	FIGURE NO. 2D
Date: FEB 2007	
Project No.: 06-002.03

Vegetation Plot 12
 Bank Erosion and Root Wad Loss; Vegetation has been Removed
 Smith Photos 6A/6B

Loose Sewage Pipe Causing Some Channel Instability
 Smith Photo 9
