ANNUAL MONITORING REPORT SMITH AND AUSTIN CREEKS

**STREAM RESTORATION
WAKE COUNTY, NORTH CAROLINA
(EEP Project Number 343)
Monitoring Year 6 of 6 (2008)**

December 2008

Prepared by:
Axiom Environmental, Inc.
2126 Rowland Pond Drive
Willow Spring, North Carolina 27592

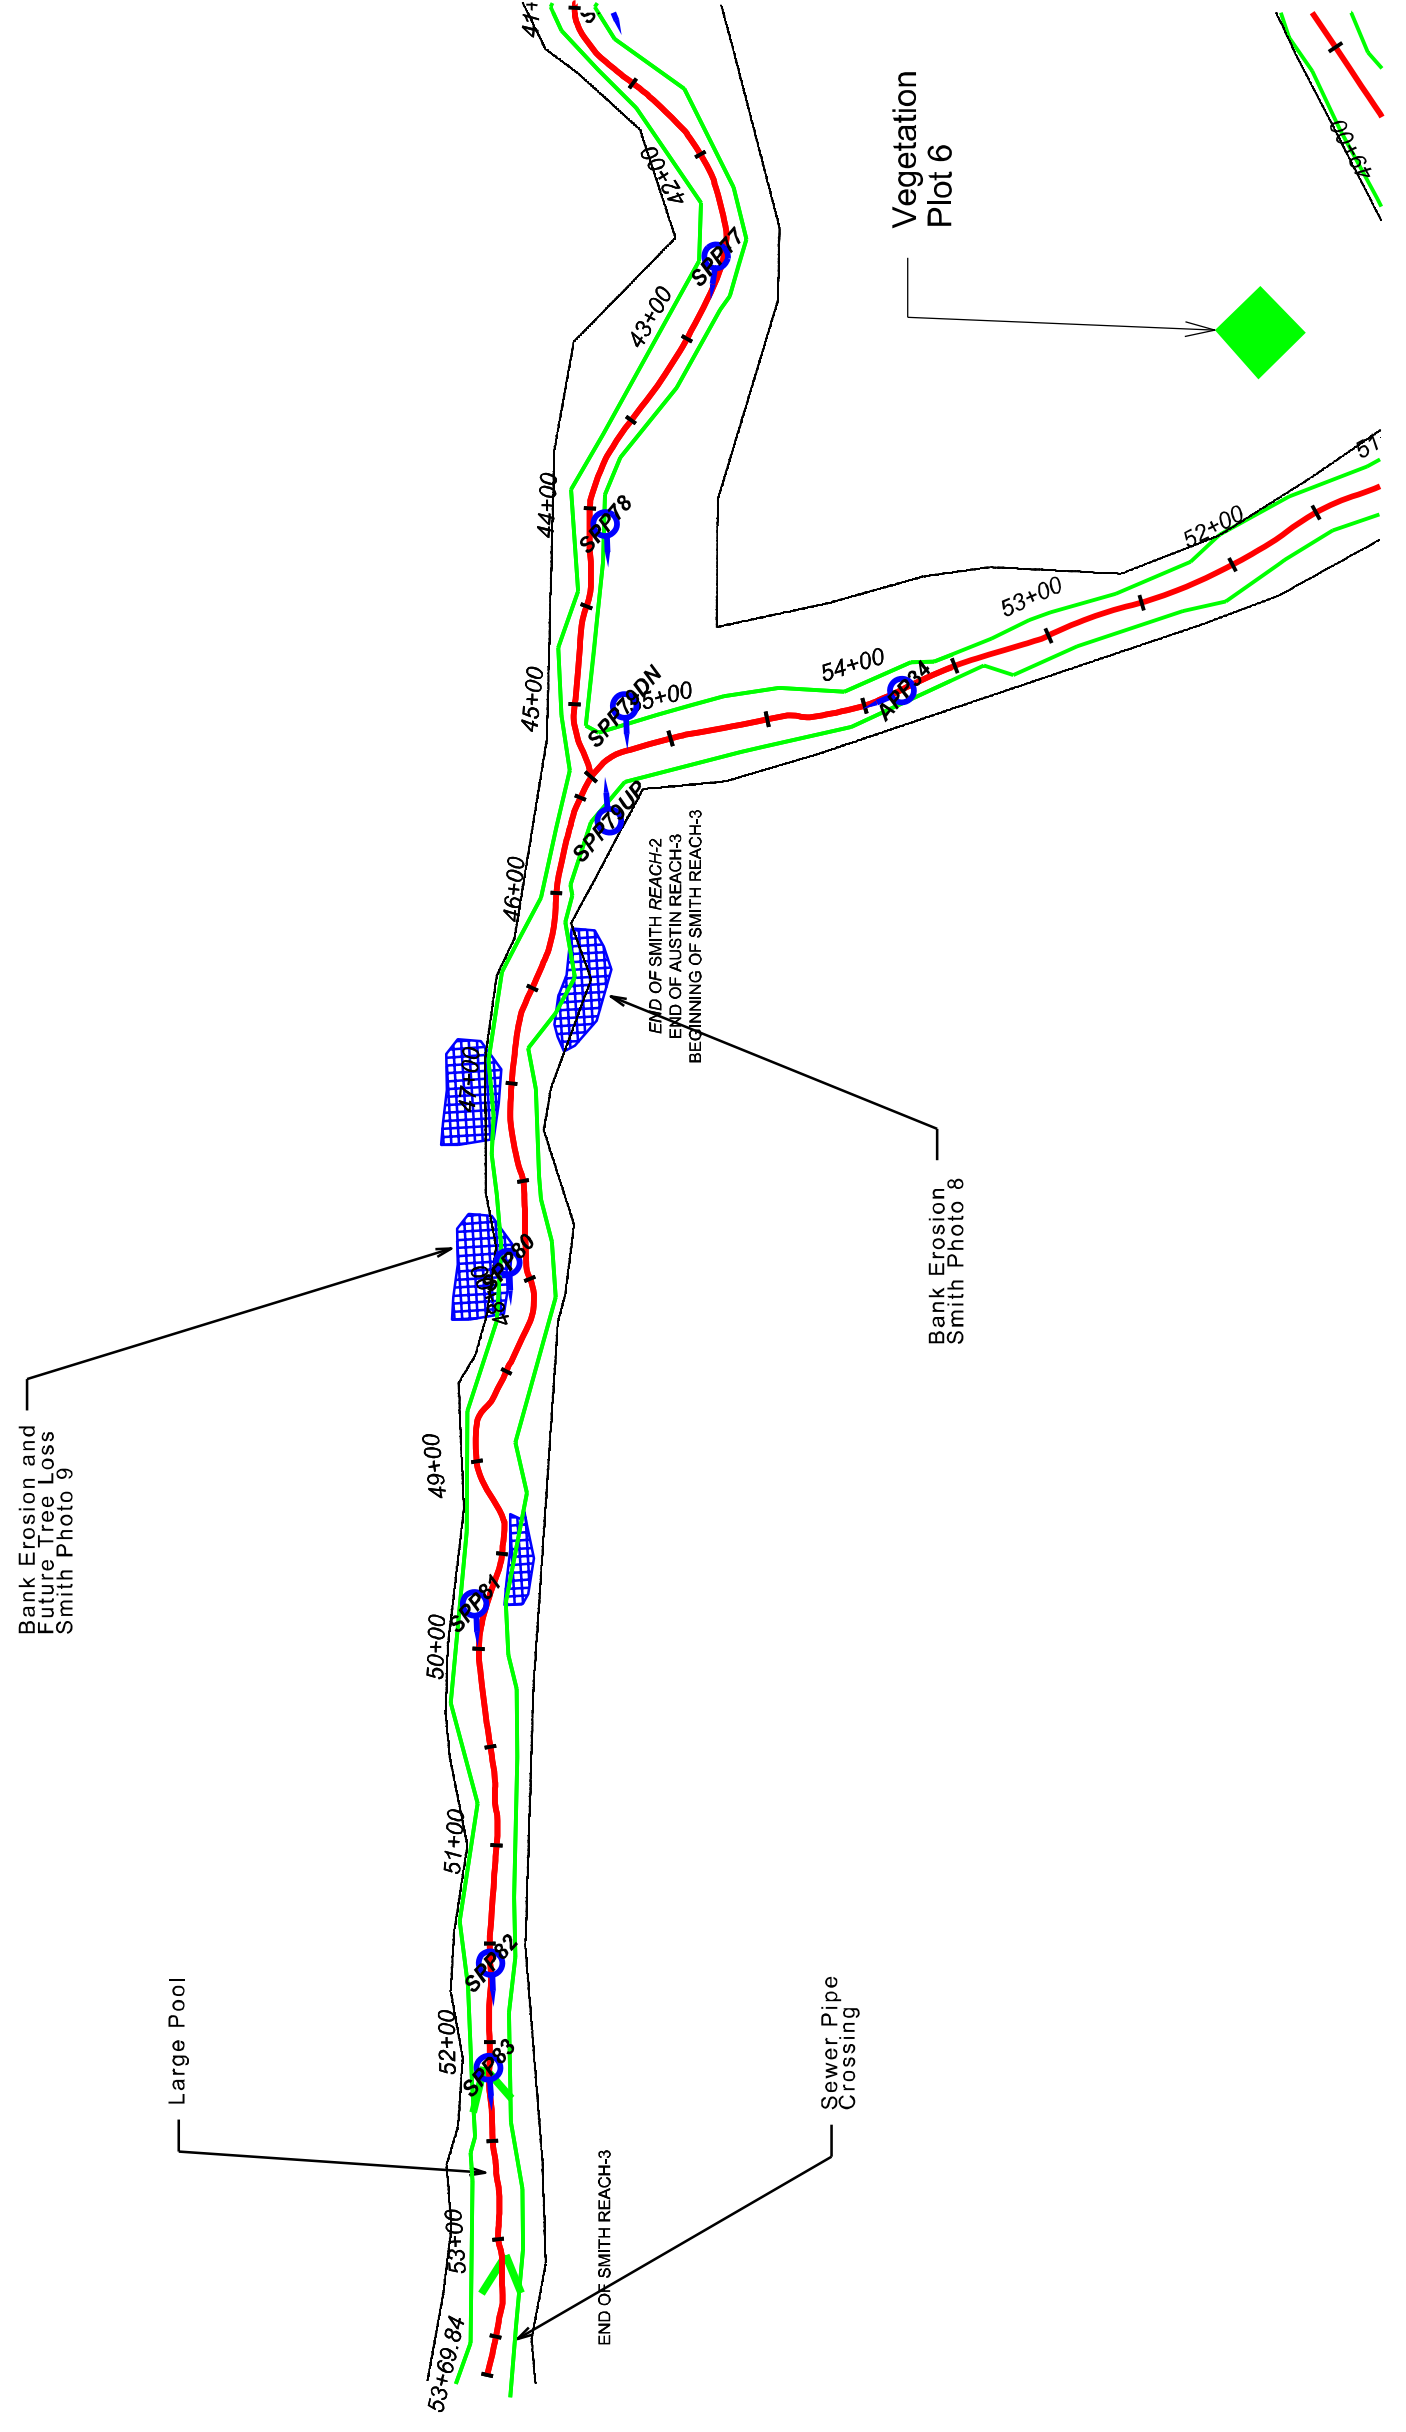
FIGURE NO.
2A

Stream problem areas within the Site are depicted on Figures 2A through 2H and are outlined in Table 8. Several problem areas noted in previous annual monitoring reports were no longer present. During the current site assessment several areas of bank erosion, mid-point bars, and reduced structure integrity/failure were identified. Example problem area photographs are included in Appendix B.

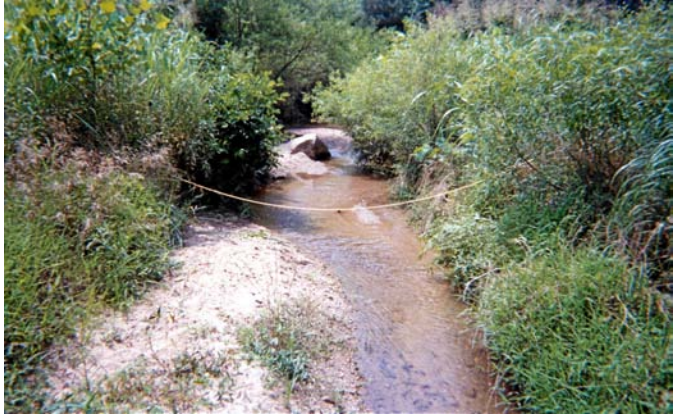
Photo of Cross-Section SR1-2 - Looking Upstream @ STA 9+35

AS-BUILT	2003	2004	2005	2006	2007	2008
Area	59.6	60.8	55.9	54.6	32.8	35.1	34.9
Width	23.5	23.6	25.1	26.1	19.5	18.2	19.2
Mean Depth	2.5	2.6	2.2	2.1	1.7	1.9	1.8
Max Depth	3.7	3.7	3.1	3.2	2.8	3.1	2.5
W/D	9.3	9.2	11.3	12.5	11.6	9.4	10.6

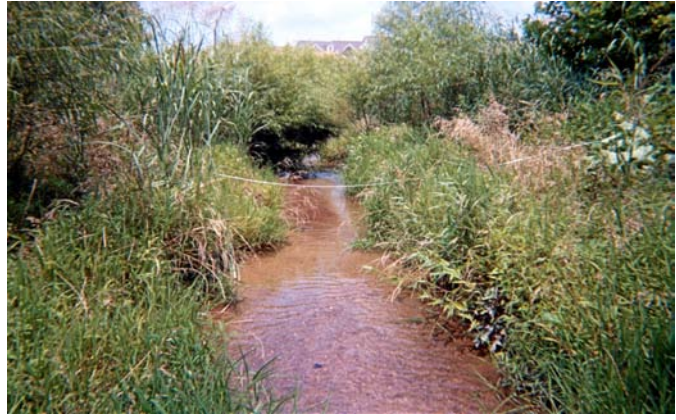
Photo of Cross-Section SR1-3 - Looking Upstream @ STA 11+30

AS-BUILT	2003	2004	2005	2006	2007	2008
Area	44.9	47.5	36.6	41.3	29.6	24.7	21.7
Width	31.3	25.6	25.9	25.8	22.0	20.7	20.9
Mean Depth	1.4	1.9	1.4	1.6	1.3	1.2	1.0
Max Depth	2.8	2.7	2.4	2.7	3.3	2.9	2.4
W/D	21.8	13.8	18.3	16.1	16.4	17.3	20.2

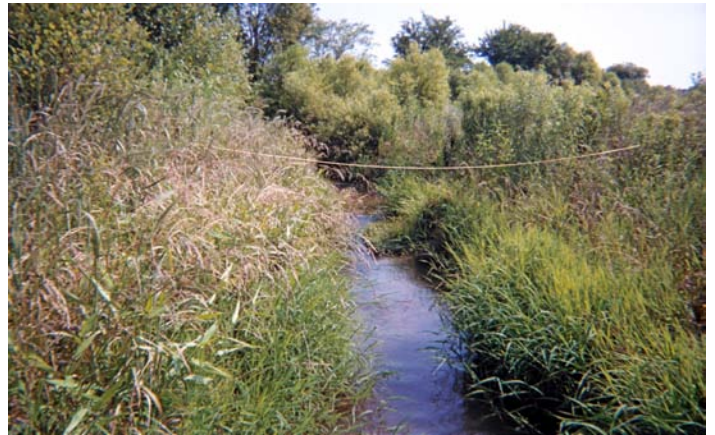
Photo of Cross-Section SR2-4 - Looking Upstream @ STA 32+45

AS-BUILT	2003	2004	2005	2006	2007	2008
Area	38.9	42.7	38.4	39.5	37.3	32.3	28.1
Width	18.7	18.9	18.4	17.6	18.0	17.8	16.4
Mean Depth	2.1	2.3	2.1	2.2	2.1	1.8	1.7
Max Depth	3.1	3.3	3.2	2.8	3.4	3.1	3.2
W/D	9.0	8.4	8.8	7.8	8.7	9.9	9.5

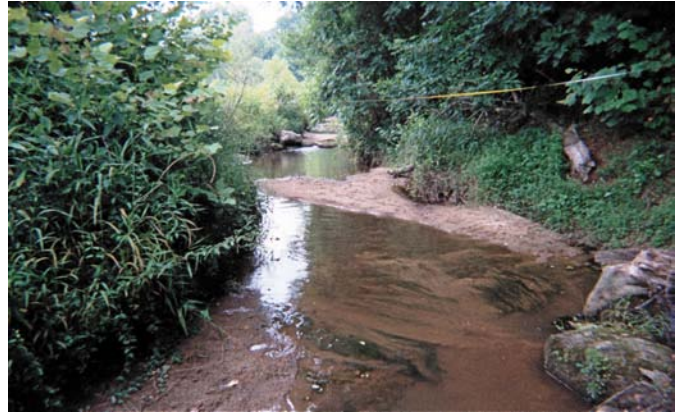
Photo of Cross-Section AR1-2 - Looking Upstream @ STA 4+42

AS-BUILT	2003	2004	2005	2006	2007	2008
Area	49.0	51.2	62.4	63.5	57.6	55.1	59.2
Width	32.4	31.1	29.5	27.3	19.6	19.4	21.9
Mean Depth	1.5	1.6	2.1	2.3	2.9	2.8	2.7
Max Depth	3.9	3.8	4.0	4.8	4.2	4.1	4.2
W/D	21.4	18.9	14.0	11.7	6.6	6.8	8.1

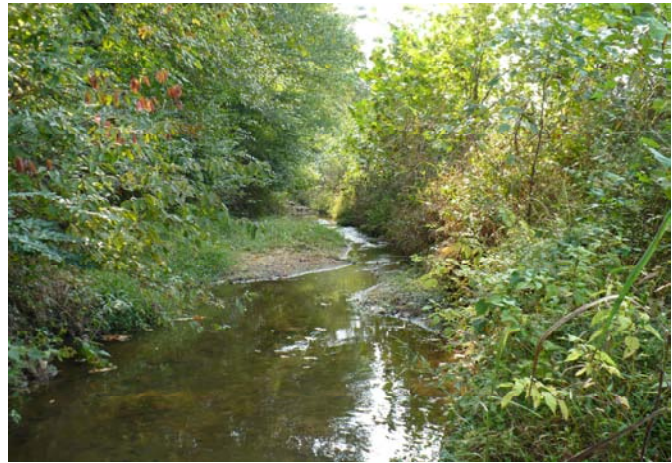
Photo of Cross-Section AR1-3 - Looking Downstream @ STA 13+95

AS-BUILT	2003	2004	2005	2006	2007	2008
Area	49.8	51.2	52.7	54.7	60.6	73.1	64.4
Width	24.4	23.8	22.8	23.5	25.0	24.8	24.8
Mean Depth	2.0	2.2	2.3	2.3	2.4	2.9	2.6
Max Depth	3.2	3.2	3.9	3.8	4.1	4.7	4.3
W/D	12.0	11.1	9.9	10.1	10.3	8.4	9.6

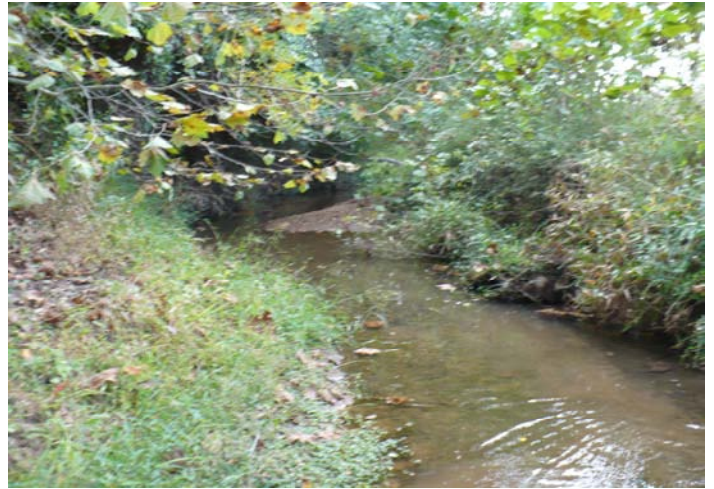
Photo of Cross-Section AR1-4 - Looking Downstream @ STA 20+90

AS-BUILT	2003	2004	2005	2006	2007	2008
Area	38.2	38.5	38.3	34.0	47.6	42.6	40.0
Width	23.3	22.5	22.7	21.4	23.9	20.2	20.9
Mean Depth	1.6	1.7	1.7	1.6	2.0	2.1	1.9
Max Depth	2.5	2.5	2.8	2.7	3.6	4.0	3.0
W/D	N/A	N/A	N/A	N/A	N/A	N/A	N/A

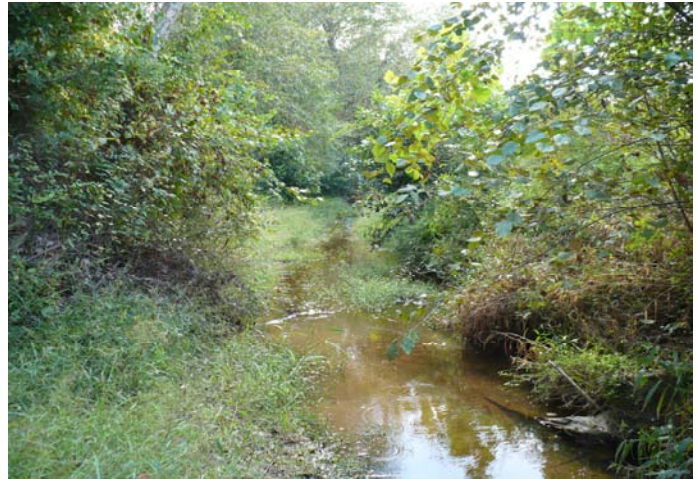
Photo of Cross-Section AR2-1 - Looking Downstream @ STA 27+90

AS-BUILT	2003	2004	2005	2006	2007	2008
Area	48.1	45.4	62.1	56.1	63.8	59.8	62.6
Width	19.3	18.8	20.8	20.6	22.2	24.2	26.1
Mean Depth	2.5	2.4	3.0	2.7	2.9	2.5	2.4
Max Depth	3.6	3.6	4.0	4.0	4.3	3.5	3.3
W/D	7.7	7.8	7.0	7.5	7.7	9.8	10.9

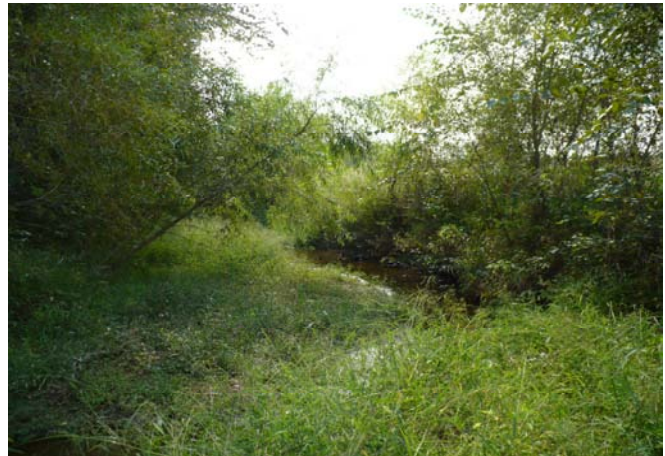
Photo of Cross-Section AR2-2 - Looking Downstream @ STA 28+35

AS-BUILT	2003	2004	2005	2006	2007	2008
Area	37.1	36.9	43.9	43.0	68.5	61.3	60.6
Width	21.3	19.7	17.3	18.2	22.8	23.5	22.3
Mean Depth	1.7	1.9	2.5	2.4	3.0	2.6	2.7
Max Depth	3.6	3.5	3.4	3.3	4.9	4.1	4.0
W/D	N/A	N/A	N/A	N/A	N/A	N/A	N/A

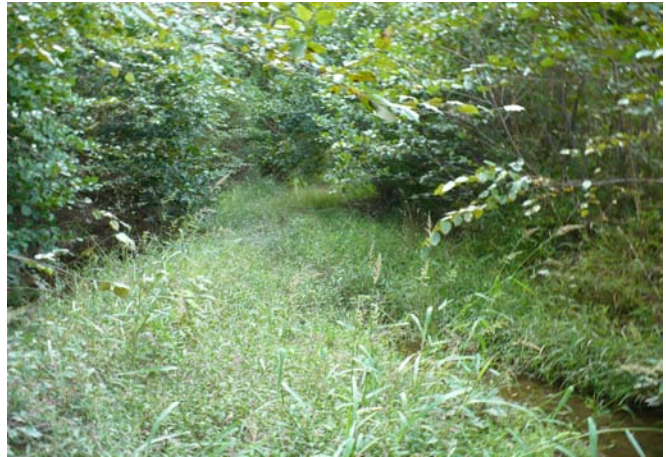
Photo of Cross-Section AR2-3 - Looking Downstream @ STA 30+45

AS-BUILT	2003	2004	2005	2006	2007	2008
Area	54.4	56.4	53.9	53.4	58.2	55.4	27.5
Width	24.9	24.0	24.1	25.1	25.7	24.4	20.1
Mean Depth	2.2	2.4	2.2	2.1	2.3	2.3	1.4
Max Depth	3.1	3.2	3.2	3.1	3.2	3.4	2.0
W/D	N/A	N/A	N/A	N/A	N/A	N/A	N/A

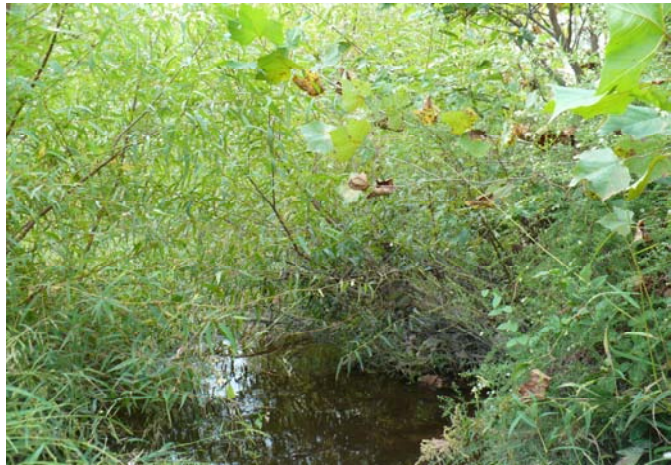
Photo of Cross-Section AR3-1 - Looking Downstream @ STA 34+55

AS-BUILT	2003	2004	2005	2006	2007	2008
Area	97.1	87.5	72.7	77.7	83.4	80.7	64.4
Width	37.3	41.2	39.6	38.5	44.5	44.8	32.2
Mean Depth	2.6	2.1	1.8	2.0	1.9	1.8	2.0
Max Depth	4.8	4.8	3.8	4.2	3.9	3.9	3.4
W/D	N/A	N/A	N/A	N/A	N/A	N/A	N/A

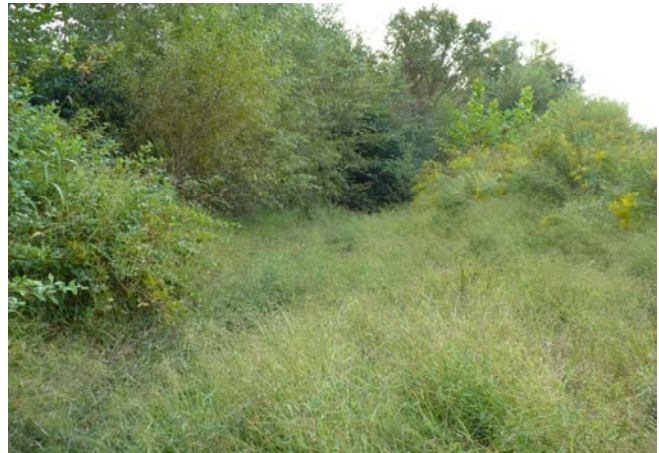
Photo of Cross-Section AR3-2 - Looking Downstream @ STA 35+15

AS-BUILT	2003	2004	2005	2006	2007	2008
Area	126.5	125.1	97.1	91.5	74.4	72.1	69.9
Width	38.4	37.2	35.5	37.6	38.7	40.9	37.8
Mean Depth	3.3	3.4	2.7	2.4	1.9	1.8	1.8
Max Depth	5.3	5.3	3.8	3.8	3.6	3.5	3.4
W/D	11.7	11.1	13.0	15.4	20.1	23.2	20.5

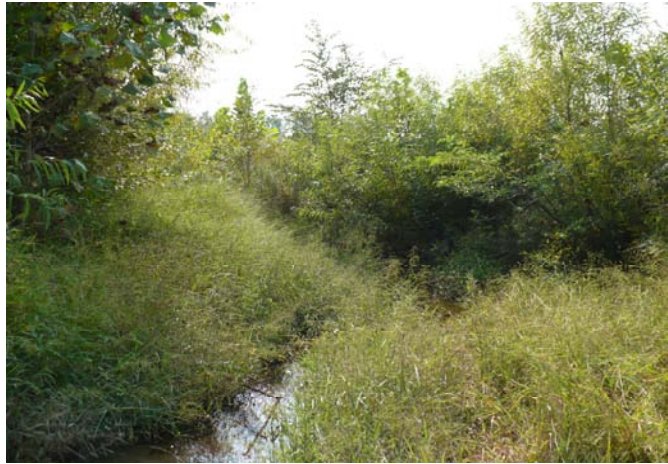
Photo of Cross-Section AR3-3 - Looking Downstream @ STA 38+15

AS-BUILT	2003	2004	2005	2006	2007	2008
Area	153.8	151.2	93.0	90.5	85.6	74.4	82.2
Width	38.5	39.4	39.1	38.8	39.6	38.8	41.3
Mean Depth	4.0	3.8	2.4	2.3	2.2	1.9	2.0
Max Depth	7.1	7.1	3.8	3.8	4.2	3.5	4.2
W/D	N/A	N/A	N/A	N/A	N/A	N/A	N/A

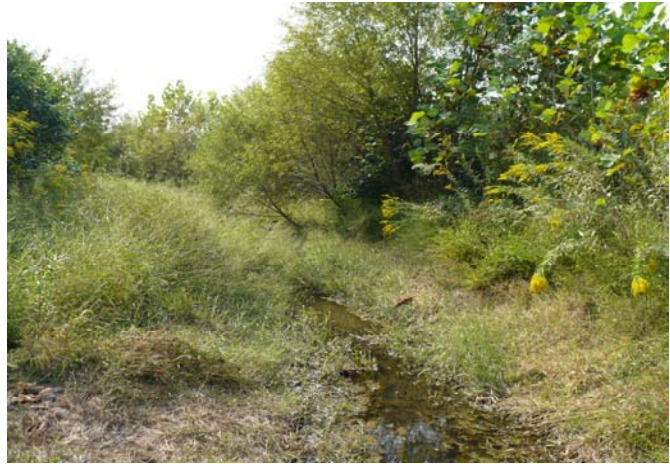
Photo of Cross-Section AR3-4 - Looking Downstream @ STA 41+00

AS-BUILT	2003	2004	2005	2006	2007	2008
Area	78.8	77.4	63.7	61.0	64.2	56.6	62.0
Width	31.6	34.1	35.1	32.7	32.9	31.6	40.1
Mean Depth	2.5	2.3	1.8	1.9	2.0	1.8	1.5
Max Depth	4.0	4.0	3.3	3.2	3.9	3.6	3.5
W/D	12.7	15.0	19.3	17.6	16.8	17.7	26.0

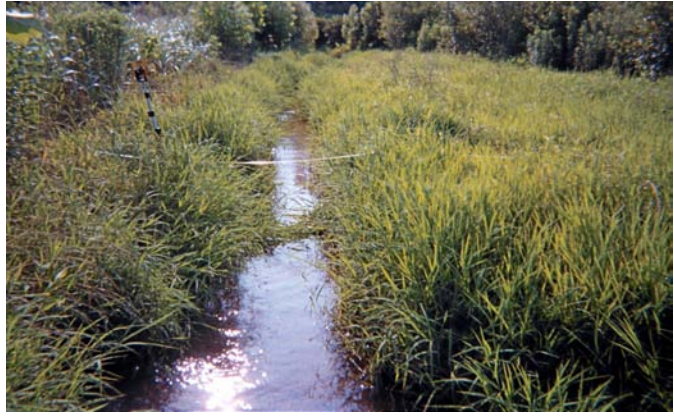
Photo of Cross-Section AR3-5 - Looking Downstream @ STA 46+40

AS-BUILT	2003	2004	2005	2006	2007	2008
Area	97.1	87.5	72.7	77.7	83.4	80.7	55.9
Width	37.3	41.2	39.6	38.5	44.5	44.8	43.8
Mean Depth	2.6	2.1	1.8	2.0	1.9	1.8	1.3
Max Depth	4.8	4.8	3.8	4.2	3.9	3.9	3.3
W/D	14.3	19.4	21.6	19.0	23.4	24.9	34.3
