# Snowbird Creek Tributaries Mitigation Project

## Year 1 Monitoring Report - Final

### Graham County, North Carolina

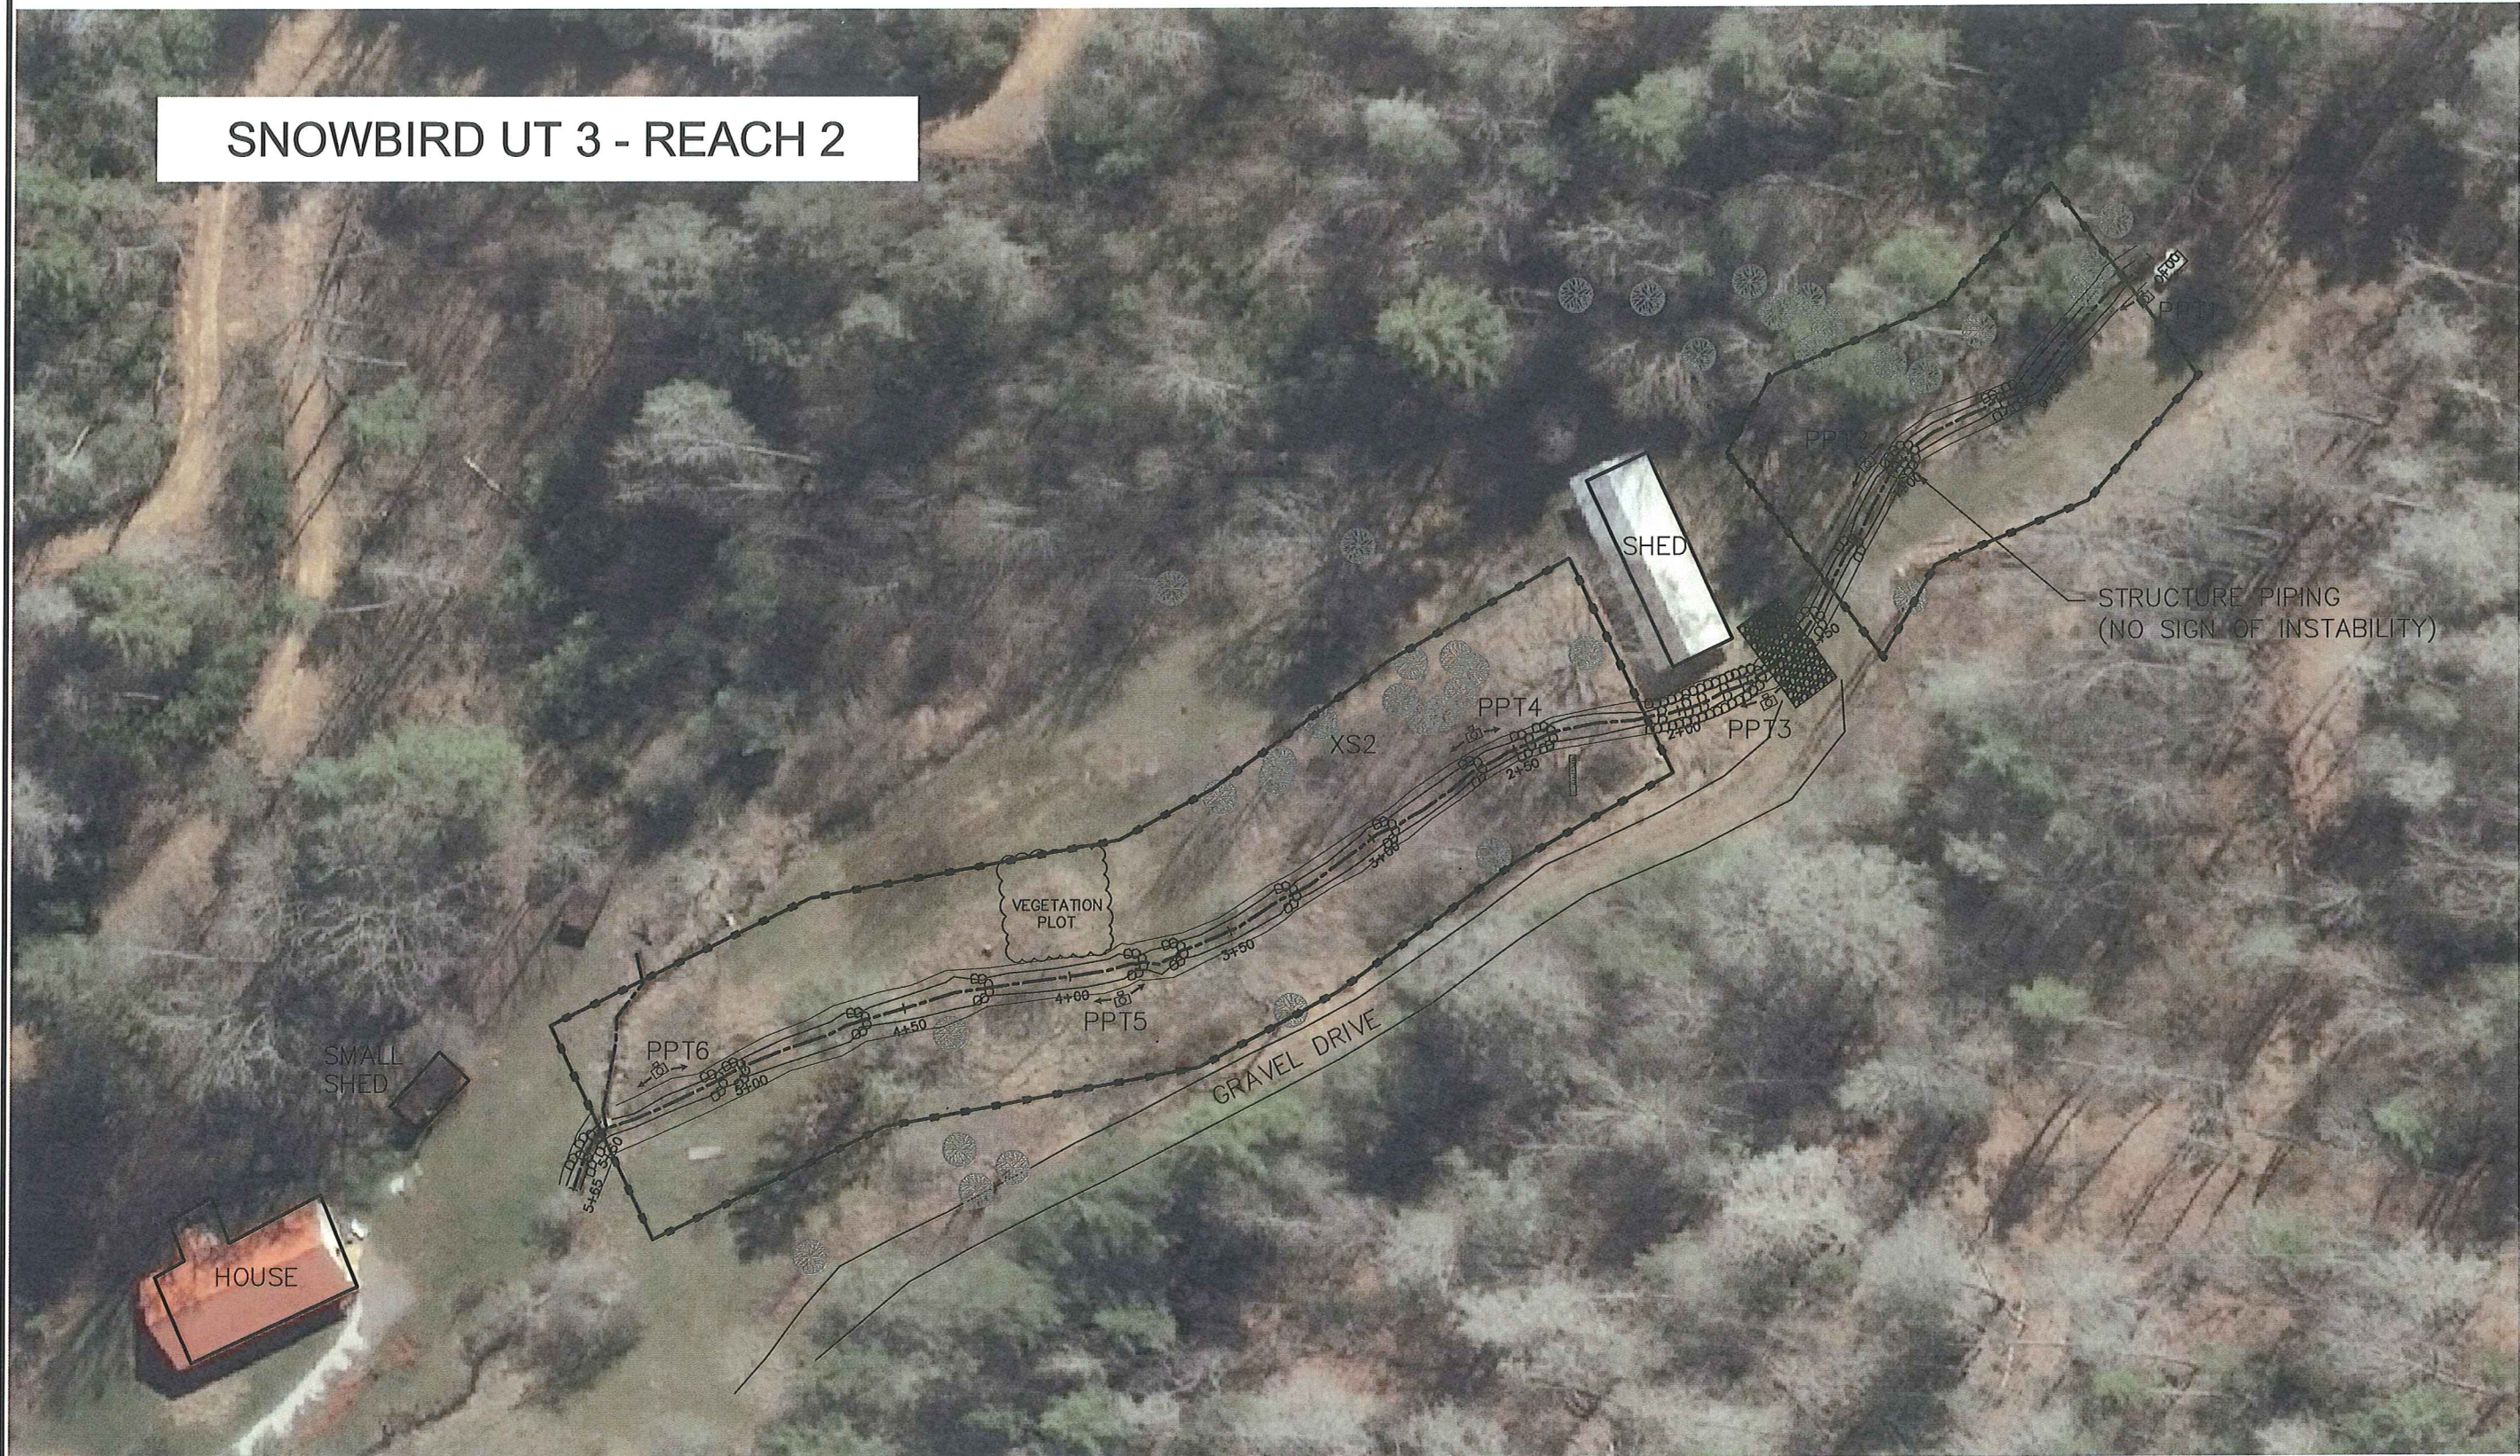
## STREAM PROBLEM AREAS YEAR 1 MONITORING

There was also little to no change in the profile of Reach 2 of UT3 since construction. There is one structure around station 0+95 where the stream is piping through the structure; however, there was no sign of bank or channel instability observed. At this time, the structure is not considered to be an area of concern. Baker will continue to monitor this structure and repairs will be made should the area become unstable or the area of piping does

<b>Feature Issue</b>	<b>Station No.</b>	<b>Suspected Cause</b>	<b>Photo Number</b>
Other	0+95 along left and right bank boulder arm tie-ins	Piping of rock drop structure along left and right bank tie-in boulders suggesting the settling of unconsolidated backfill material over time.	No photo included as piping water around structure is not discernable in the image.

At this time, there are no areas of concern. Baker will monitor the structure where piping is occurring and will repair the structure if the bank or channel becomes unstable; a small vegetation plot will be established on UT2-Reach 2 prior to the next report, the survival of stems within the plot will be monitored annually to document riparian conditions in the Enhancement II reach.

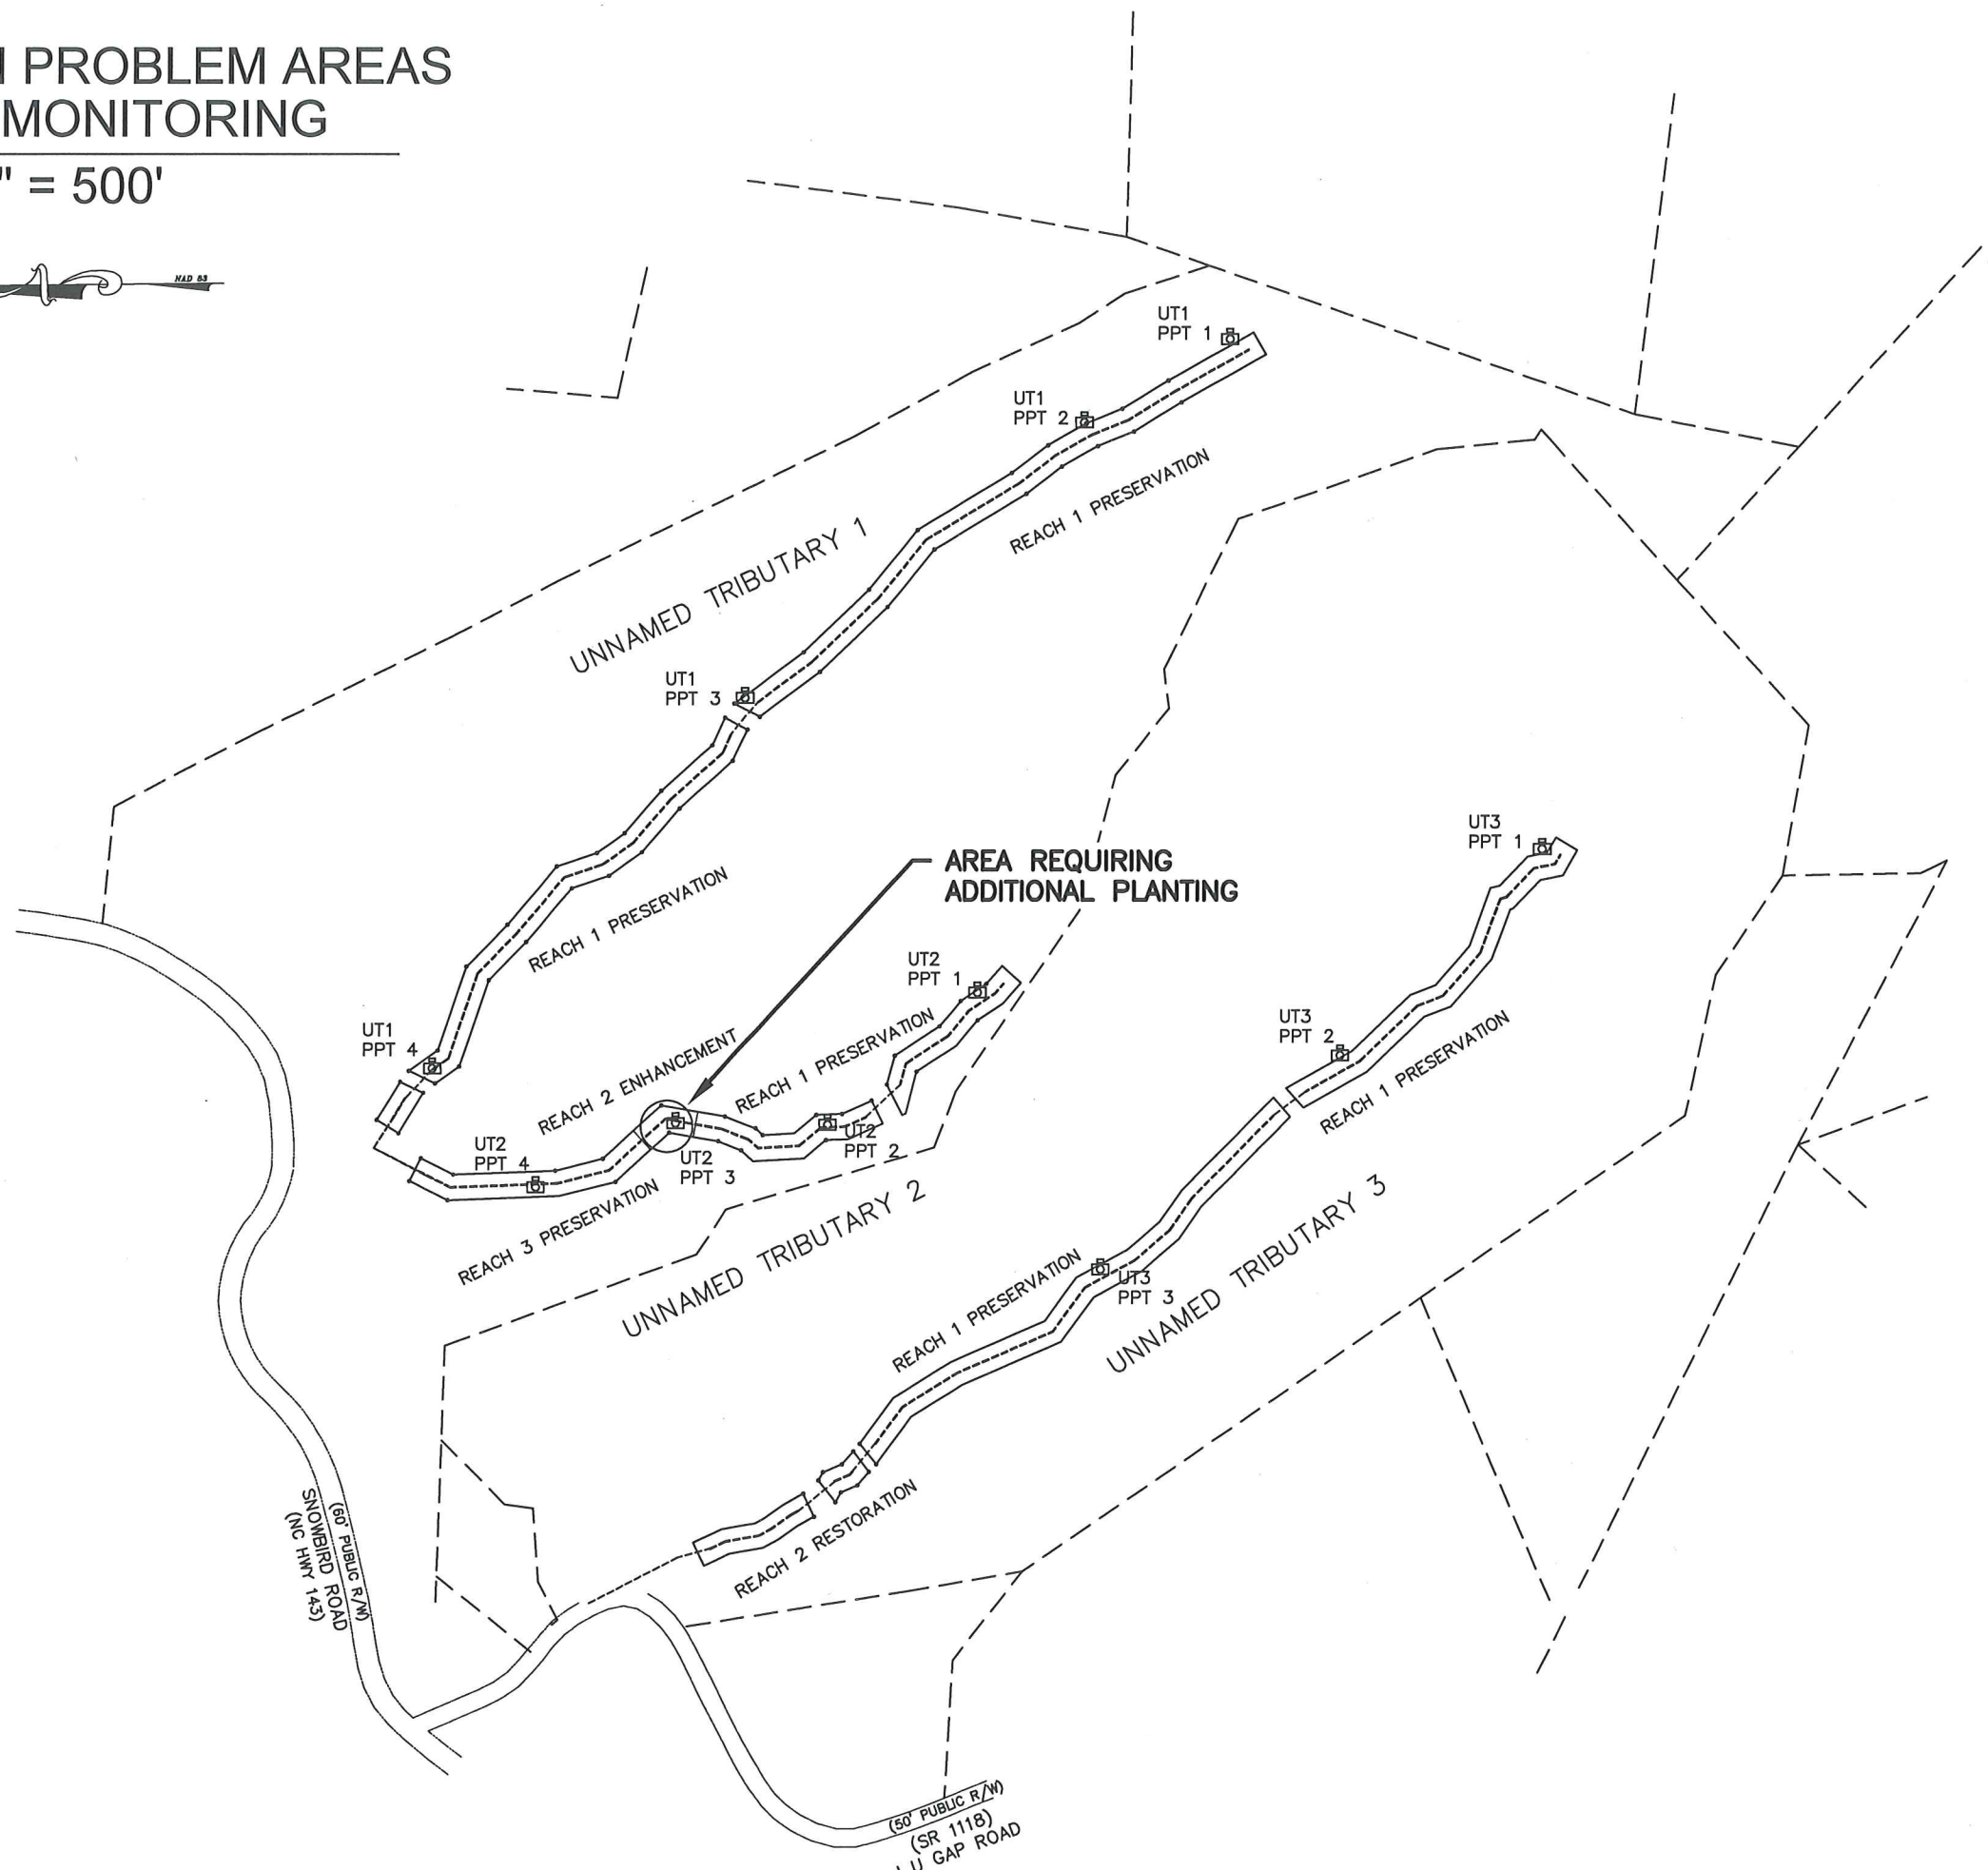
# VEGETATION PROBLEM AREAS YEAR 1 MONITORING

As noted in the Executive Summary, a smaller vegetation plot is to be established in the Enhancement II Reach on UT2. The plot, which will be 5m<sup>2</sup> in size, will be used to collect tree survival data from a subsampling of the vegetation planted. The plot will be installed once the planting contractor replants the Enhancement II reach, whereupon Baker will annually record the number of stems within the plot and the height of each stem. The plot will also be photographed to visually document changes in the riparian corridor over the course of the monitoring period. Figure 4 and Table 13 in Appendix F document this area that are in need of planted stems along Reach 2 of UT2.

<b>Feature Issue</b>	<b>Station No.</b>	<b>Suspected Cause</b>	<b>Photo Number</b>
Other	N/A	N/A	N/A
Bare Bank	Left and right bank along the entire 171 LF reach (reach is not stationed).	Both banks need to be planted as a result of the planting contractor neglecting to set out stems after conducting debris removal from the channel. Baker is coordinating with the contractor to plant the area prior to a vegetation plot being established (which will be included in Year 2 monitoring).	UT2 Photo Point 3 in Appendix B
Bare Bench	N/A	N/A	N/A
Bare Flood Plain	N/A	N/A	N/A
Invasive/Exotic Populations	N/A	N/A	N/A
