Snowbird Creek Tributaries Mitigation Project

Year 2 Monitoring Report - Final

Graham County, North Carolina

Monitoring Firm: Michael Baker Engineering, Inc. (Baker)

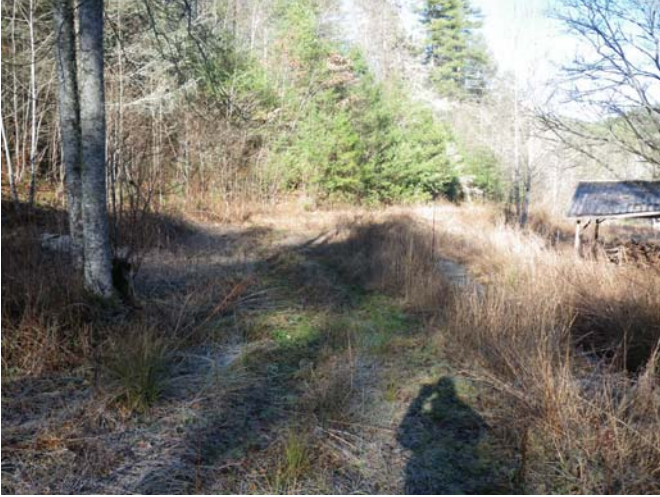
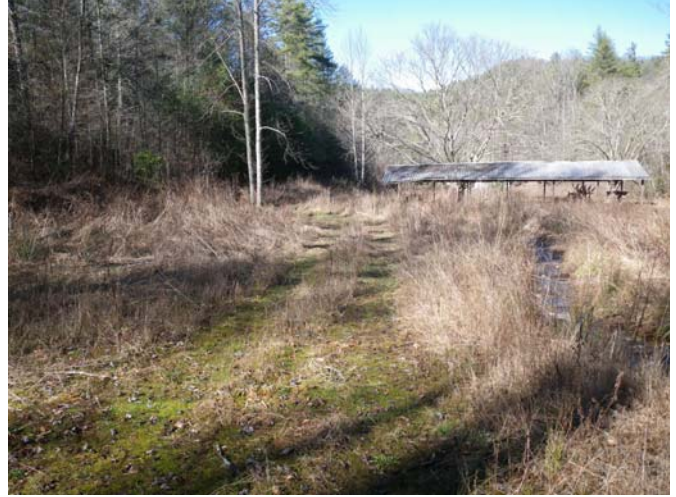
Only one vegetation problem area was identified during the Year 2 monitoring period. It is a small strip of impacted buffer paralleling the upstream limits of UT3-Reach 2. This buffer impact is approximately 30 feet wide by 130 (from station 0+10 to 1+40) feet long and is located within the left floodplain; it is caused by local residents encroaching on a portion of the easement in order to gain vehicle access to existing logging roads (trails) that continue on the property further upstream of the project reach/easement limits. Vegetation within this impacted swath of buffer is sparse from the mowing over and flattening by vehicles to the extent that a defined path has become apparent. Baker is coordinating with the contractor and land owner to correct this situation by relocating the easement encroached portion of the vehicle access to outside of and adjacent to the easement to avoid further encroachment. The impacted buffer within the easement will be reseeded and replanted after construction of the relocated vehicle access. This is scheduled to be completed by the end of 2013 and will be documented within the Year 3 monitoring report. Supplemental information can be found in Appendix F which includes a planview figure, photos, and a summary table.

Feature Issue	Station No.	Suspected Cause	Photo Number
Bare Floodplain	0+10 to 1+40 (left floodplain)	Easement encroachment by vehicles accessing existing forest road located further upstream of project reach limits. Baker is coordinating with the contractor and land owner to create an alternate vehicle access located outside the easement to avoid further encroachment. The impacted buffer within the easement will be reseeded and replanted during construction of the alternate vehicle access.	VPA1

VPA1 – Easement encroachment/buffer impact from access road paralleling the upstream limits of UT3-Reach 2 (looking downstream from left floodplain)

sparse from the mowing over and flattening by vehicles to the extent that a defined path has become apparent. Baker is coordinating with the contractor and land owner to correct this situation by relocating the easement encroached portion of the vehicle access to outside of and adjacent to the easement to avoid further encroachment. The impacted buffer within the easement will be reseeded and replanted after construction of the relocated vehicle access. This is scheduled to be completed by the end of 2013 and will be documented within the Year 3 monitoring report. Supplemental information can be found in Appendix F which includes a planview figure, photos, and a summary table.
