Snowbird Creek Tributaries Mitigation Project

Year 3 Monitoring Report - Final

Graham County, North Carolina

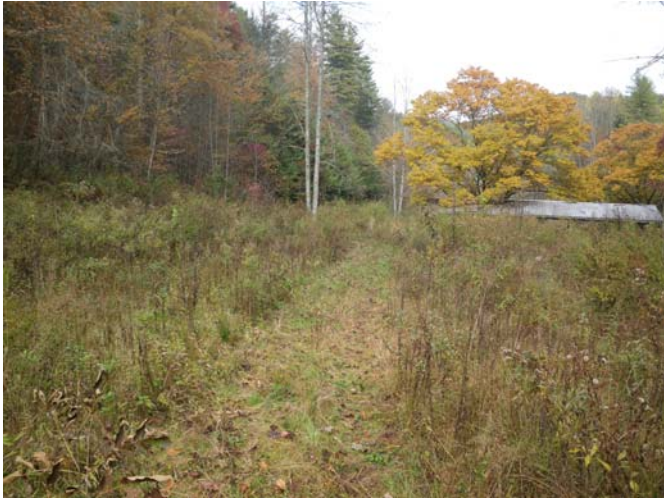
Only one vegetation problem area was identified during the Year 3 monitoring period. It is a small strip of impacted buffer paralleling the upstream limits of UT3-Reach 2. This buffer impact is approximately 30 feet wide by 130 (from station 0+10 to 1+40) feet long and is located within the left floodplain; it is caused by local residents encroaching on a portion of the easement in order to gain 4-wheeler vehicle access to the existing logging roads (trails) that continue on the property further upstream of the project reach/easement limits. Vegetation within this impacted path through the buffer is mashed from being driven on, to the extent that a defined path has become apparent. Baker is coordinating with a contractor and the land owner to correct this situation by relocating the path for vehicle access outside of, and adjacent to, the easement, to avoid further encroachment. The impacted buffer within the easement will be reseeded and replanted after construction of the relocated vehicle access. This is scheduled to be completed in the spring of 2014 and will be documented within the Year 4 monitoring report. Supplemental information can be found in Appendix F which includes a planview figure, photos, and a summary table.

Feature Issue	Station No.	Suspected Cause	Photo Number
Bare Floodplain	0+10 to 1+40 (left floodplain)	Easement encroachment by vehicles accessing existing forest road located further upstream of project reach limits. Baker is coordinating with the contractor and land owner to create an alternate vehicle access located outside the easement to avoid further encroachment. The impacted buffer within the easement will be reseeded and replanted during construction of the alternate vehicle access.	VPA1

VPA1 – Easement encroachment/buffer impact from access road paralleling the upstream limits of UT3-Reach 2 (looking downstream from left floodplain)

sparse from the driving over and flattening by vehicles to the extent that a defined path has become apparent. Baker is coordinating with a contractor and the land owner to correct this situation by relocating the easement encroached portion of the vehicle access to outside of and adjacent to the easement to avoid further encroachment. The impacted buffer within the easement will be reseeded and replanted after construction of the relocated vehicle access. This is scheduled to be completed by the end of 2014 and will be documented within the Year 4 monitoring report. Supplemental information can be found in Appendix F which includes a planview figure, photos, and a summary table.

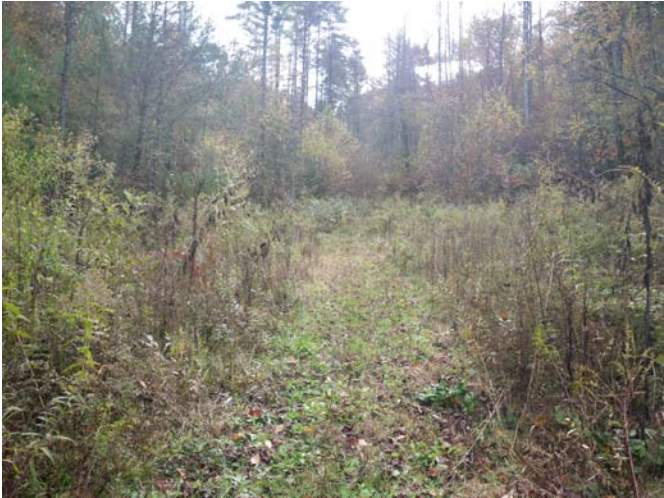
VPA1 – Easement encroachment/buffer impact from access road paralleling the upstream limits of UT3-Reach 2 (looking upstream from left floodplain)
