# Snowbird Creek Tributaries Mitigation Project

## Year 4 Monitoring Report - Final

### Graham County, North Carolina

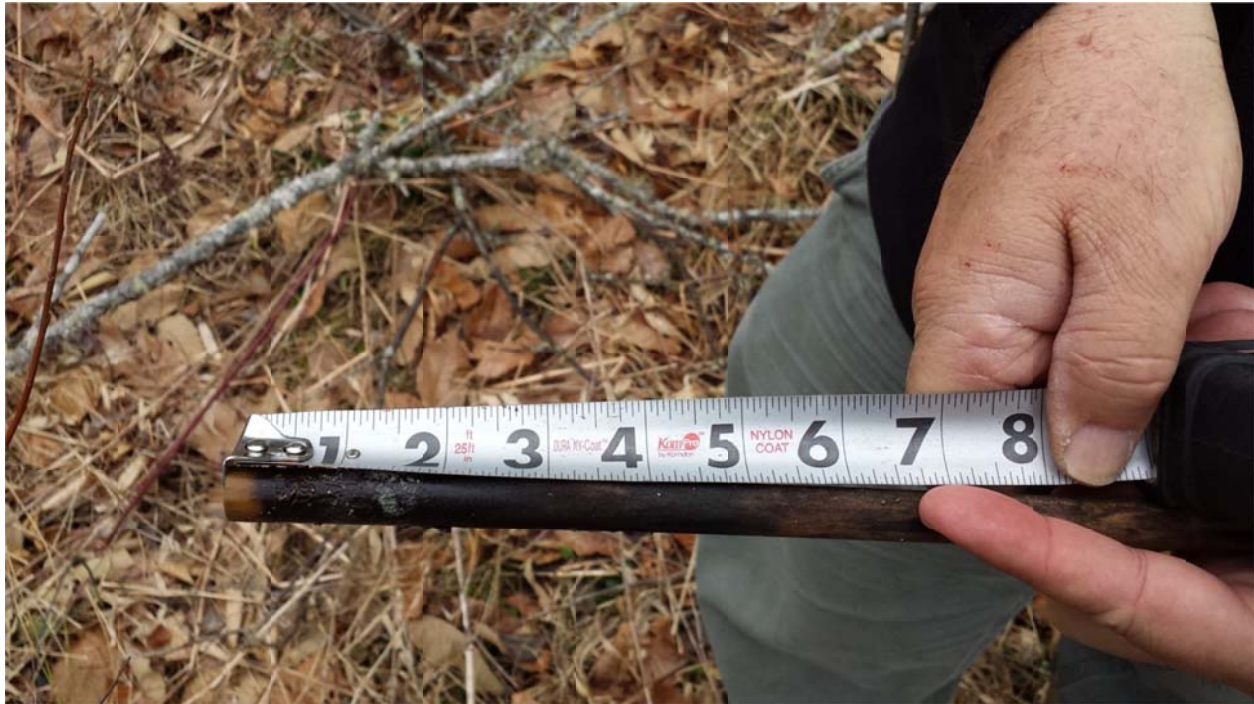
Photo of cork at 6.5 inches, or 0.54 feet above the floodplain.

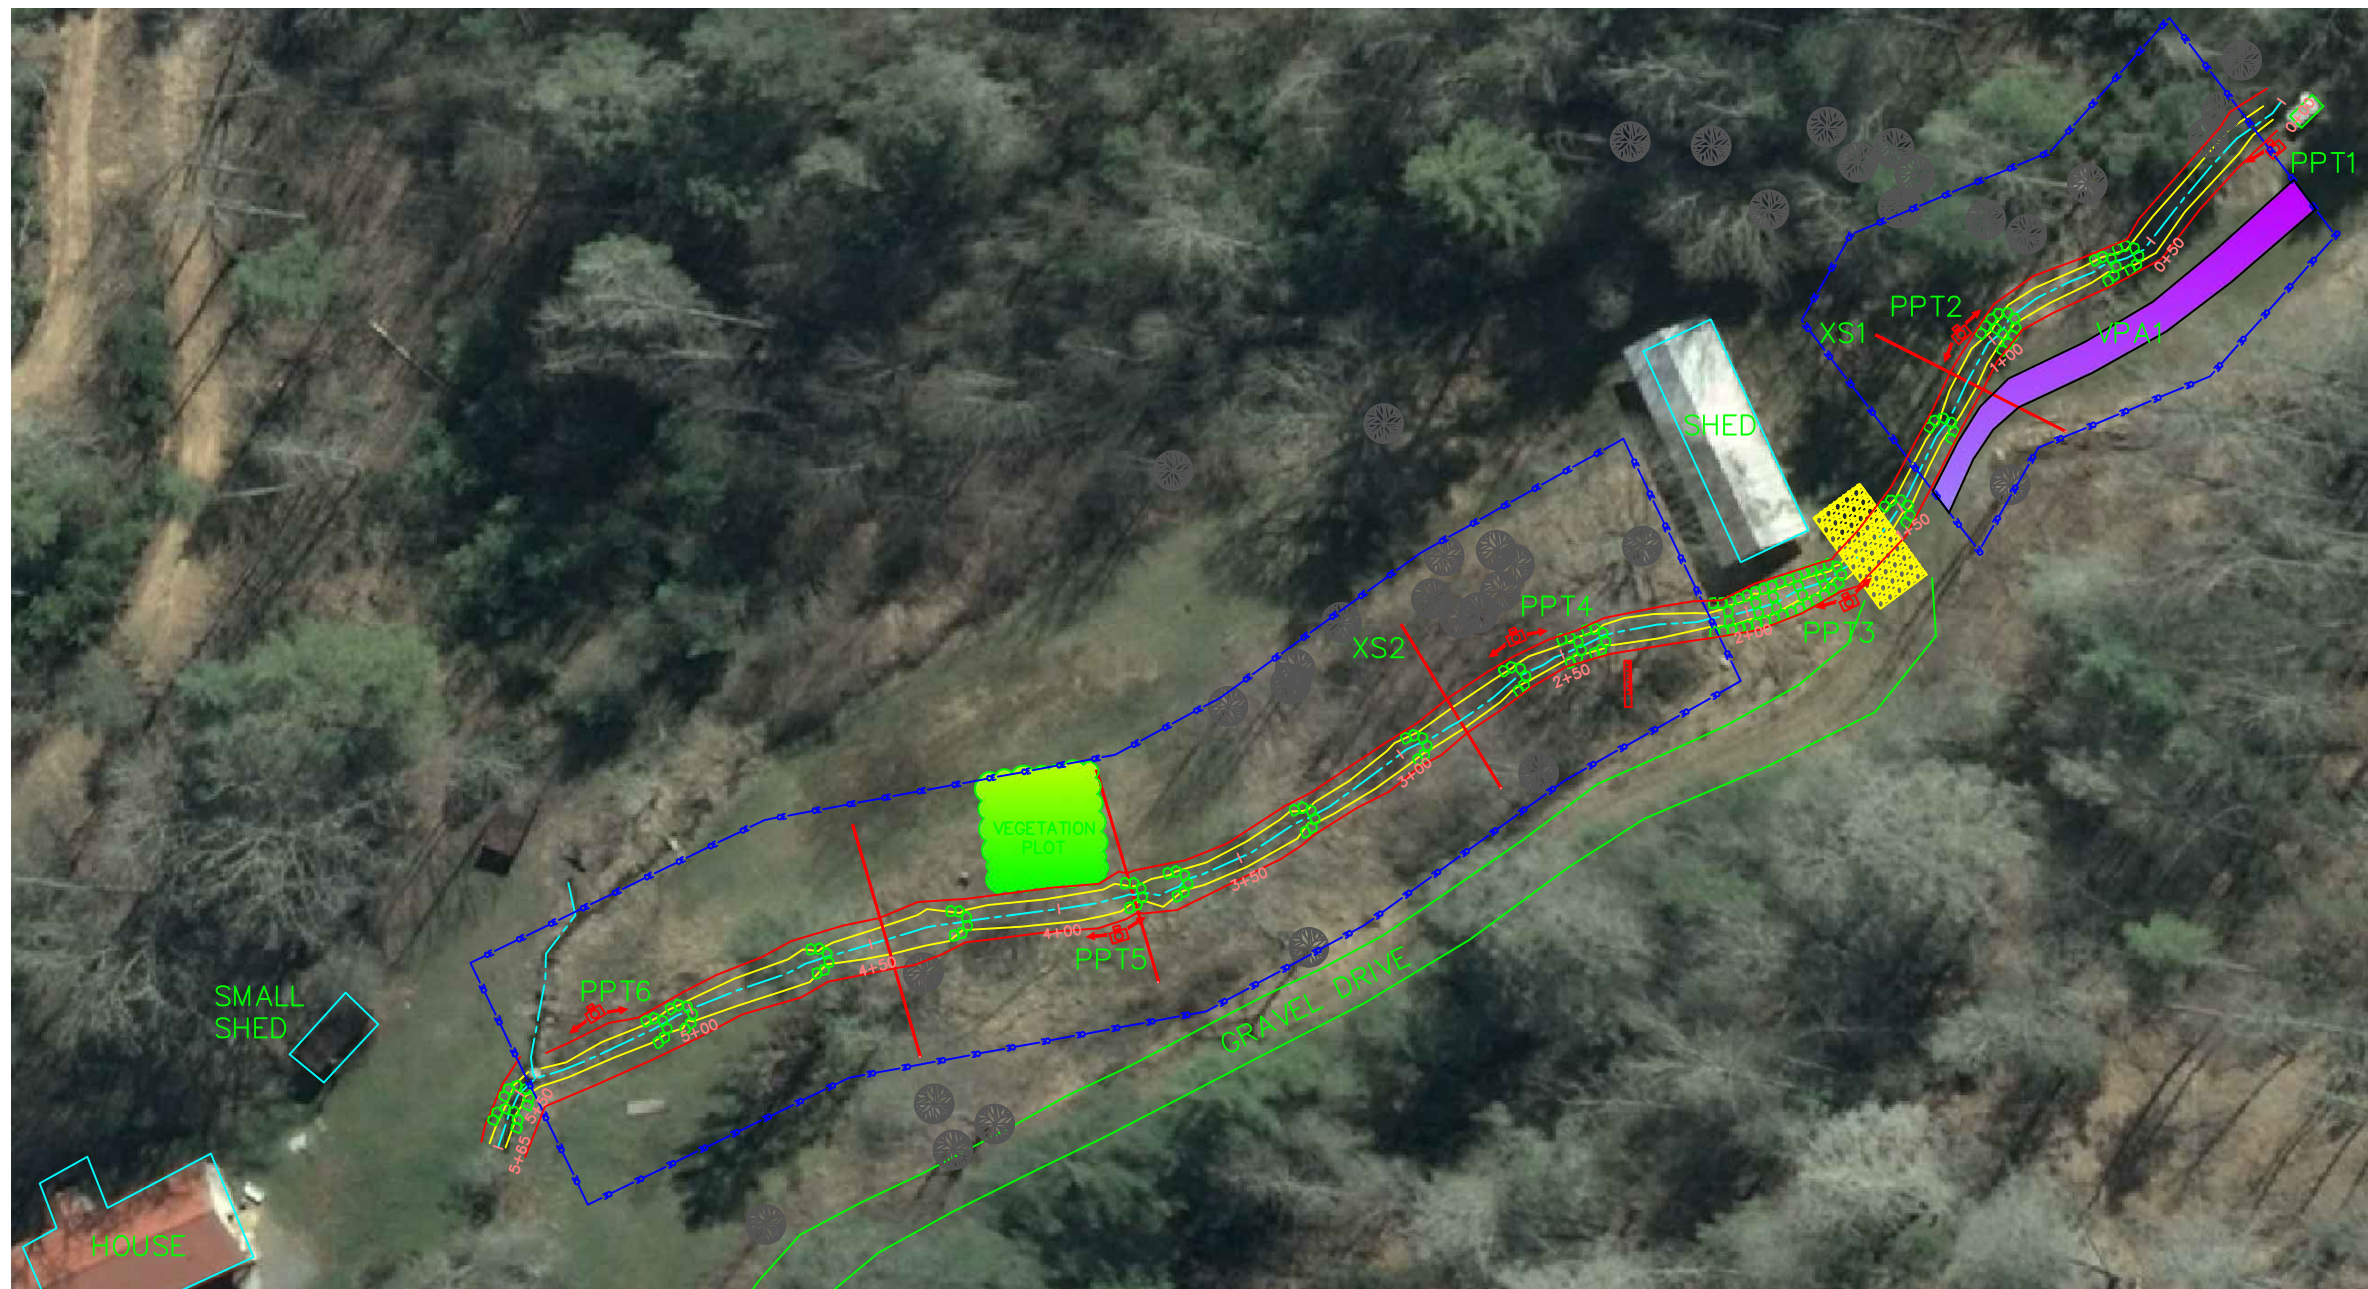
SNOWBIRD UT3 REACH 2  
CURRENT CONDITION  
PLAN VIEW  
YEAR 4 MONITORING

- 🟢 VEG PLOT CRITERIA MET
- 🟠 VEG PLOT CRITERIA UNMET (NO PLOTS CURRENTLY MEETING THIS CRITERIA)
- 🟡 VEGETATION PROBLEM AREA (VPA) (BARE FLOOD PLAIN)
- 🟦 STREAM PROBLEM AREAS (NO STREAM PROBLEM AREAS)

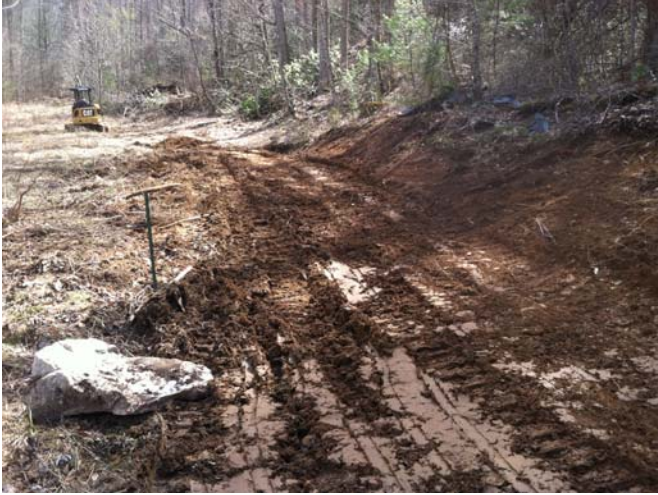
Only one vegetation problem area has continued to be an issue during the Year 4 monitoring period. It is a small strip of impacted buffer paralleling the upstream limits of UT3-Reach 2. This buffer impact is approximately 15 feet wide by 130 feet long (from station 0+10 to 1+40) and is located within the left floodplain. It was caused by a local resident encroaching on a portion of the easement in order to gain vehicle access to a cistern box that is upstream of the project reach/easement limits and supplies water to his residence. Baker hired a local contractor to correct this situation by relocating the path that the vehicle has used to an alignment outside of the easement, to avoid further encroachment. The impacted buffer within the easement was replanted with trees, after construction of the relocated path. Herbaceous vegetation was already growing within this area, so reseeding was not needed. Baker purchased larger trees that were planted within this impacted area. This realignment construction and planting was completed in March, 2015. We have continued to show this area as a Vegetation Problem Area on the Current Condition Plan View in Appendix F because for most of YR4 this was an issue; however, as stated above, it was fixed at the end of the monitoring year. Supplemental information can be found in Appendix F which includes a planview figure, photos, and a summary table.

VPA1 – New path being graded to move access road outside of the easement and eliminate easement encroachment. View looking upslope from near the stream crossing.

Baker hired a local contractor to correct this situation by relocating the path that the vehicle has used to an alignment outside of the easement, to avoid further encroachment. The impacted buffer within the easement was replanted with trees, after construction of the relocated path. Baker purchased larger trees that were planted within this impacted area. This construction and planting was completed in March, 2015. Supplemental information can be found in Appendix F which includes a planview figure, photos, and a summary table.

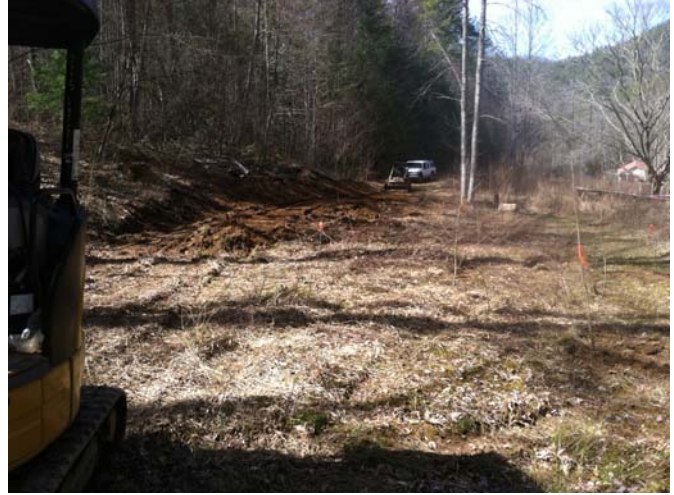
VPA2 – New path being graded to move access road outside of the easement and eliminate easement encroachment. View looking downslope from above easement alignment.

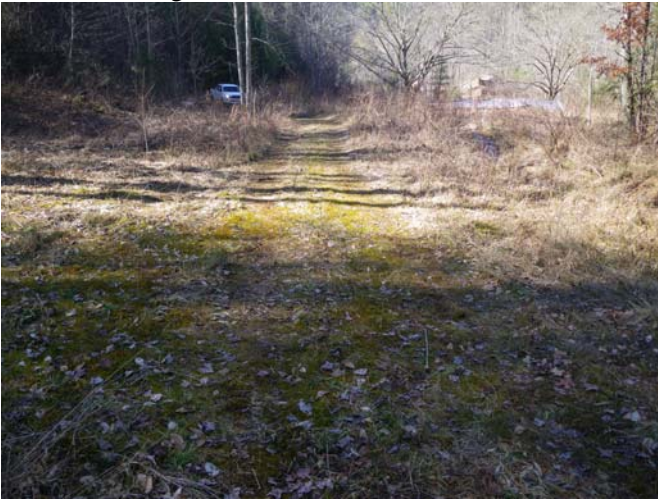
provides water to his residence) that is further upstream of the project reach/easement limits. Vegetation within this impacted swath of buffer is sparse from the driving over and flattening by a four-wheeler to the extent that a defined path has become apparent.

VPA3 – Easement encroachment impact from access path paralleling the upstream limits of UT3-Reach 2 prior to realignment and planting of trees.

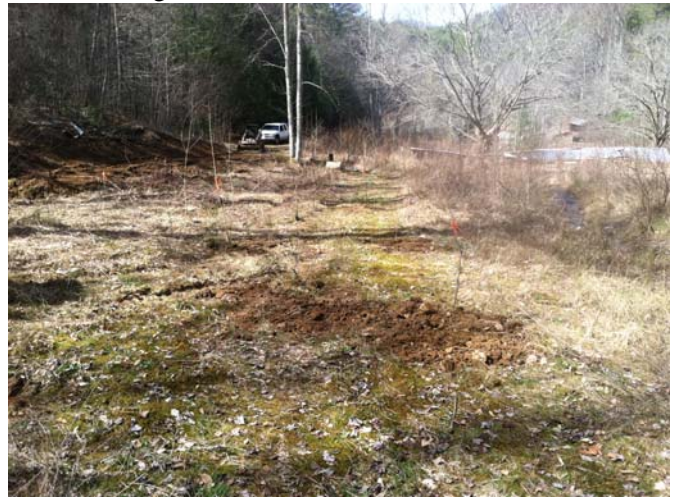
VPA4 – Impacted area planted with trees and shrubs. Trees are between 5 and 10 feet tall and spaced approximately 10 feet apart along the impacted path.

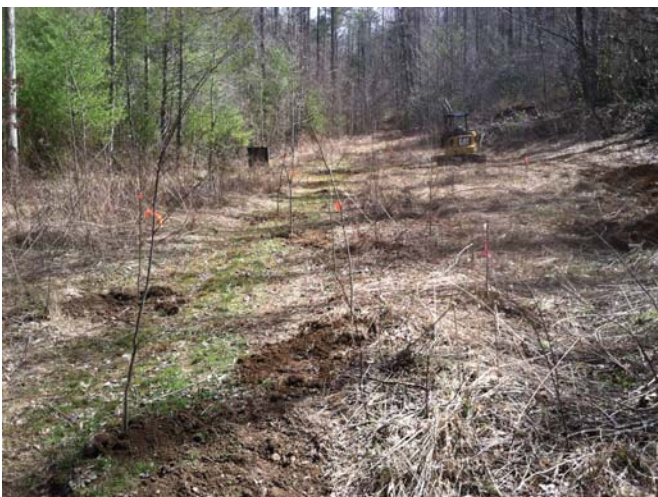
VPA5 – (At Left) Impacted area planted with trees and shrubs. Trees are between 5 and 10 feet tall and spaced approximately 10 feet apart along the impacted path. View is upslope from stream crossing.
