# **Snowbird Creek Tributaries Mitigation Project**

## **Year 5 Monitoring Report**

### **Graham County, North Carolina**

Report Submitted: December 2015

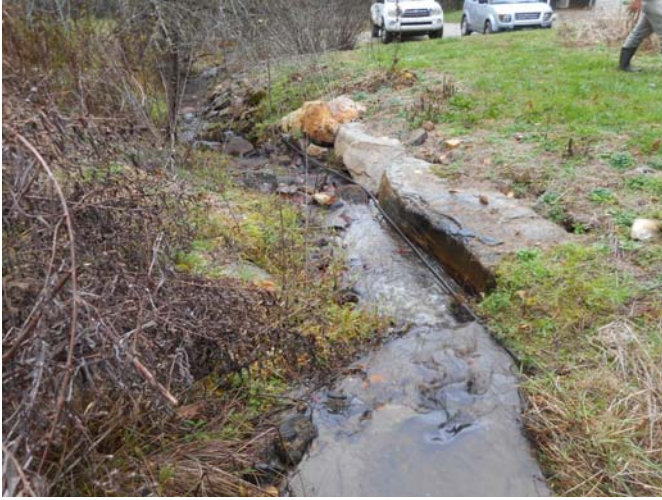
Photo Point 6: looking downstream (out of easement)

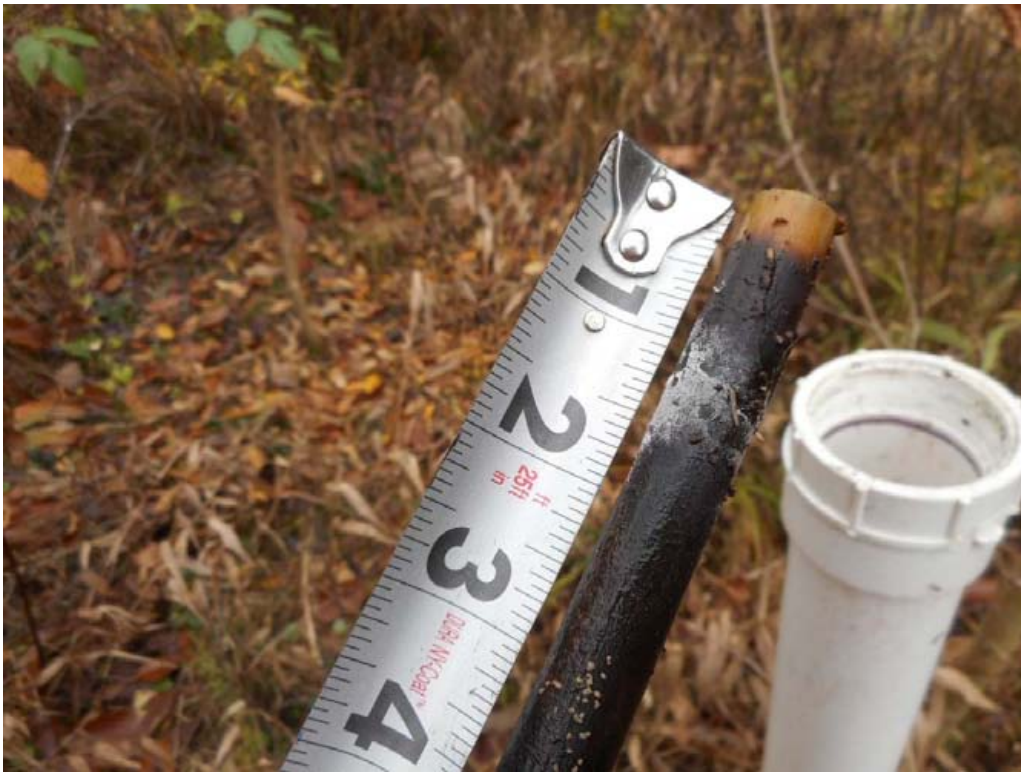
The site was found to have at least one bankfull event over the Year 5 monitoring period based on a crest gauge reading. A total of at least five bankfull events have now been documented onsite within the five year monitoring period (with at least one event documented per monitoring period). These bankfull events were documented to have occurred in five separate years and thus fulfills the hydrology success criteria for this stream mitigation project site. Information on these events is provided in Table E10 (Appendix E).

Photo of cork at 3.25 inches, or 0.27 feet above the floodplain.

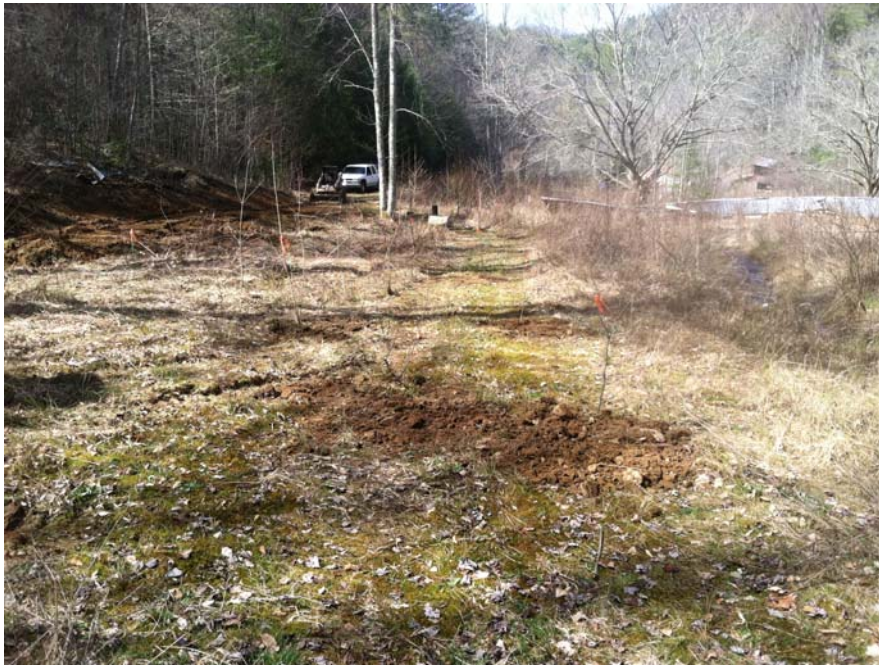
In the Monitoring Year 4 Report we explained that an area of concern reported in previous years, located along the left bank floodplain of the UT3-Restoration reach (near station 0+10 to 1+40), had been repaired. The path within the easement was approximately 15 feet wide by 130 feet long. We moved this path outside of the easement and replanted the area with larger trees in March 2015. There have been no further encroachments into this area and the planted vegetation is growing well. This area is no longer considered an Area of Concern.

Table 12. Vegetation Problem Areas			
Snowbird Creek Tributaries Mitigation Project: Project No. 92764			
UT3 Reach 2			
Feature Issue	Station No.	Suspected Cause	Photo Number
No Vegetation Problem Areas in YR5	N/A	N/A	N/A
Corrected Bare Floodplain (reported in YR4 Report)	0+10 to 1+40 (left floodplain)	REPAIR OF THIS FORMER PROBLEM: ISSUE: Easement encroachment by vehicles accessing existing cistern just upstream of project reach limits. Baker hired a contractor who created an alternate vehicle access path located outside the easement to avoid further encroachment. The impacted buffer within the easement has been replanted. Large trees were planted and are growing in the impacted area, as well as thick herbaceous vegetation.	Photos 1 and 2

Photo 1 – Impacted area planted with trees and shrubs in March 2015. Trees are between 5 and 10 feet tall and spaced approximately 10 feet apart along the impacted path.

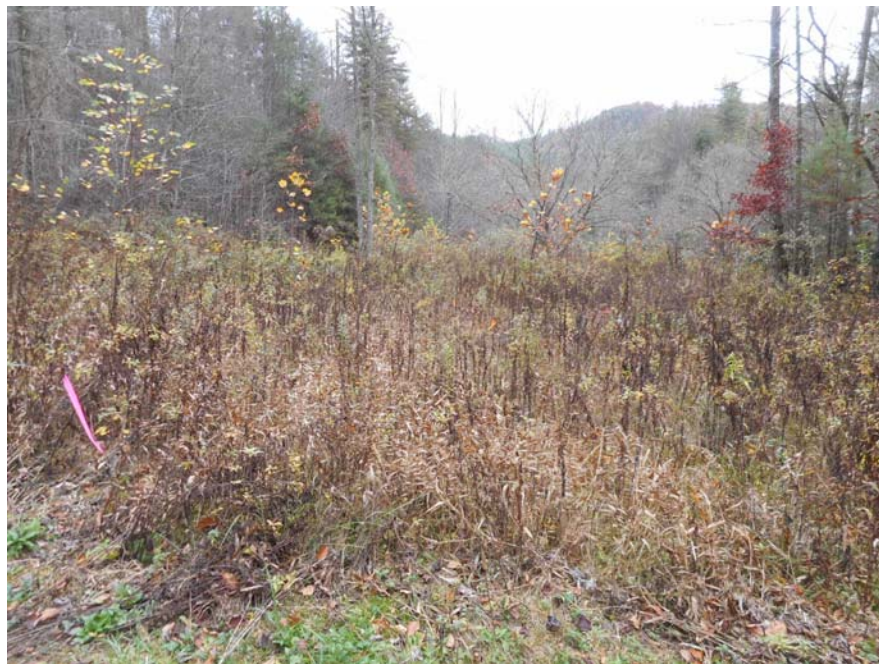
Photo 2 – The same area shown above after growing season. The planted trees have survived and are growing in the old path area. Herbaceous vegetation has also established a good stand in this area. Access to the well house, which is to the right of where this photo was taken, is over the rerouted path.
