**Snow Creek Stream Restoration
2006 Monitoring Report
Monitoring Year Two**

Ecosystem Enhancement Program Project Number 00344

Submitted: January 19, 2007

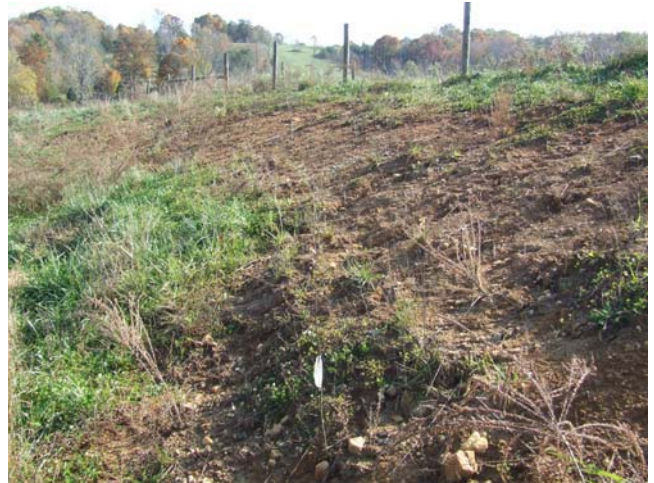
VPA2 on right bank, facing south

Table A6a. Vegetative Problem Areas – Snow Creek			
Snow Creek			
EEP Project Number 00344			
Feature/Issue	Station #/Range	Probable Cause	Photo #
Bare floodplain	5+60	Poor vegetation establishment	VPA1
Bare slope	7+60	Dry slope	VPA2

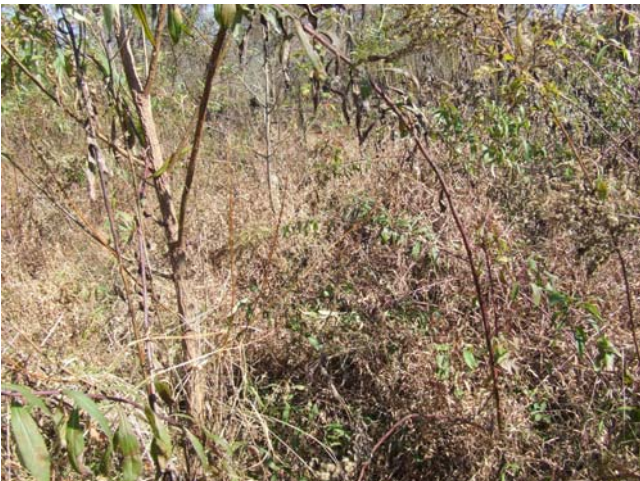
UTVPA1 on right bank, facing north

The 2006 monitoring revealed one new problem area along the Unnamed Tributary (Table A6b). The presence of Japanese stilt grass (*Microstegium vimineum*) poses a concern at the site. During 2006 monitoring, it was observed along the entire right bank of the Unnamed Tributary. It was also noted that small populations of the invasive species were appearing on the left bank of the Unnamed Tributary and along portions of Snow Creek. While the current infestation is not severe, Japanese stilt grass is known to be an aggressive plant and prolific seed producer and will likely expand rapidly throughout the project site. As with other invasive species, eradication is far less expensive and more successful if conducted at early stages, before the plant is allowed to take over a large area. Therefore, eradication of the Japanese stilt grass is recommended. Vegetative Problem Area Photos are located in Appendix A-II.

Table A6b. Vegetative Problem Areas – Unnamed Tributary			
Snow Creek			
EEP Project Number 00344			
Feature/Issue	Station #/Range	Probable Cause	Photo #
Invasive population	0+00 to 4+50	<i>Microstegium vimineum</i>	UTVPA1

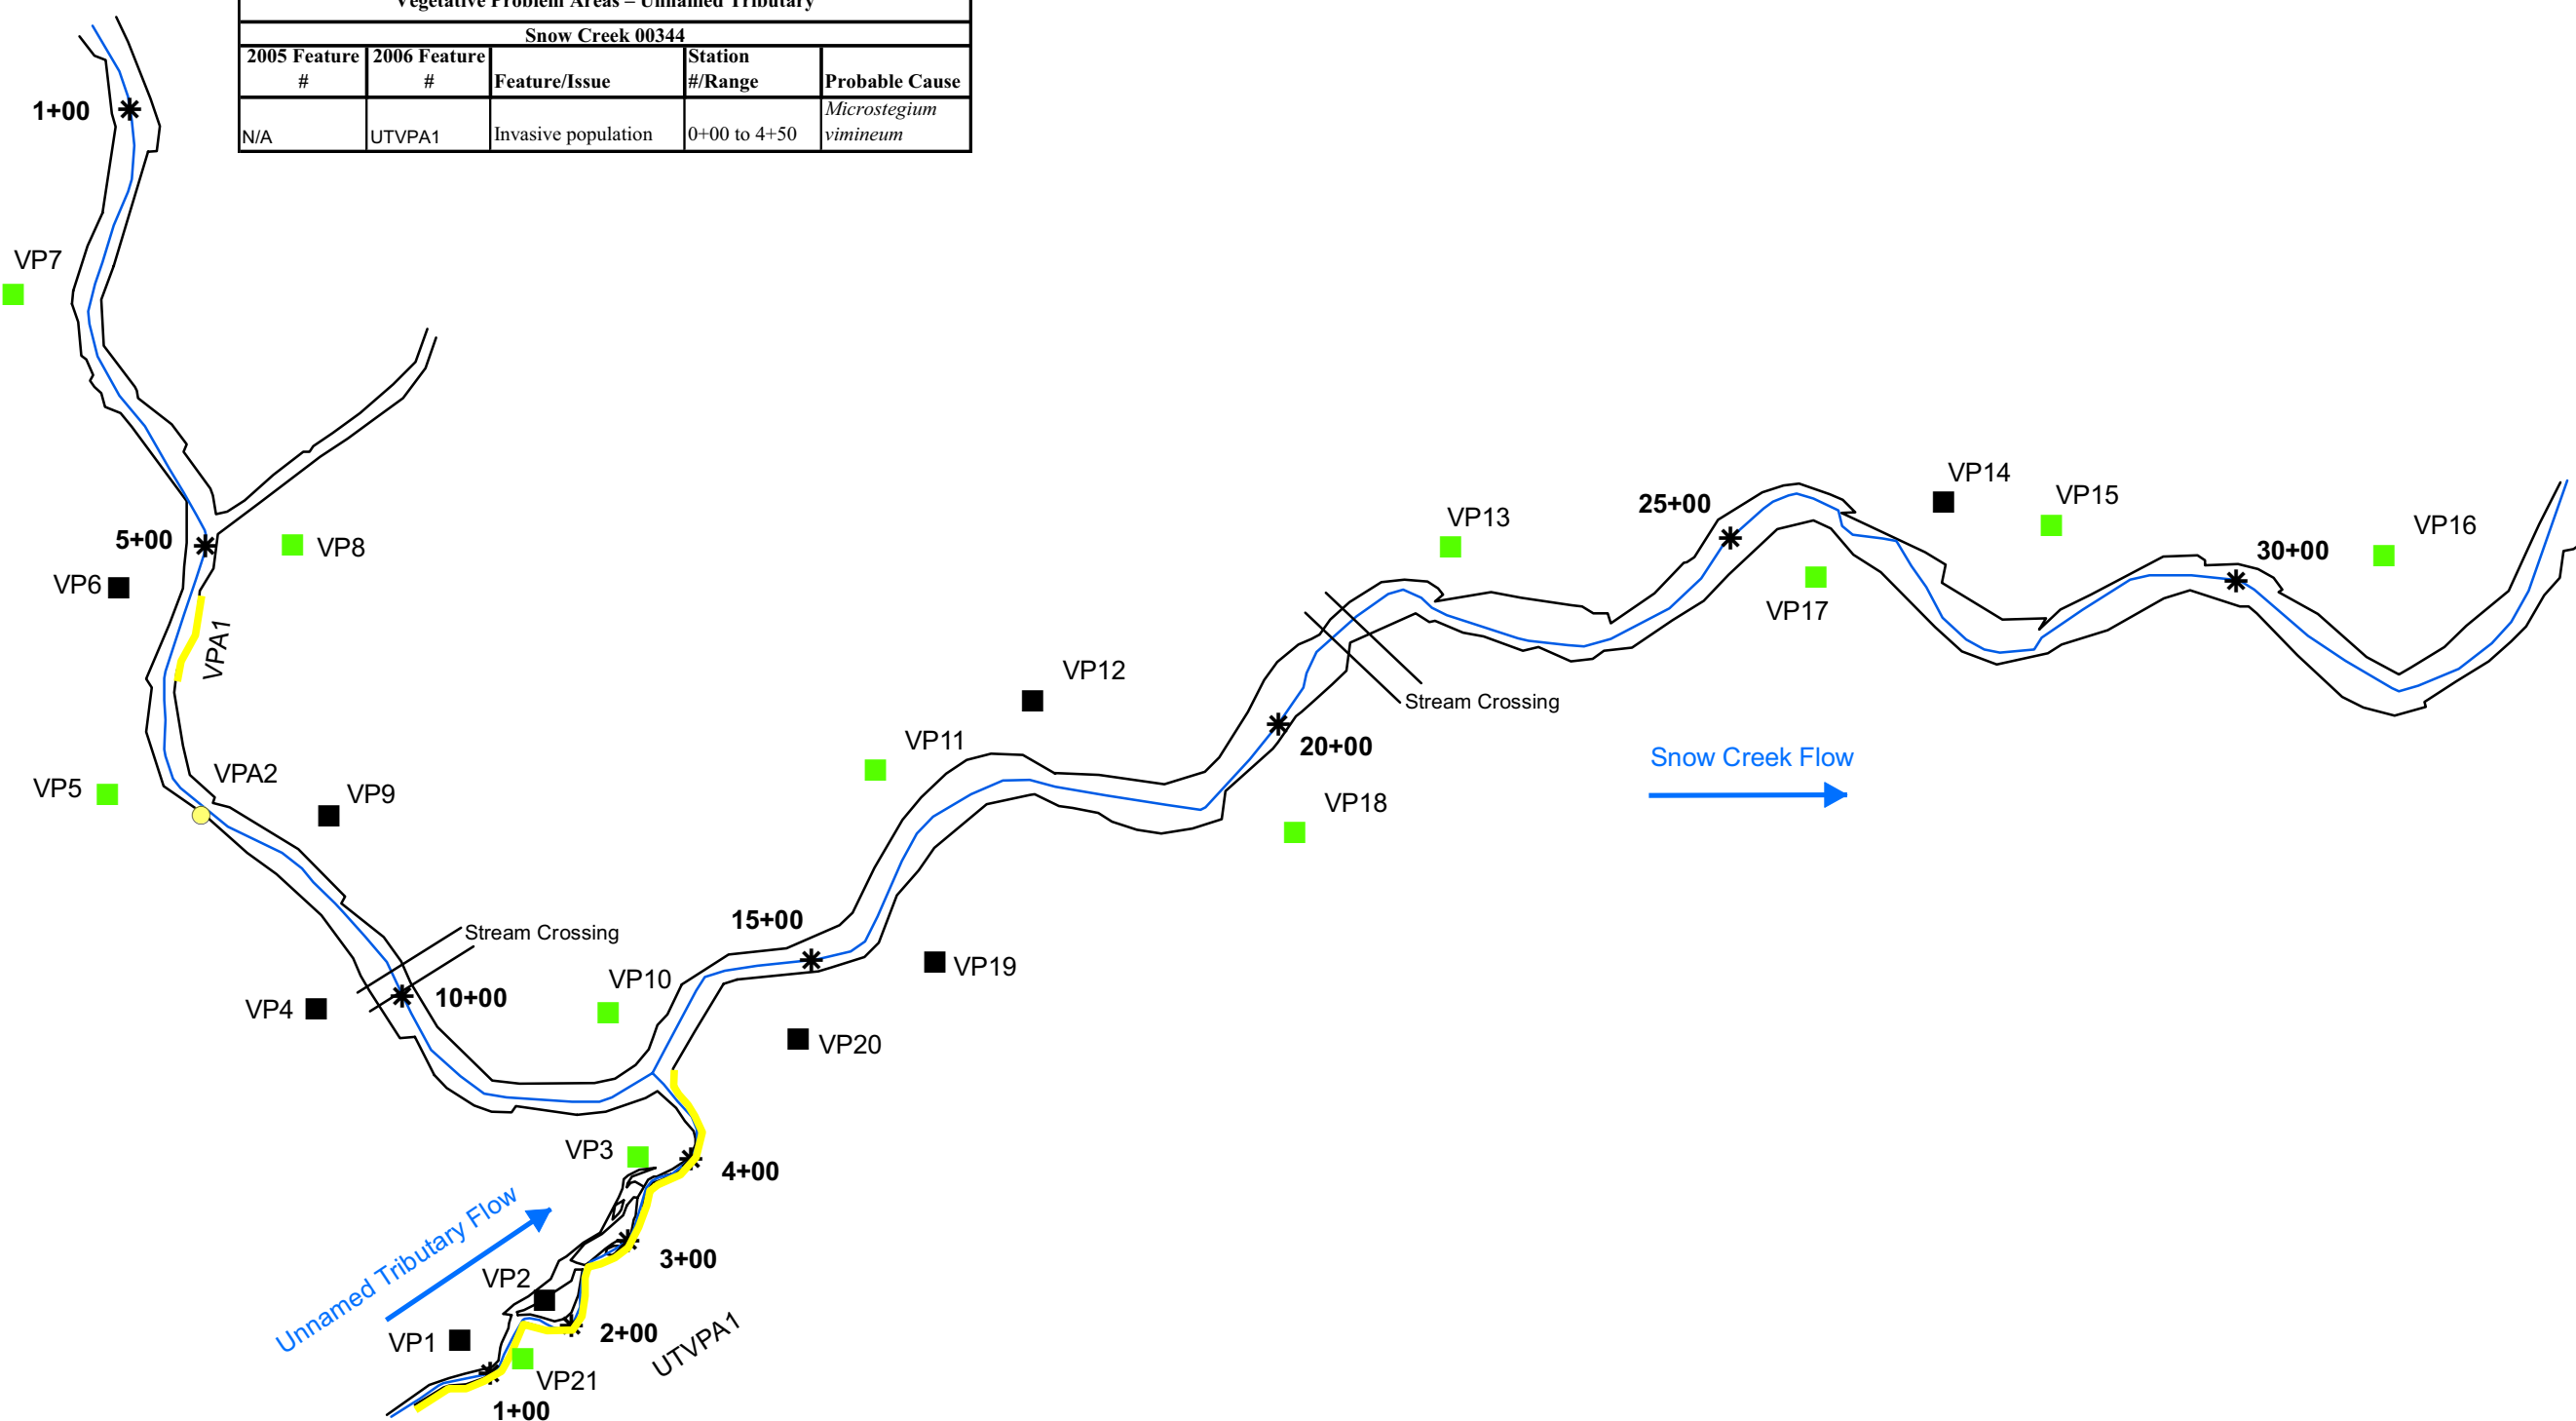
Figure 3
 Vegetative
 Problem Areas
 Plan View

Vegetative Problem Areas – Snow Creek				
Snow Creek 00344				
2005 Feature #	2006 Feature #	Feature/Issue	Station #/Range	Probable Cause
PA10	VPA1	Bare floodplain	5+60	Poor vegetation establishment
PA9	VPA2	Bare slope	7+60	Dry slope

Vegetative Problem Areas – Unnamed Tributary				
Snow Creek 00344				
2005 Feature #	2006 Feature #	Feature/Issue	Station #/Range	Probable Cause
N/A	UTVPA1	Invasive population	0+00 to 4+50	<i>Microstegium vimineum</i>

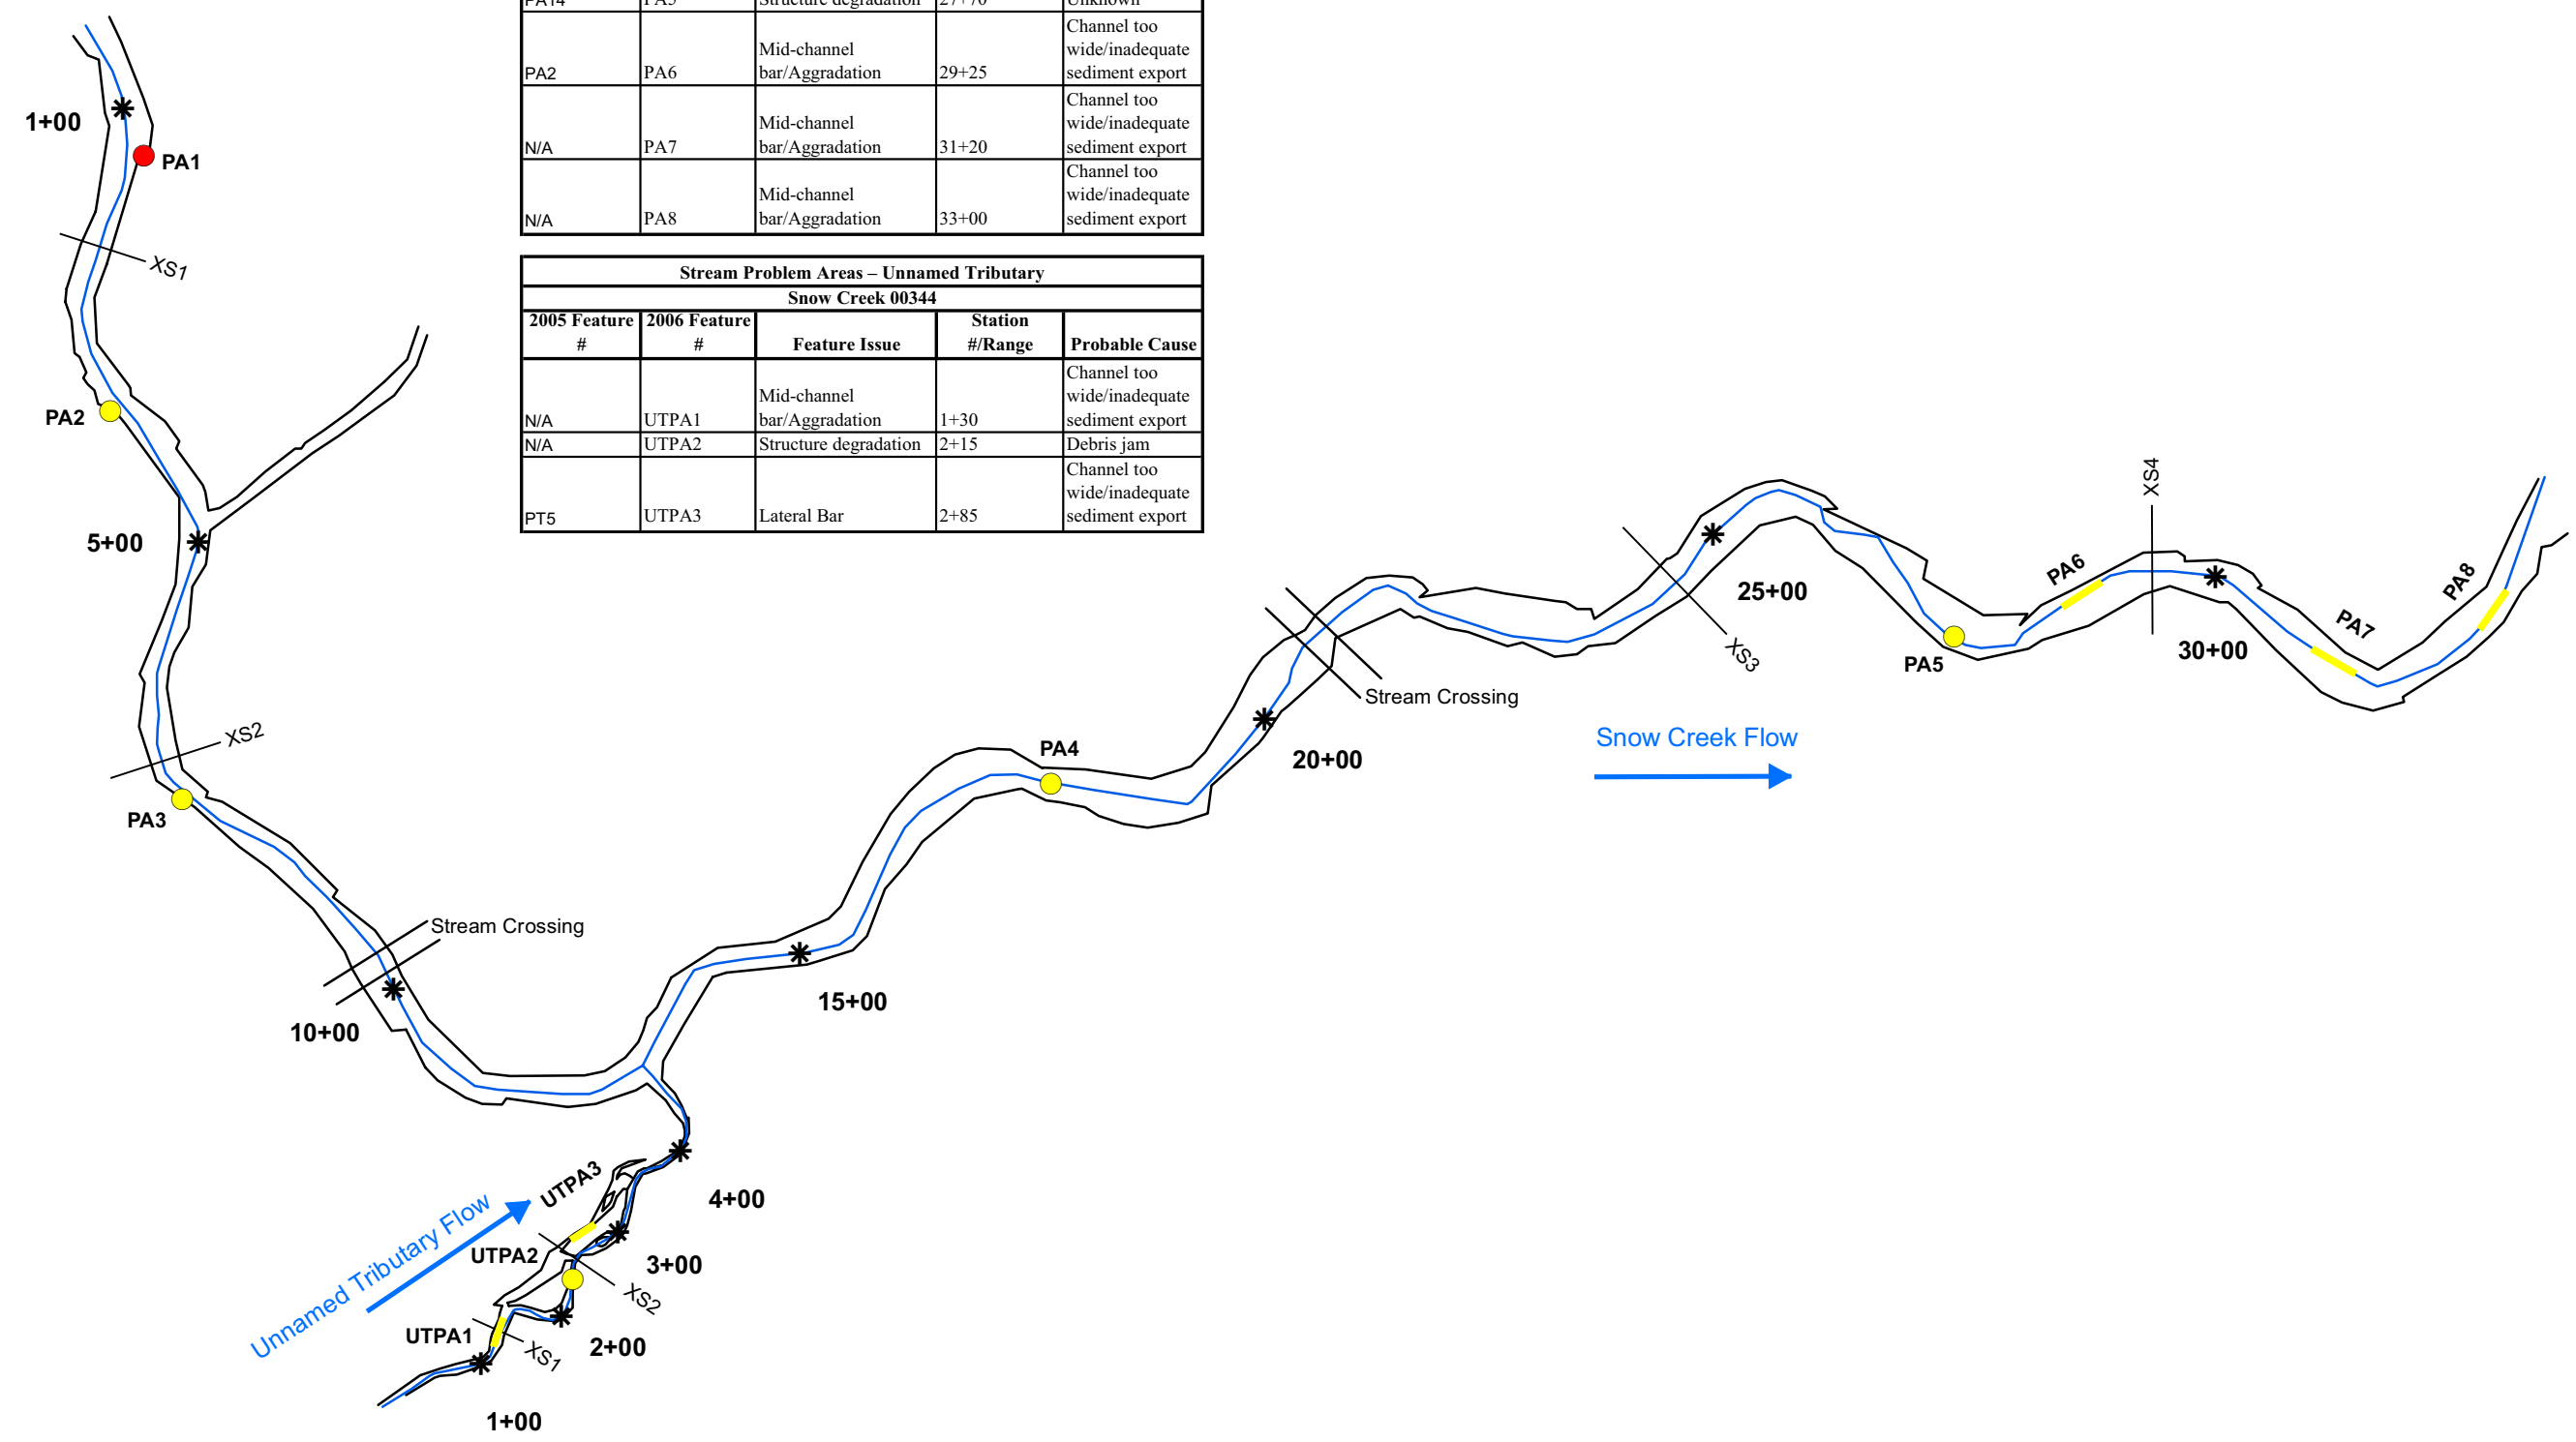
Figure 5
 Stream
 Problem Areas
 Plan View

Stream Problem Areas – Snow Creek Snow Creek 00344				
2005 Feature #	2006 Feature #	Feature Issue	Station #/Range	Probable Cause
PA11	PA1	Structure degradation	1+05	Unknown
N/A	PA2	Structure failure	3+80	Unknown
PA9	PA3	Structure degradation	7+60	Unknown
PA13	PA4	Structure degradation	17+50	Beaver activity
PA14	PA5	Structure degradation	27+70	Unknown
PA2	PA6	Mid-channel bar/Aggradation	29+25	Channel too wide/inadequate sediment export
N/A	PA7	Mid-channel bar/Aggradation	31+20	Channel too wide/inadequate sediment export
N/A	PA8	Mid-channel bar/Aggradation	33+00	Channel too wide/inadequate sediment export

Stream Problem Areas – Unnamed Tributary Snow Creek 00344				
2005 Feature #	2006 Feature #	Feature Issue	Station #/Range	Probable Cause
N/A	UTPA1	Mid-channel bar/Aggradation	1+30	Channel too wide/inadequate sediment export
N/A	UTPA2	Structure degradation	2+15	Debris jam
PT5	UTPA3	Lateral Bar	2+85	Channel too wide/inadequate sediment export

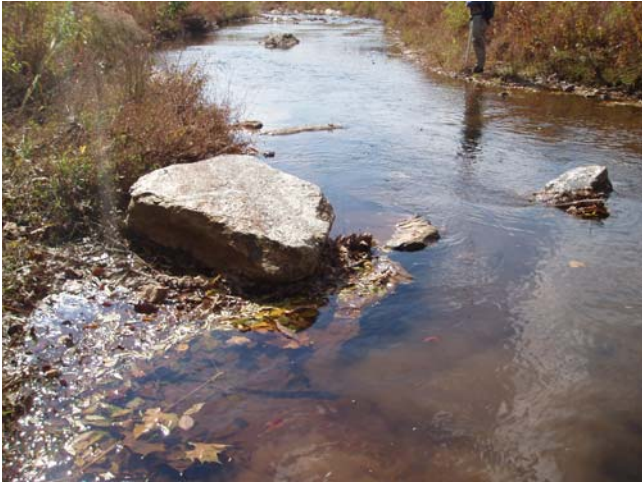
Table B1a. Stream Problem Areas – Snow Creek Snow Creek 00344			
Feature Issue	Station	Suspected Cause	Photo #
Structure degradation	1+05	Unknown	PA1
Structure failure	3+80	Unknown	PA2
Structure degradation	7+60	Unknown	PA3
Structure degradation	17+50	Beaver activity	PA4
Structure degradation	27+70	Unknown	PA5
Mid-channel bar/Aggradation	29+25	Channel too wide/inadequate sediment export	PA6
Mid-channel bar/Aggradation	31+20	Channel too wide/inadequate sediment export	PA7
Mid-channel bar/Aggradation	33+00	Channel too wide/inadequate sediment export	PA8

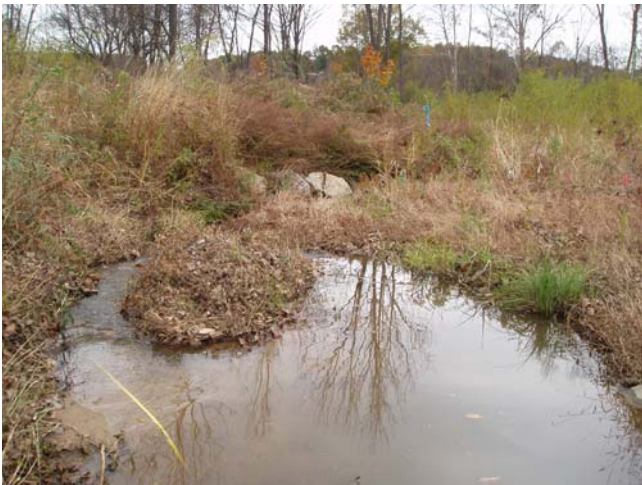
Table B1b. Stream Problem Areas – Unnamed Tributary Snow Creek 00344			
Feature Issue	Station	Suspected Cause	Photo #
Mid-channel bar/Aggradation	1+30	Channel too wide/inadequate sediment export	UTPA1
Structure degradation	2+15	Debris jam	UTPA2
Lateral Bar	2+85	Channel too wide/inadequate sediment export	UTPA3
