**Snow Creek Stream Restoration  
2007 Final Monitoring Report  
Monitoring Year Three**

**Ecosystem Enhancement Program Project Number 00344**

Prepared by: URS Corporation – North Carolina  
1600 Perimeter Park Drive, Suite 400  
Morrisville, NC 27560

Submitted: February 22, 2008

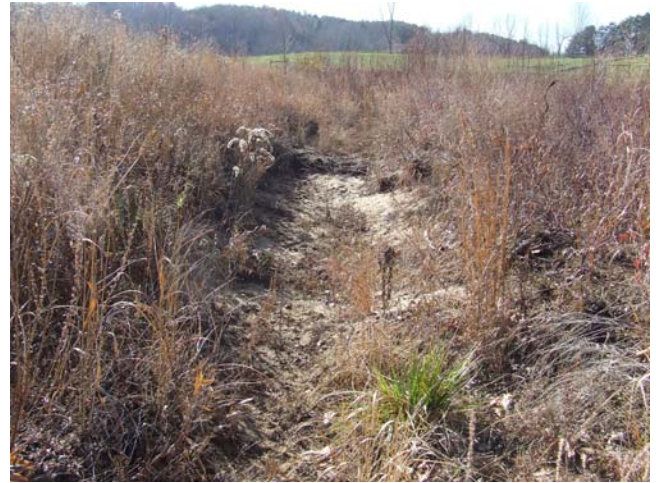
NVPA1 on left bank, facing downstream

Vegetative Problem Areas – Snow Creek			
Feature #	Feature Issue	Station # / Range	Probable Cause
VPA2	Bare Slope	7+60	Dry Slope
NVPA1	Scour of floodplain	5+60	Storm Flows
NVPA2	Poor survival	12+80	Beaver activity
NVPA3	Invasive population	19+90 to 20+40	<i>Microstegium vimeneum</i>
NVPA4	Poor survival	21+40 to 25+50	Beaver activity
Vegetative Problem Areas – Unnamed Tributary			
UTVPA1	Invasive population	0+00 to 4+50	<i>Microstegium vimeneum</i> <i>Ligustrum sinense</i>

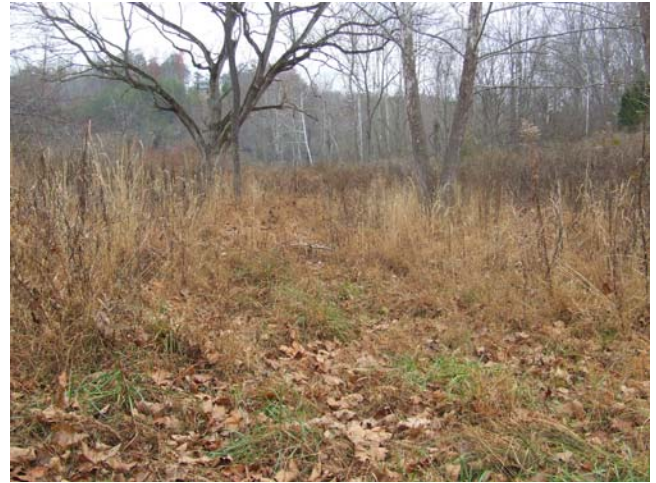
NVPA3 on right bank, facing downstream

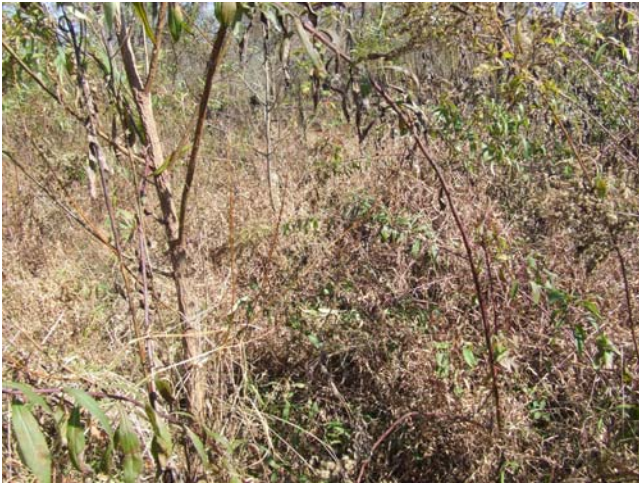
UTVPA1 on right bank, facing downstream

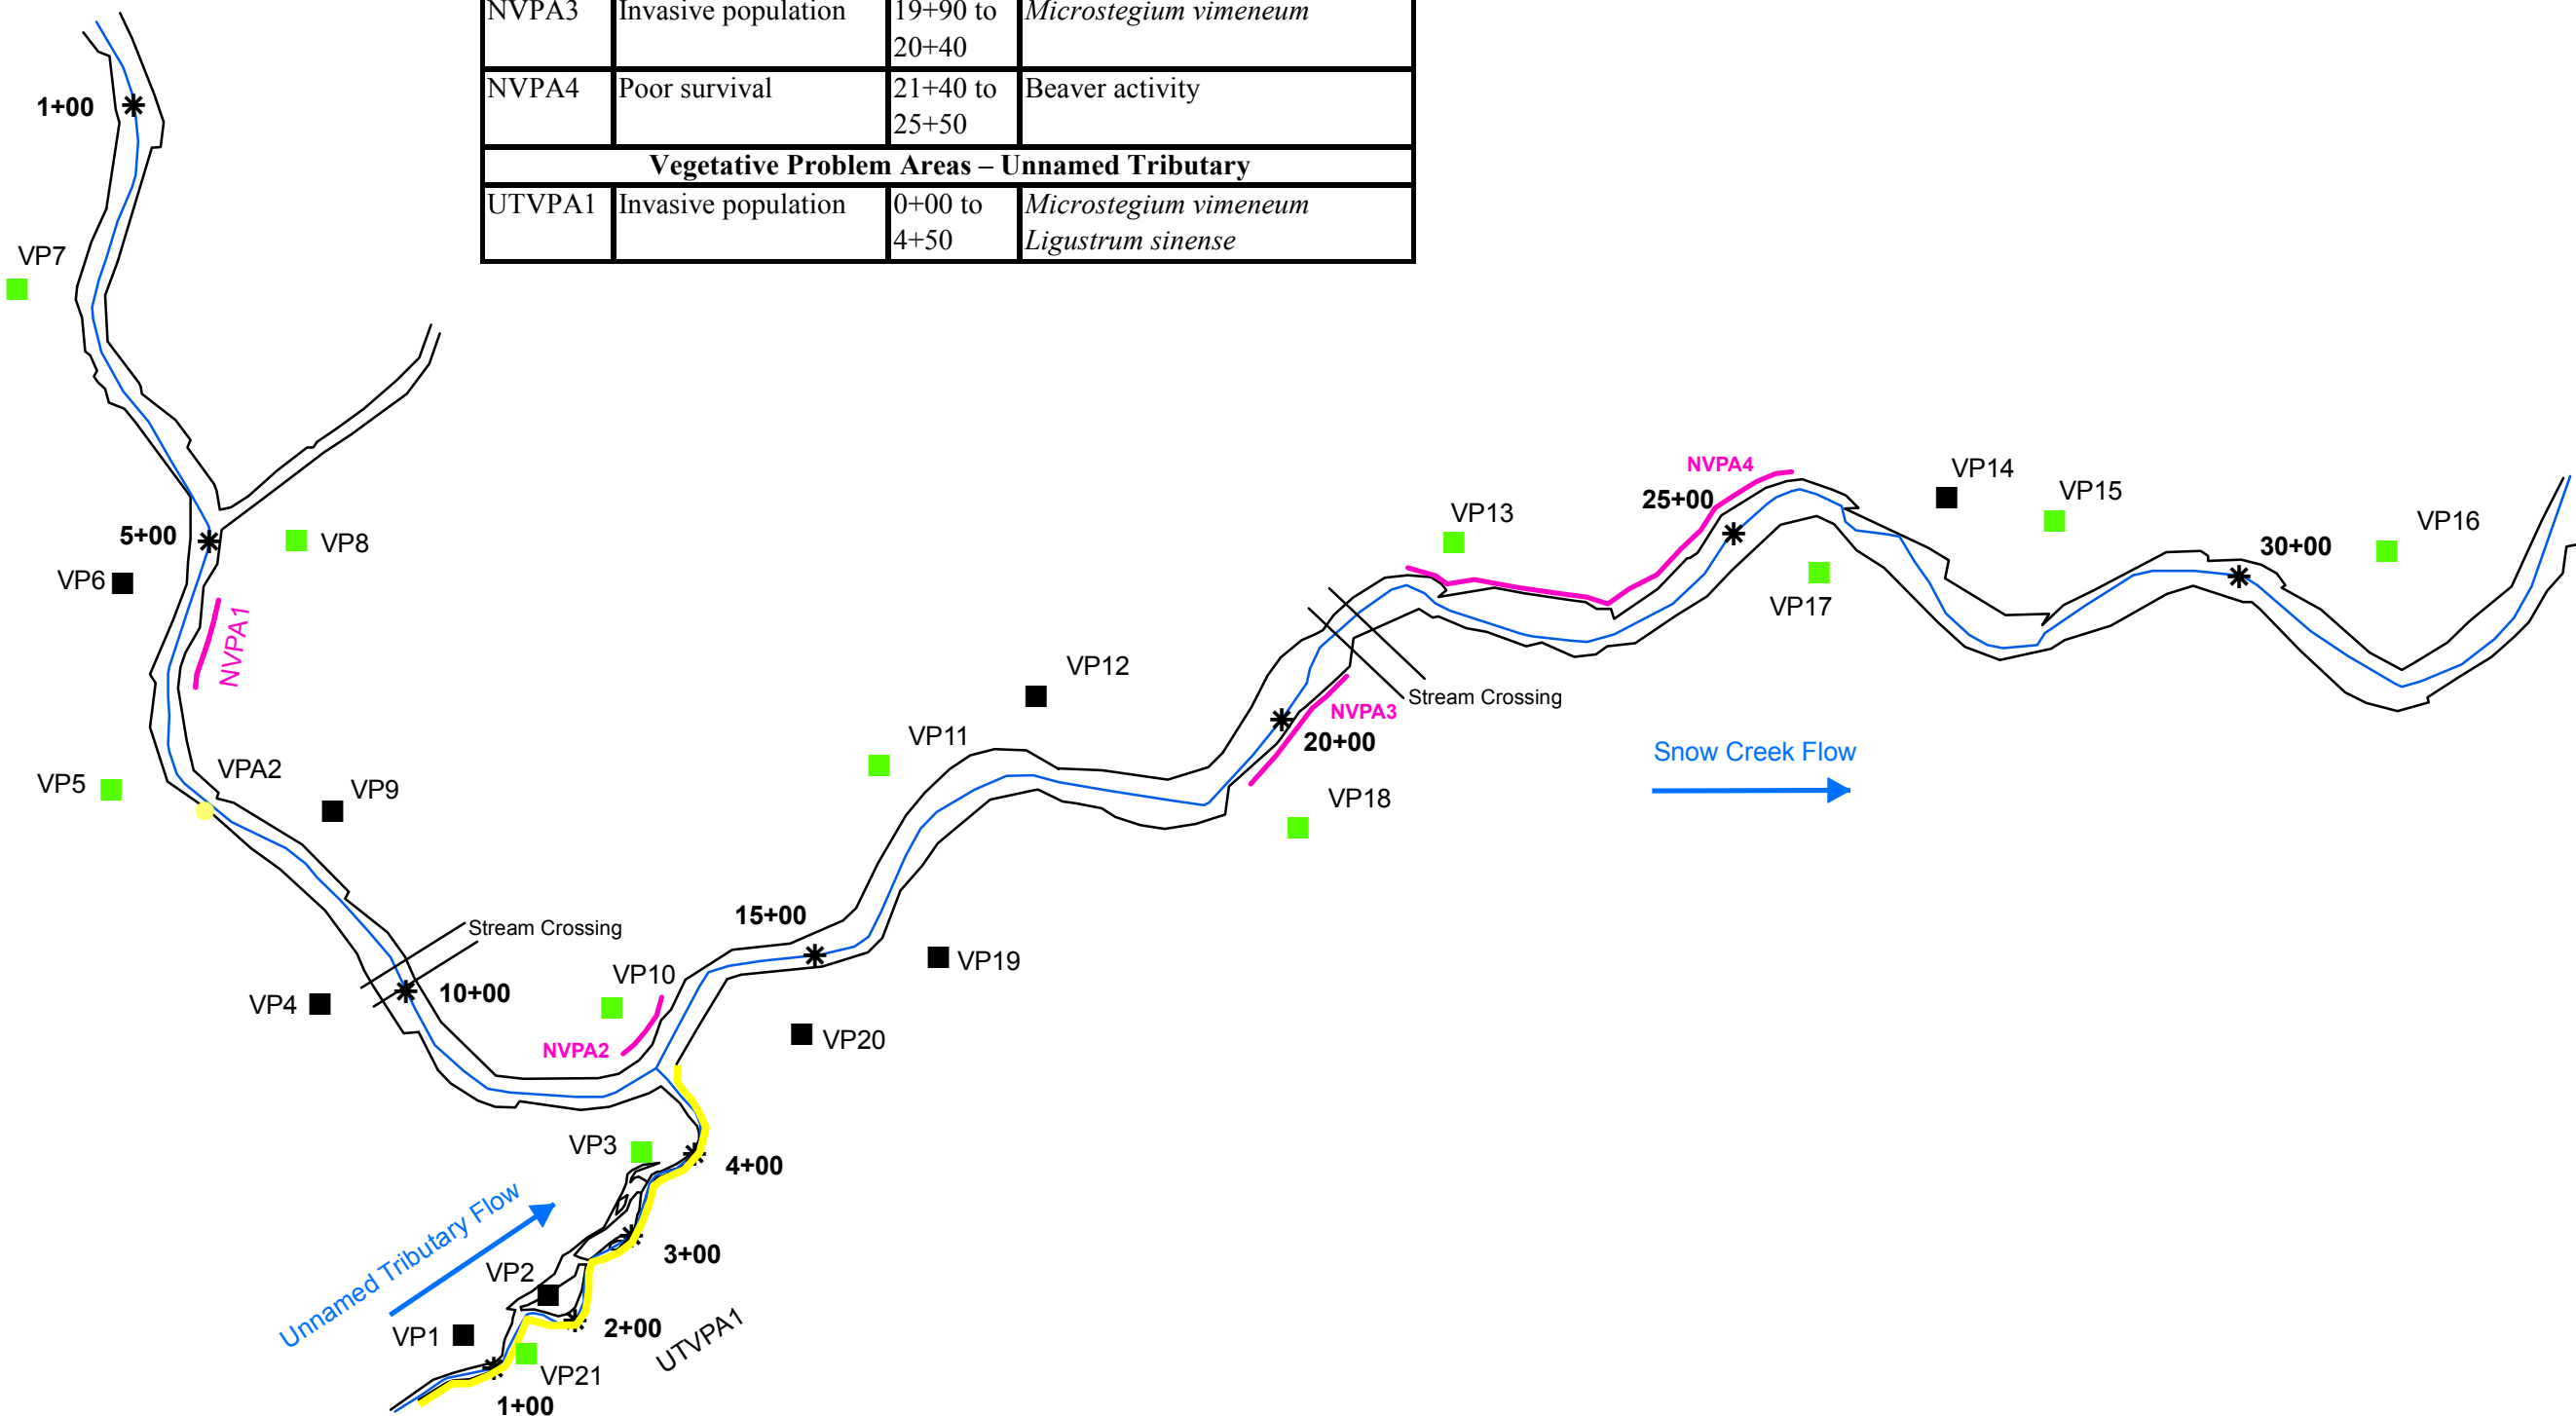
\* The 2007 Initial Site Assessment revealed that Snow Creek has experienced excessive sedimentation since the 2006 monitoring was conducted. The entire project reach has been impacted by sediment (sand) ranging from 6 inches to 4 feet deep. Several vegetation plots have been buried under more than 3 feet of sand. The entire project reach is a Problem Area Concern.

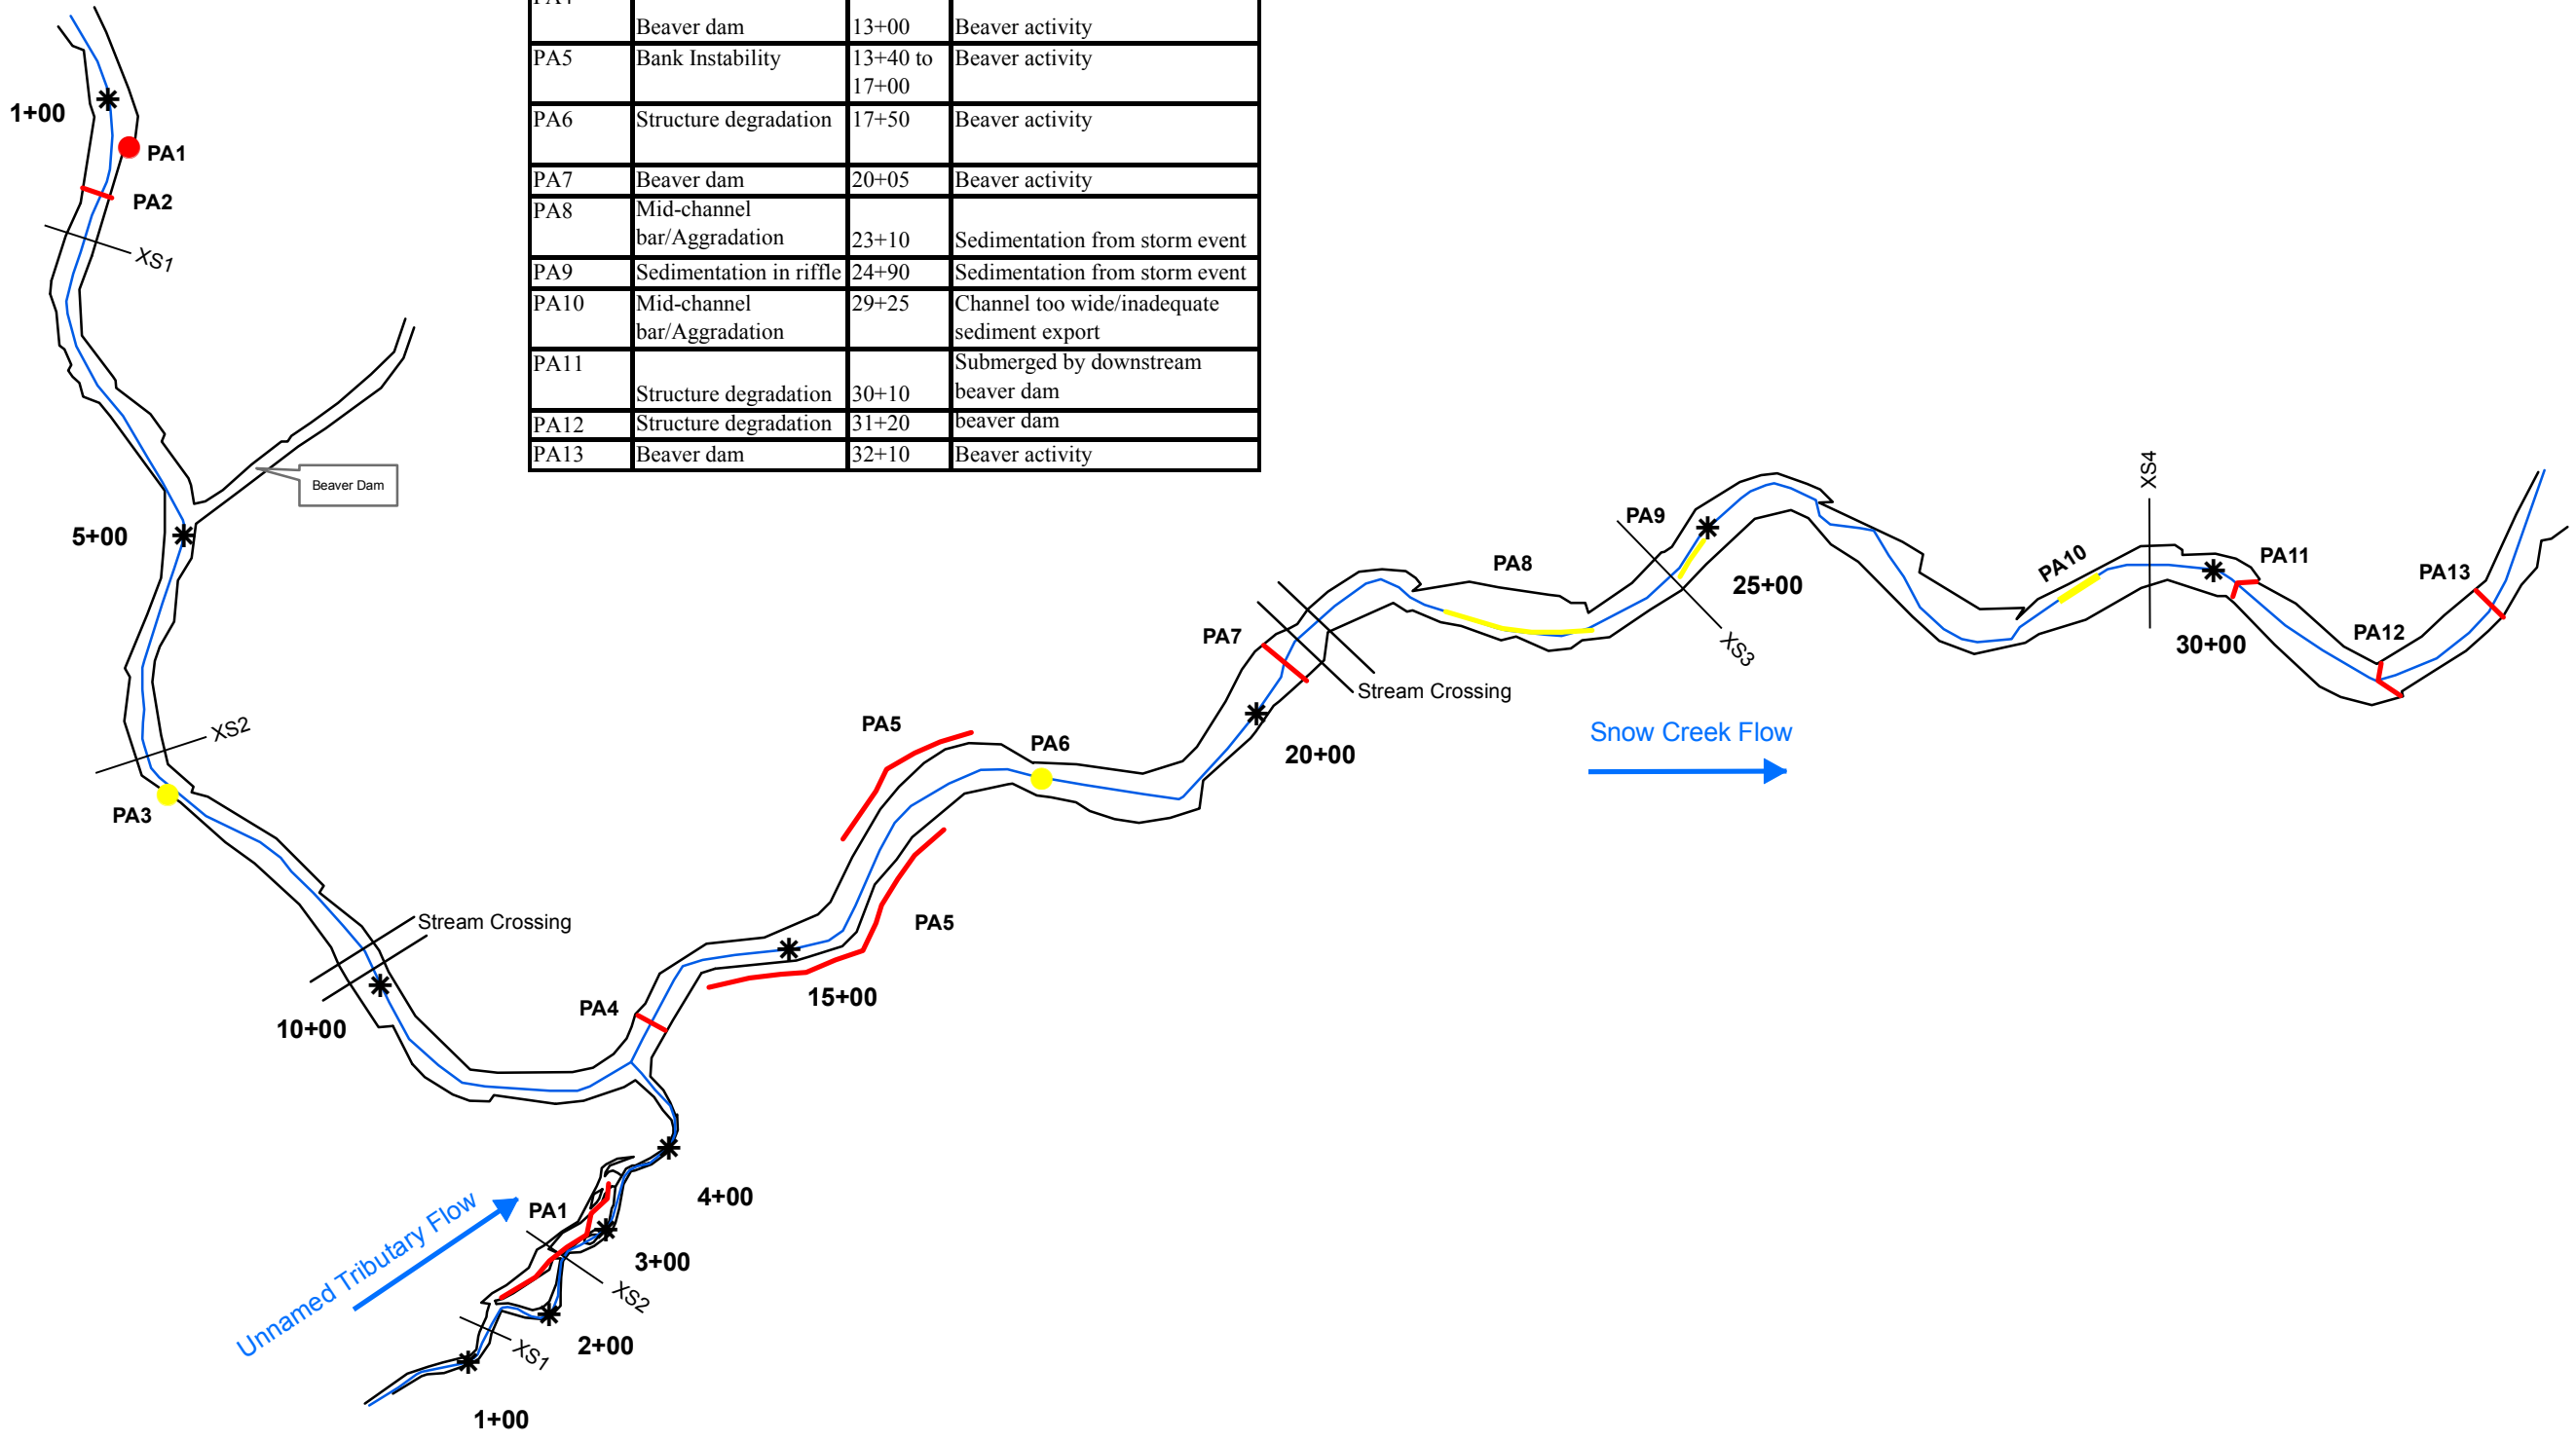
**Stream  
 Current Condition  
 Plan View**

Stream Problem Areas – Snow Creek			
Feature #	Feature Issue	Station # / Range	Probable Cause
PA1	Structure degradation	1+05	Submerged by downstream beaver dam
PA2	Beaver dam	1+40	Beaver activity
PA3	Structure degradation	7+60	Sedimentation from storm event
PA4	Beaver dam	13+00	Beaver activity
PA5	Bank Instability	13+40 to 17+00	Beaver activity
PA6	Structure degradation	17+50	Beaver activity
PA7	Beaver dam	20+05	Beaver activity
PA8	Mid-channel bar/Aggradation	23+10	Sedimentation from storm event
PA9	Sedimentation in riffle	24+90	Sedimentation from storm event
PA10	Mid-channel bar/Aggradation	29+25	Channel too wide/inadequate sediment export
PA11	Structure degradation	30+10	Submerged by downstream beaver dam
PA12	Structure degradation	31+20	beaver dam
PA13	Beaver dam	32+10	Beaver activity

Stream Problem Areas – Unnamed Tributary			
Feature #	Feature Issue	Station # / Range	Probable Cause
PA1	Bank instability	1+50 to 3+40	Beaver activity
