**Snow Creek Stream Restoration
2008 Final Monitoring Report
Monitoring Year Four**

Ecosystem Enhancement Program Project Number 00344

February 12, 2009

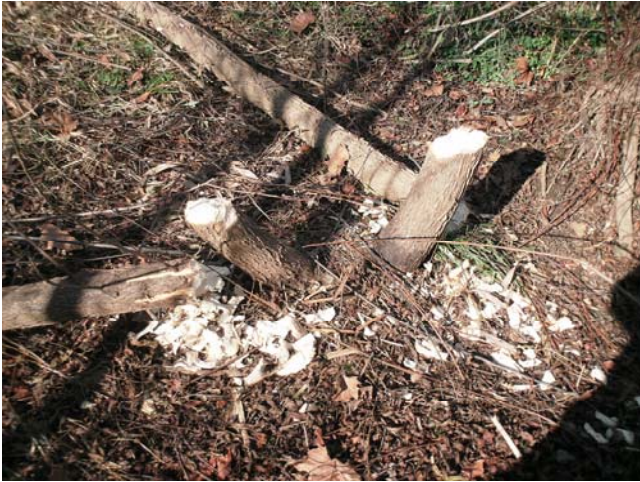
VPA1 on left bank (11/19/08)

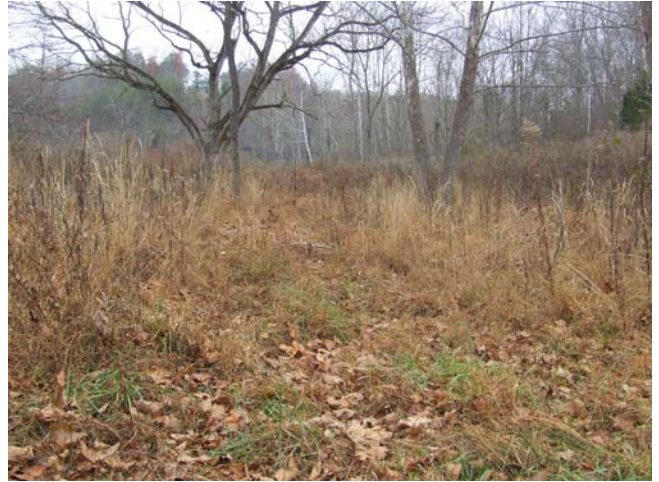
VPA2 on right bank (11/20/08)

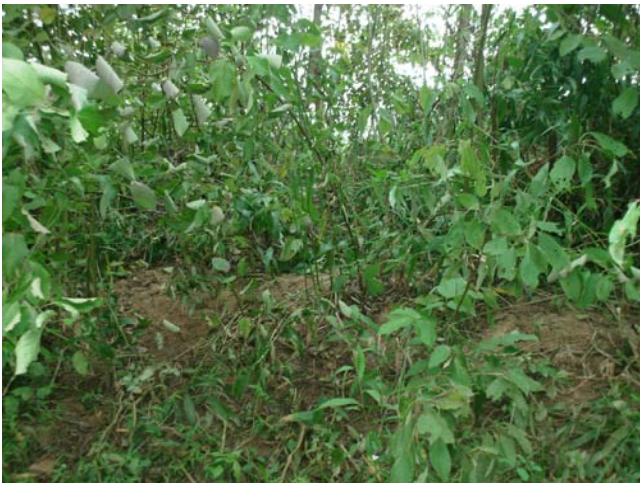
VPA3 facing left bank (9/10/08)

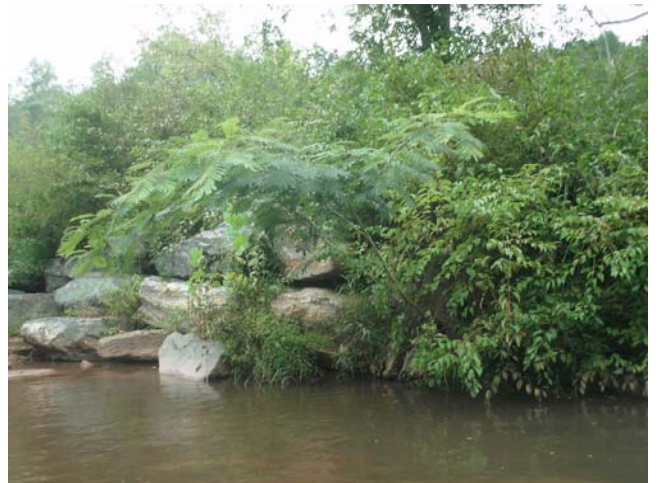
VPA4 facing left bank (9/10/08)

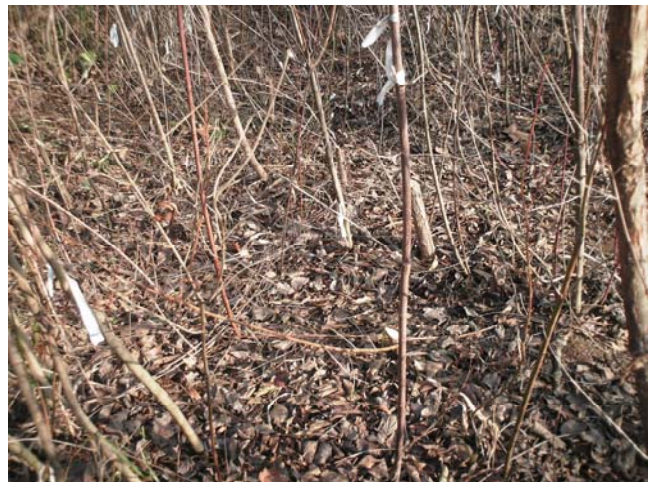
VPA6 on left bank (11/20/08)

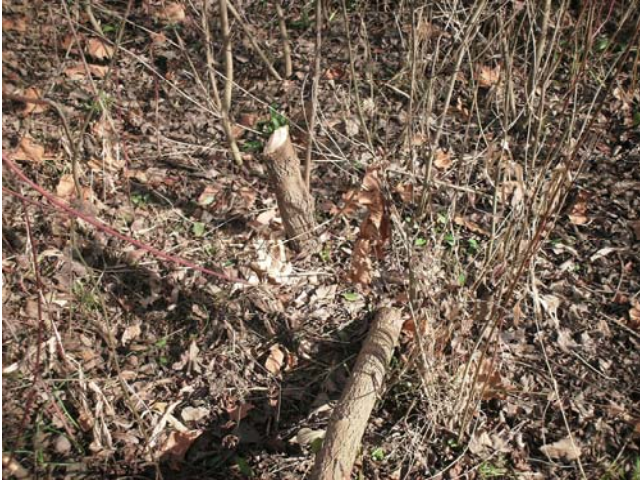
UTVPA1 on right bank (11/19/08)

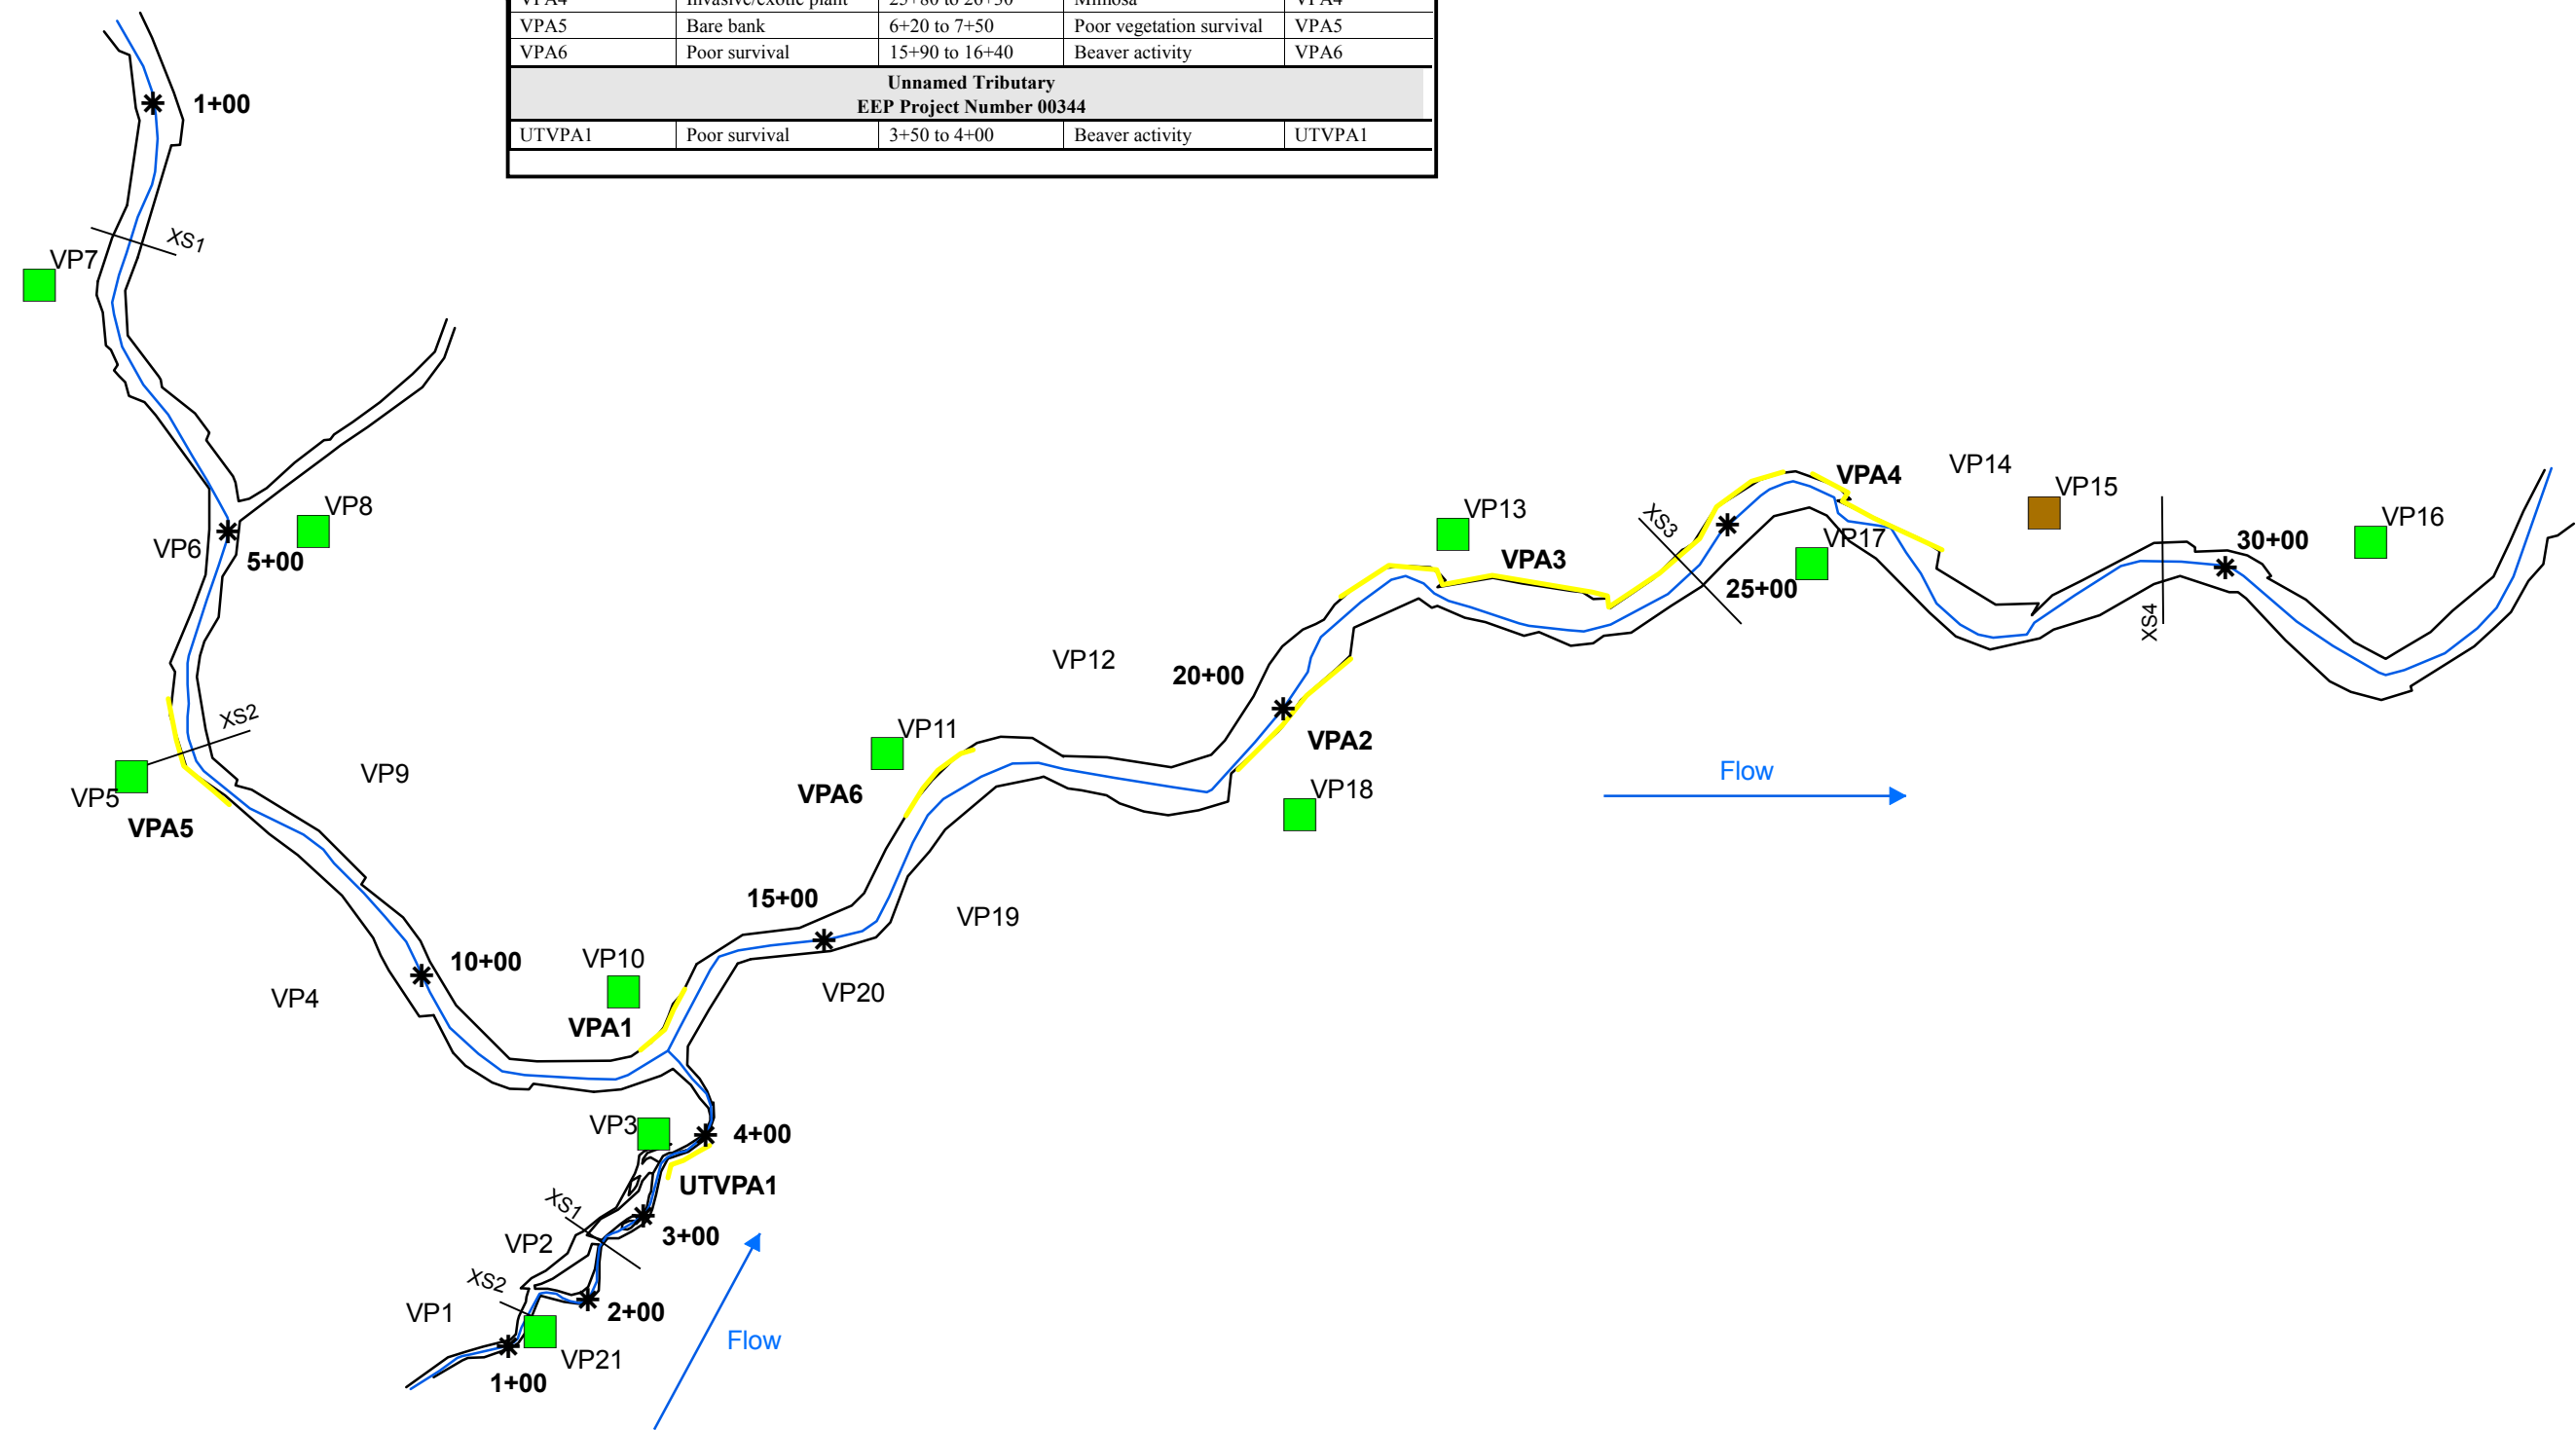
Vegetation
 Current Condition
 Plan View

Snow Creek EEP Project Number 00344				
Feature #	Feature/Issue	Station # / Range	Probable Cause	Photo #
VPA1	Poor survival	12+50 to 12+80	Beaver activity	VPA1
VPA2	Invasive/exotic plant	19+90 to 20+40	Microstegium	VPA2
VPA3	Poor survival	21+40 to 25+50	Beaver activity	VPA3
VPA4	Invasive/exotic plant	25+80 to 26+30	Mimosa	VPA4
VPA5	Bare bank	6+20 to 7+50	Poor vegetation survival	VPA5
VPA6	Poor survival	15+90 to 16+40	Beaver activity	VPA6
Unnamed Tributary EEP Project Number 00344				
UTVPA1	Poor survival	3+50 to 4+00	Beaver activity	UTVPA1

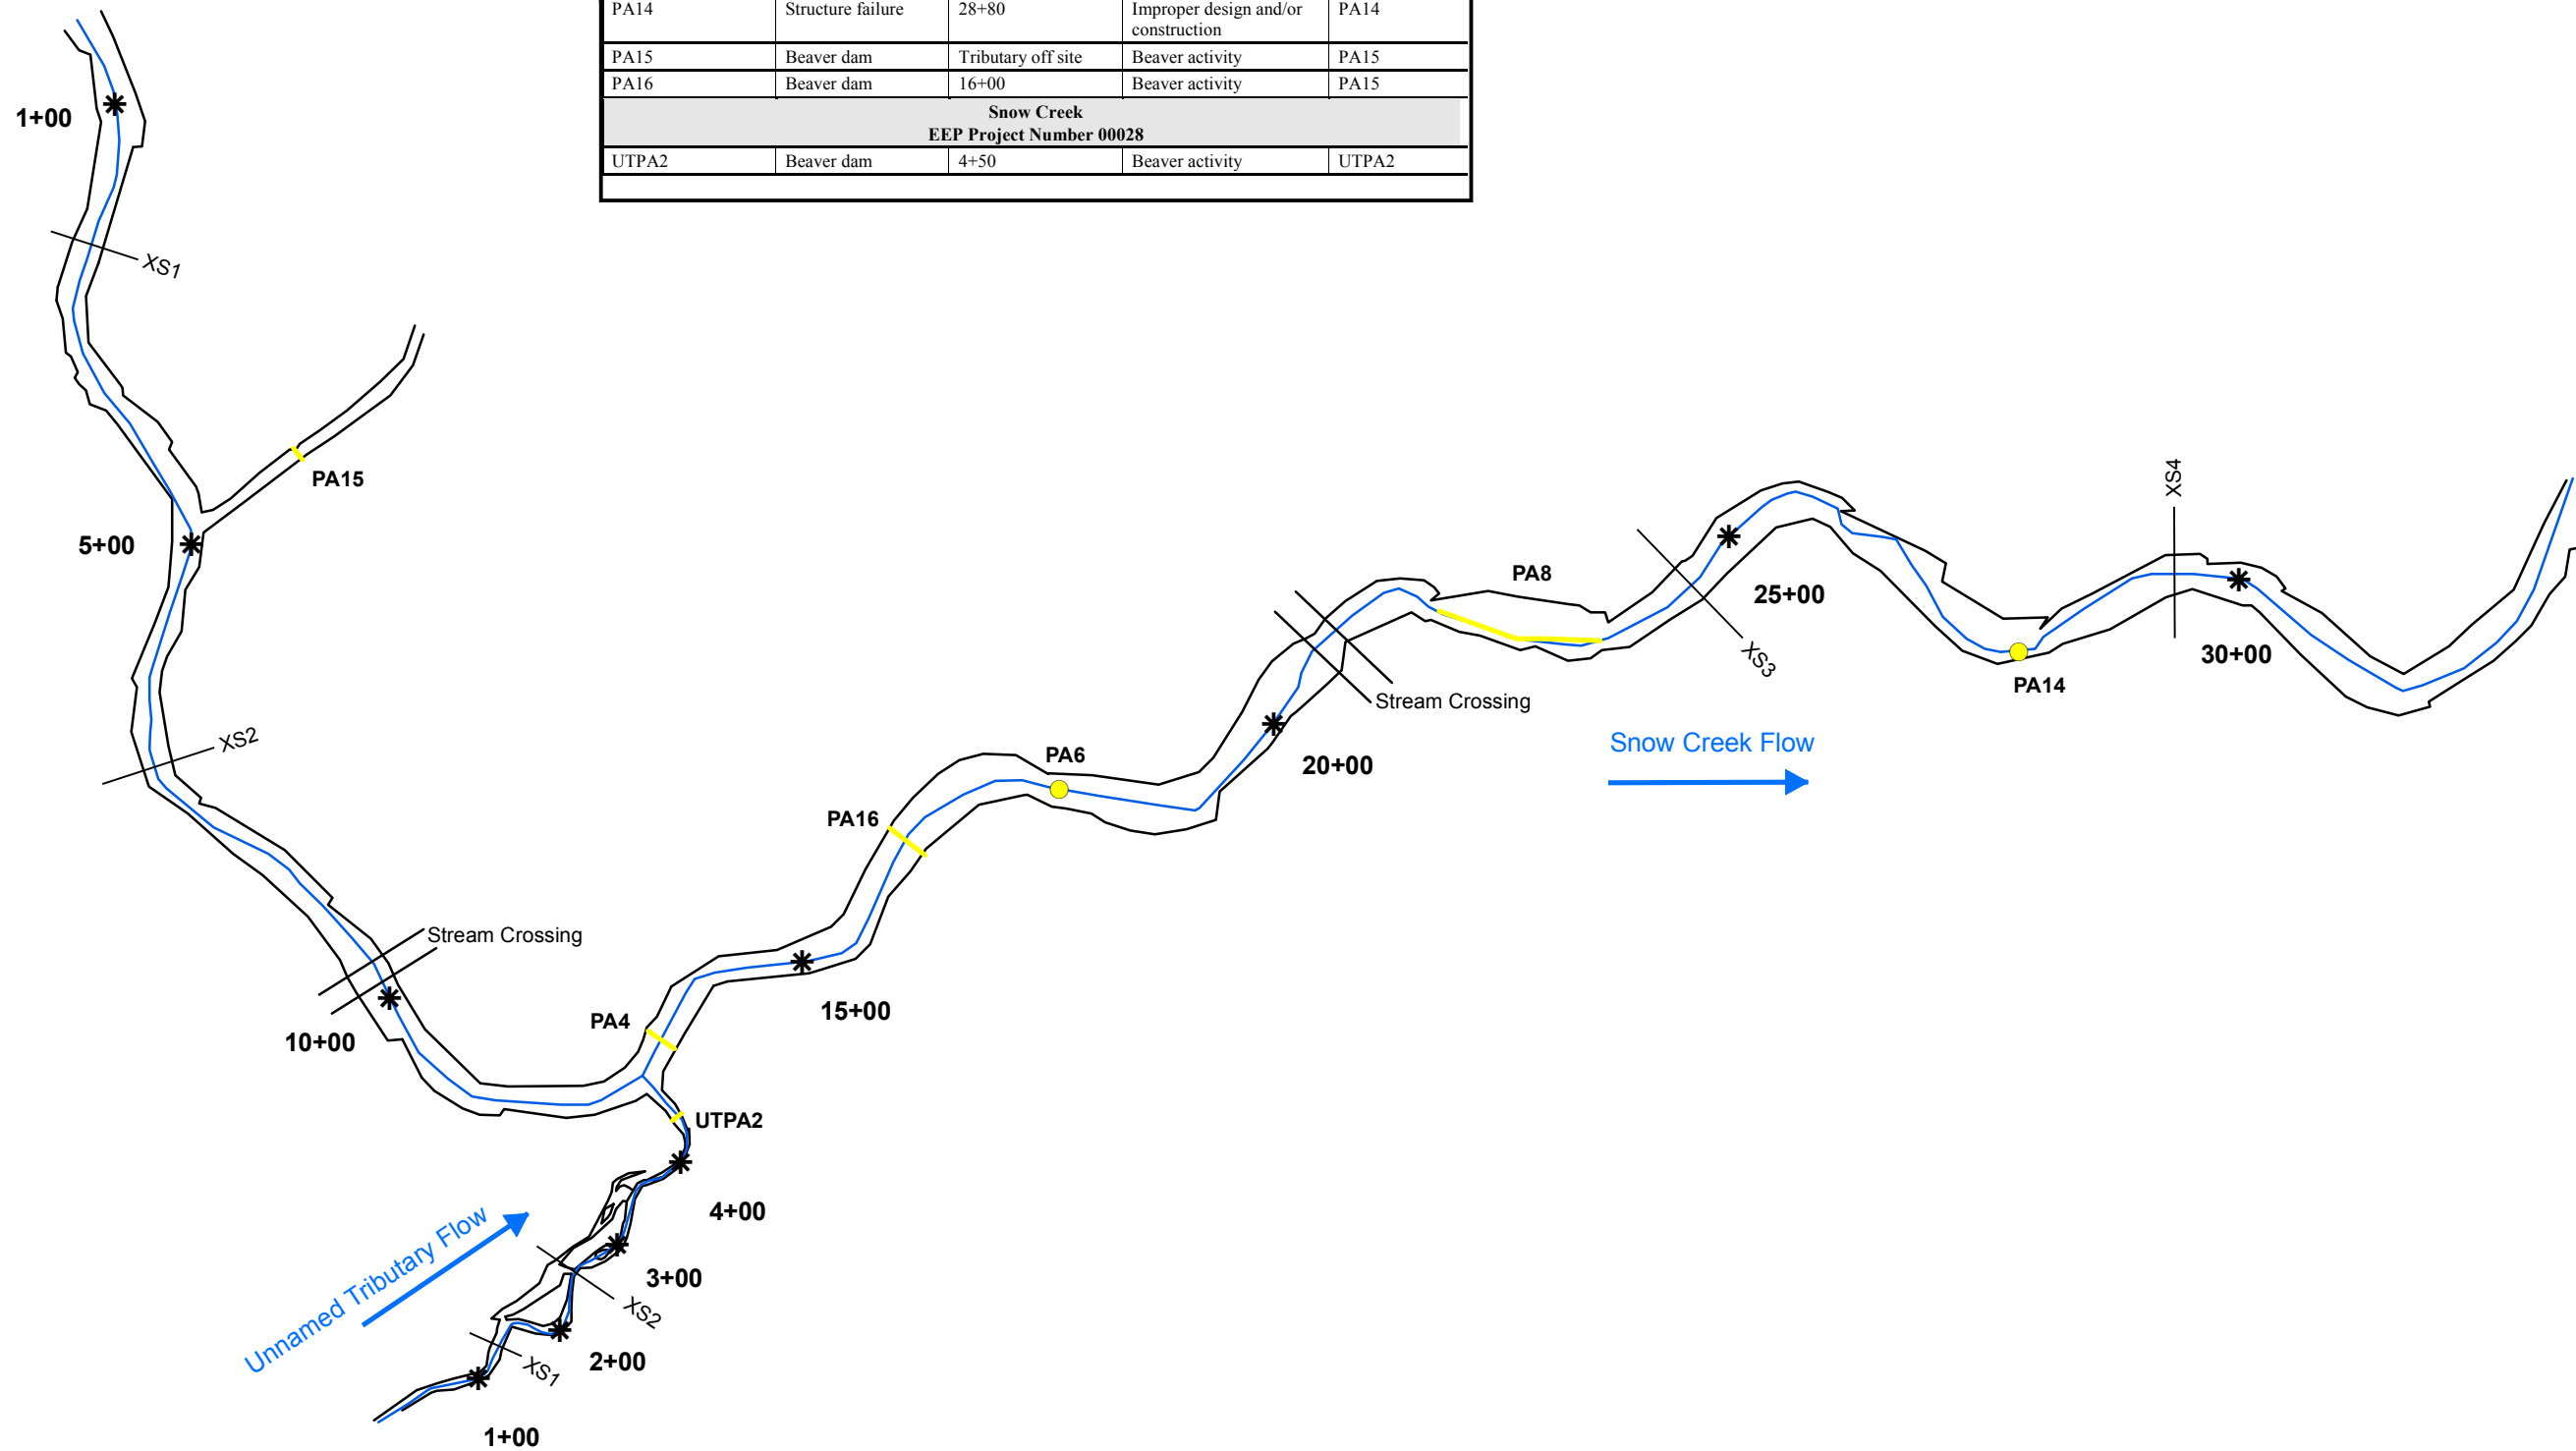
Stream
 Current Condition
 Plan View

Snow Creek EEP Project Number 00028				
Feature #	Feature/Issue	Station # / Range	Probable Cause	Photo #
PA4	Beaver dam	13+00	Beaver activity	PA4
PA6	Structure degradation	17+50	Slipped rock on left arm	PA6
PA8	Mid channel bar / aggradation	22+00 to 23+10	Storm event	PA8
PA14	Structure failure	28+80	Improper design and/or construction	PA14
PA15	Beaver dam	Tributary off site	Beaver activity	PA15
PA16	Beaver dam	16+00	Beaver activity	PA15
Snow Creek EEP Project Number 00028				
UTPA2	Beaver dam	4+50	Beaver activity	UTPA2

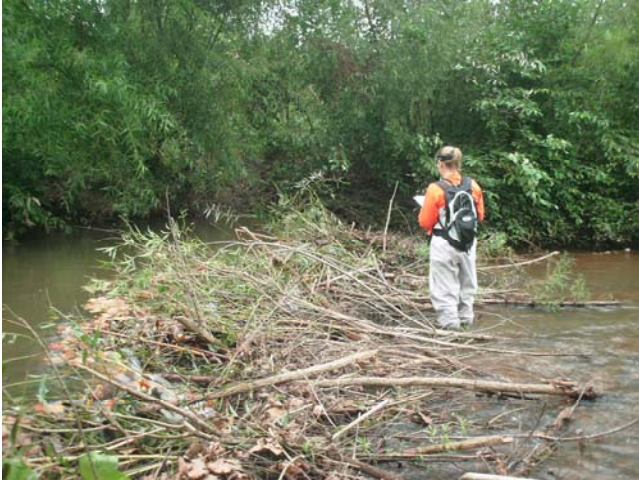
PA4 facing left bank (9/10/08)

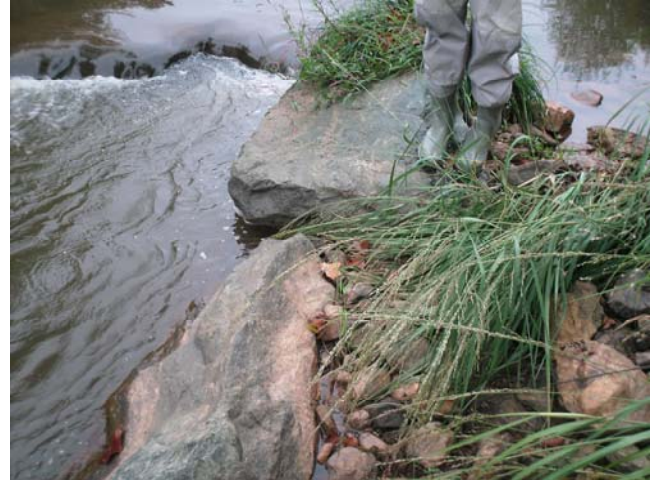
PA6 facing upstream (9/10/08)

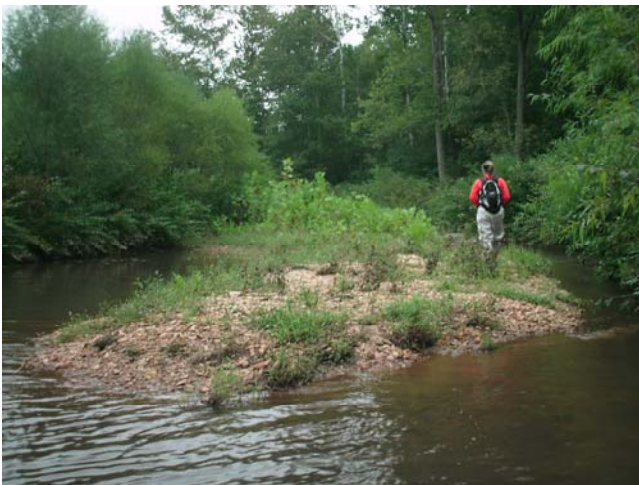
PA8 facing downstream (9/10/08)

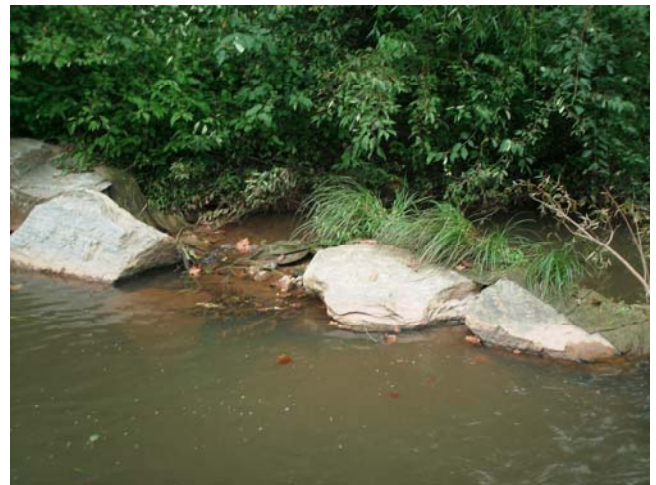
PA14 facing left bank (9/10/08)

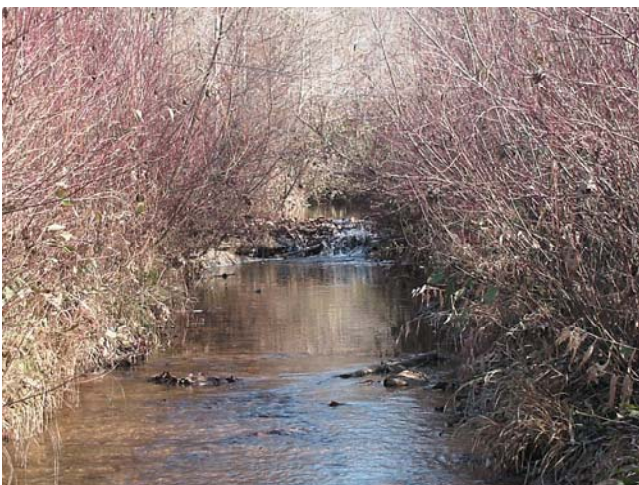
PA15 facing upstream (11/19/08)

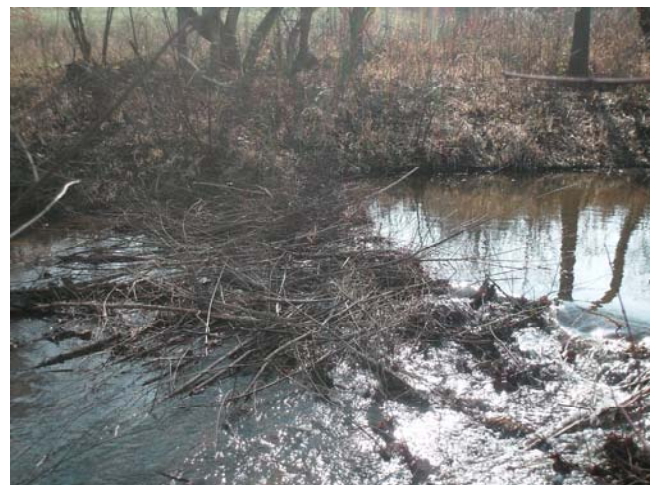
PA16 facing right bank (11/20/08)

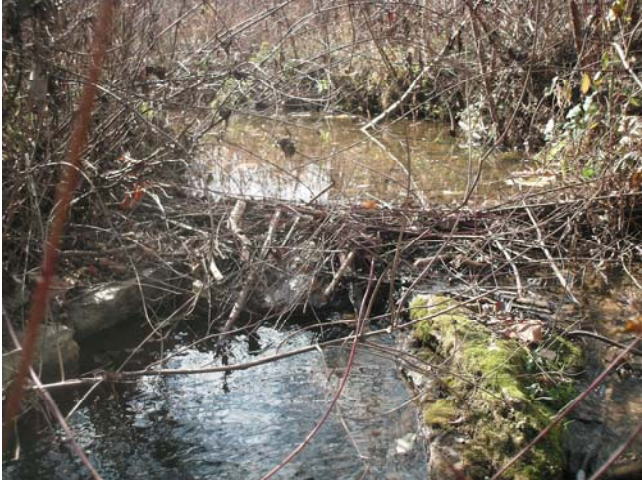
UTVPA2 facing upstream (11/19/08)
