**Snow Creek Stream Restoration
2009 Final Monitoring Report
Monitoring Year Five**

Ecosystem Enhancement Program Project Number 00344

Submitted: April 23, 2010

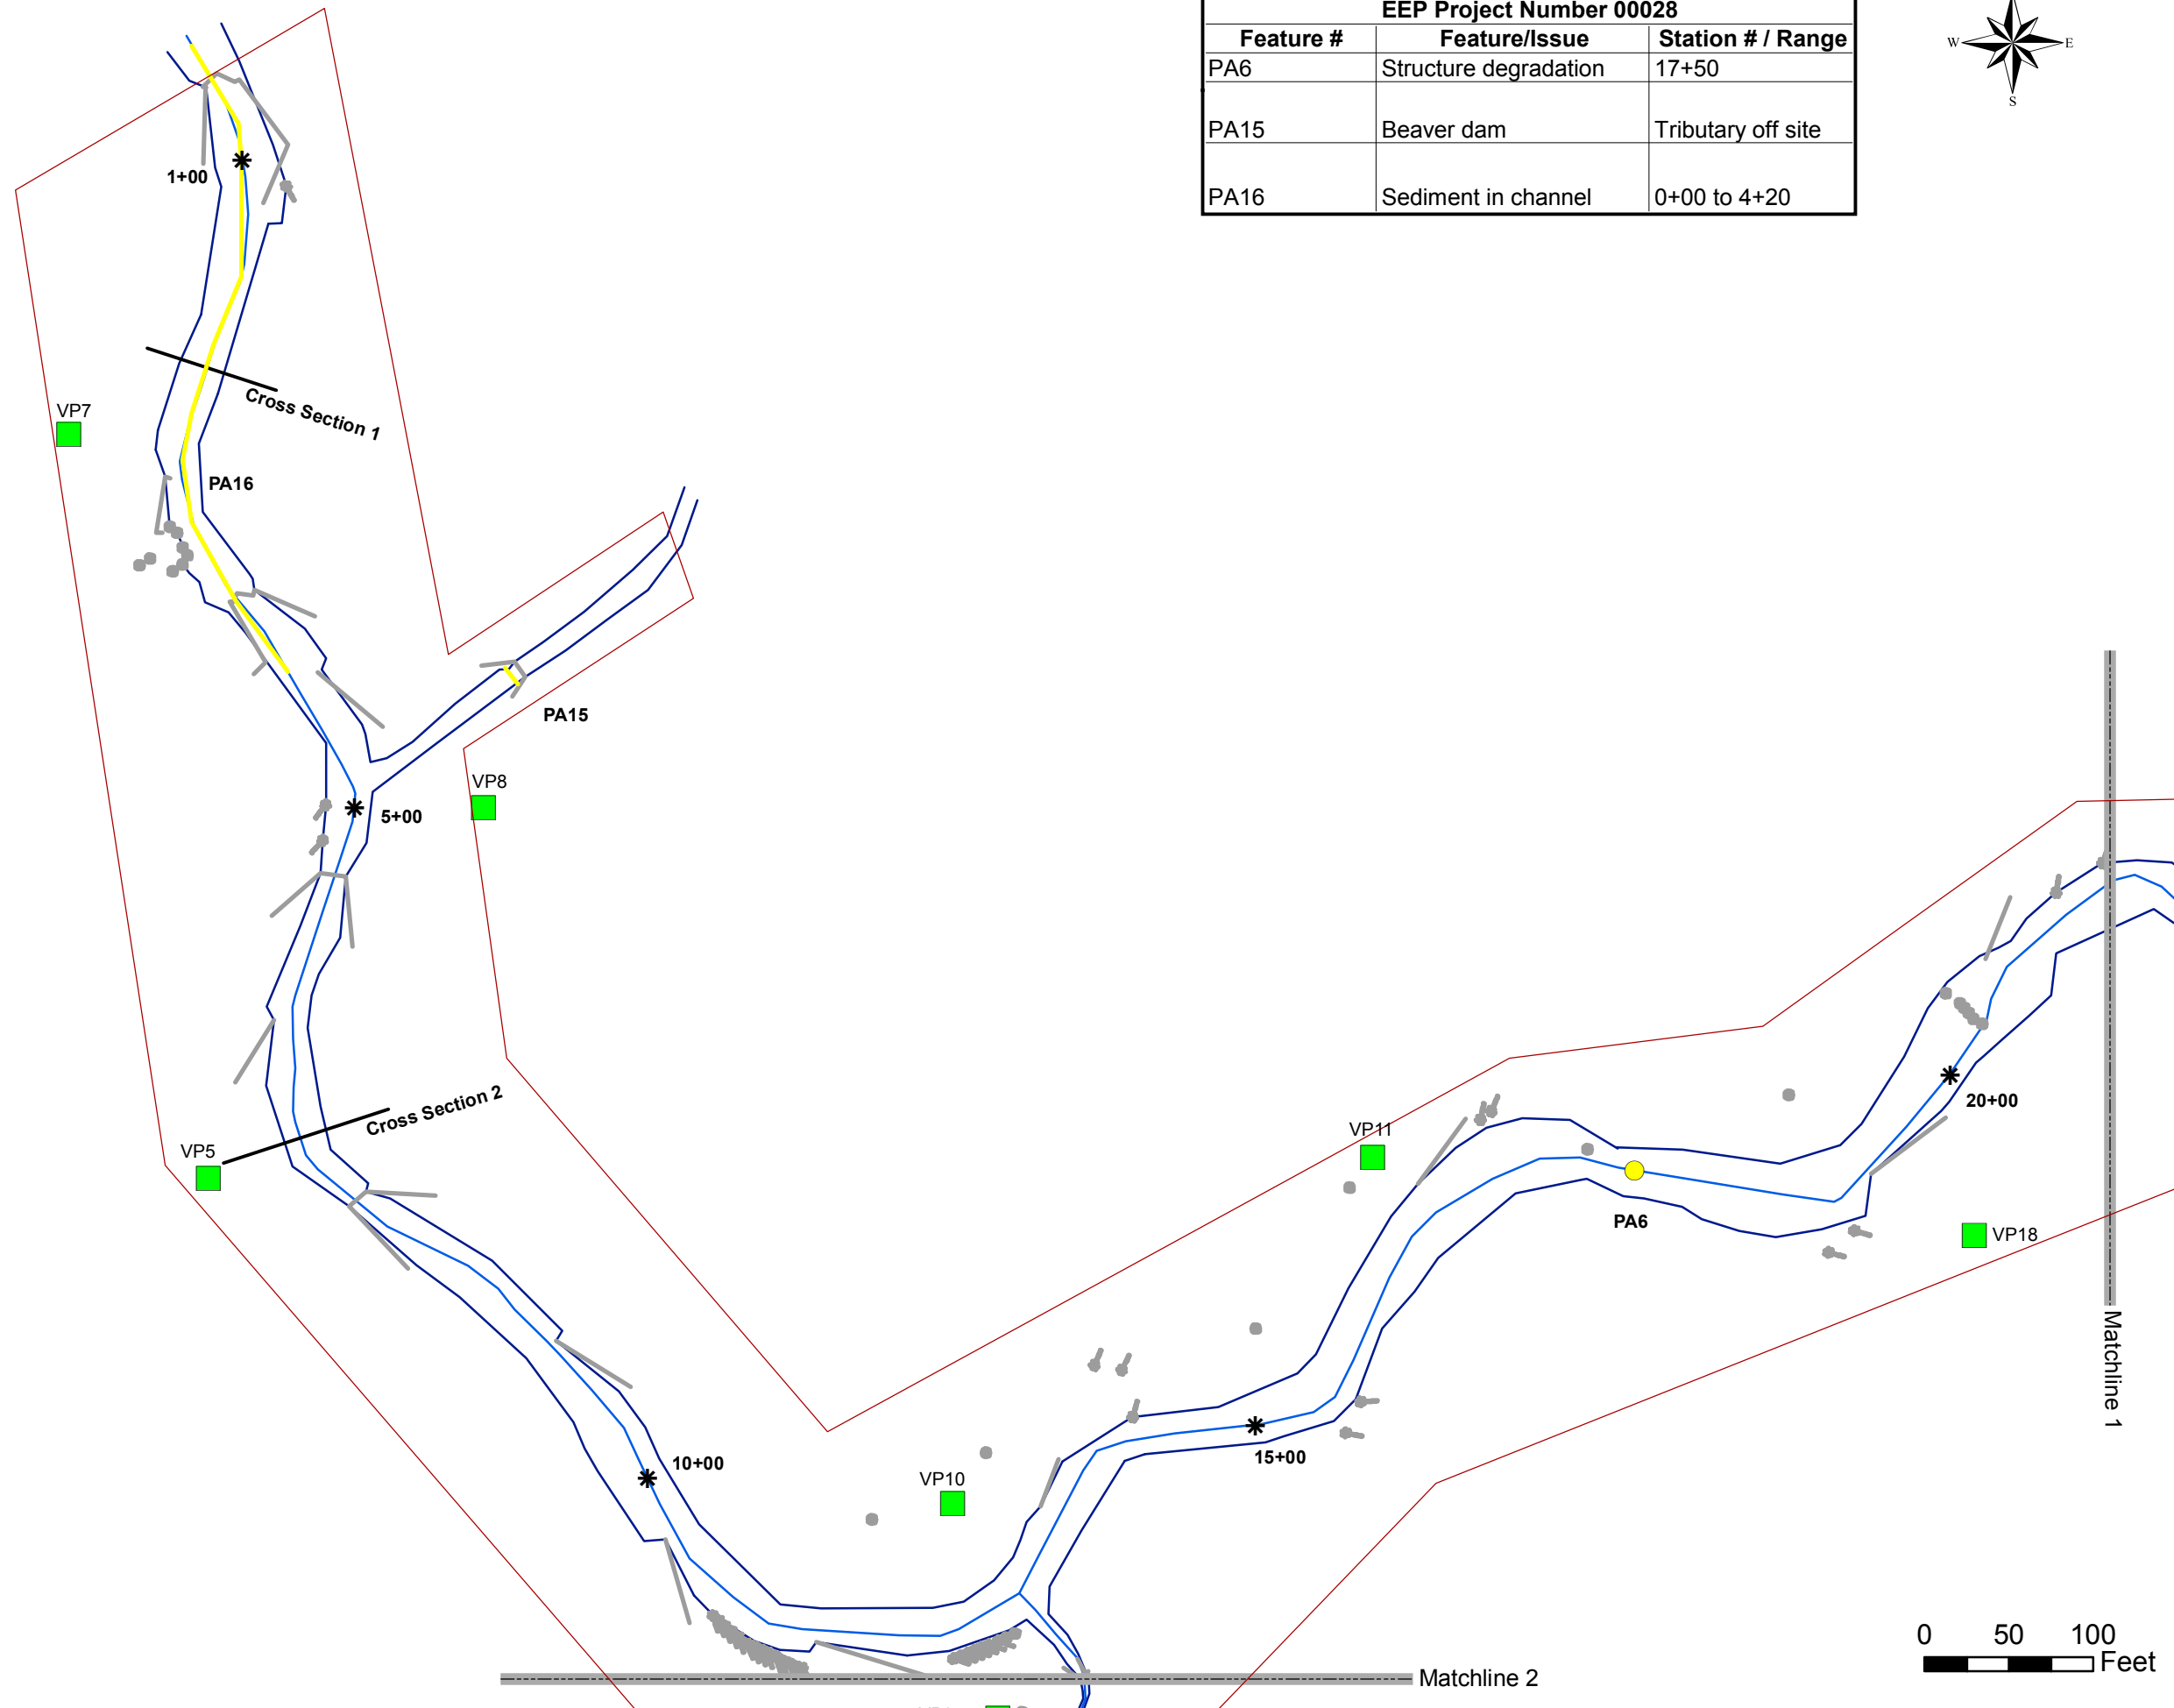
Stream
 Current Condition
 Plan View
 Sheet 1 of 3

Snow Creek		
EEP Project Number 00028		
Feature #	Feature/Issue	Station # / Range
PA6	Structure degradation	17+50
PA15	Beaver dam	Tributary off site
PA16	Sediment in channel	0+00 to 4+20

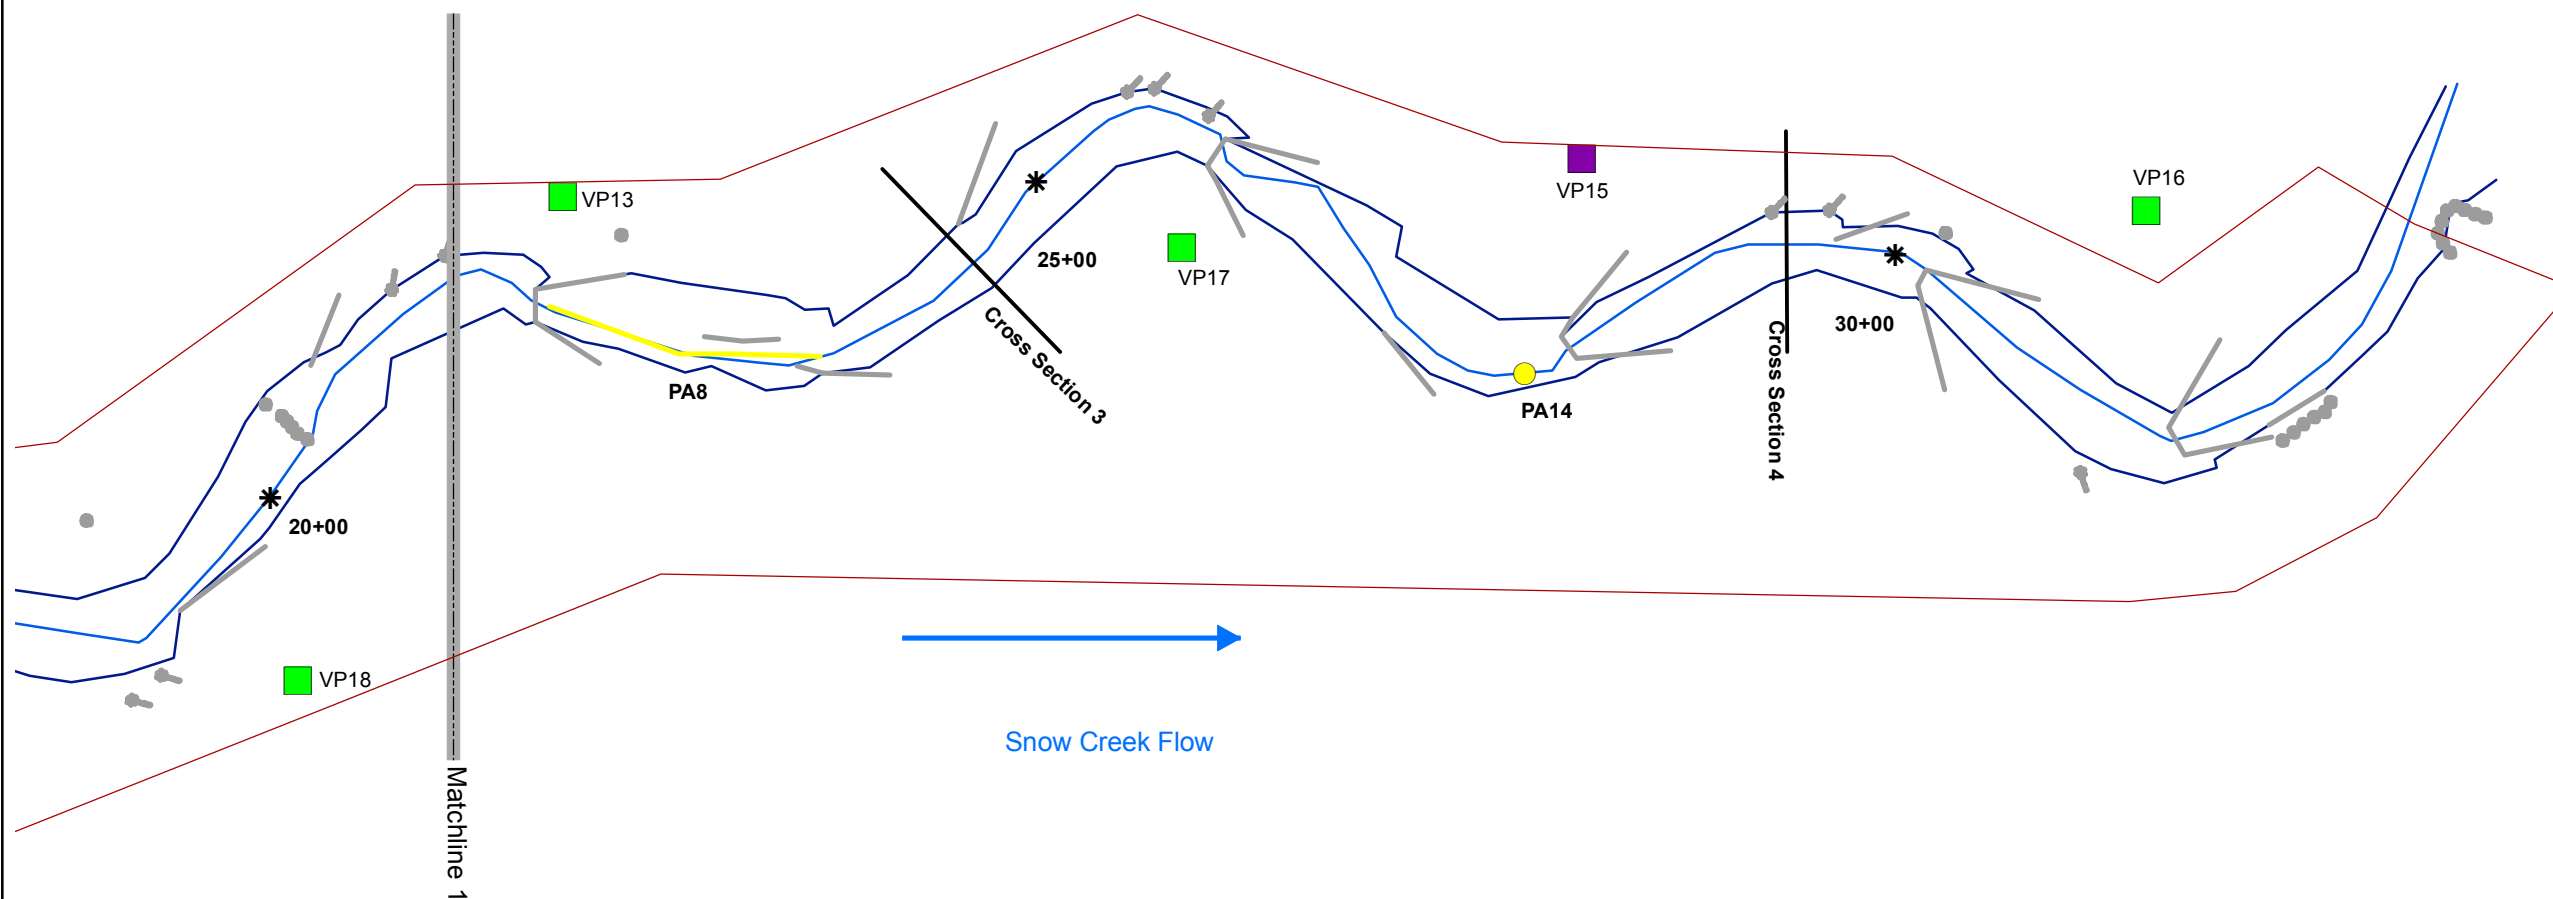
Sheet 2 of 3

Snow Creek		
EEP Project Number 00028		
Feature #	Feature/Issue	Station # / Range
PA8	Mid channel bar / aggradation	22+00 to 23+10
PA14	Structure failure	28+80

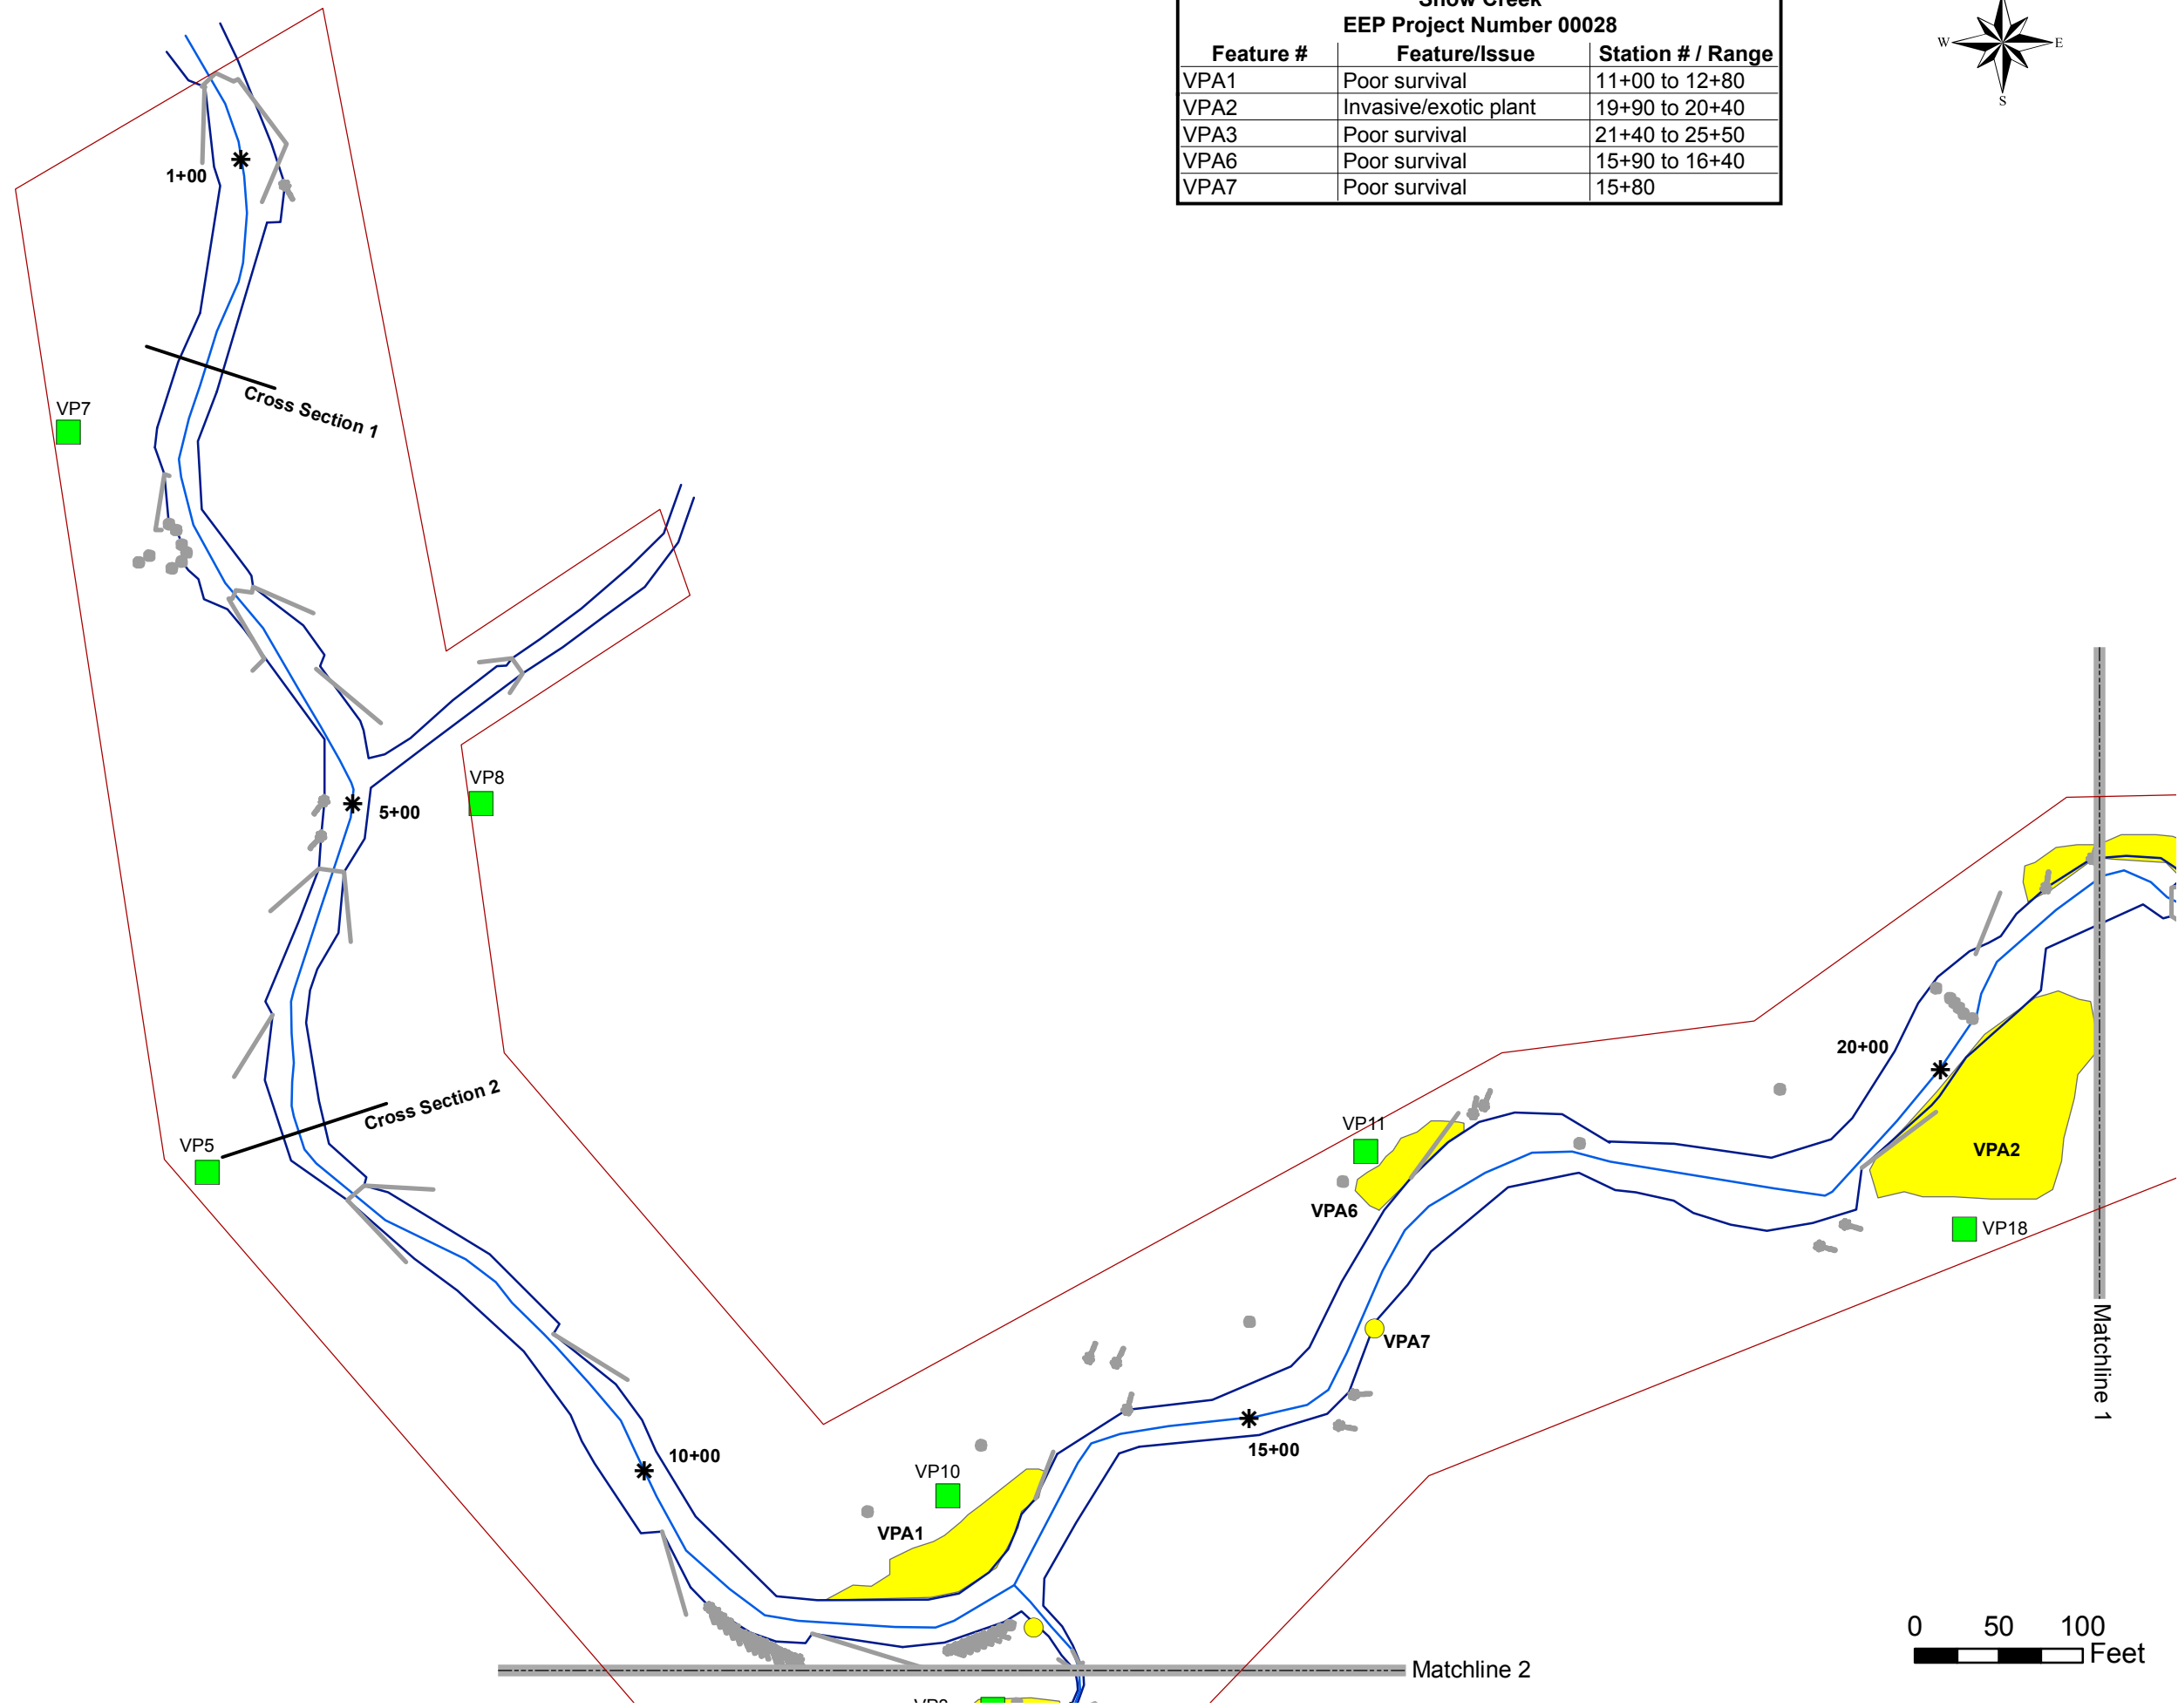
Sheet 1 of 3

Snow Creek EEP Project Number 00028		
Feature #	Feature/Issue	Station # / Range
VPA1	Poor survival	11+00 to 12+80
VPA2	Invasive/exotic plant	19+90 to 20+40
VPA3	Poor survival	21+40 to 25+50
VPA6	Poor survival	15+90 to 16+40
VPA7	Poor survival	15+80

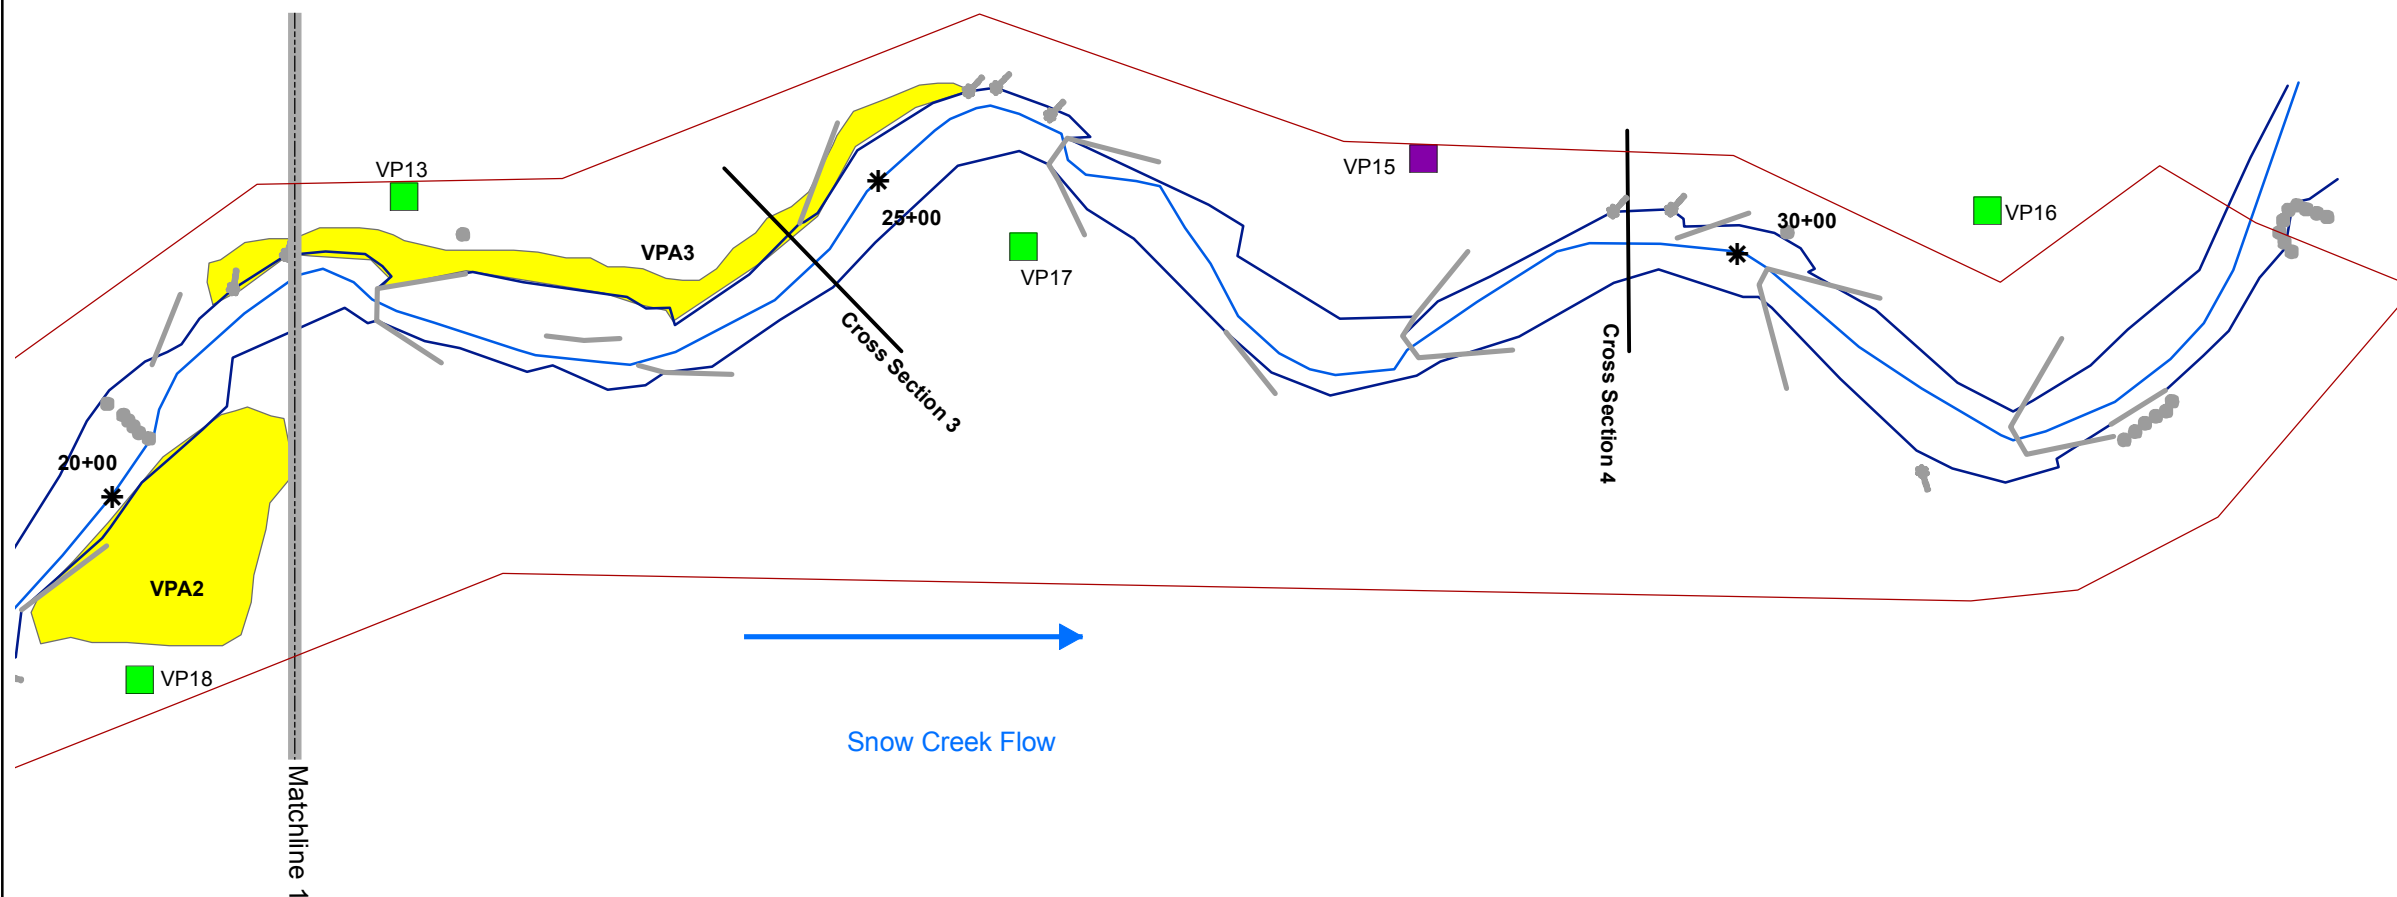
Vegetation
 Current Condition
 Plan View

Snow Creek EEP Project Number 00028		
Feature #	Feature/Issue	Station # / Range
VPA2	Invasive/exotic plant	19+90 to 20+40
VPA3	Poor survival	21+40 to 25+50

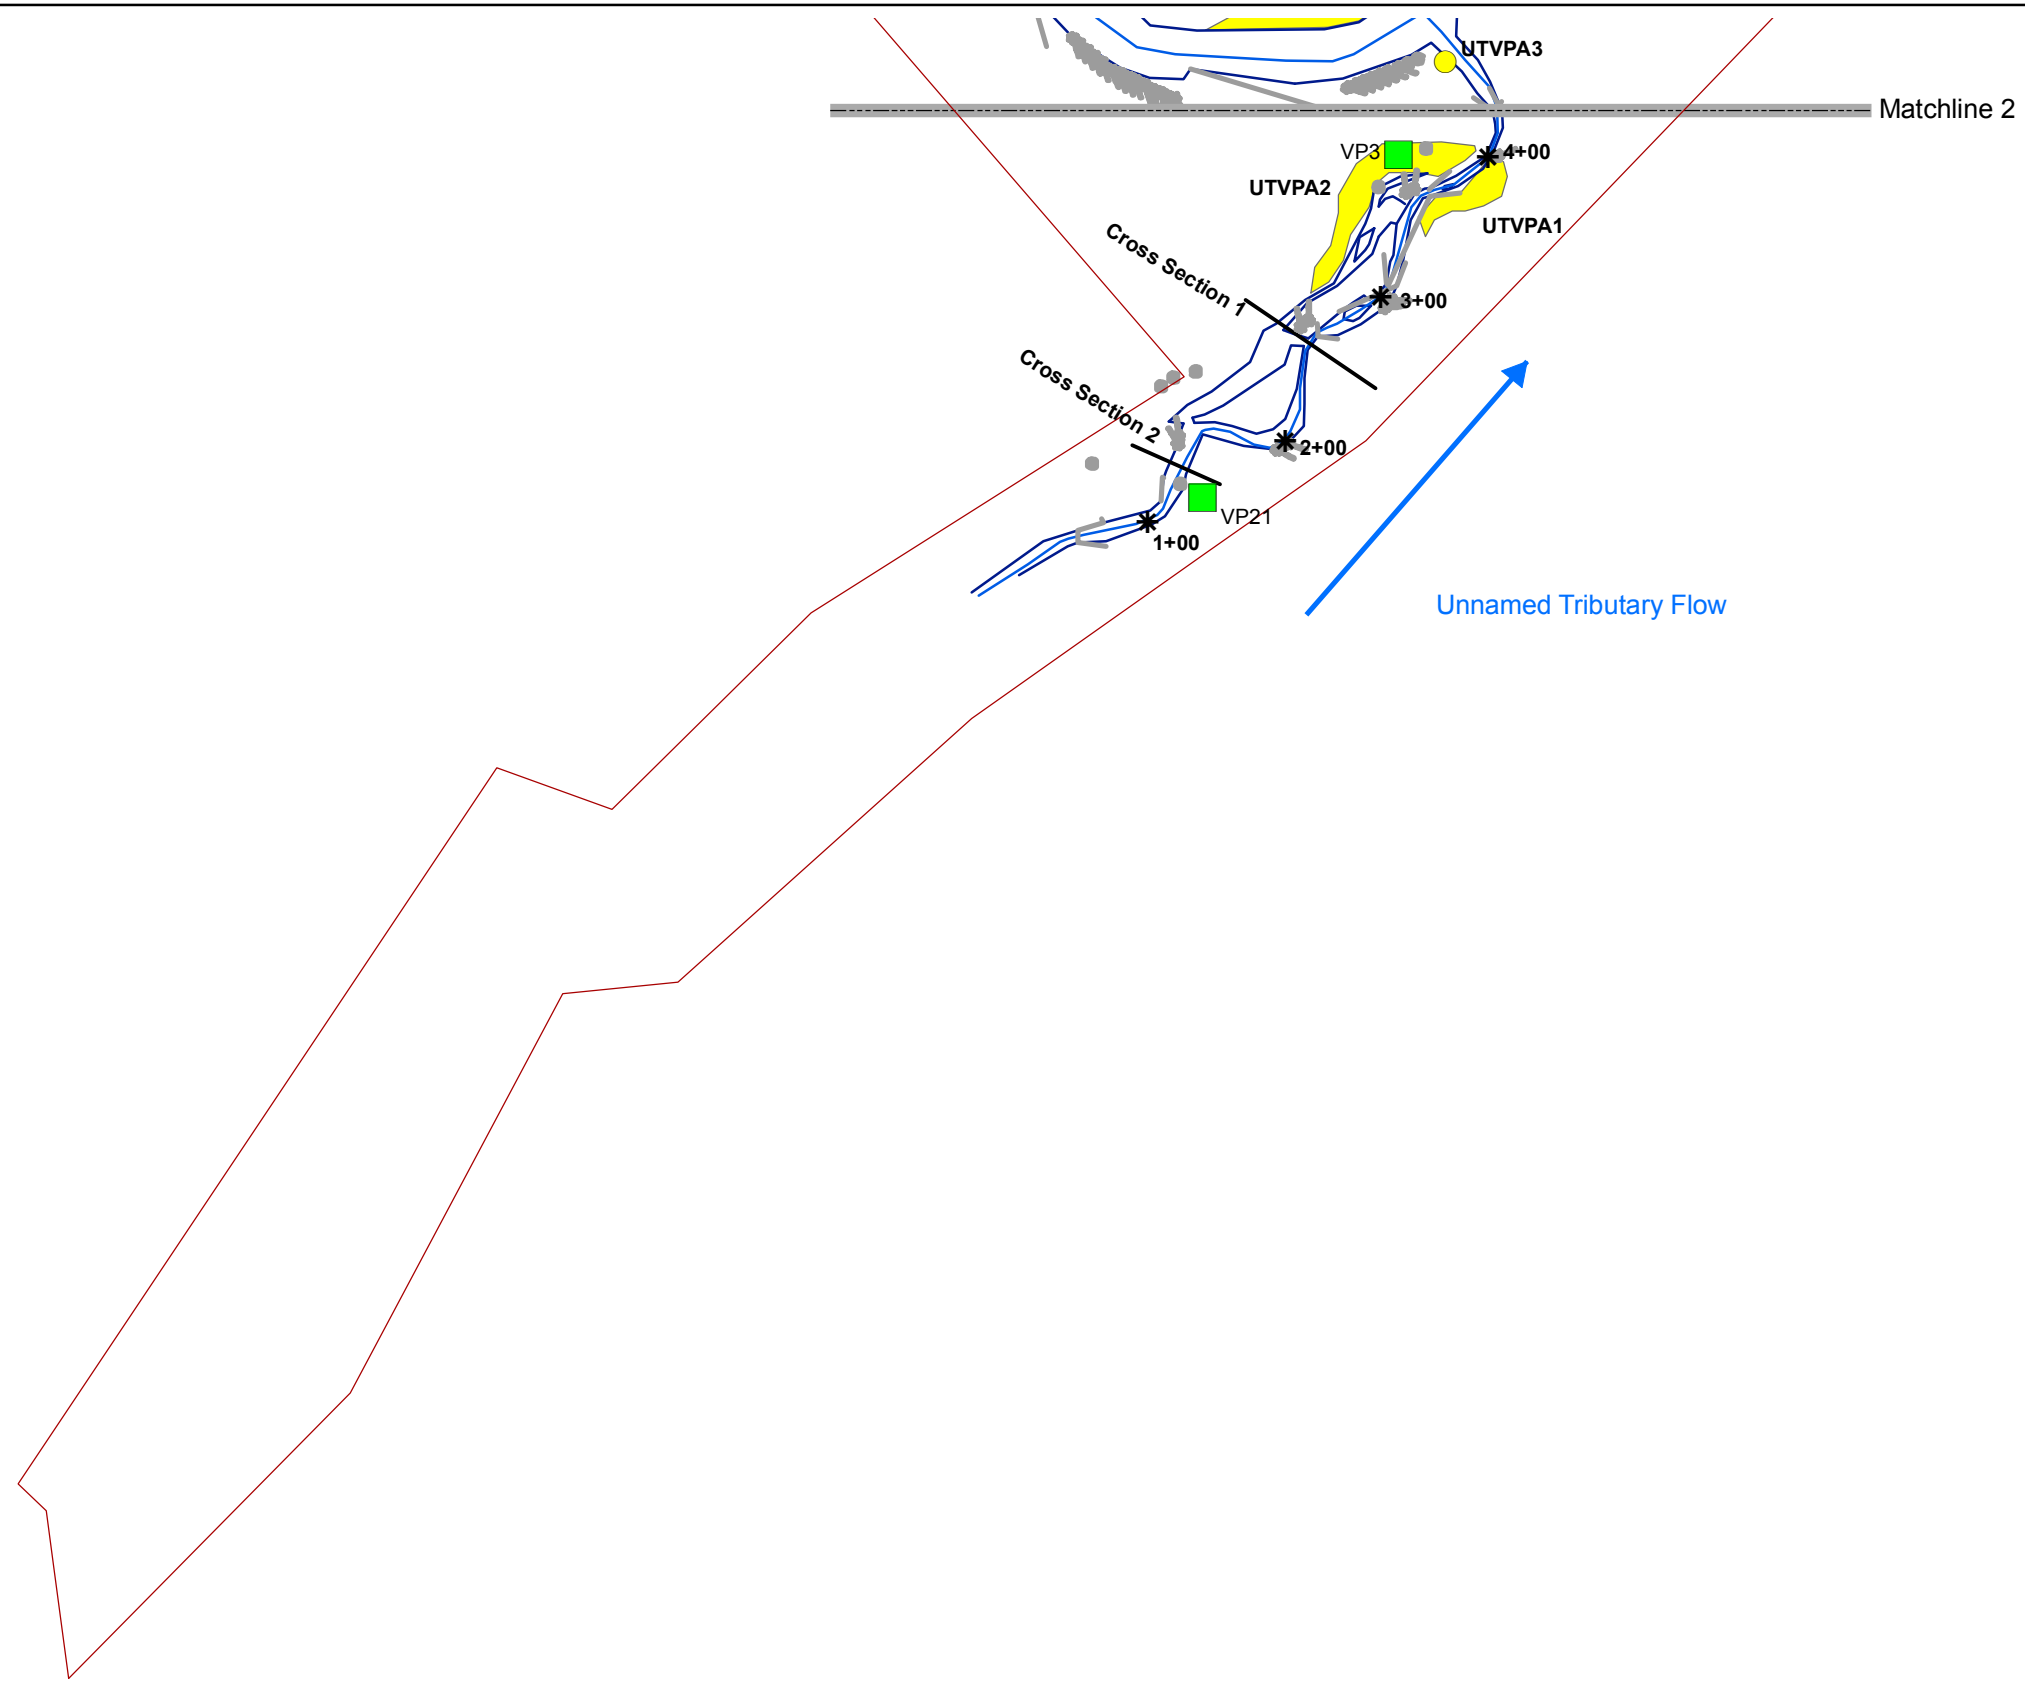
Vegetation
 Current Condition
 Plan View

Unnamed Tributary EEP Project Number 00028		
UTVPA1	Poor survival	3+50 to 4+00
UTVPA2	Poor survival	2+80 to 4+00
UTVPA3	Poor survival	4+90

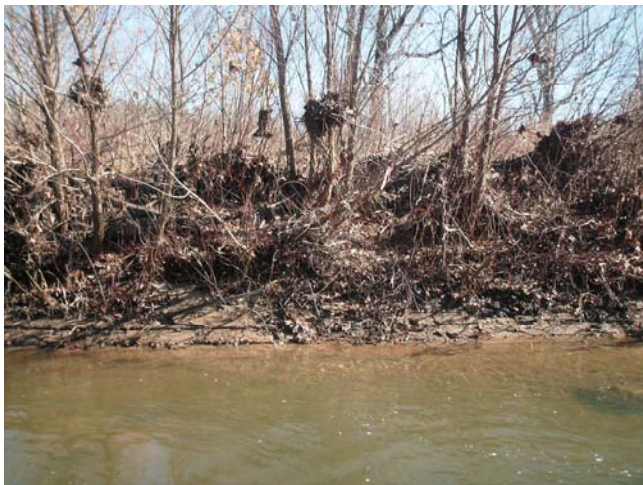
2009 wrack lines above bankfull

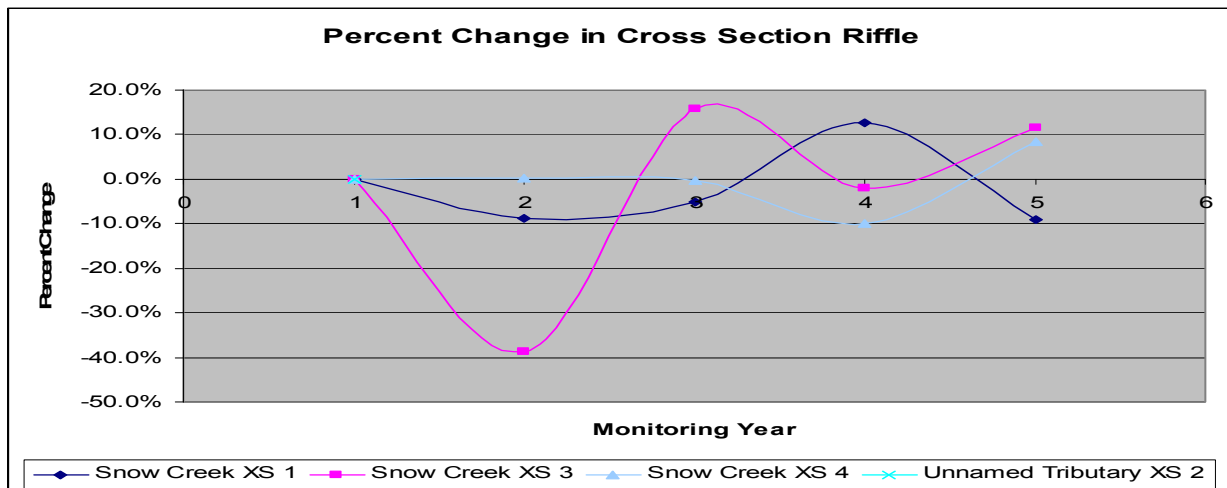
Figure 5: Percent Change in Cross Section Riffle

Figure 5 summarizes the percent changes in each riffle cross section monitored. The peaks and valleys beginning to reduce in size by monitoring year (remaining closer to zero) reveals a stabilizing trend as shown in each riffle cross section on-site.

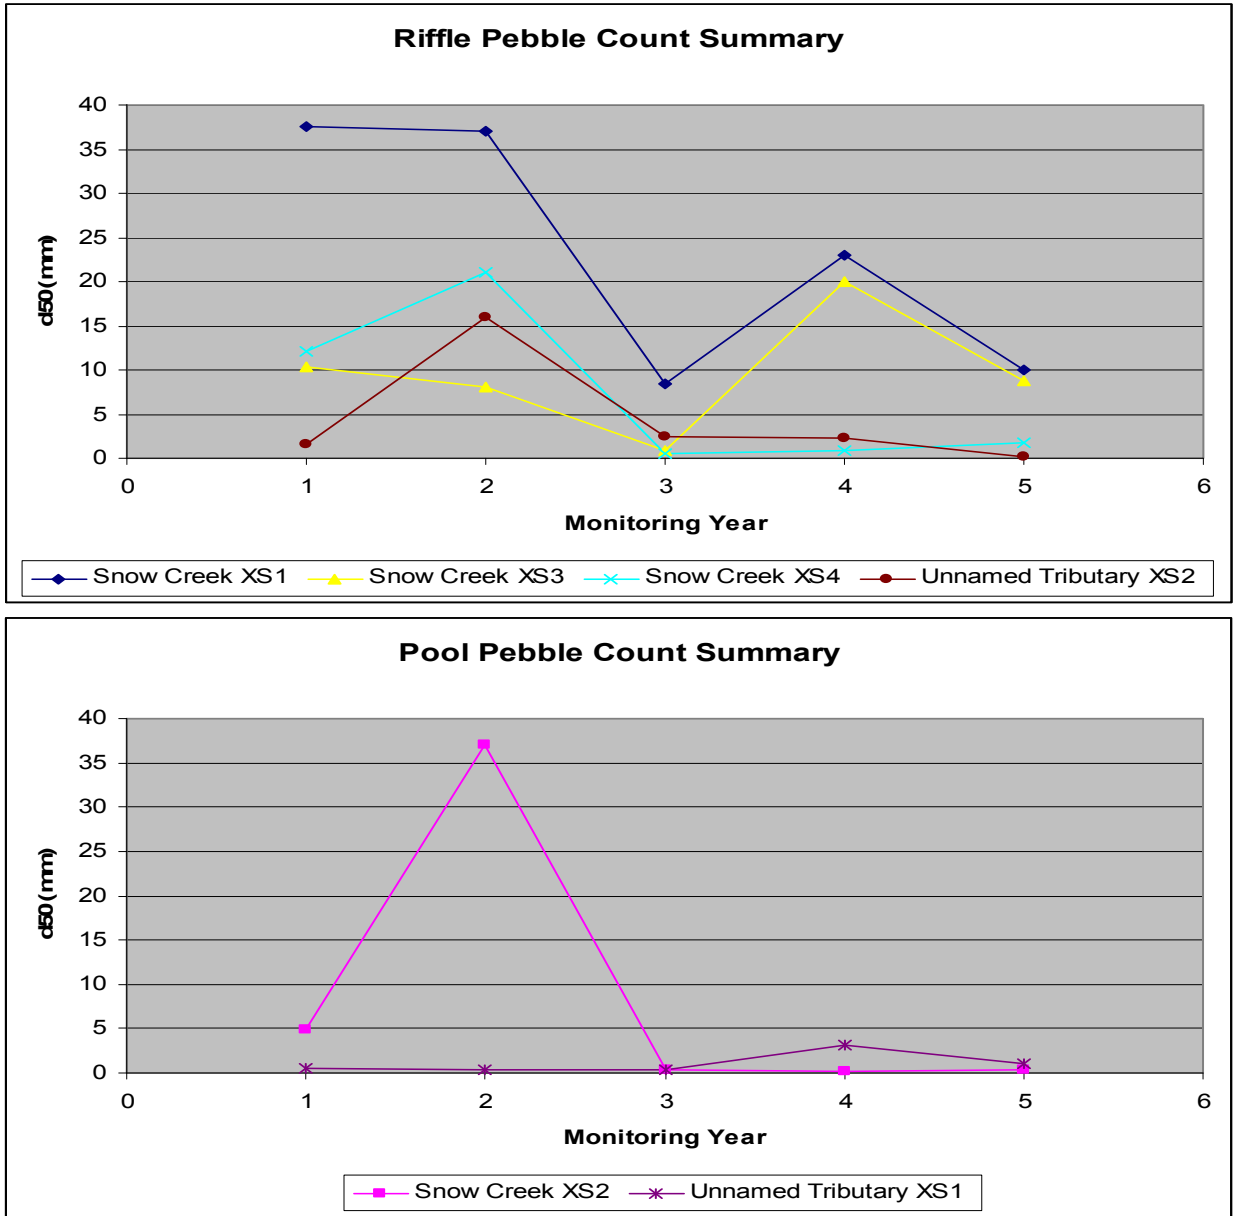
Figure 6: Pebble Count Summaries

In a riffle cross section, a stable system is indicated by a d50 maintaining or increasing. Maintaining a d50 indicates the riffles are not filling with sediment and pools are not moving into the reach. In a pool cross section, the bed material in a stable system typically remains small.
