**South Fork Mitigation Project
Catawba County, North Carolina**

Year 3 Monitoring Report

November 2007

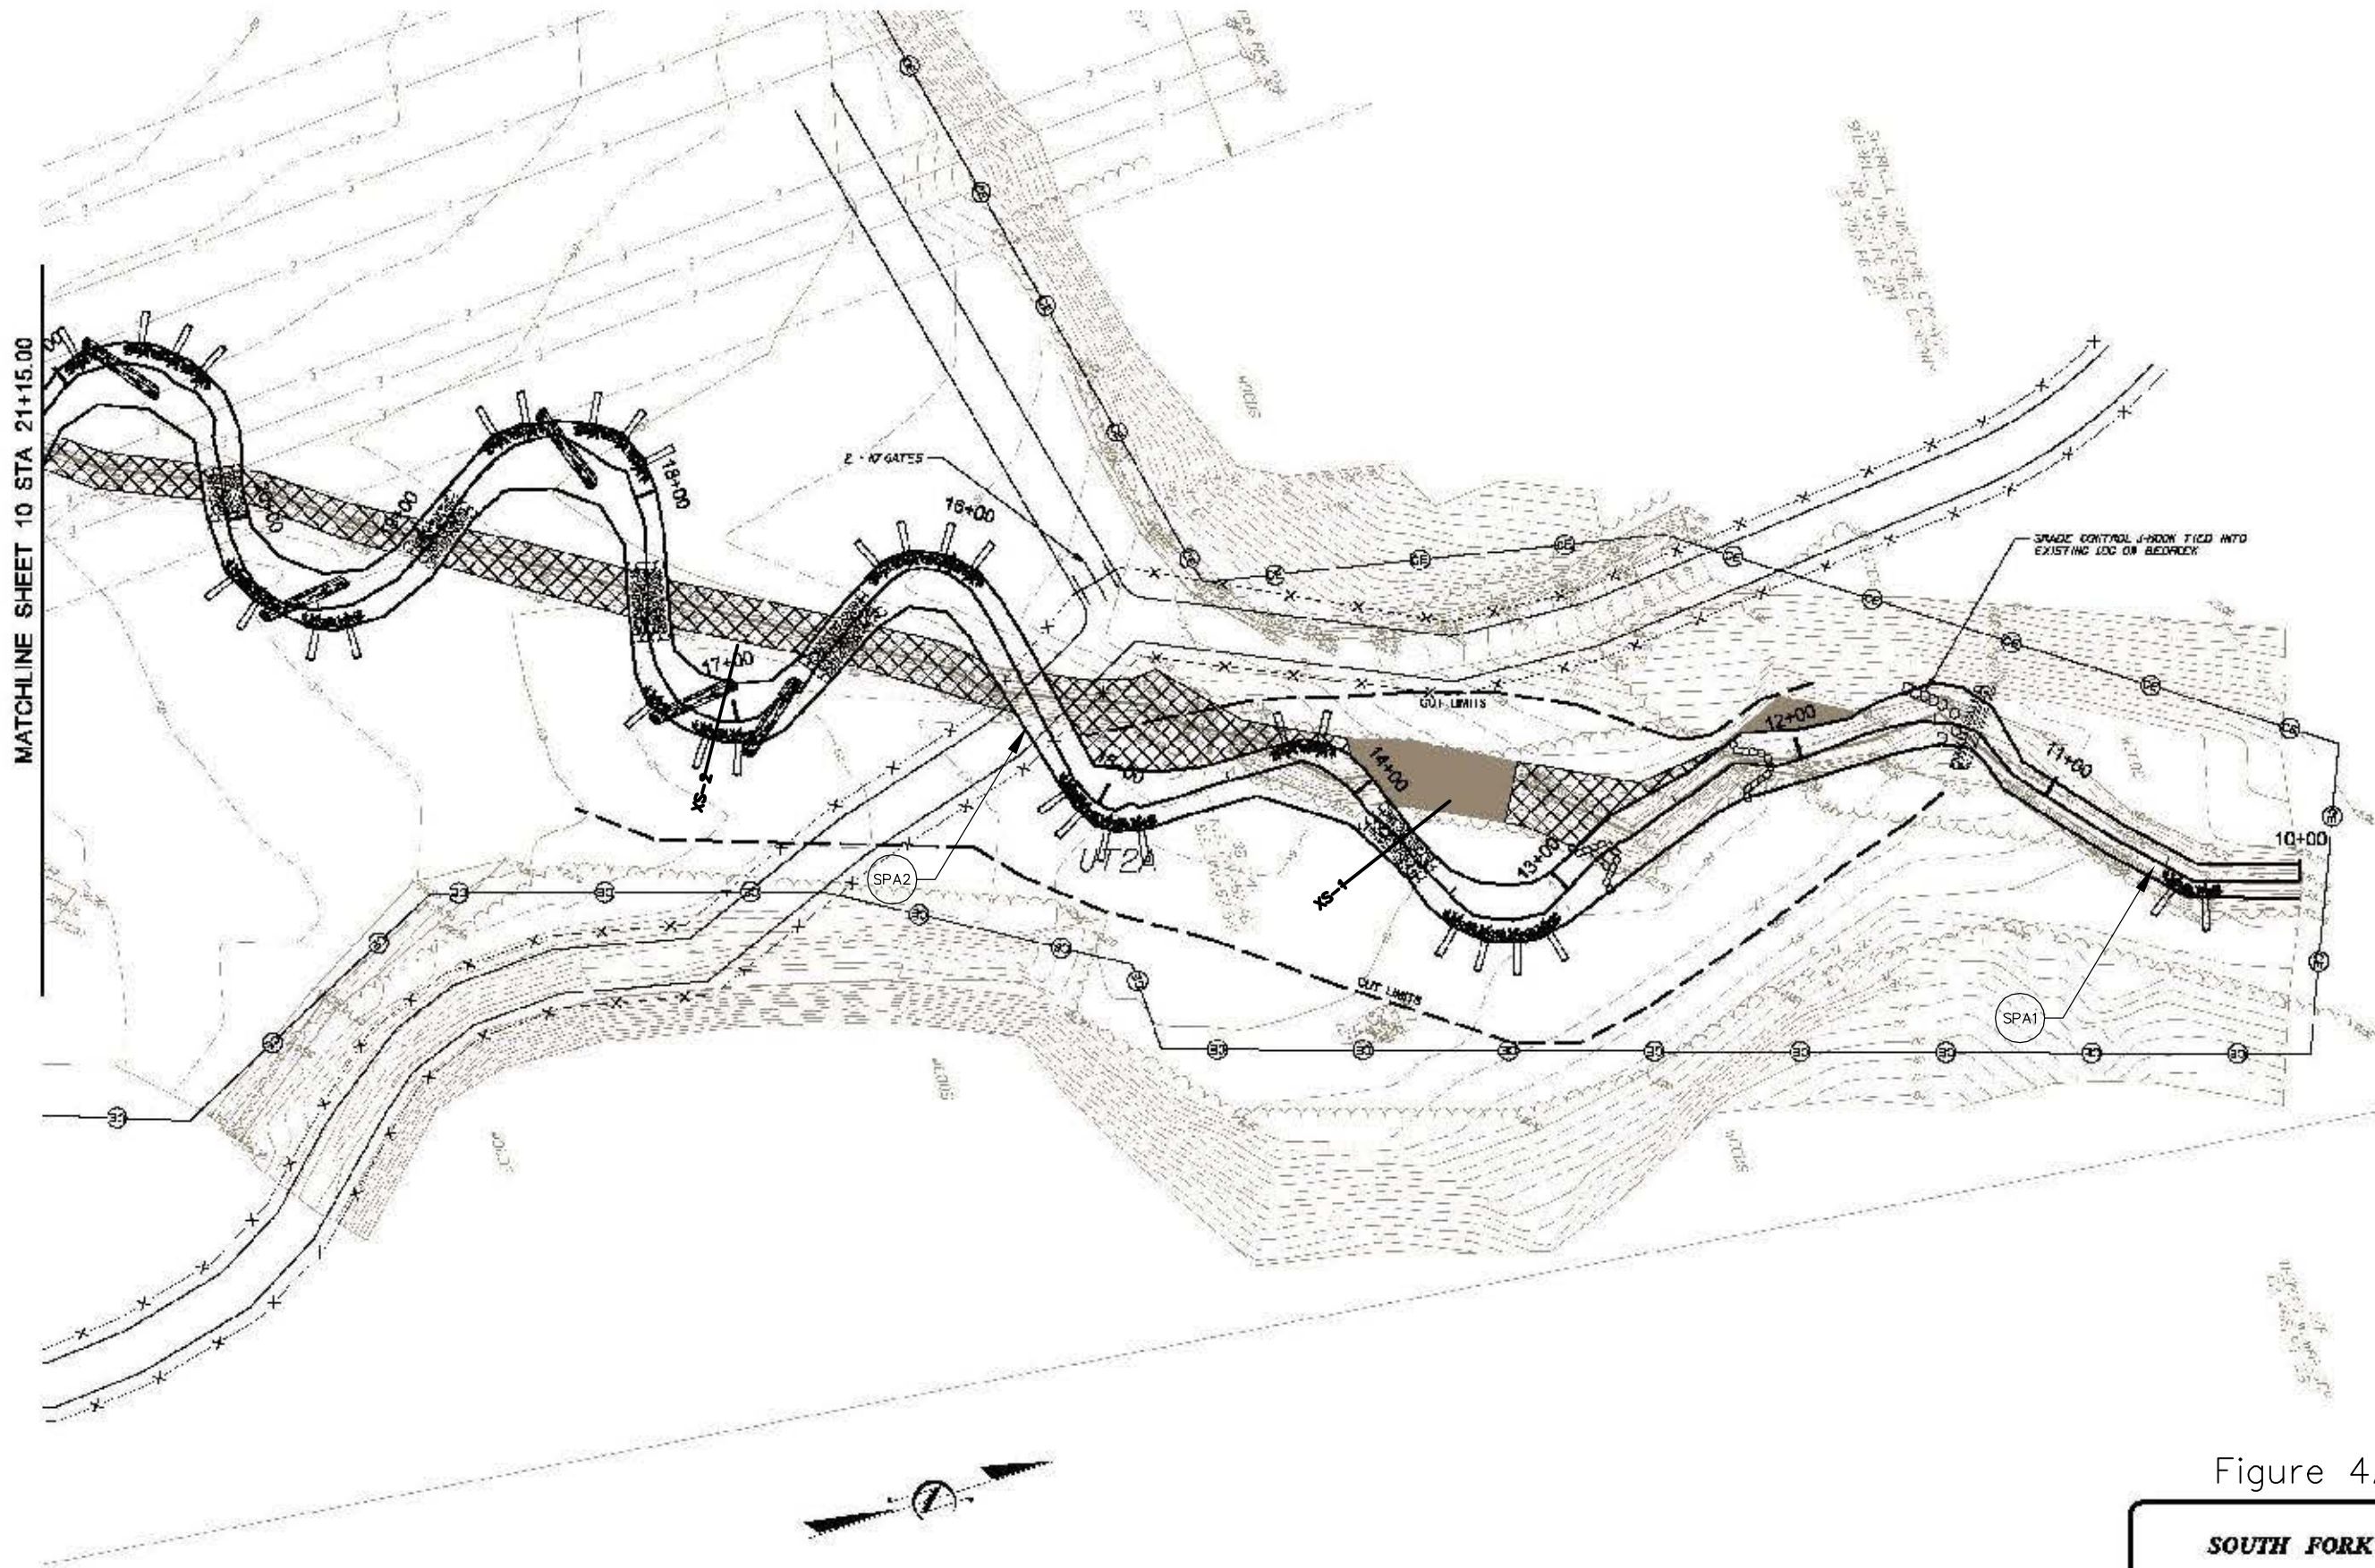
Figure 4A

In-stream structures installed within the channel included constructed riffles, cross vanes, log vanes, log weirs, root wads, and step-pool structures. Visual observations of structures throughout the past growing season indicated that nearly all structures are functioning as designed. The step pool structure in Reach M2 is beginning to show signs of wear. Erosion was evident behind boulders at the step pool and there is a head cut occurring just upstream of the step pool. A plan view drawing of the stream areas is provided in **Figure 4A-4F** for each reach and **Table 8** below outlines areas requiring further observation with station and description of each issue.

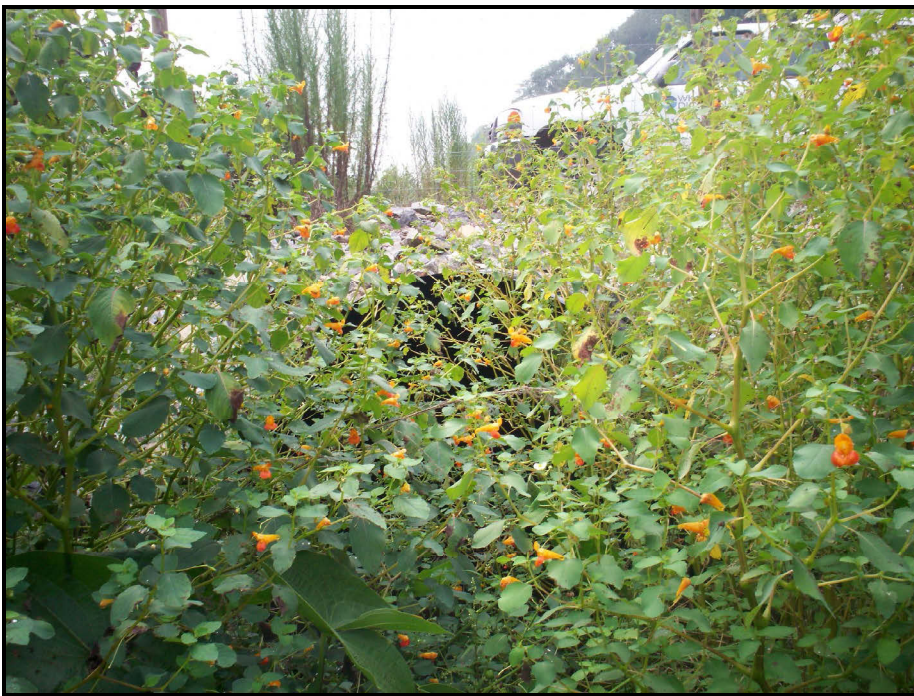
SPA 1. Erosion along left bank in UT-2A North at STA 10+50

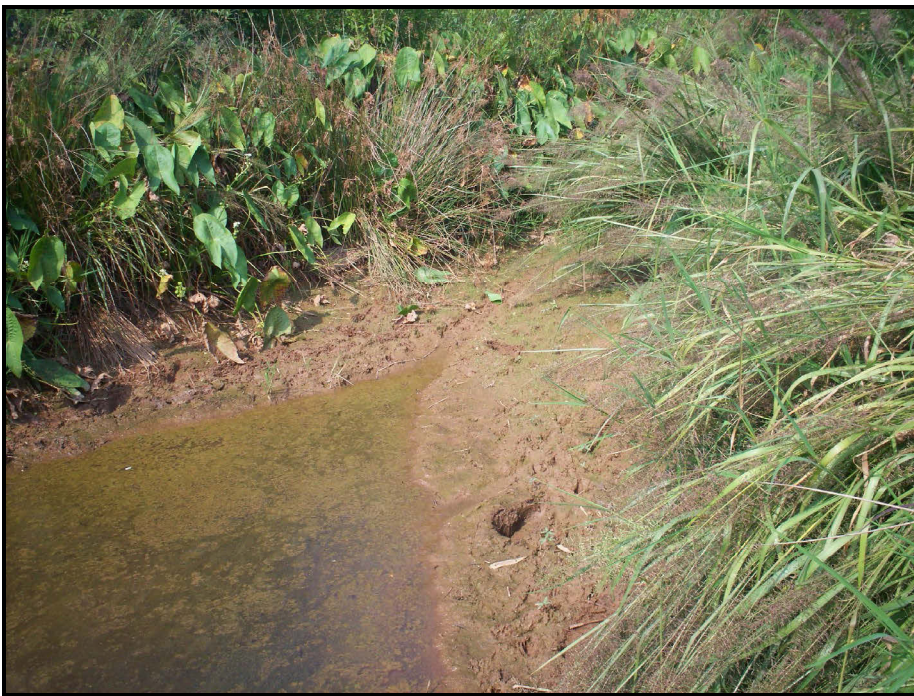
SPA 3. Stagnant flow in UT2A North at STA 25+50 resulting from excess vegetation downstream of the photo.

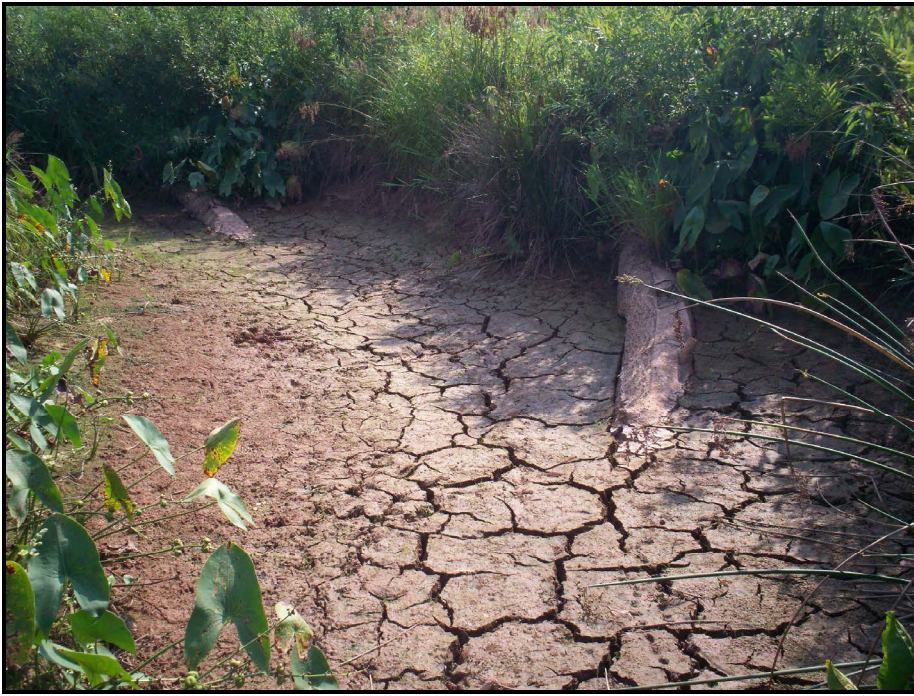
SPA 4. Sediment aggradation in UT2A North at STA 27+50.
