**South Fork Mitigation Project
Catawba County, North Carolina**

Year 4 Monitoring Report

December 2008

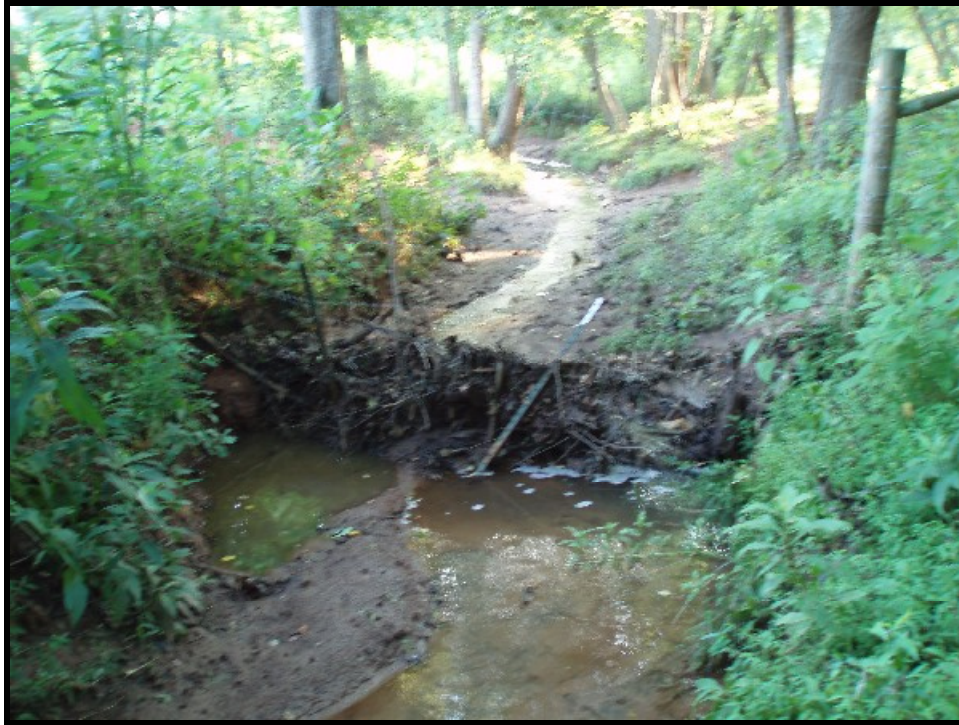
UT1A station 10+00. Wrack in fence.

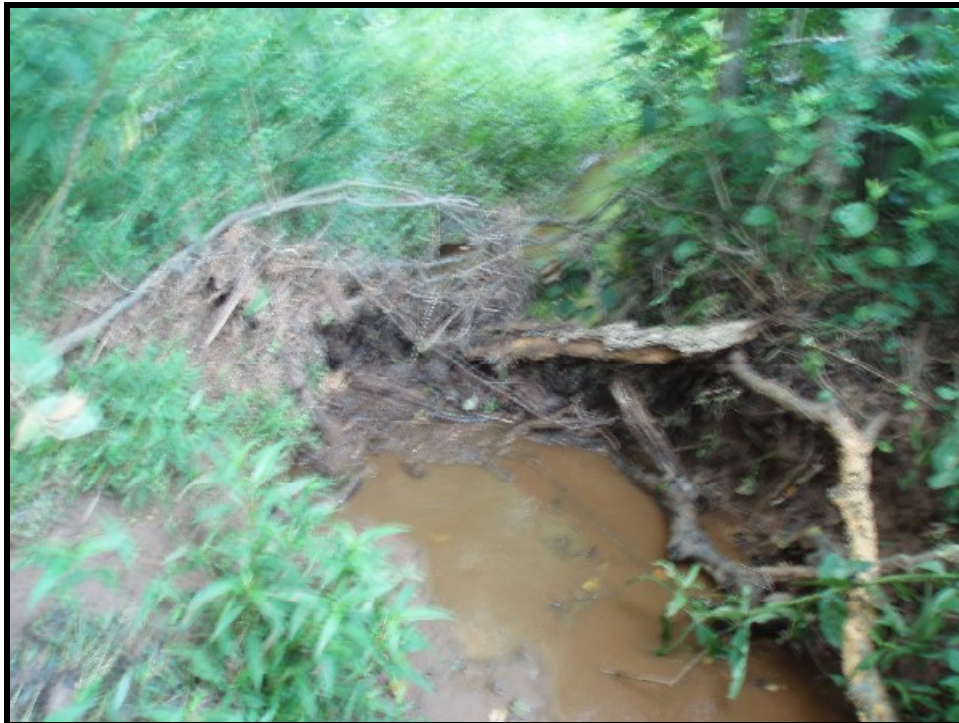
UT1A station 13+00. Small debris jam.

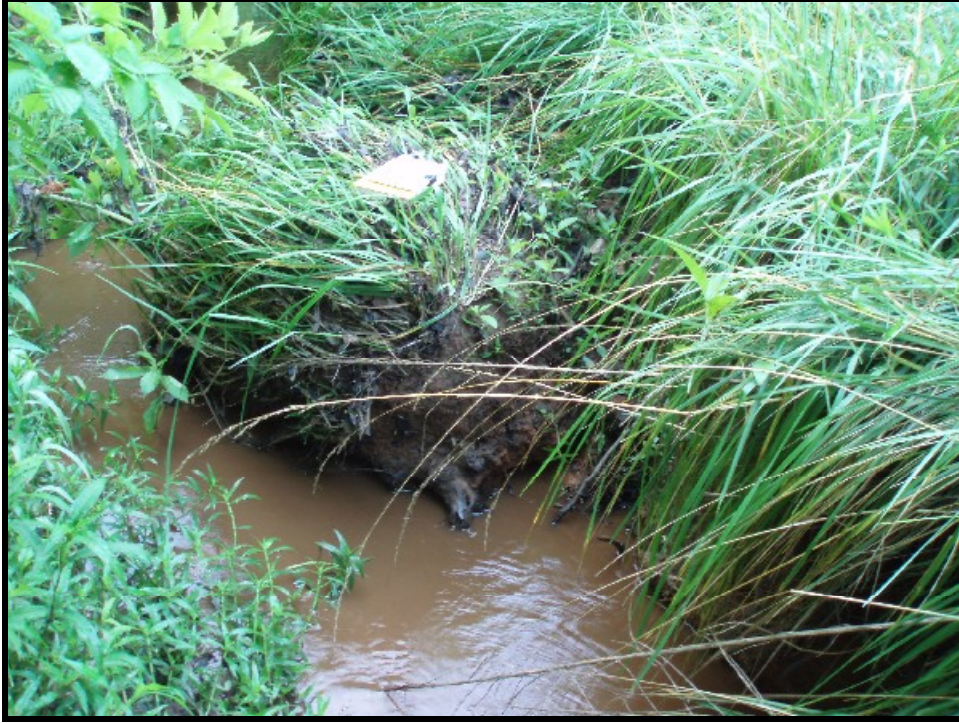
UT1A station 14+80. Slump on right bank.

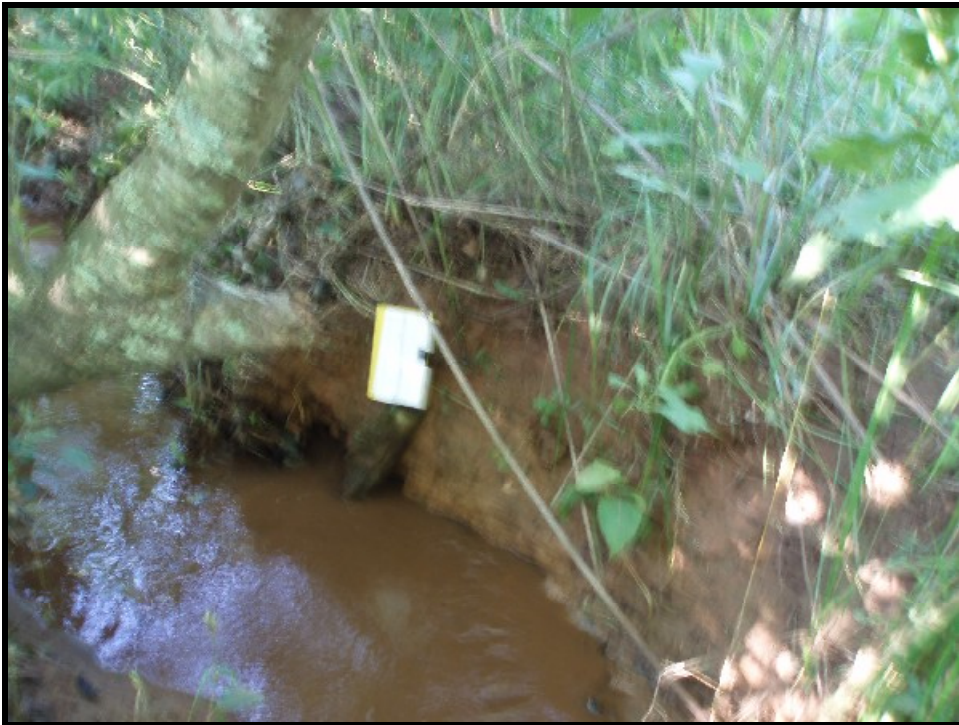
UT1A station 19+00. Typical bank erosion.

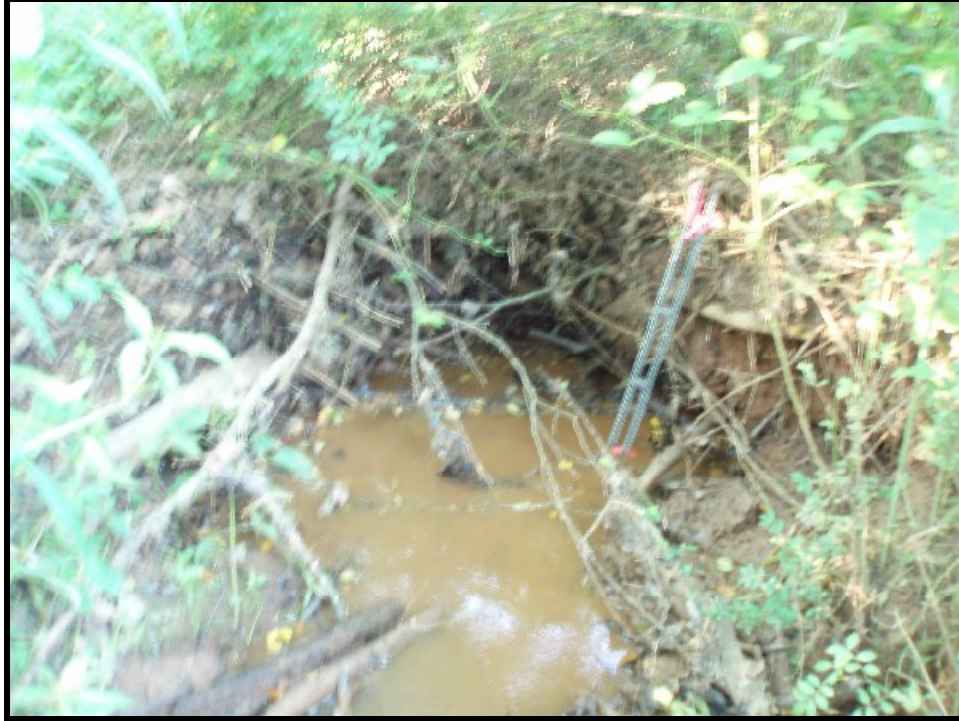
UT1A station 33+00. Debris jam and right bank erosion.

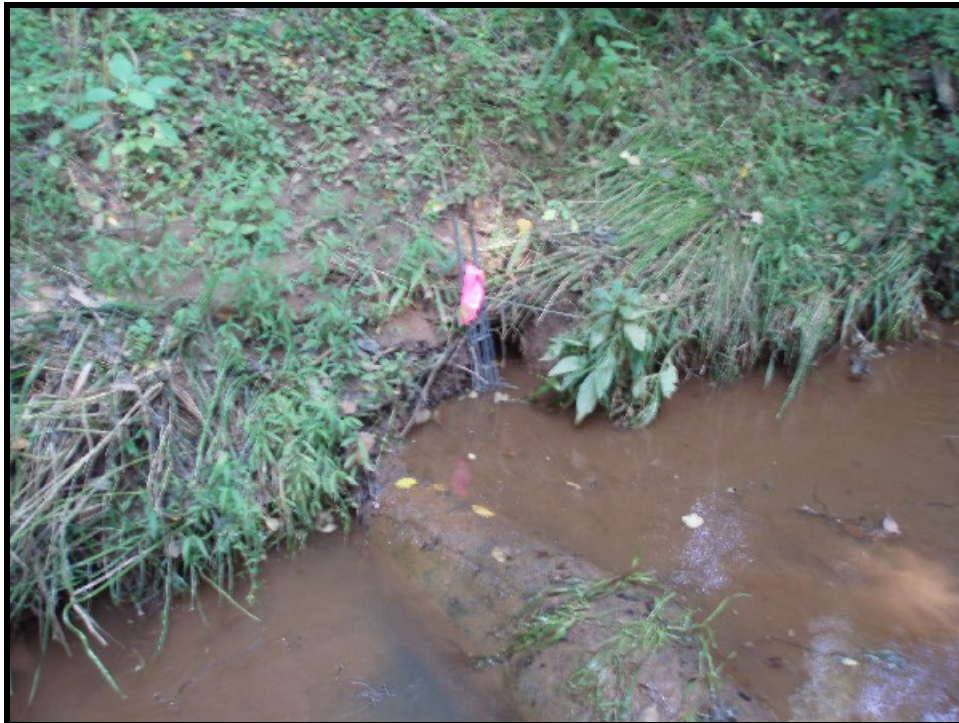
UT1B station 37+60. End cut on right bank at grade control structure.

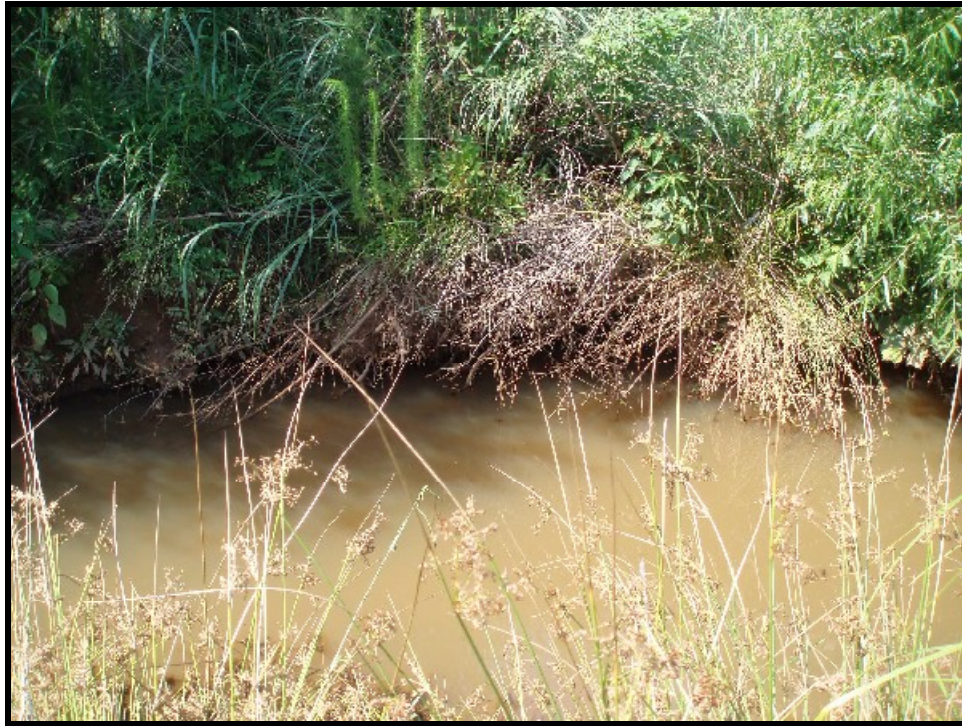
UT1B station 58+40. Unstable root wad.

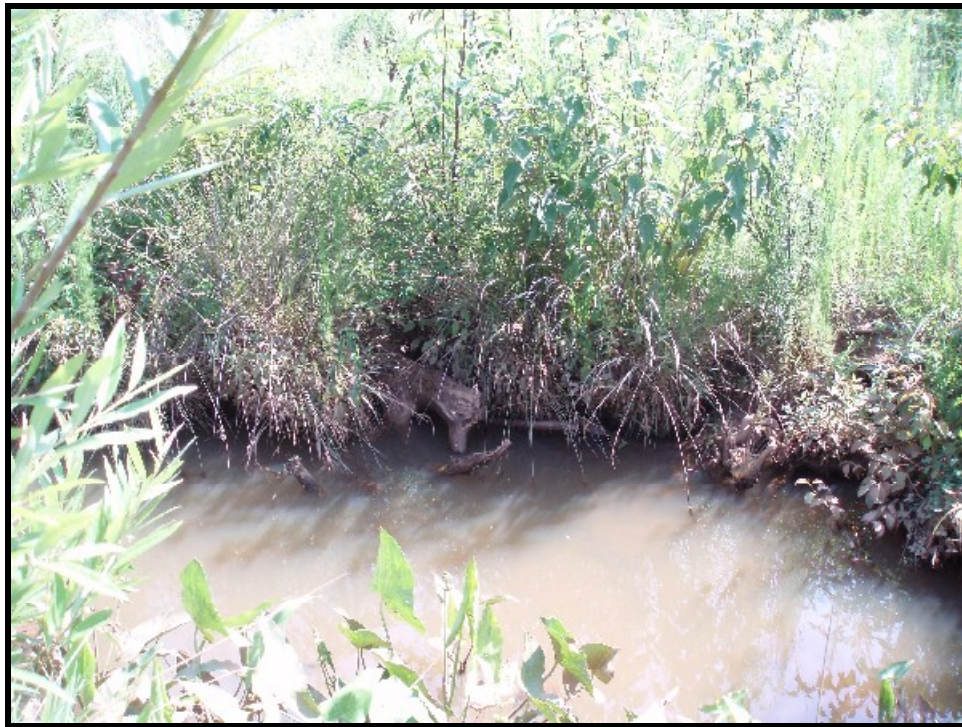
UT1B station 60+00. Unstable root wad.

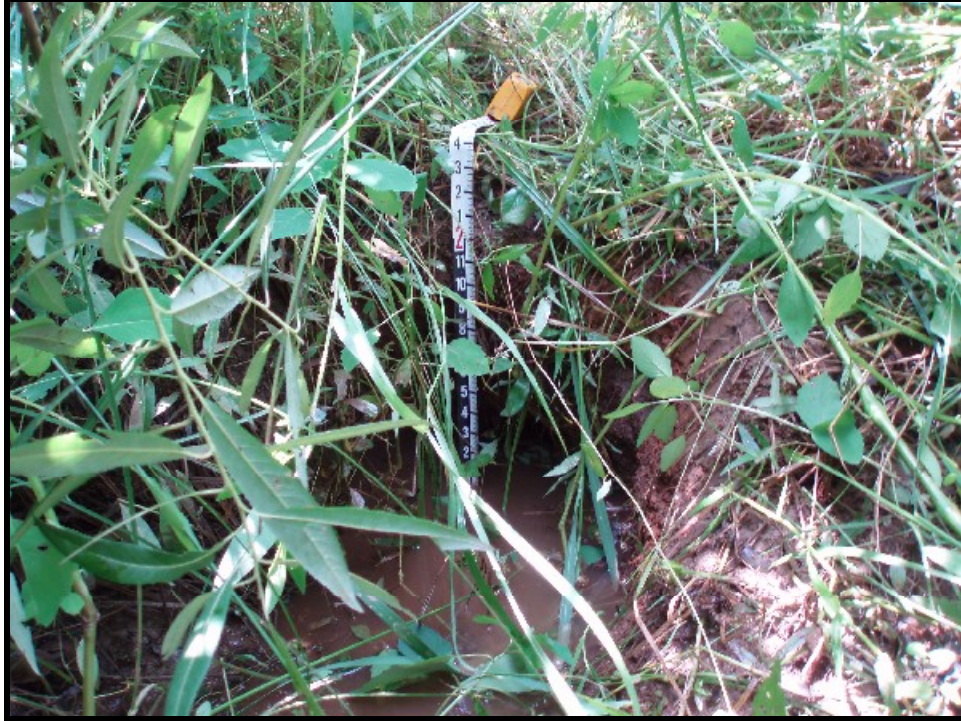
UT2A station 17+60. Left bank erosion.

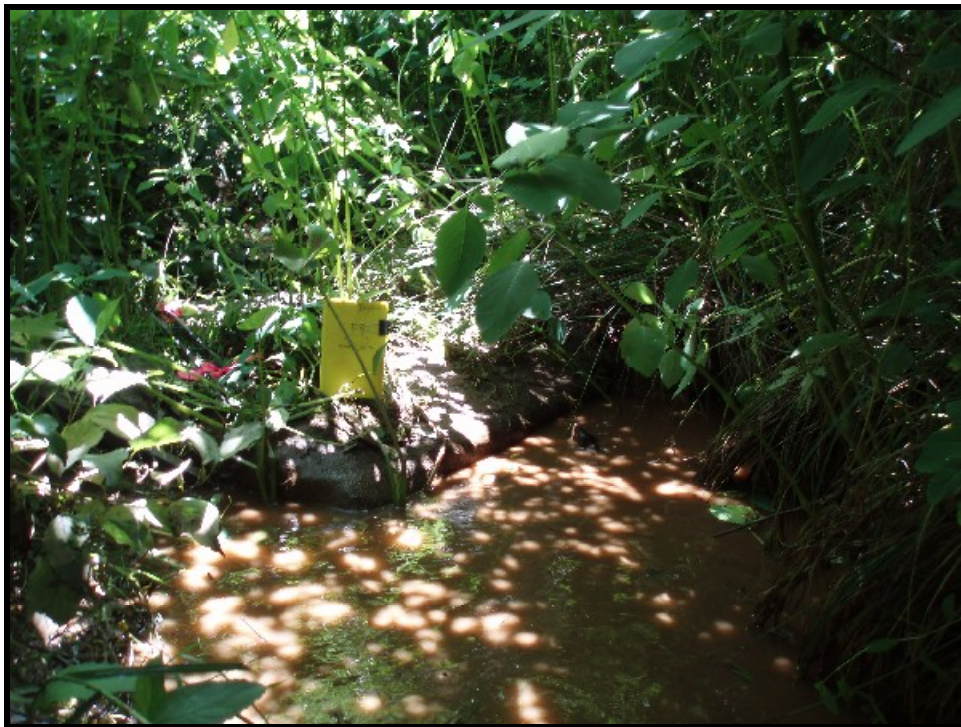
UT2A station 18+90. Rock cross vane header perched.

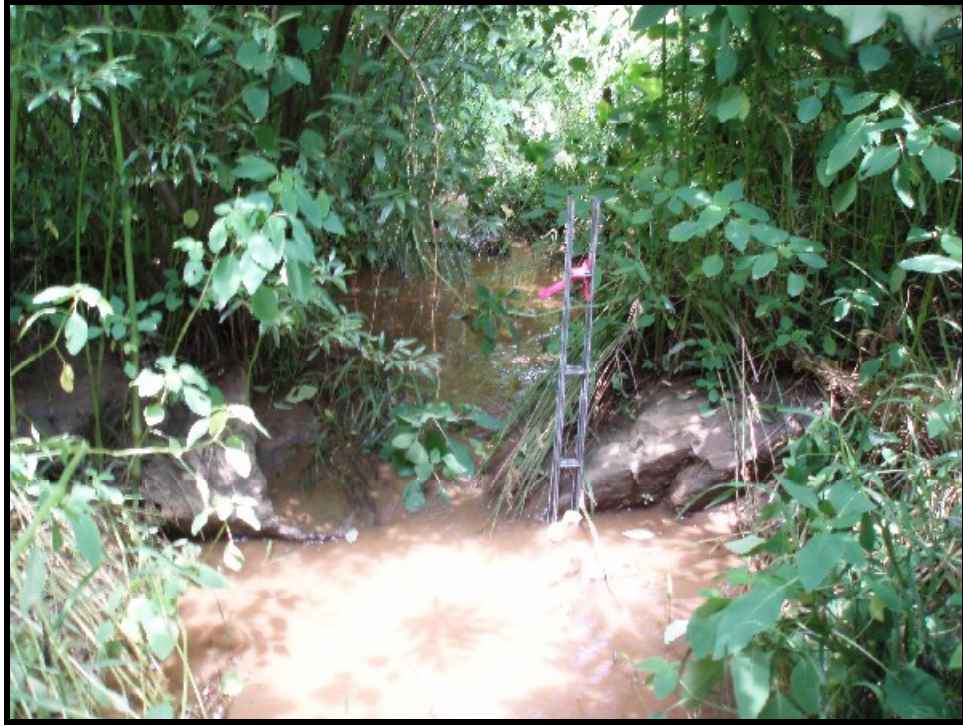
UT2A station 21+60. Constructed riffle header perched.

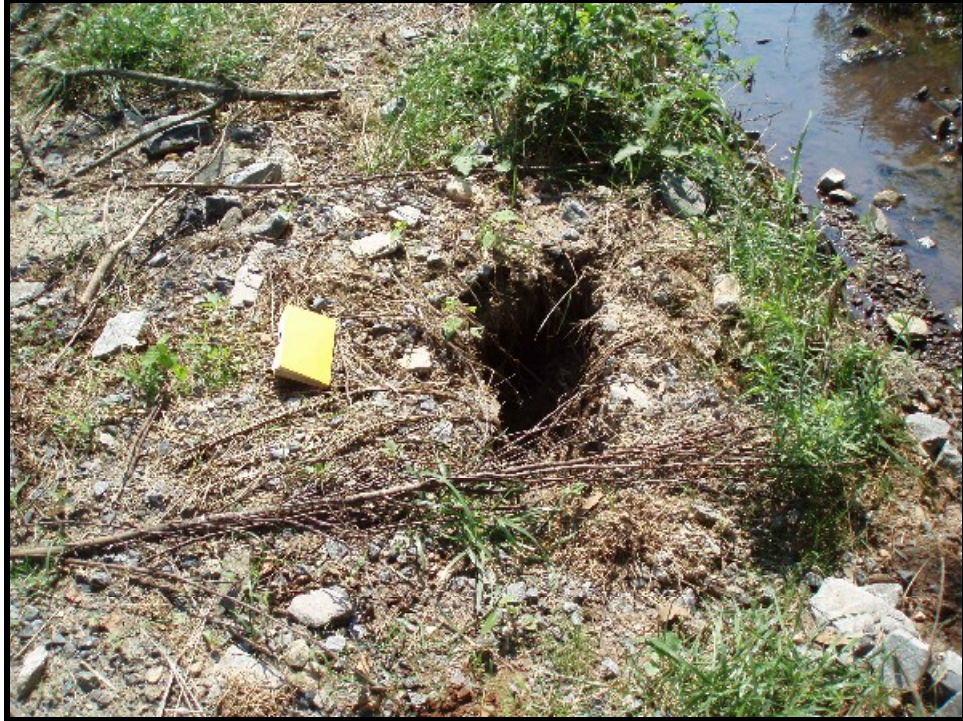
M2 station 38+20. Erosion/settling on right bank.
