**South Fork Mitigation Project
Catawba County, North Carolina**

Year 5 Monitoring Report

FINAL

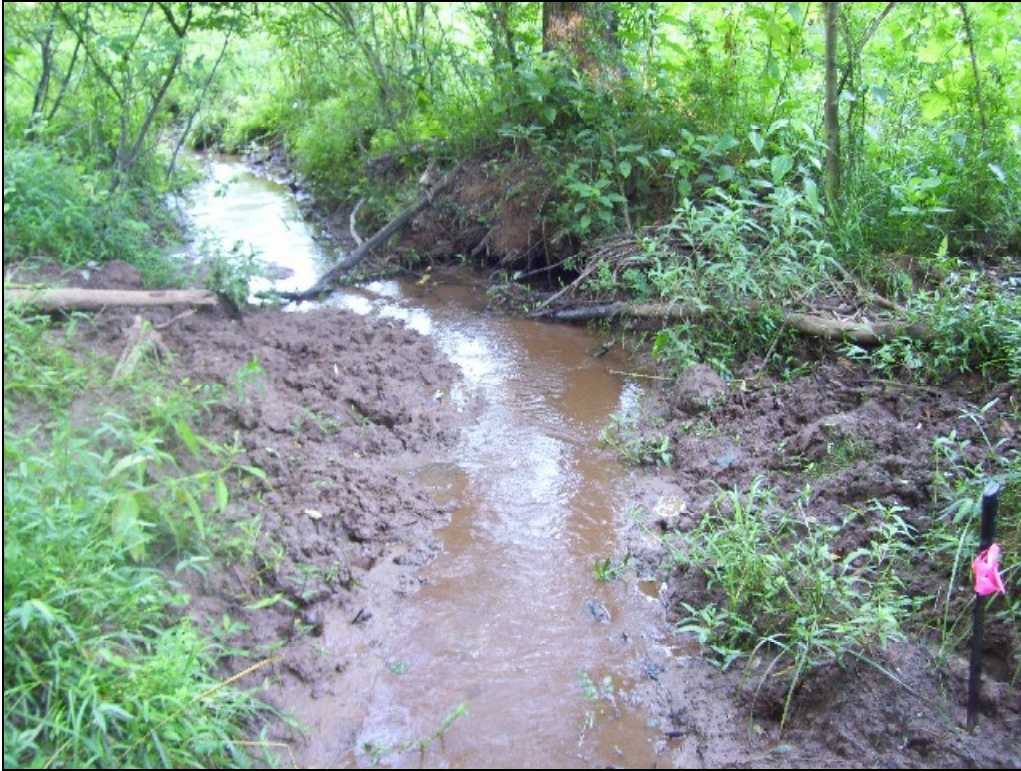
SPA No.	Reach	Station	Feature	Condition
1	UT1A	10+00 – 35+00	Easement Area	Cattle in easement have degraded stream banks at several channel access points; the banks are stabilizing and no repairs are recommended
2	UT2A	19+00	Constructed Riffle	Header rock is perched; bed is stable; no repair necessary
3	UT2A	21+50	Constructed Riffle	Minor piping around header rock; no repair necessary
4	UT4	18+60	Step Pools	Piping beneath lower header rocks; upper step pools stable; no repair necessary
5	UT5	24+50	Rock Cross Vane	Piping below header rock; bed is stable; no repair necessary
6	M2	28+70	Rock Cross Vane	Header rock perched; bed is stable; no repair necessary
7	M2	30+90	Constructed Riffle	Minor piping beneath header rock; bed is stable; no repair necessary
8	M2	38+10	Step Pools	Lower header rocks are perched; minor erosion on banks; overall system is stable and re-vegetating; no repairs recommended

UT1A STA 10+00–35+00 Typical minor bank erosion from cattle access

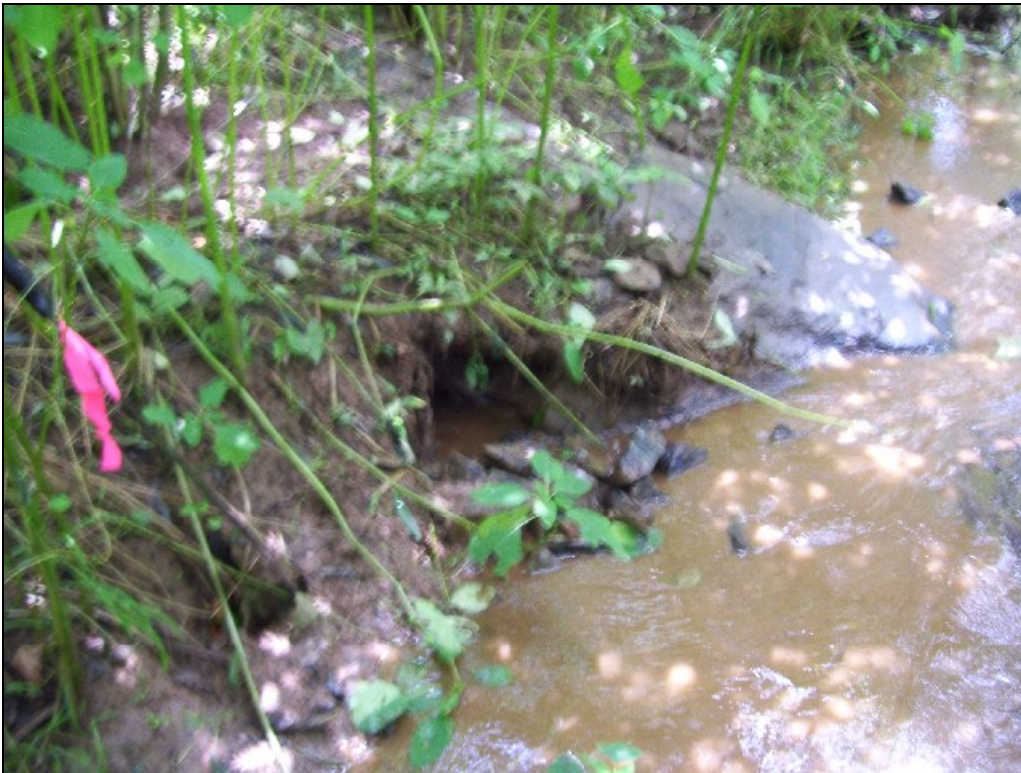
UT2A STA 21+50 minor piping around header rock on left bank of constructed riffle

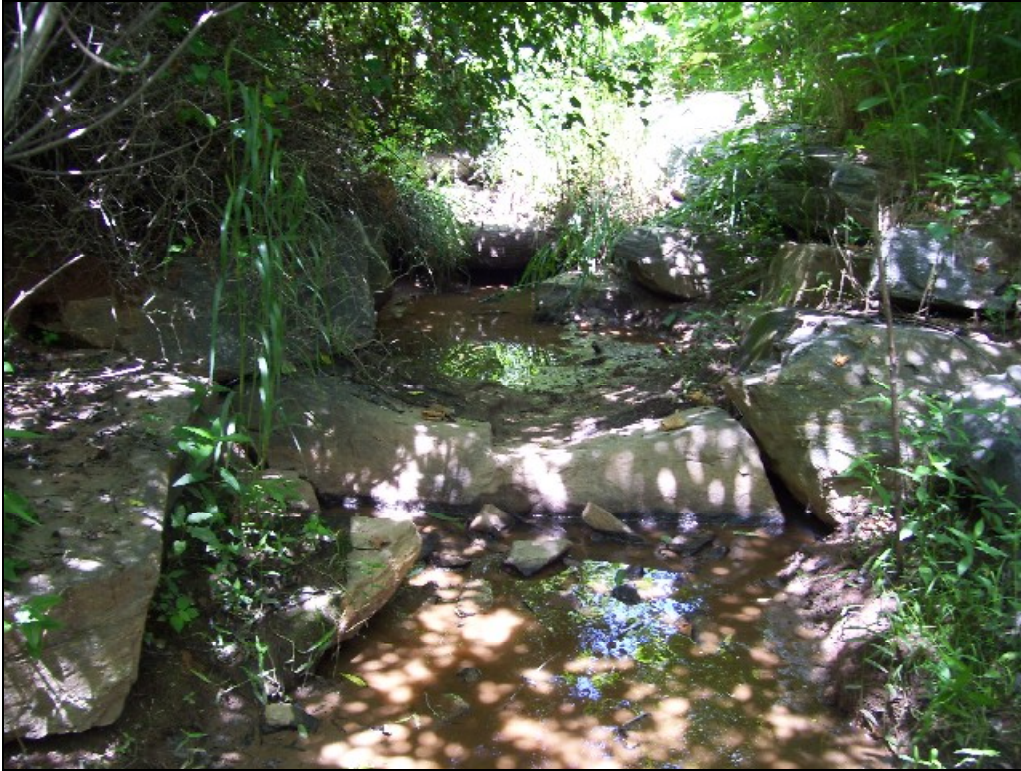
UT4 STA 18+60 Piping beneath lower header rocks of step pool system

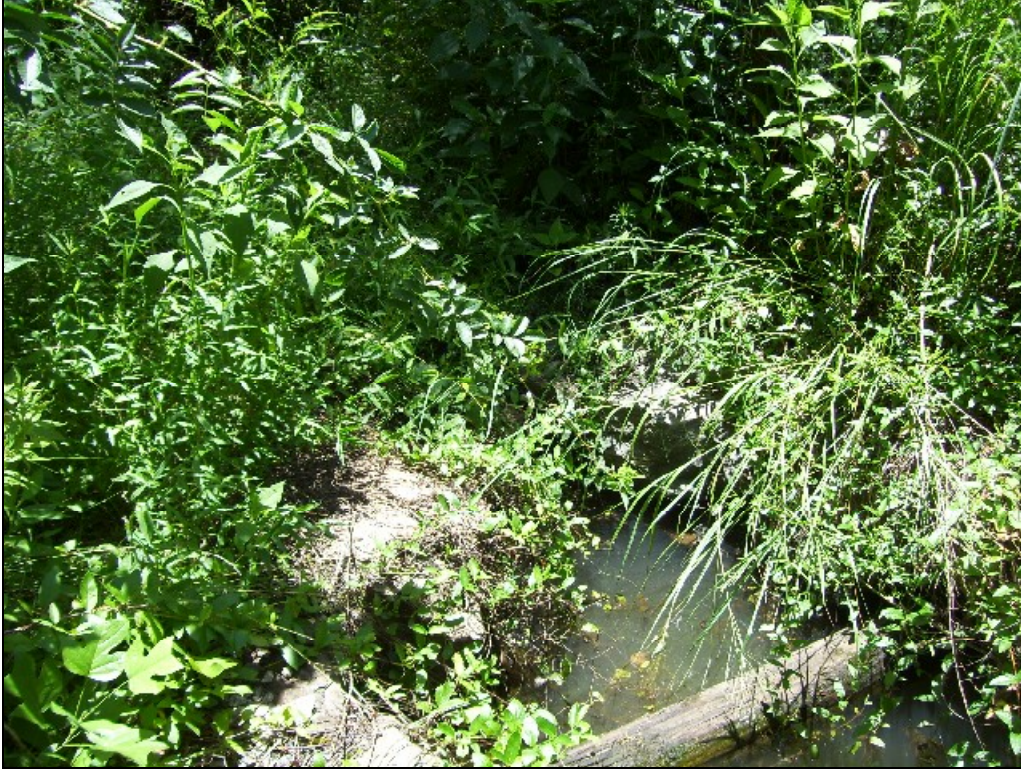
UT5 STA 24+50 Piping below header rock of rock cross vane

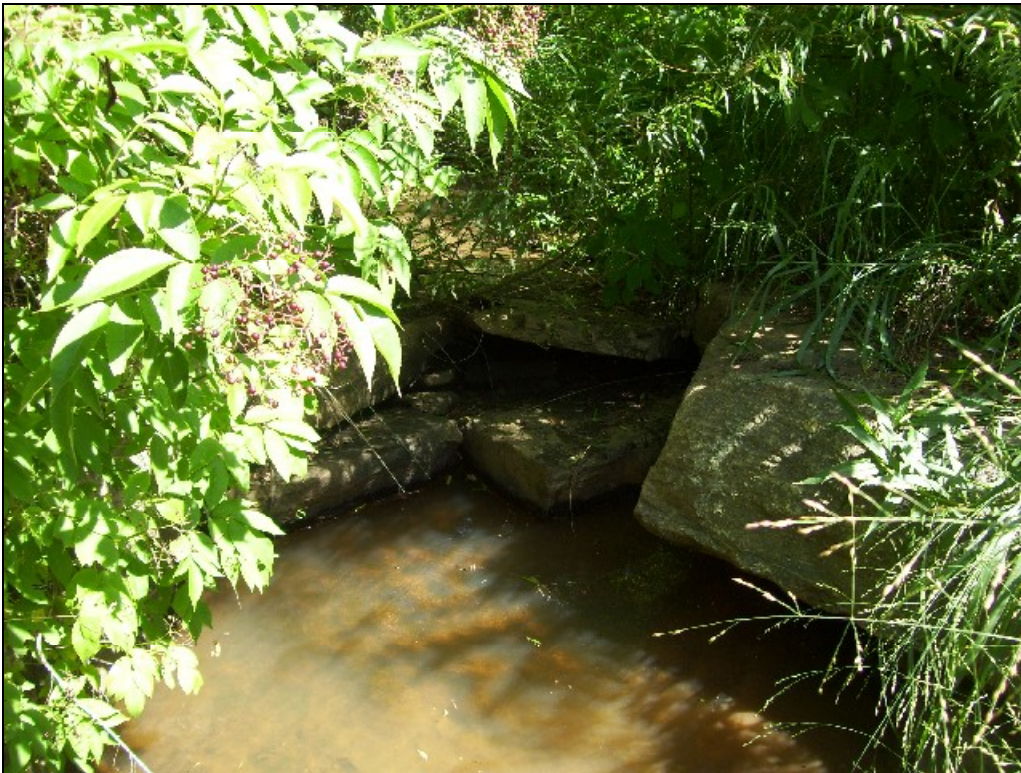
M2 STA 28+70 Perched header on rock cross vane

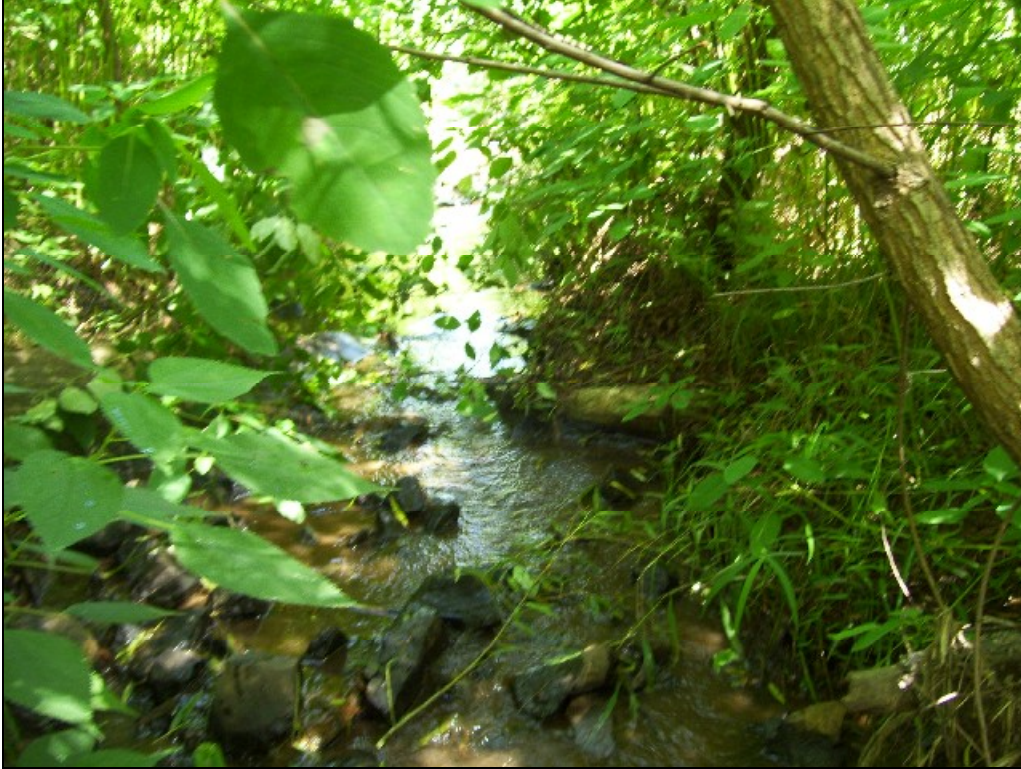
M2 STA 30+90 Minor piping beneath constructed riffle header rock

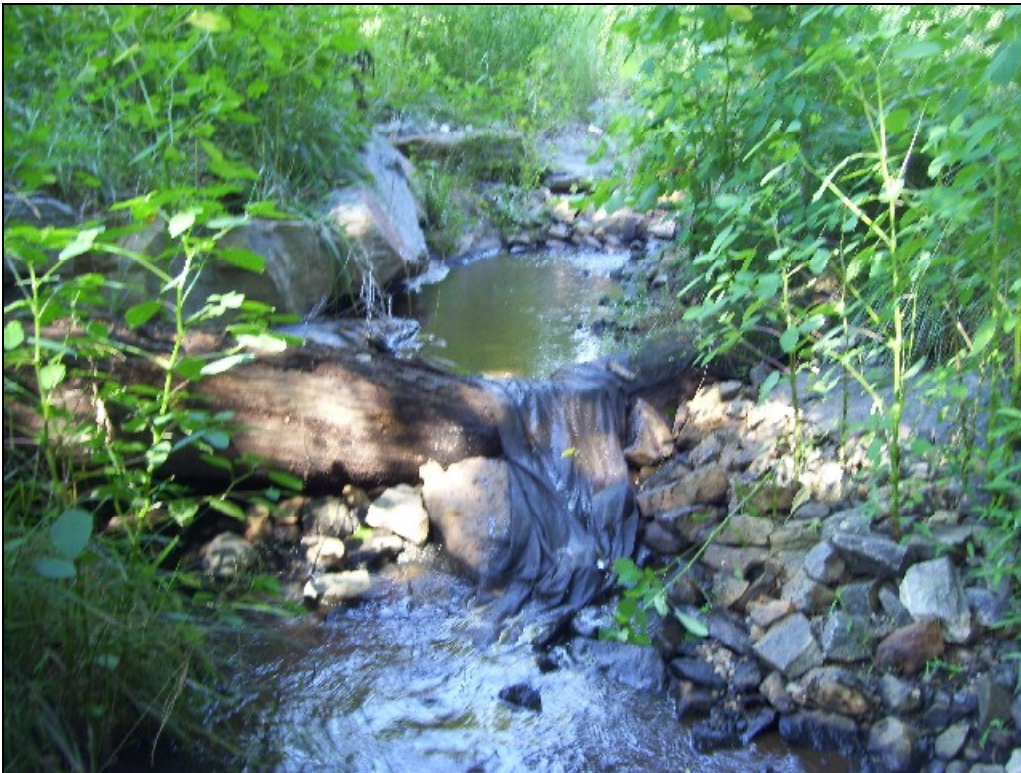
M2 STA 38+10 Lower header rocks perched in step pool system

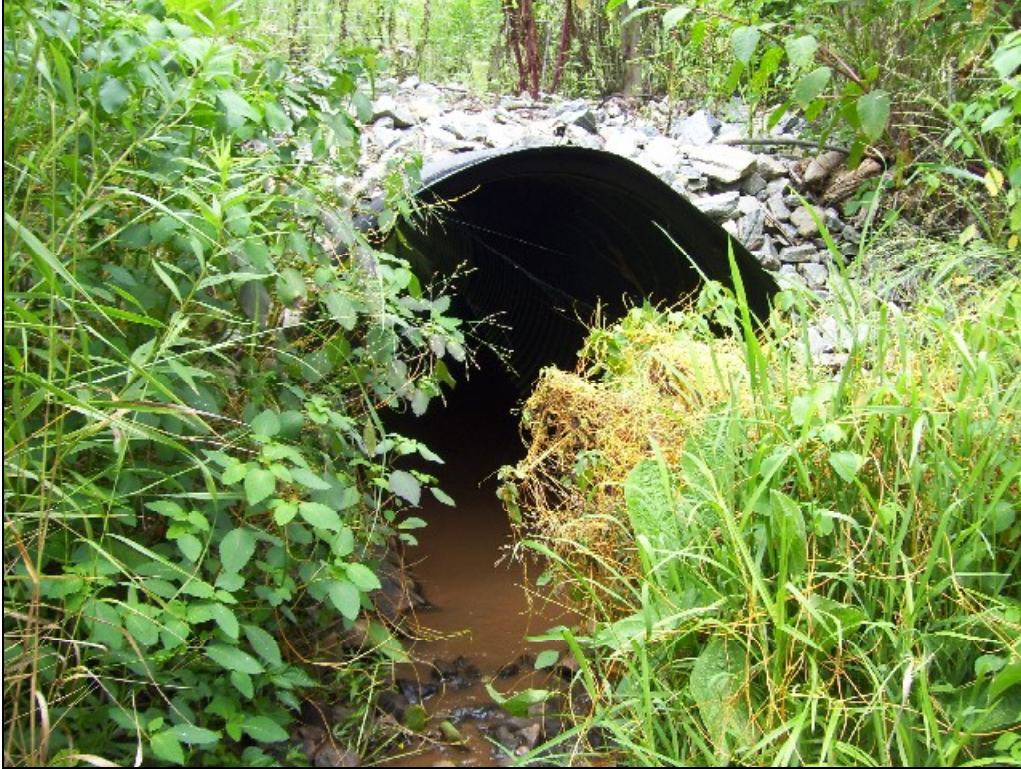
Typical stable culvert outlet

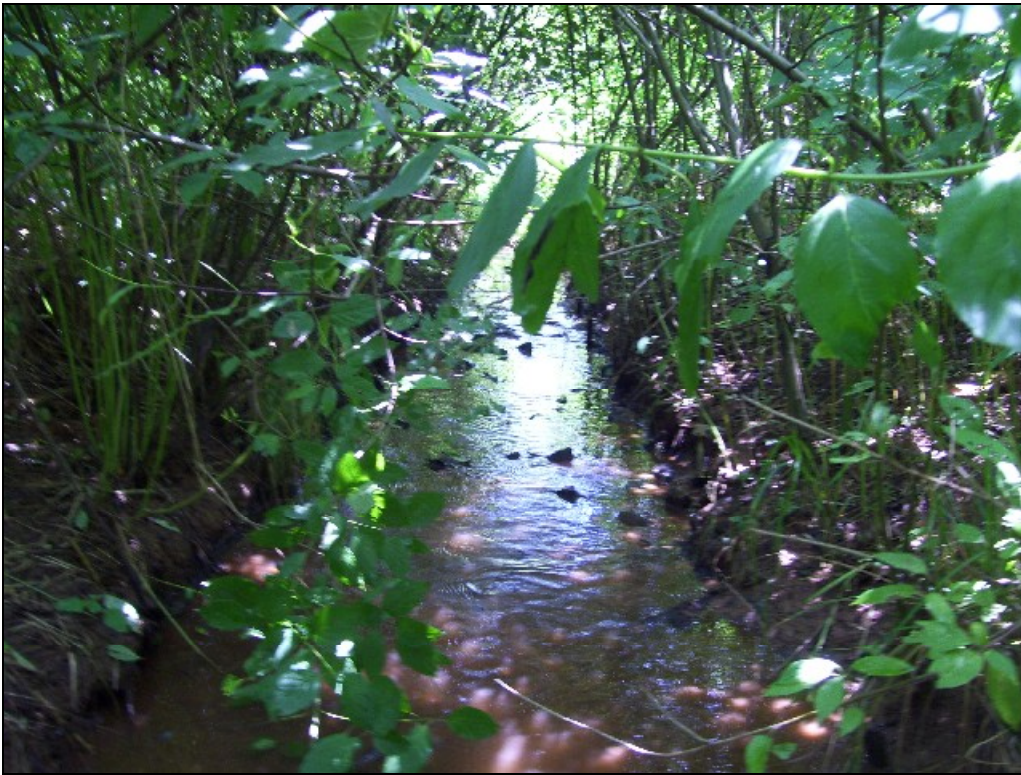
Typical narrow riffle with closed canopy

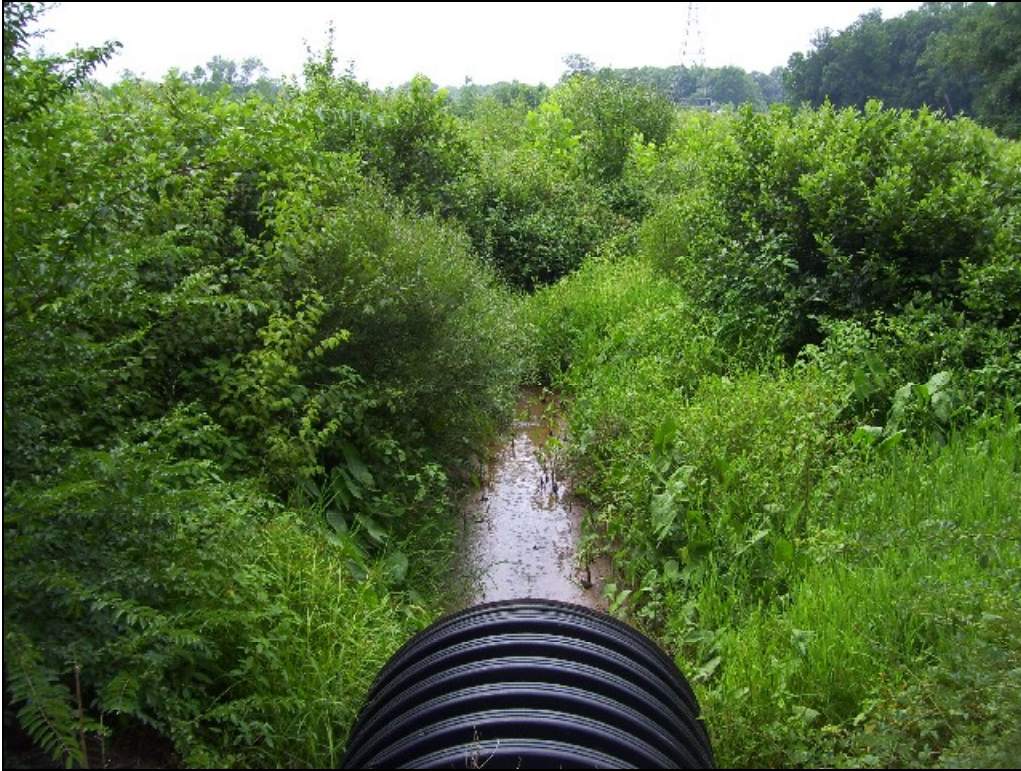
Typical densely vegetated banks

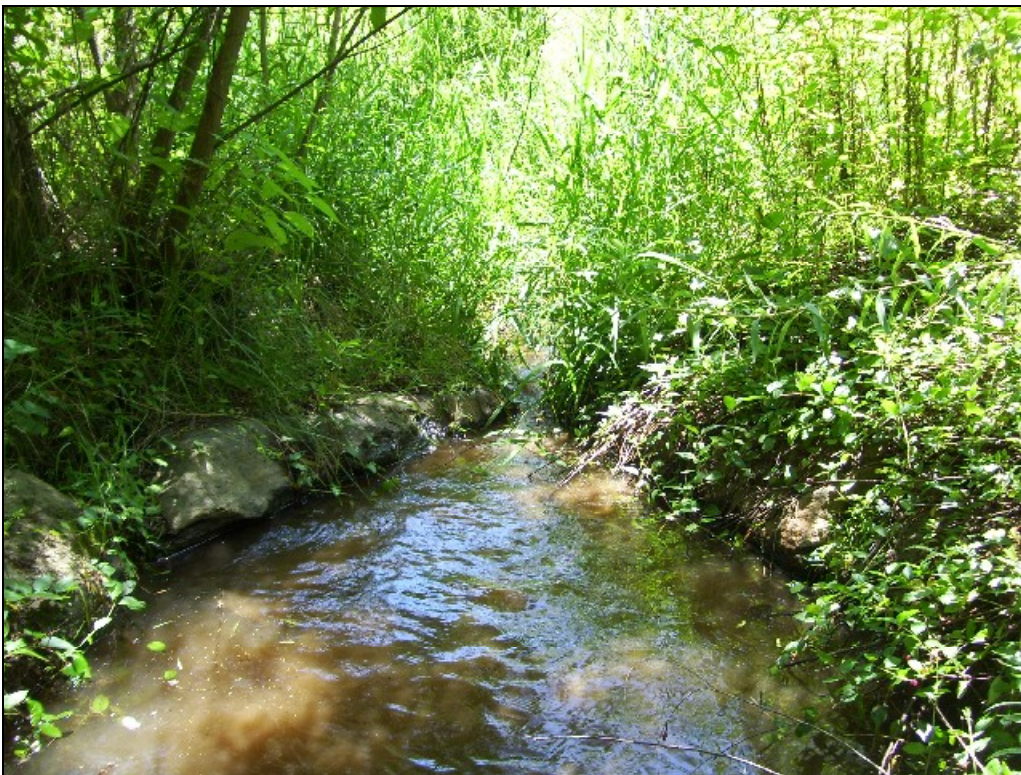
Typical stable and functional rock cross vane, well vegetated

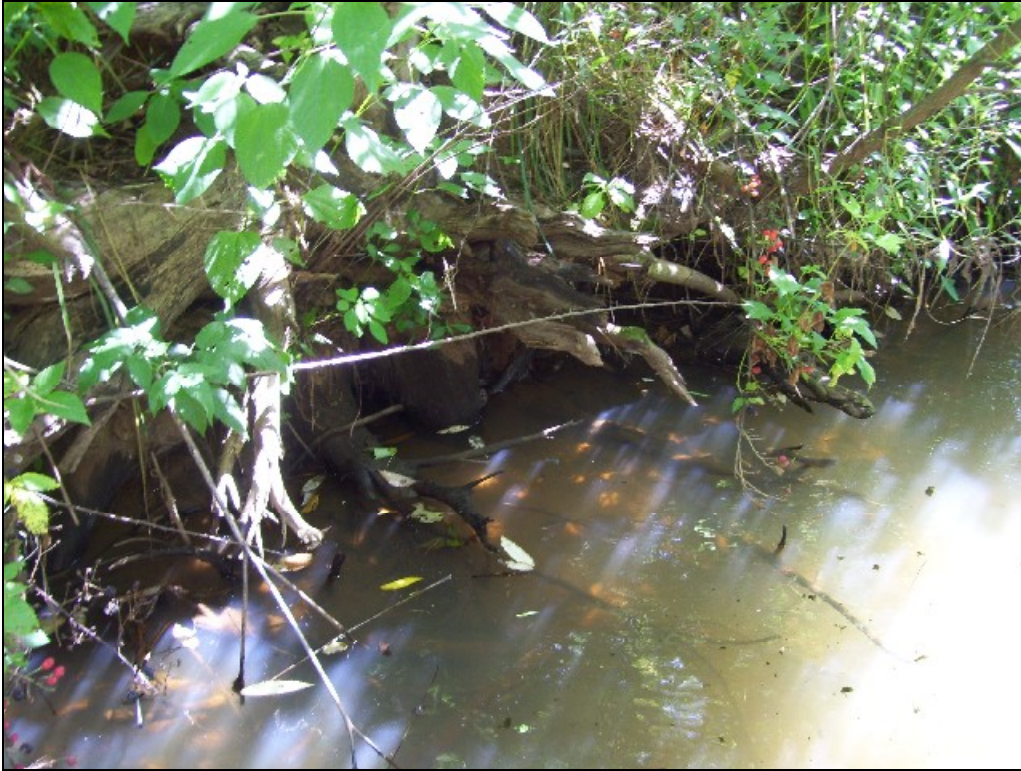
Typical stable and naturalized root wad
